GE-SSO-70SD4286
FEBRUARY 1, 1971

FINAL REPORT

DESIGN AND DEVELOPMENT OF
A THIRTY WATT PER POUND 250
SQUARE FOOT ROLL-UP SOLAR ARRAY

VOLUME I PROGRAM SUMMARY

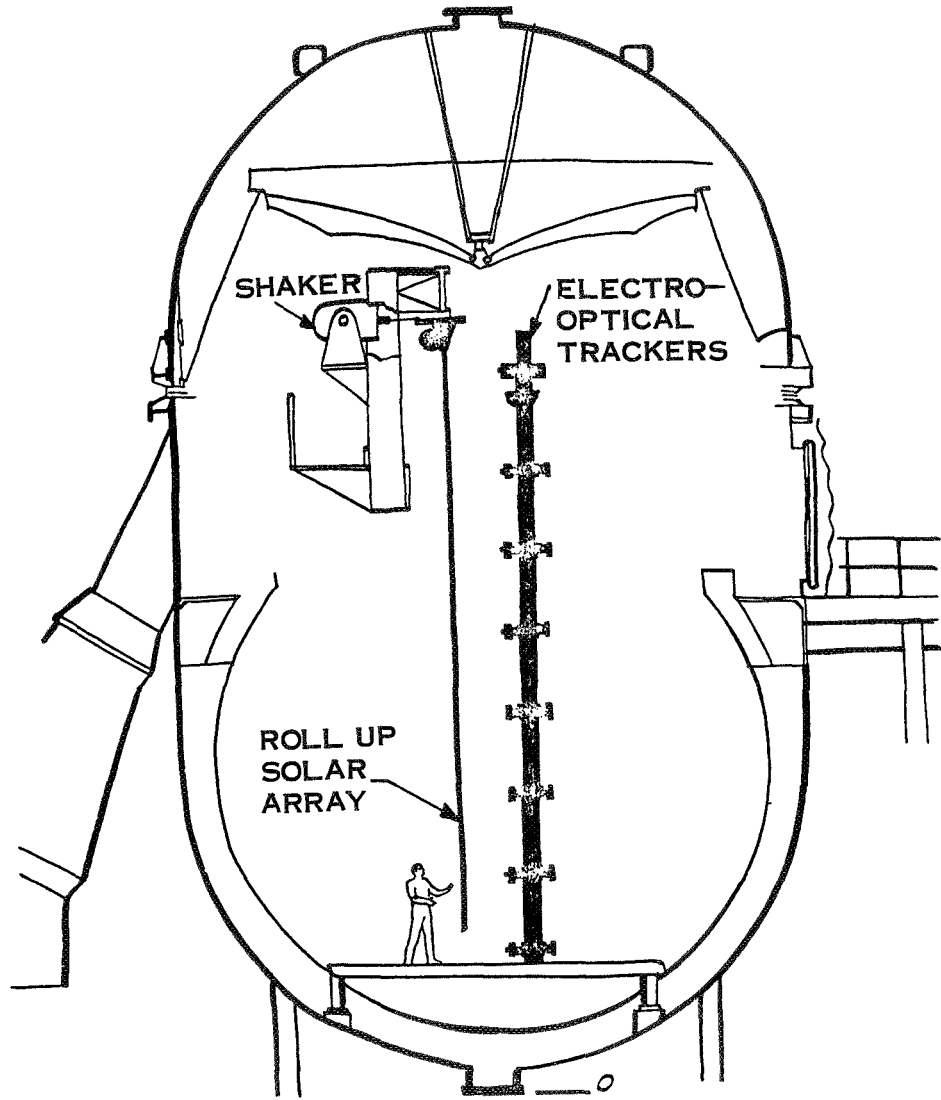
Figure 3.3-1. Deployed Dynamics Test Set-Up

The physical arrangement of the test is shown in Figure 3.3-1 which is a sketch of the cross section of the setup in the 32 foot by 54 foot Space Simulator at the General Electric Valley Forge Space Center. The locations of the optical trackers are conceptual and are not specifically correct with respect to location or number. The array is suspended from the support fixture which includes a linear bearing system that can be arranged to provide motion in either of two

directions in the horizontal plane or rotation about a vertical axis. The test data flow is shown in Figure 3.3-2.

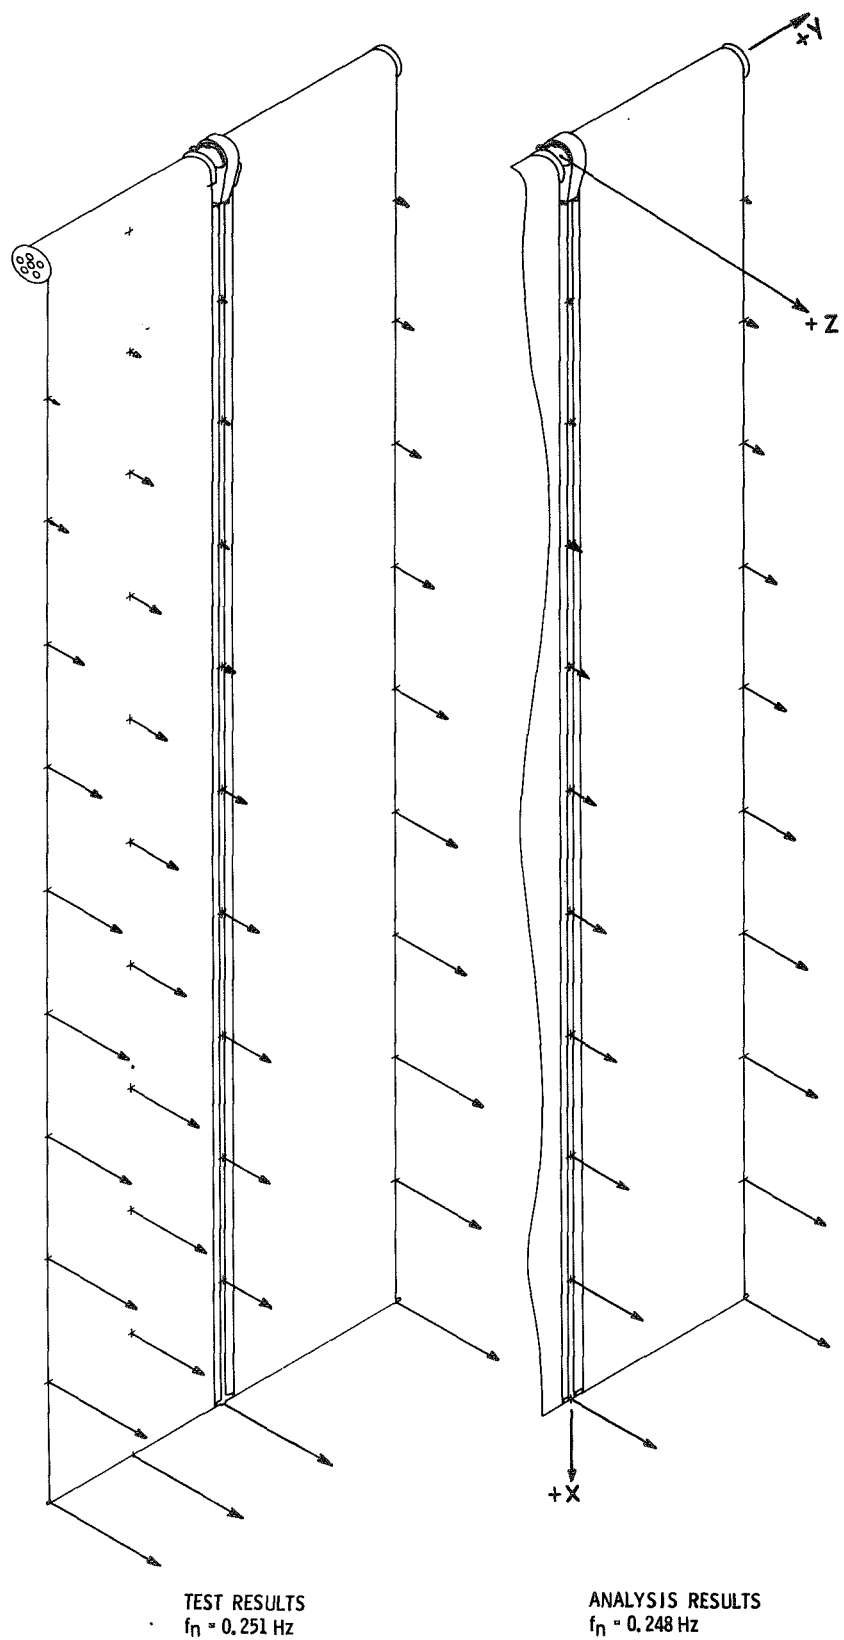
Figure 3.3-3 Mode Shape - First Mode-Out-of-Plane Symmetric Excitation

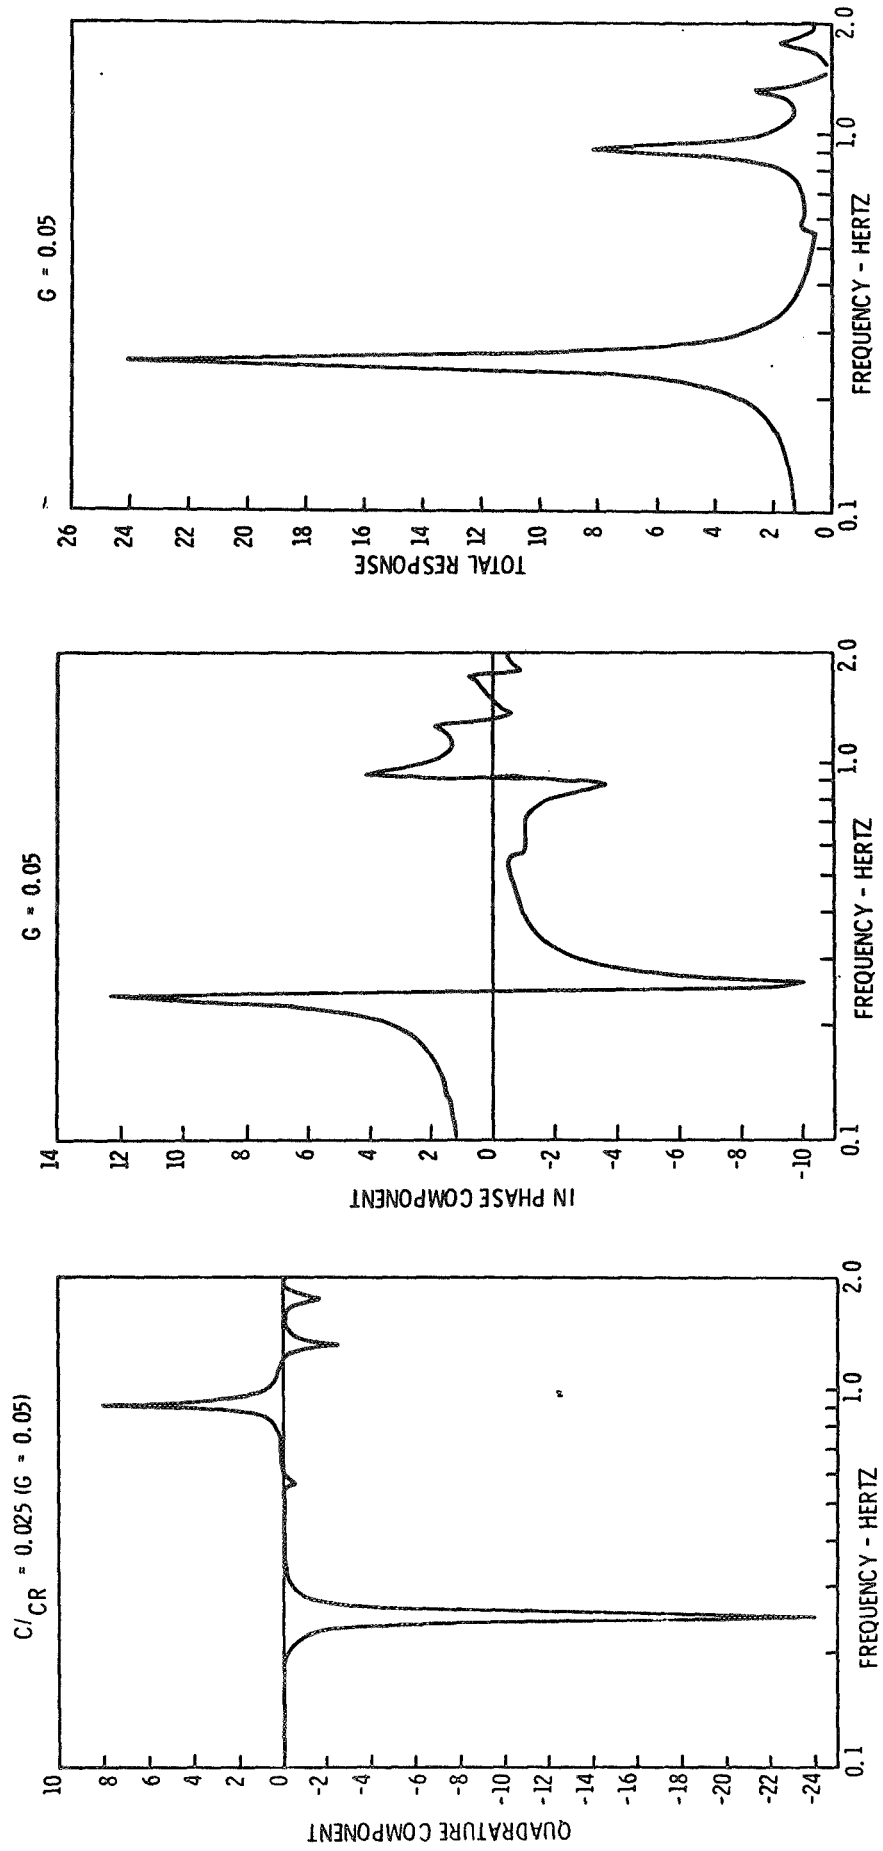
Figure 3.3-4. Predicted Response at Outboard Edge of Blanket (80% Span) Out-of-Plane Symmetric Excitation

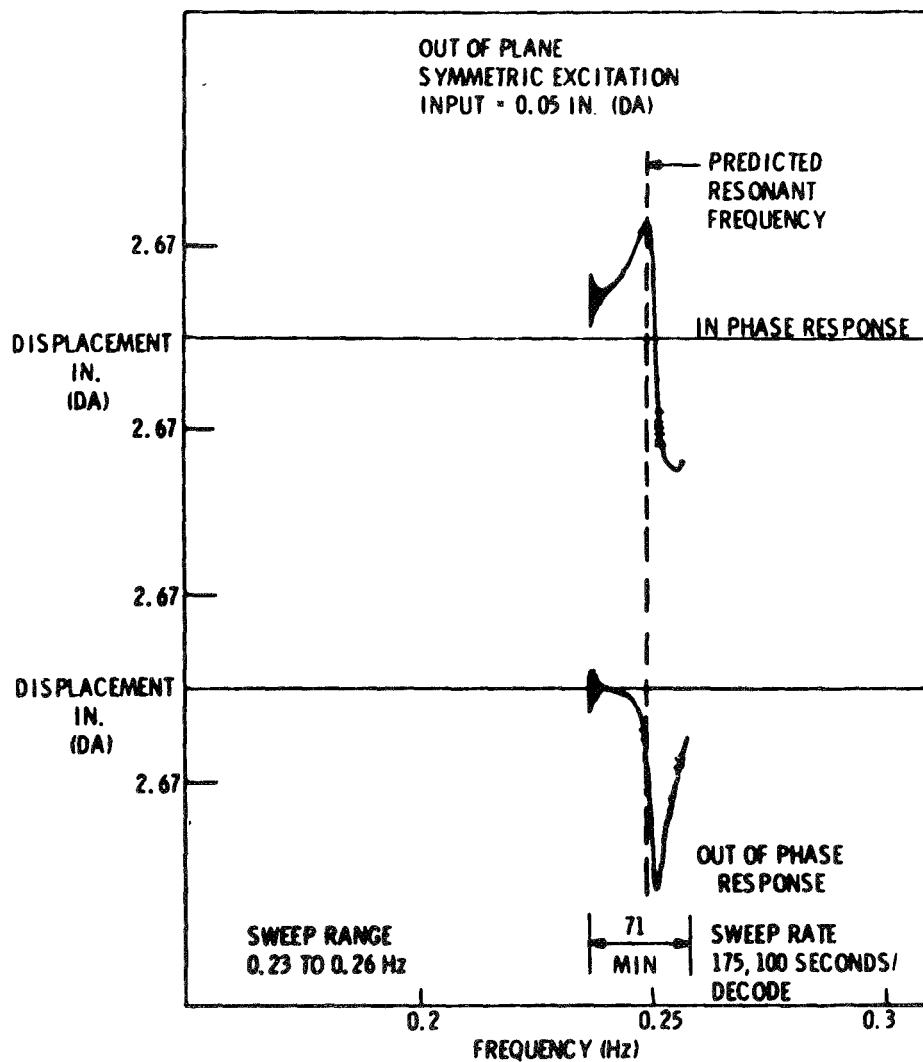
Figure 3.3-5. Results of Narrow Band Frequency Sweep
3-59

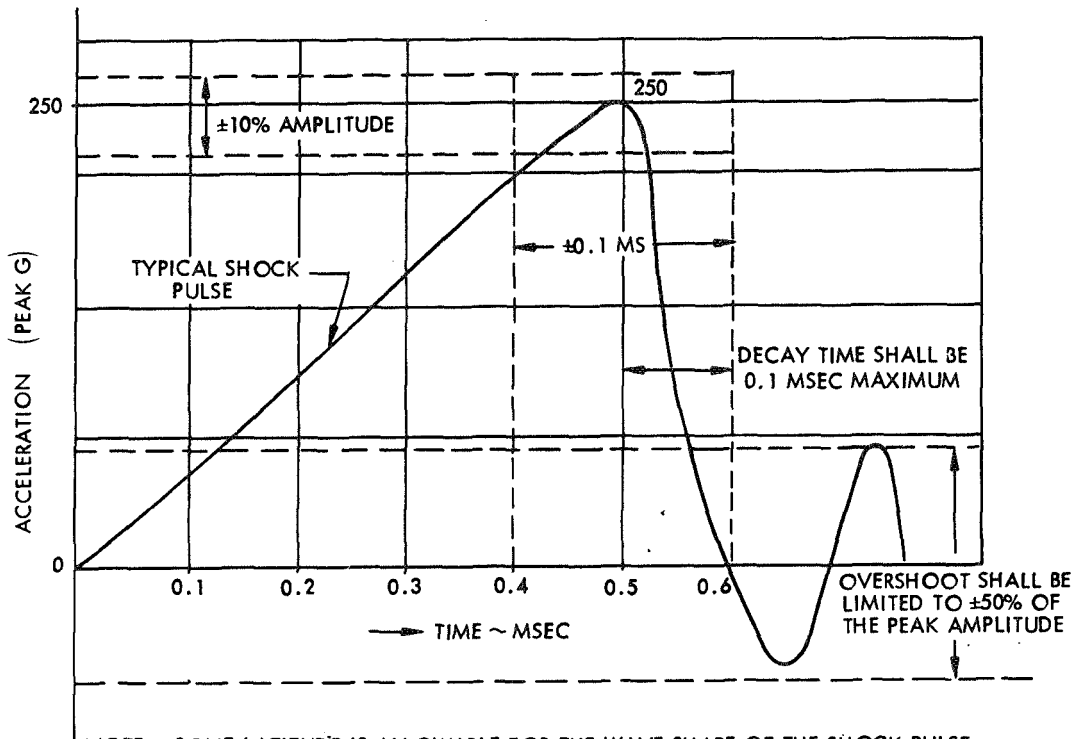
NOTE: SOME LATITUDE IS ALLOWABLE FOR THE WAVE SHAPE OF THE SHOCK PULSE. HOWEVER, IT IS DESIRABLE THAT THE SHAPE CONFORM TO THAT OF A TERMINAL PEAK SAWTOOTH AS NEAR AS PRACTICAL.

Figure 3.3-6. Shock Pulse

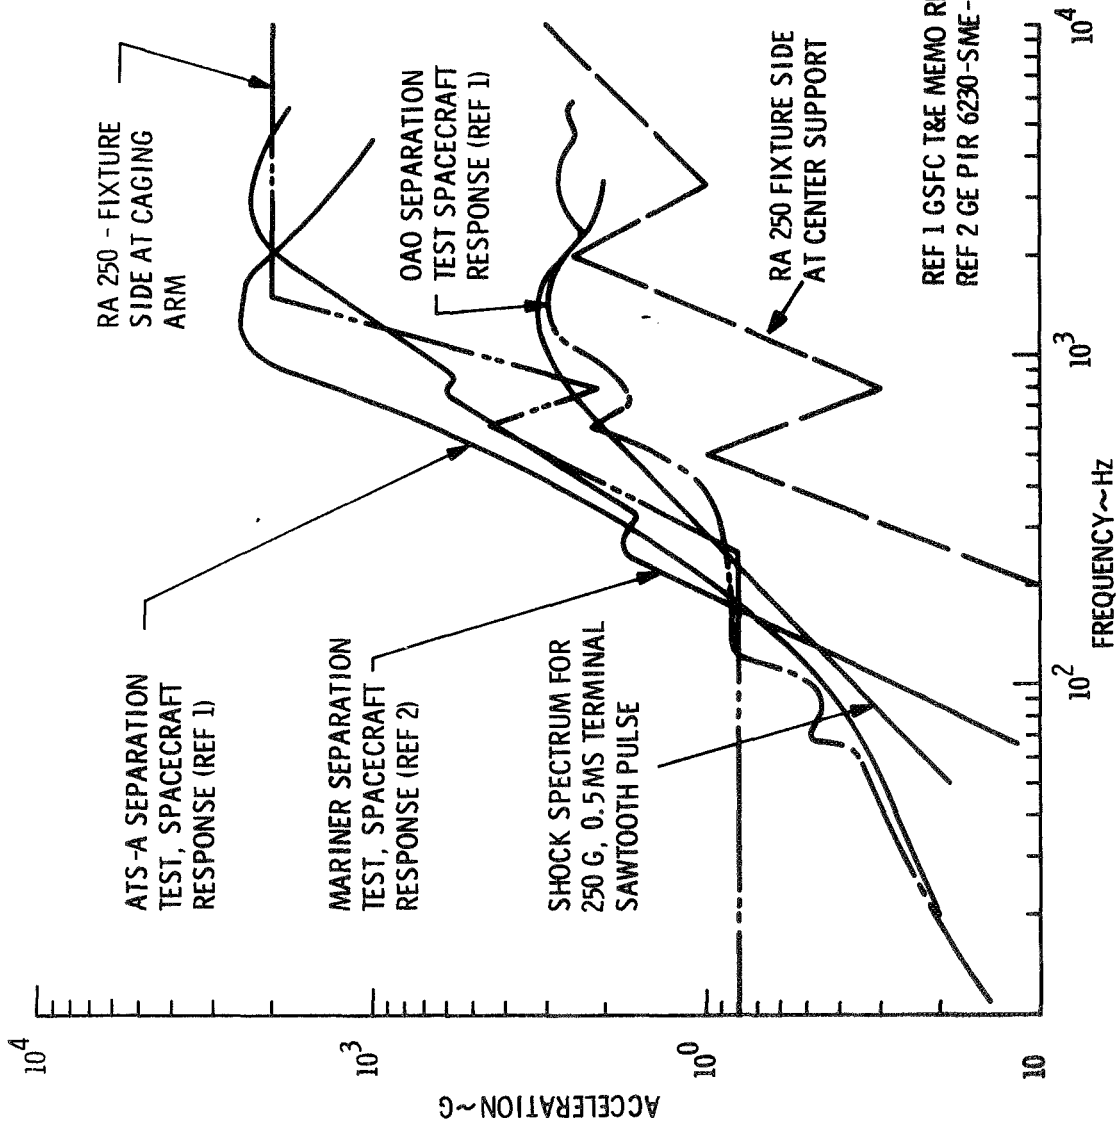
Figure 3.3-7. Comparison of Various Spacecraft Separation Shock Spectra with the RA250 Specification and Realized Shock Spectra

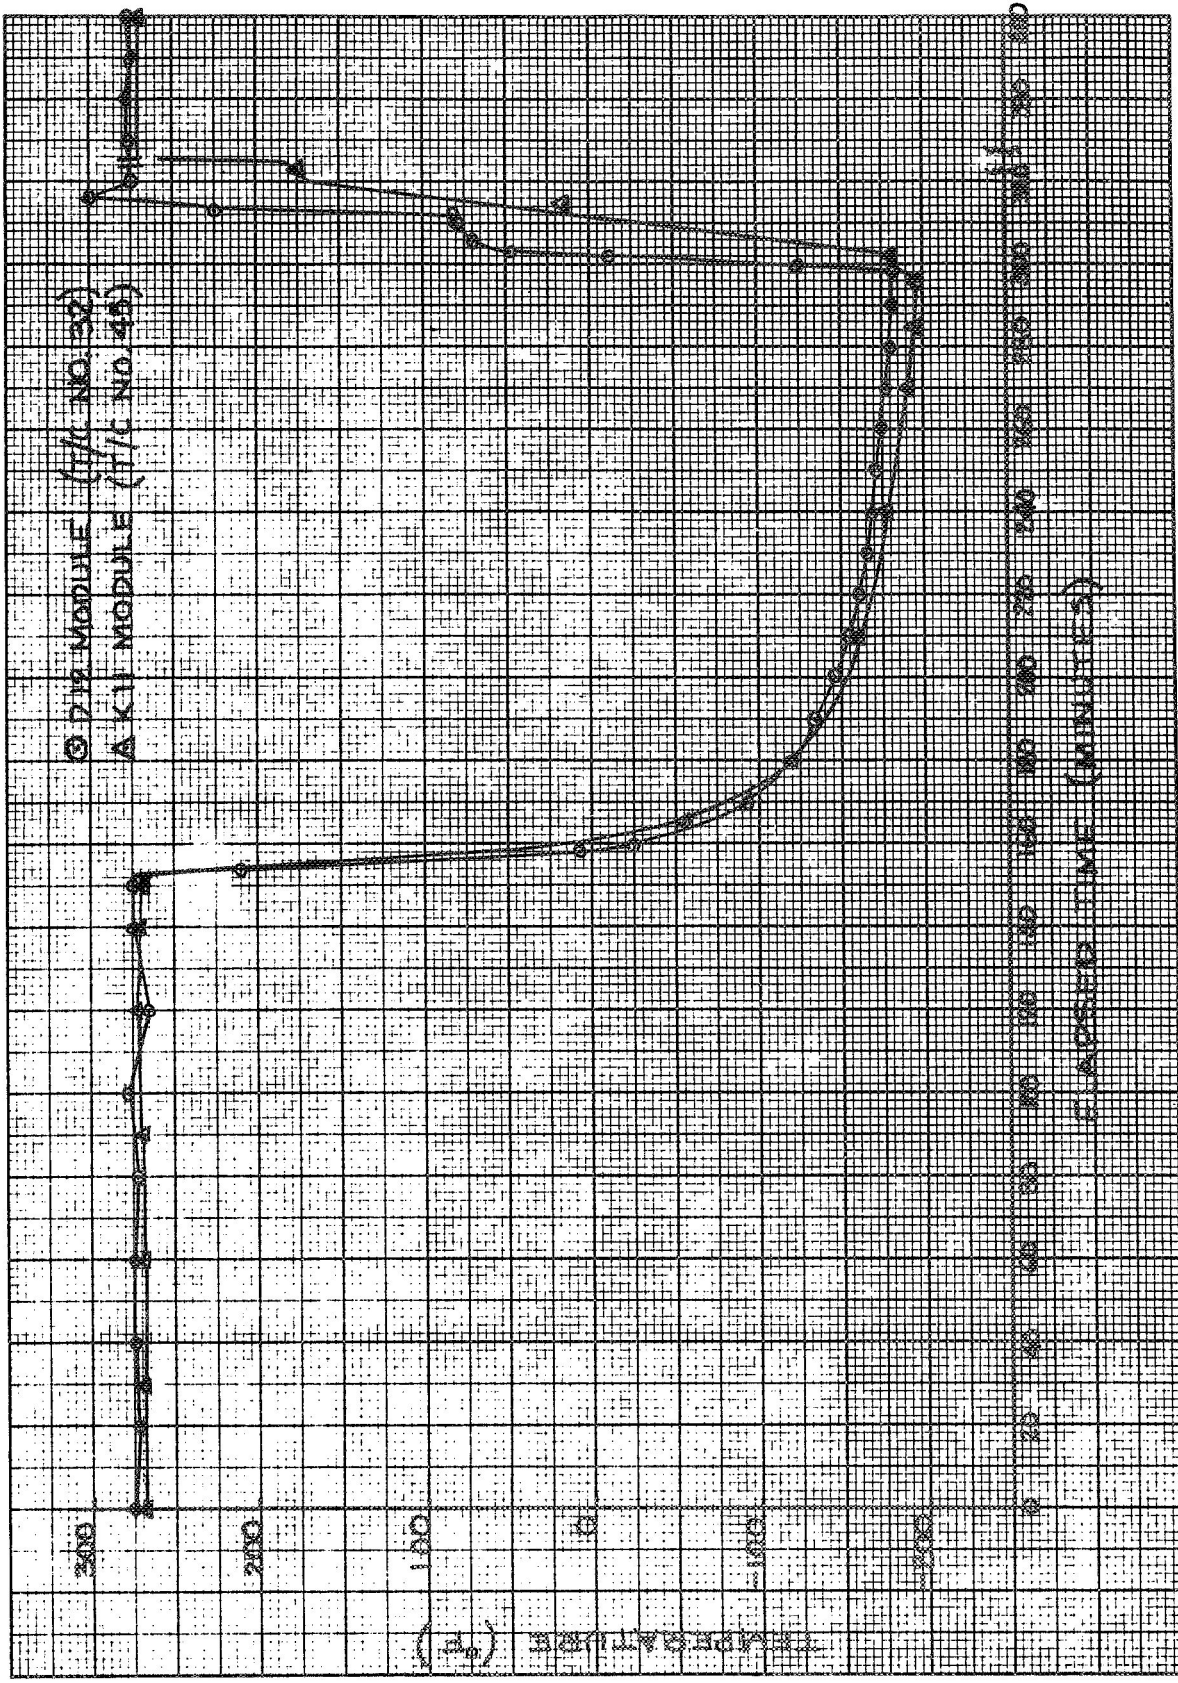
Figure 3.3-8 Deployed Transient Temperature History

The deployed array transient test was performed without incident. An example of the temperature vs. time histories for two active solar cell modules are shown in Figure 3.3-8. All active solar cell modules had similar transient response temperature histories. In all cases, the warm-up to +284°F was performed by first turning on the lamps at a very low voltage to allow the filaments to heat up before applying full voltage. This procedure was necessary to avoid blowing fuses as a result of the high inrush current associated with the cold lamp filaments. This turn on procedure caused the step-like appearance of the temperature rise plots for active solar cell modules.

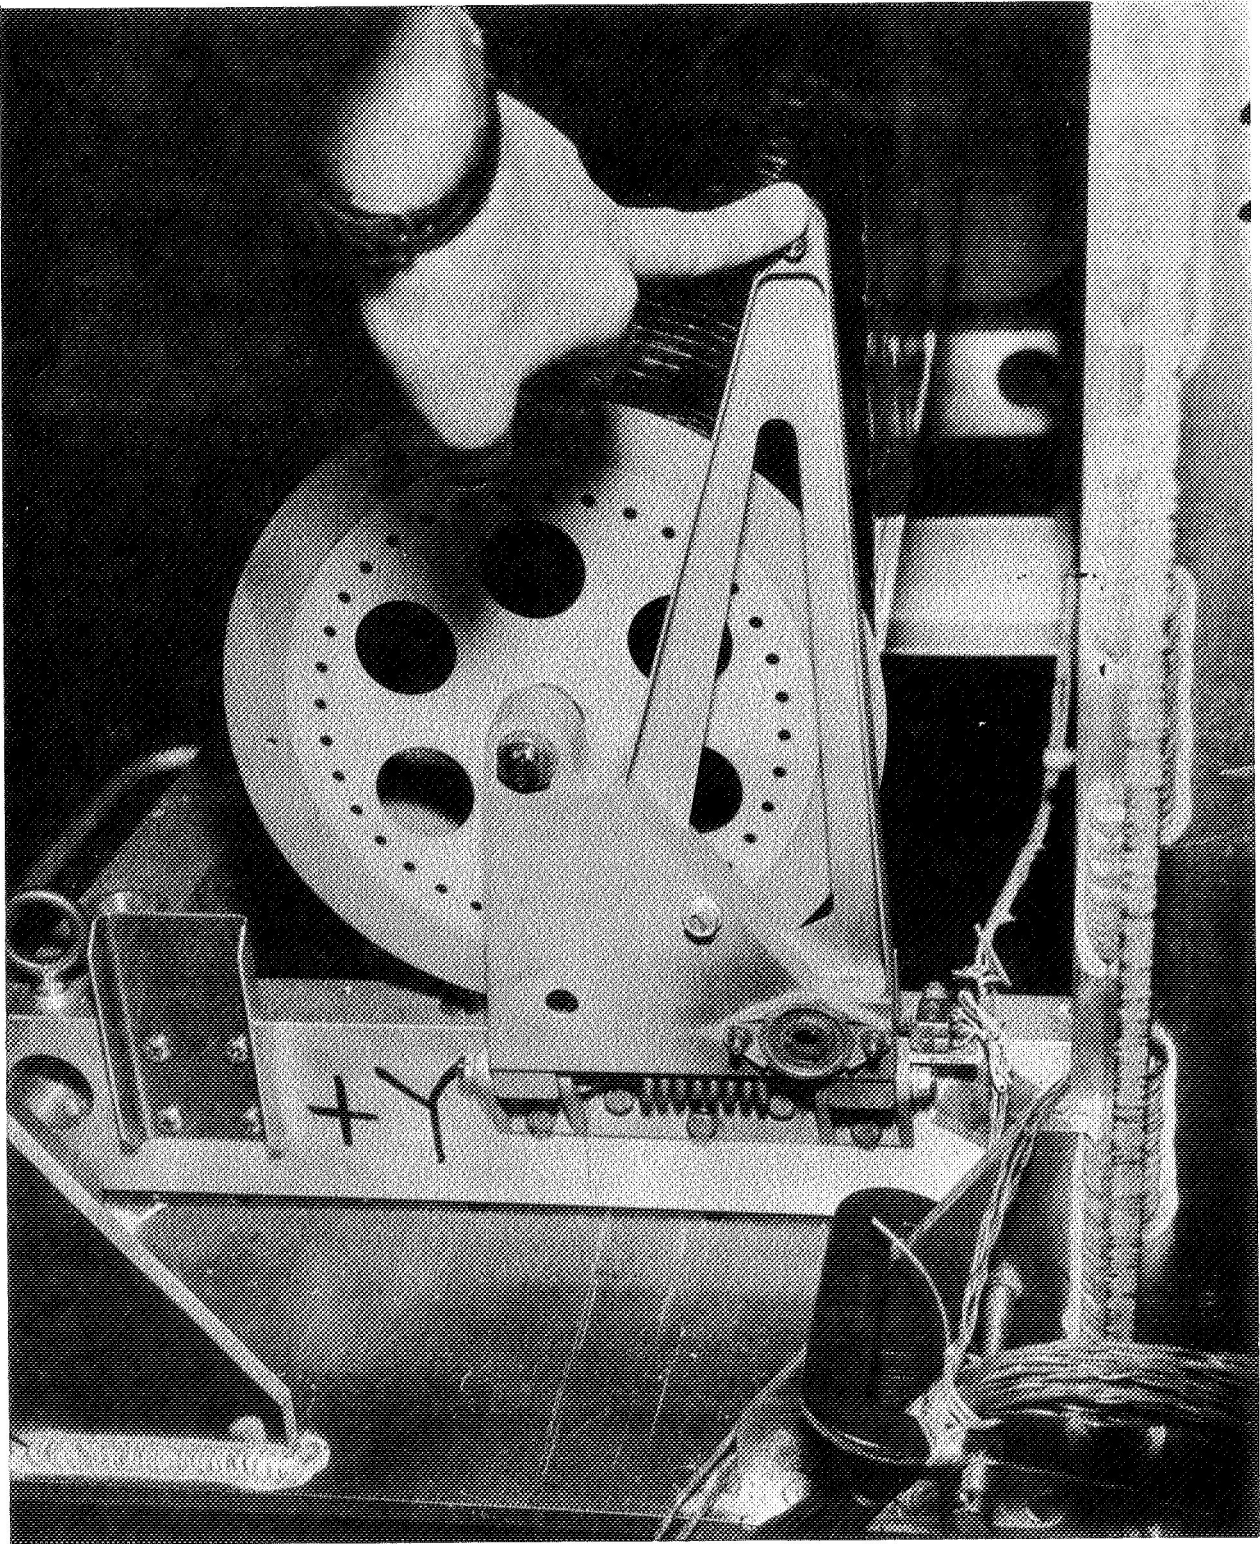
Figure 3.3-9. Outboard End Support Showing Fractured Separation Nut Mounting Base (VF 70224B)

1. Both separation nuts fractured at the mounting flange during the outboard end support release immediately prior to the low temperature deploy/retract cycle.
2. The array blankets failed to rewrap properly on the storage drums during the low temperature retraction test. Post test inspection showed that a pull-away thermocouple wire had tangled with the Y drum.
3. A localized heating condition occurred during the high temperature stowed test. This anomaly is attributed to a "greenhouse" phenomenon which resulted when visible and near-infrared energy from the

The low temperature deployment of the array was initiated by the simultaneous firing of both squibs in each separation nut. The temperature recorded on a thermocouple located on the outboard end support adjacent to the -Y separation

nut was -76°F at the time of firing. An audible report was heard in the control room and a flash was seen on the closed circuit T.V. screen. Outboard end support release was verified by the signal from the microswitches at each end. Post test inspection of the test specimen revealed that both separation nuts had completely fractured at the mounting base (see Figure 3.3-9) and had been propelled against the cryopanel. The loose parts of the separation nuts (see Figure 3.3-10) were found in the bottom of the chamber completely detached from the electrical harness.

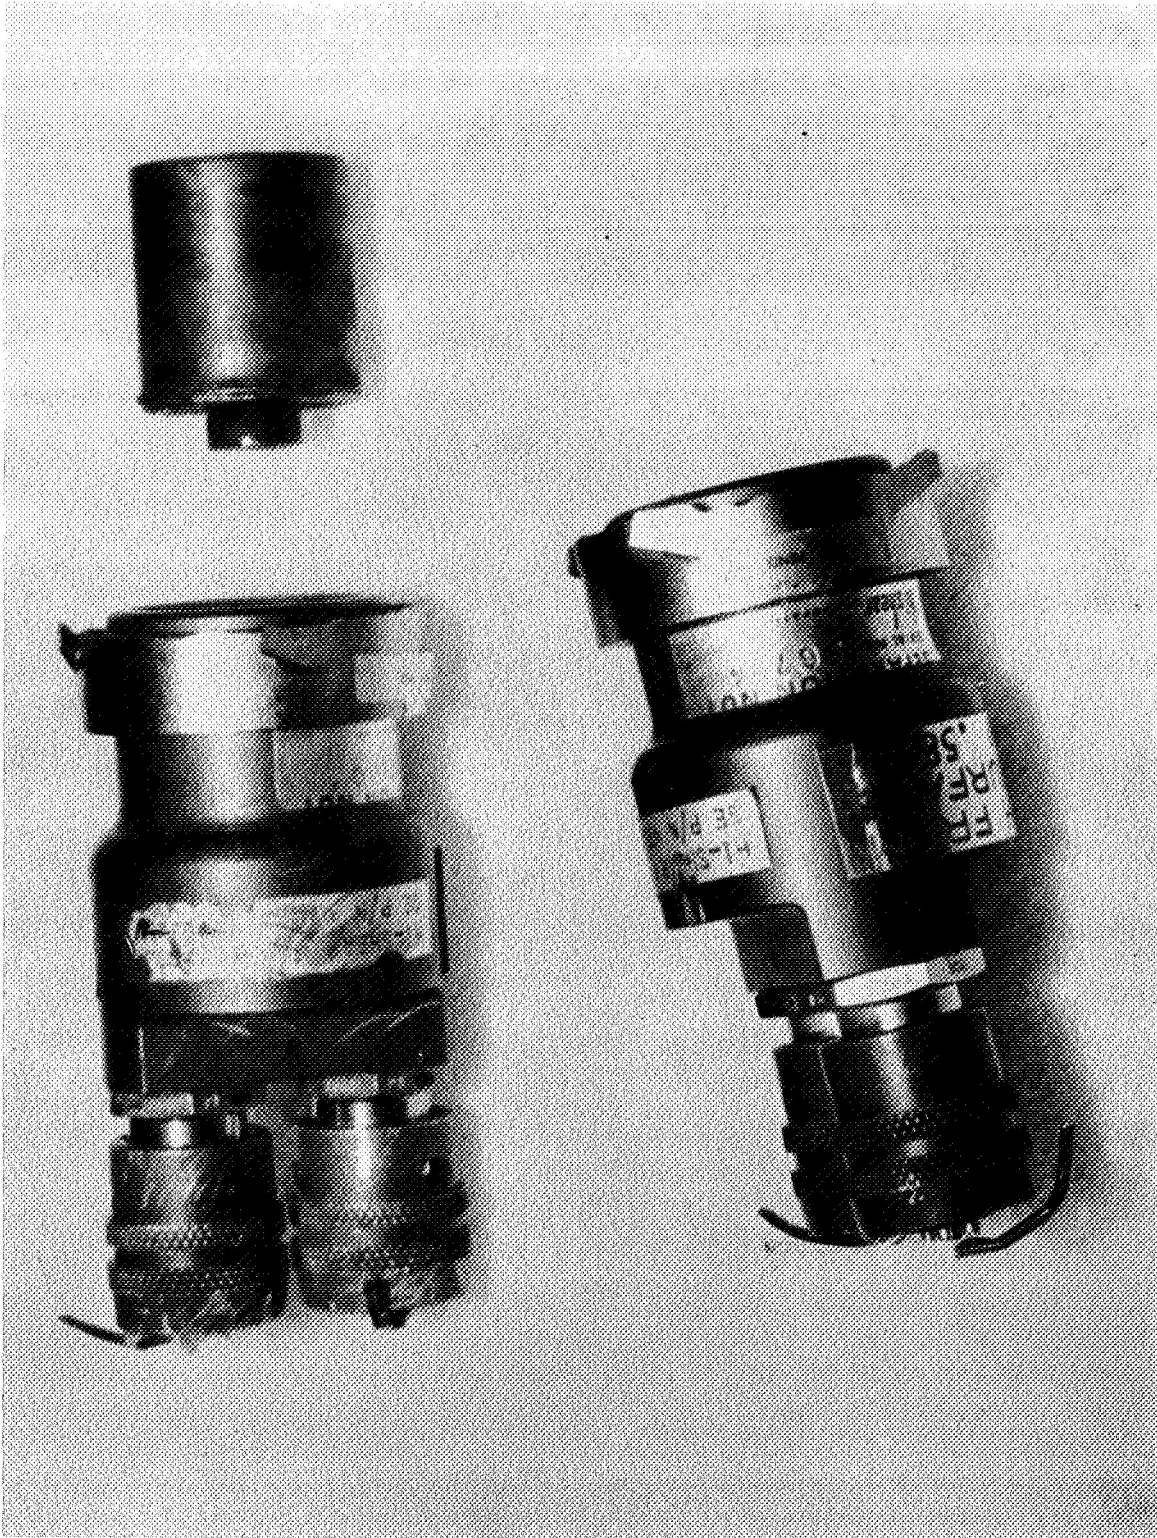
Figure 3.3-10. Both Separation Nuts with Fractured Mounting Bases (VF 70244C)

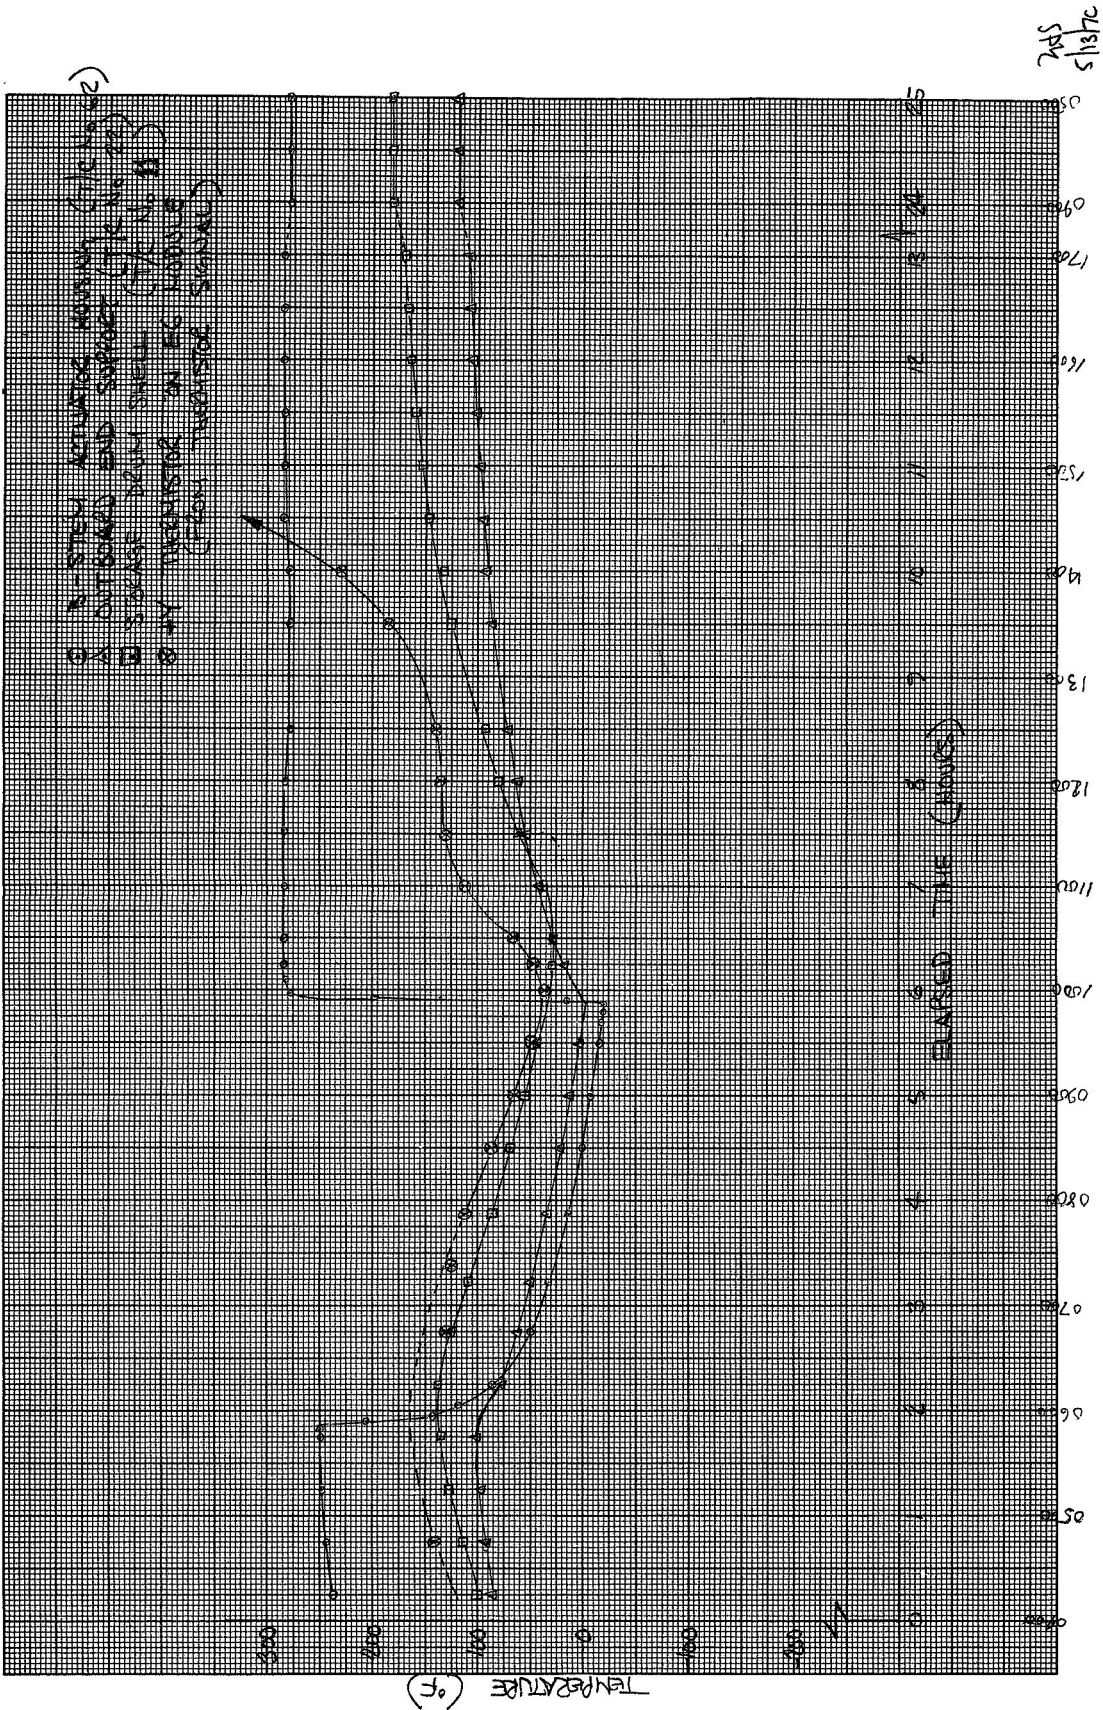
Figure 3.3-11. Stowed Transient Temperature History

Some typical results of the stowed transient test are shown in Figure 3.3-11. Subsequent post test inspection of both array blankets revealed that localized heating of the blanket had occurred as a result of the high temperature stowed test. Areas of scorched adhesive were indicative of temperatures in excess of 350°F. Two active solar cell modules were situated within an overheated area at the same longitudinal station on the blankets. One of these modules (J6) suffered extensive lifting of the interconnect top contact feet due to solder melting in the overheated area. The cause of this overheating is discussed in Volume II, Section 4.4.5.6.

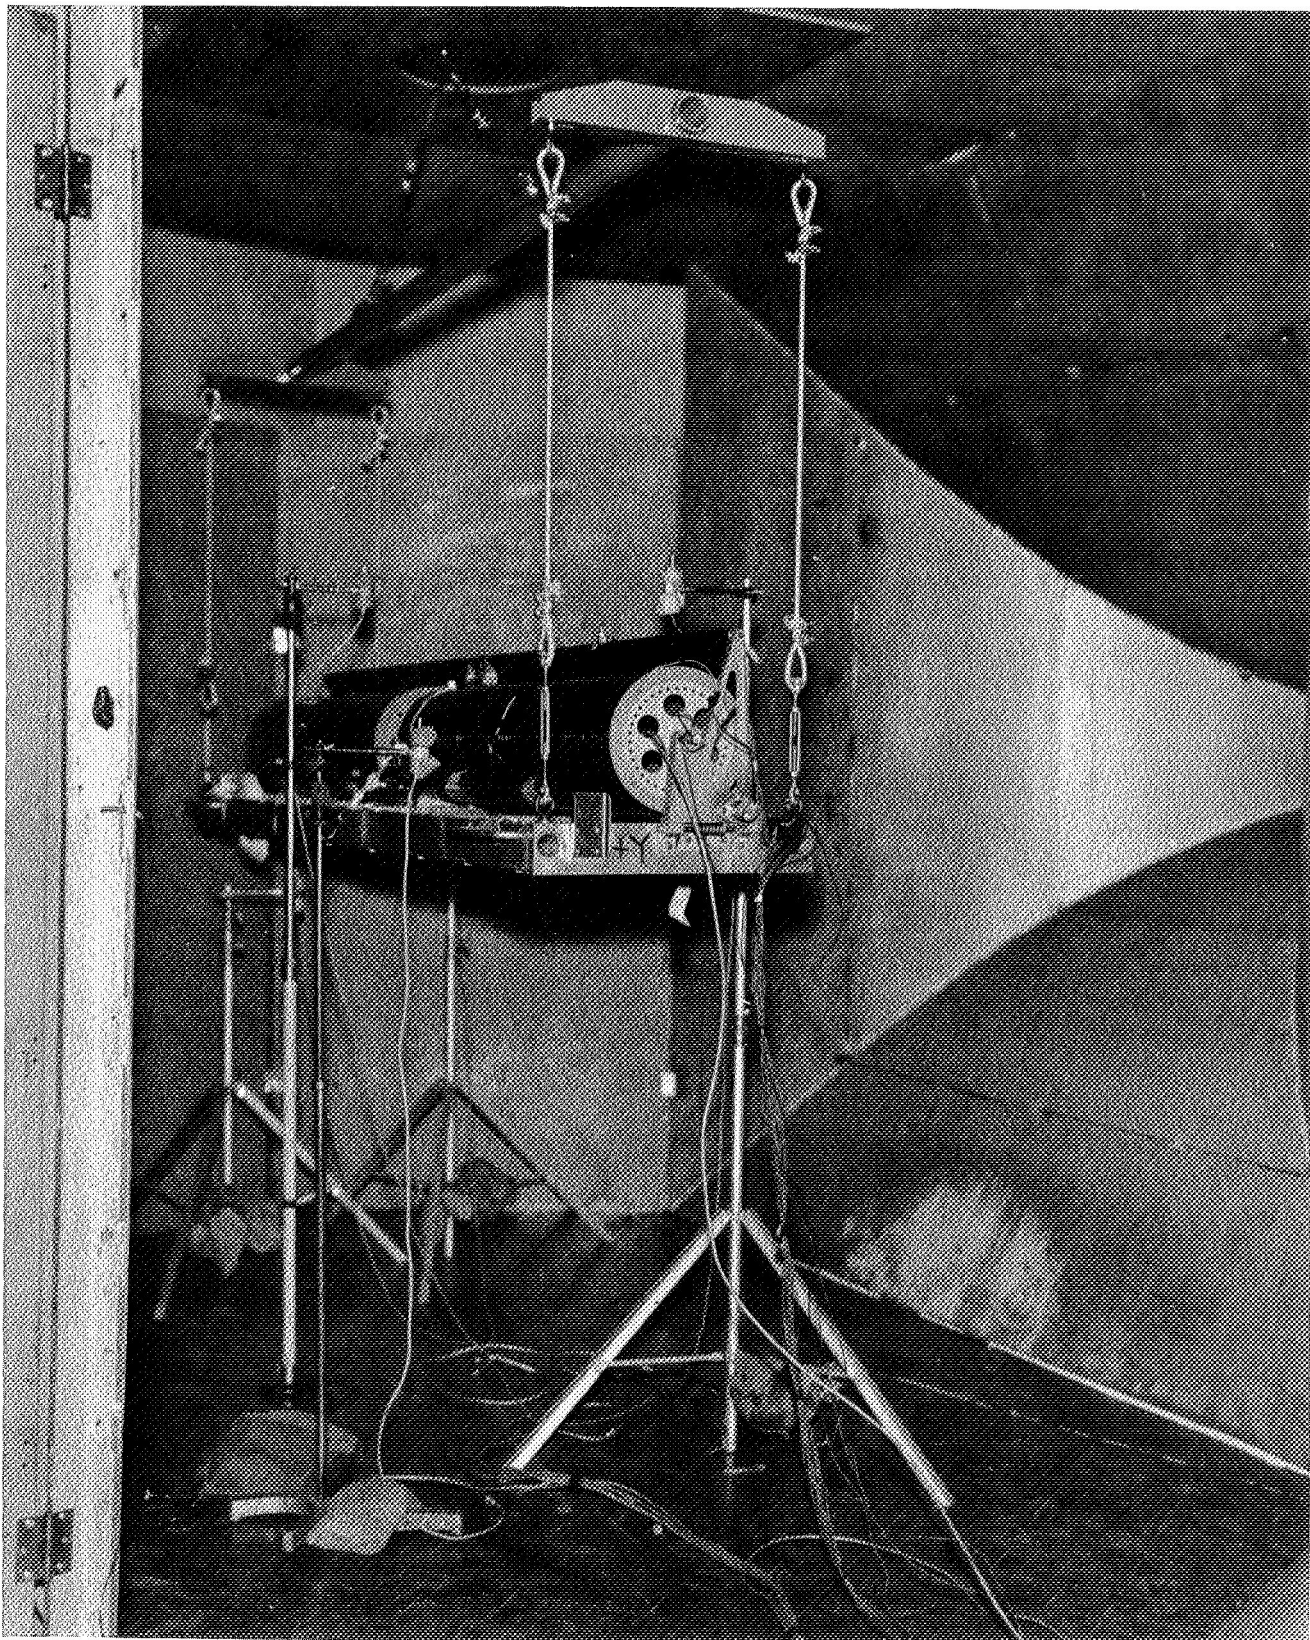
Figure 3.3-12. View of the Rollup Solar Array Installed in the Acoustic Chamber (C 70-0115-A)

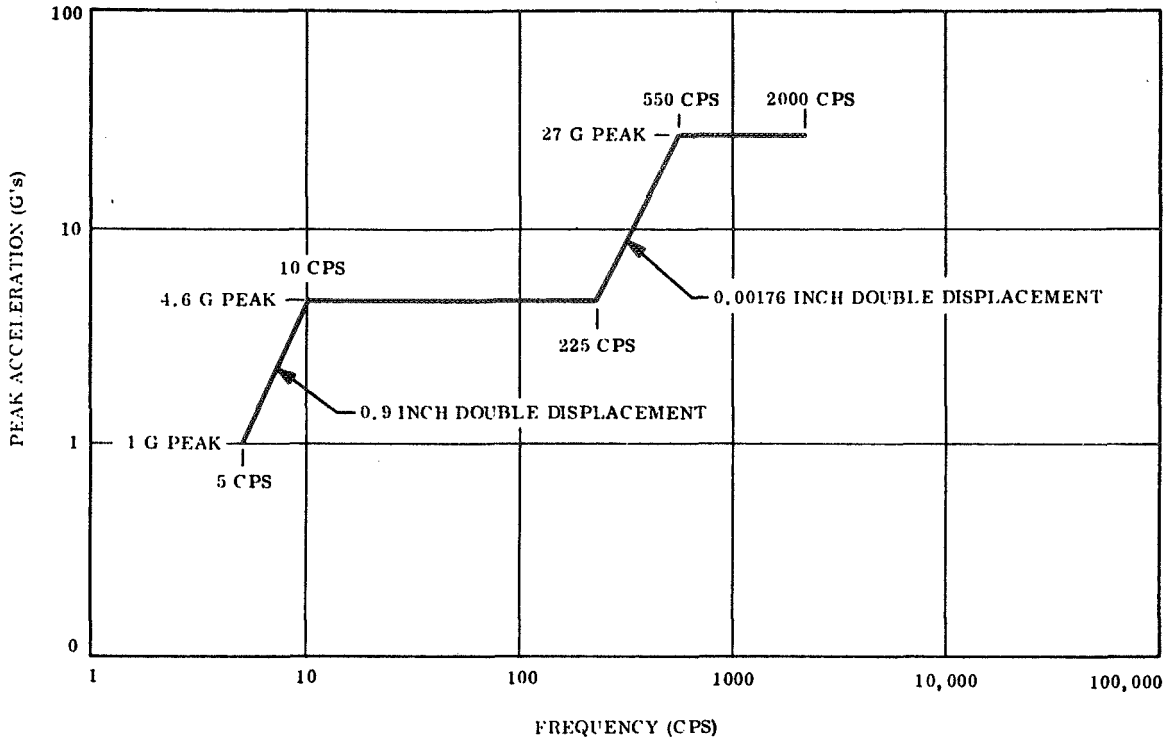
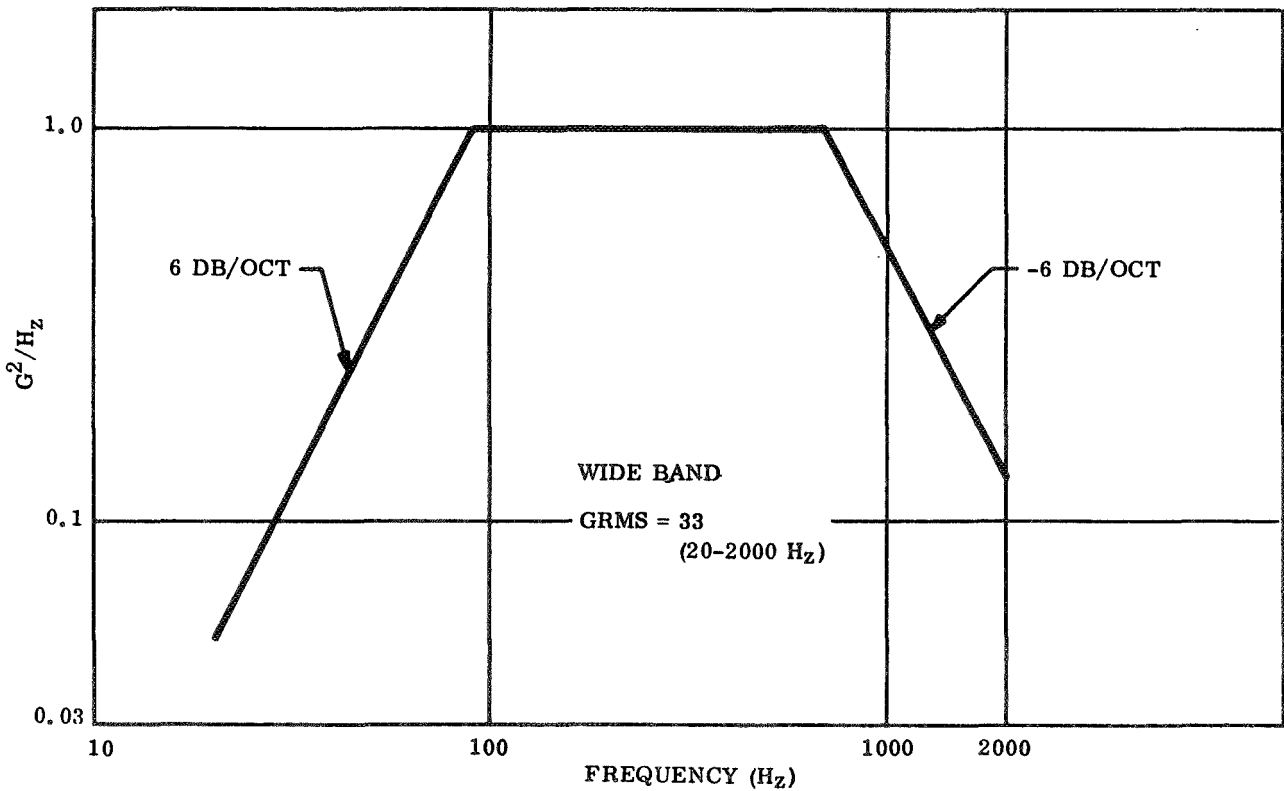
(a) Sinusoidal Vibration

(b) Random Vibration Noise Plot

The object of this test series was to subject the stowed array to qualification levels sinusoidal and random vibration spectra as defined in Figure 3.3-14. In addition, low level sinusoidal sweeps were performed to locate stowed array resonant modes below 100 Hz. A detailed discussion of this test is contained in Volume II, Section 4.7.

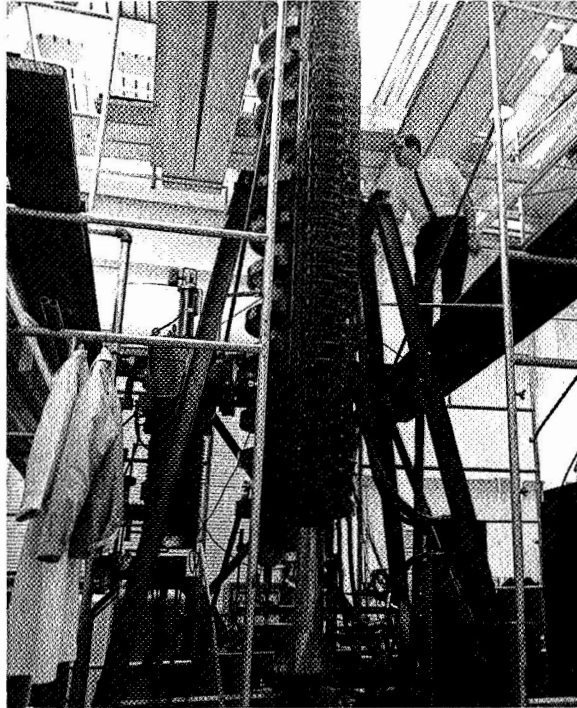
Figure 3.4-1 Thermal Bending Test Setup (NASA G-69-4536)

Over the past two years, NASA/GSFC has employed this facility in the development of a technique for measurement of gravity gradient rod deflections under the influence of solar heating. The RA250 BI-STEM is one of many boom configurations tested by NASA/GSFC. Results of the entire boom deflection study will be published by NASA/GSFC on completion of this program of boom investigations.

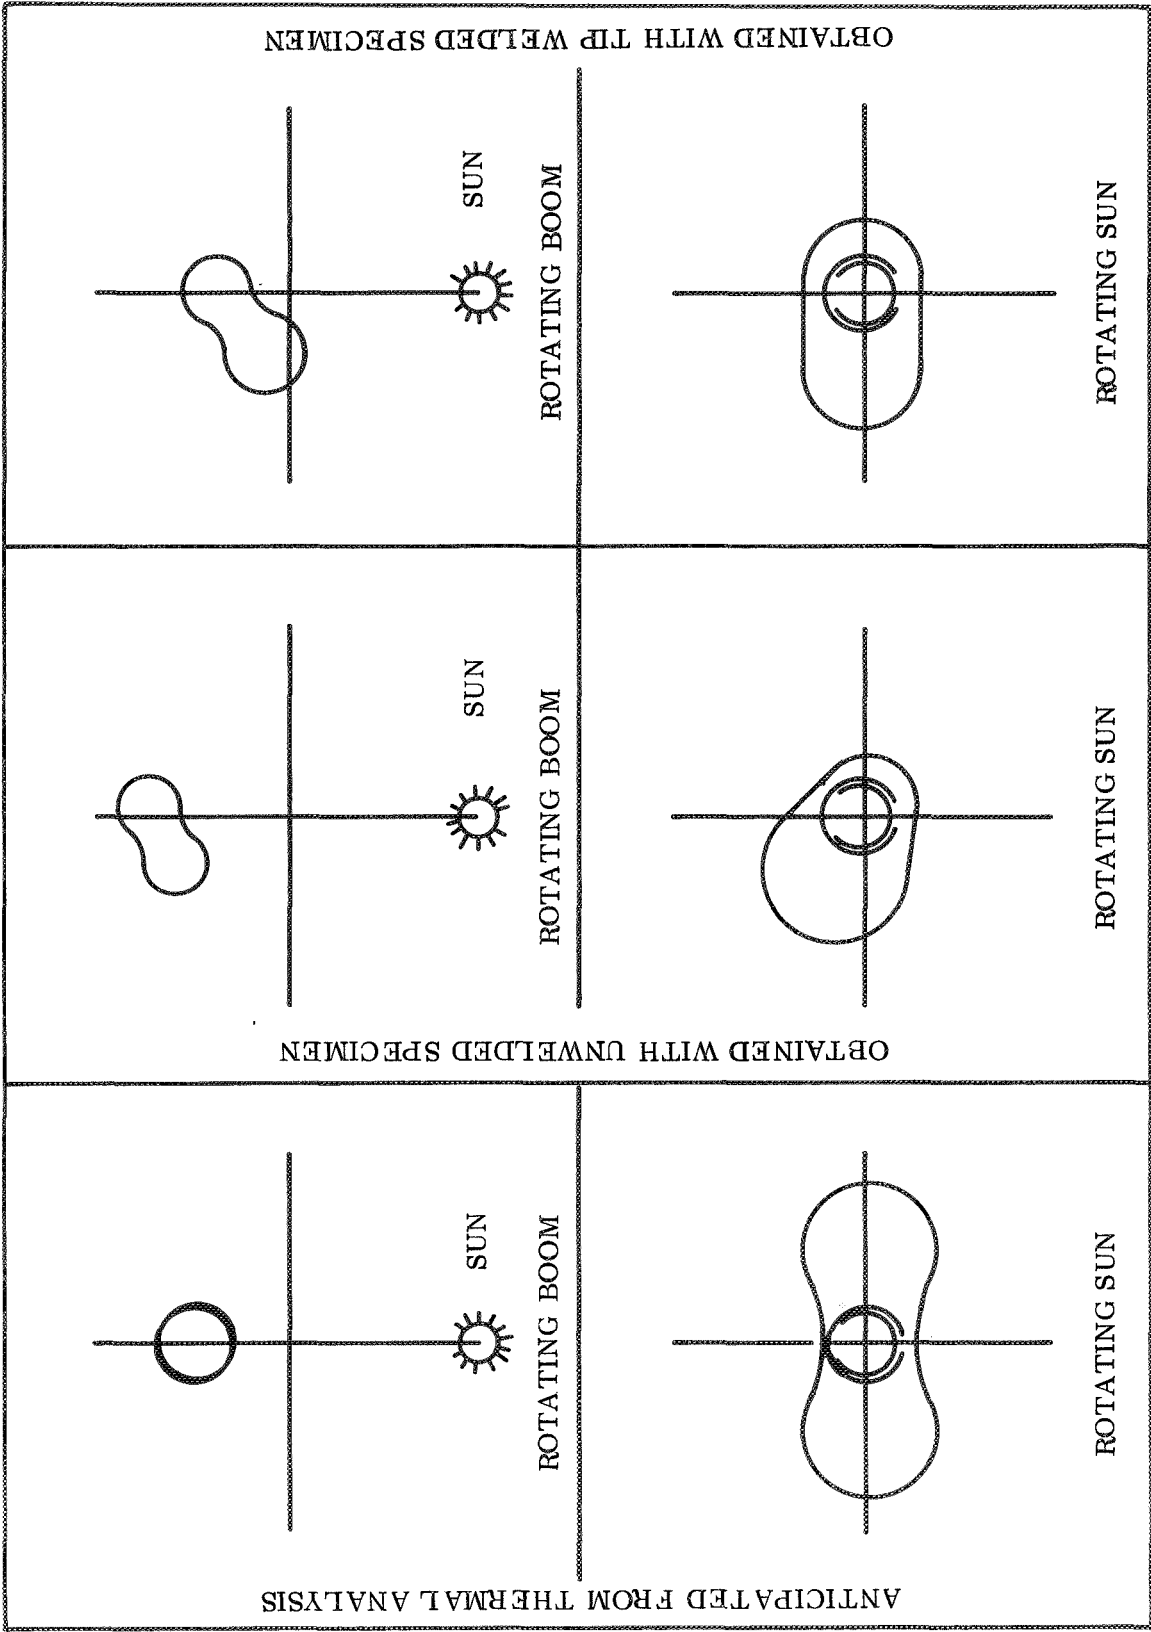
Figure 3.4-2 Idealized Tip Deflection Patterns

When the maximum absolute value of the zero-g thermal deflections indicated on Figure 3.4-3 are added to the BI-STEM vertically deployed tip deflections measured during SPAR actuator acceptance tests, the following apparent maximum total tip deflections occur:
