GE-SSO-70SD4286
FEBRUARY 1, 1971

FINAL REPORT

DESIGN AND DEVELOPMENT OF
A THIRTY WATT PER POUND 250
SQUARE FOOT ROLL-UP SOLAR ARRAY

VOLUME I PROGRAM SUMMARY

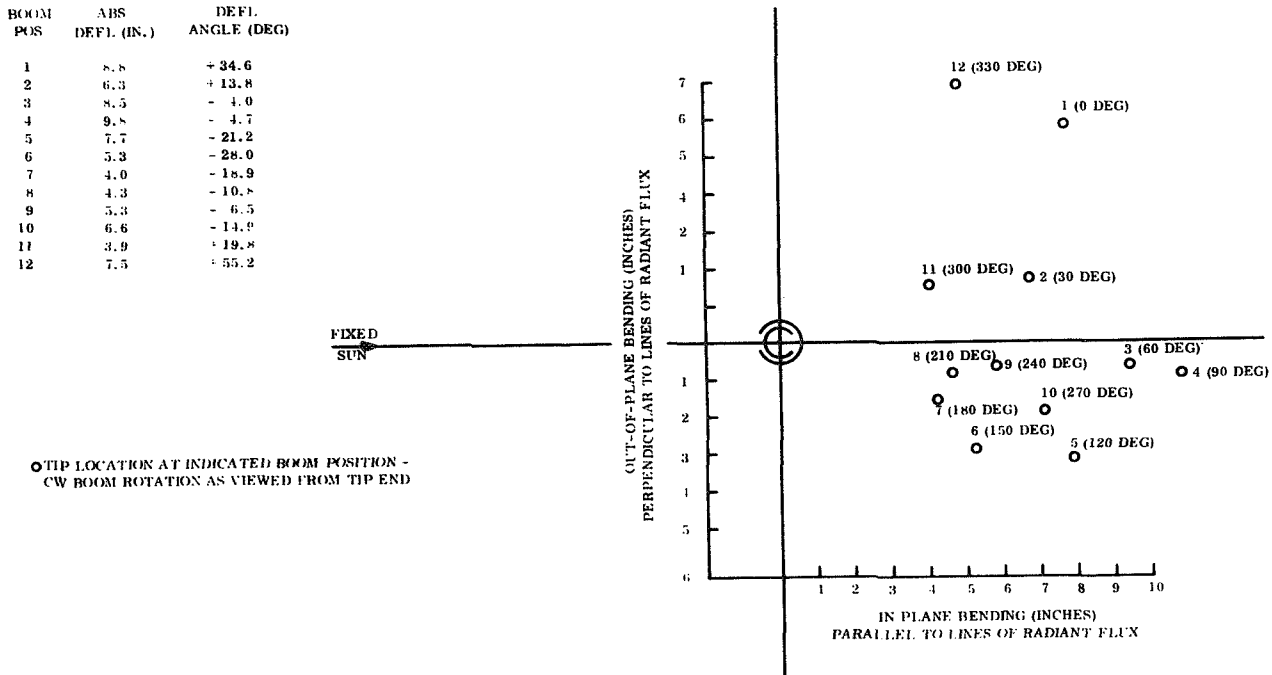
TEST CONFIGURATION
 1.34 IN. DIA BI-STEM SILVER PLATED OD
 10 FT LONG, 301 STAINLESS ELEMENTS
 NOT WELDED AT TIP

Figure 3.4-3 Extrapolated Absolute Zero-G Bending at 33.5 Ft.²

When the maximum absolute value of the zero-g thermal deflections indicated on Figure 3.4-3 are added to the BI-STEM vertically deployed tip deflections measured during SPAR actuator acceptance tests, the following apparent maximum total tip deflections occur:

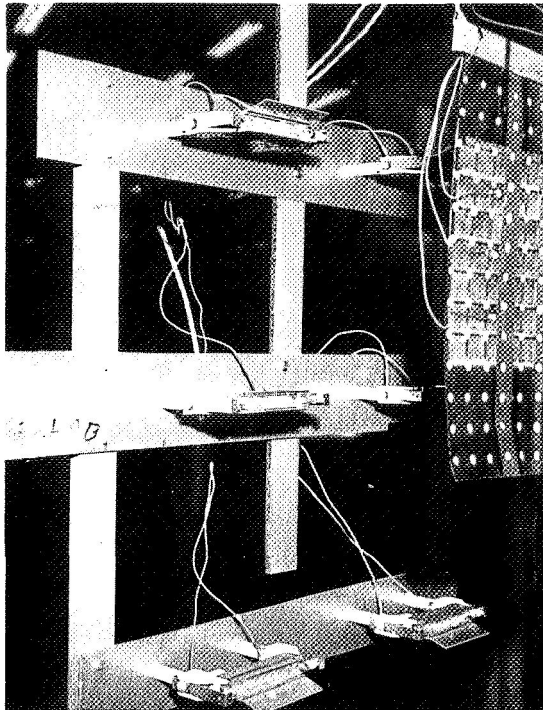
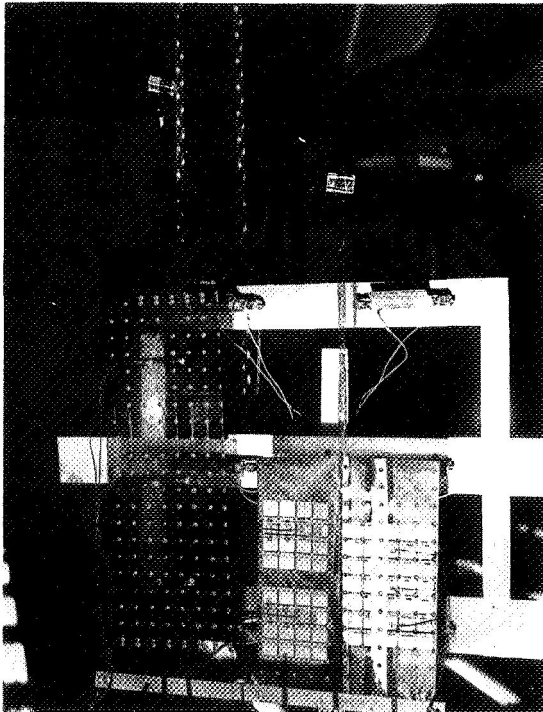
Figure 3.4-4. Thermal Cycling Module Test Set-Up

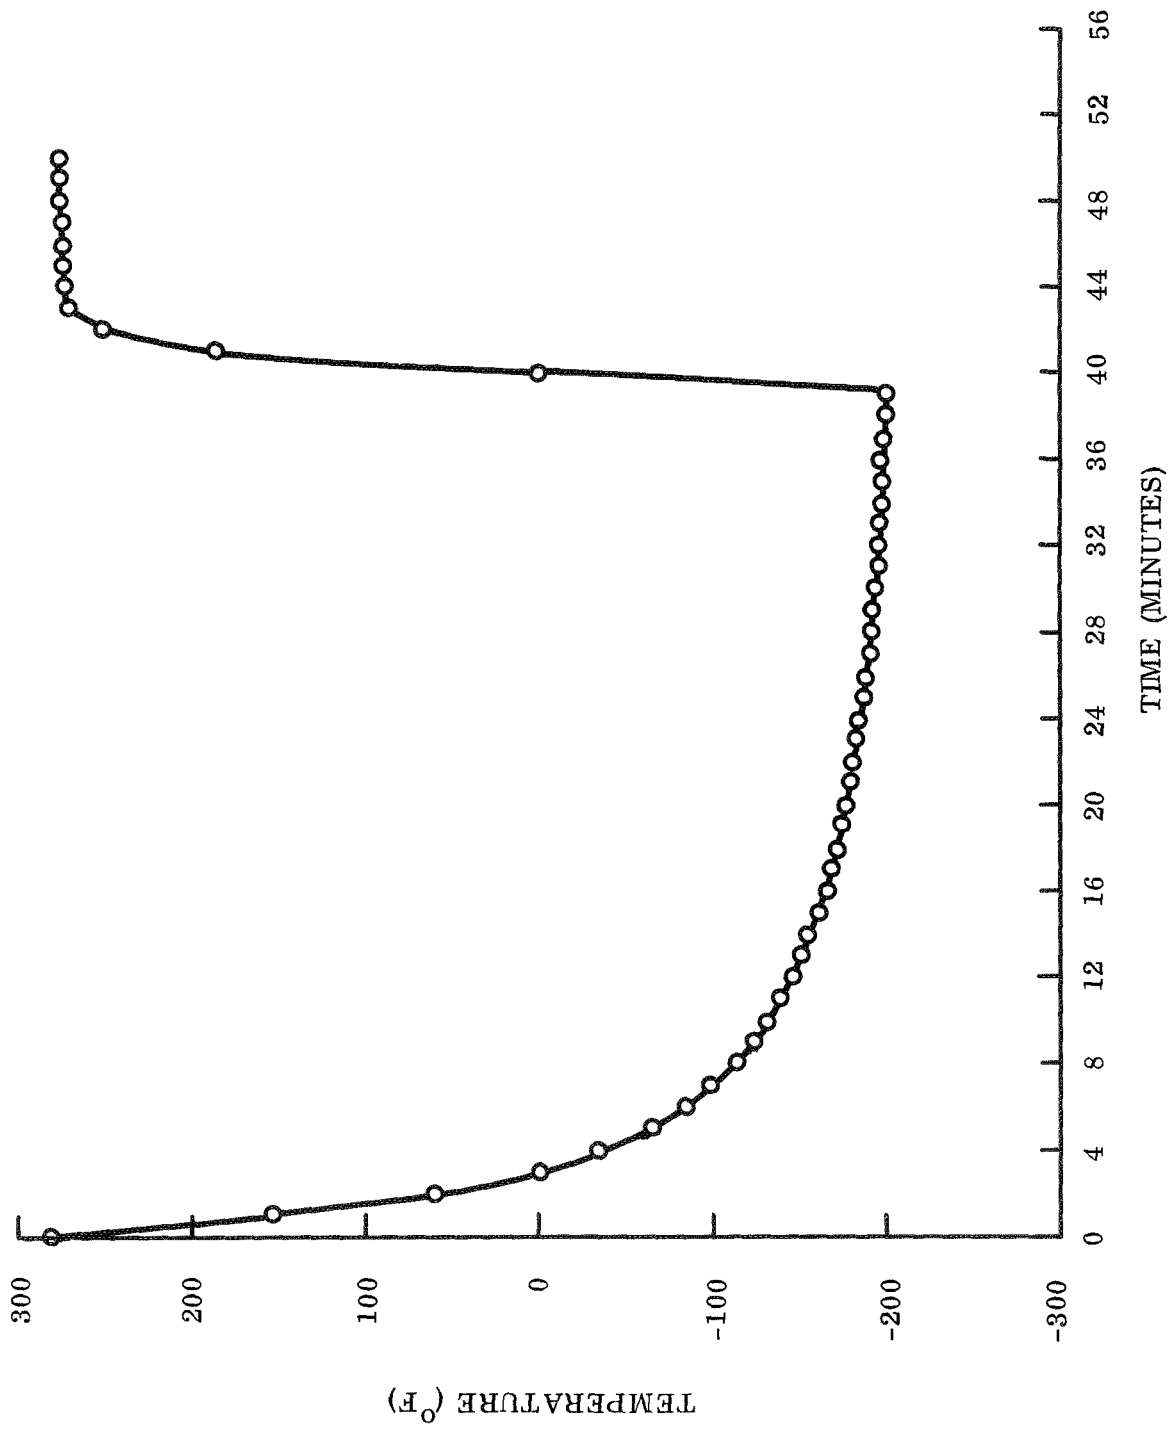
Figure 3.4-5 Typical Active Module Temperature Profile

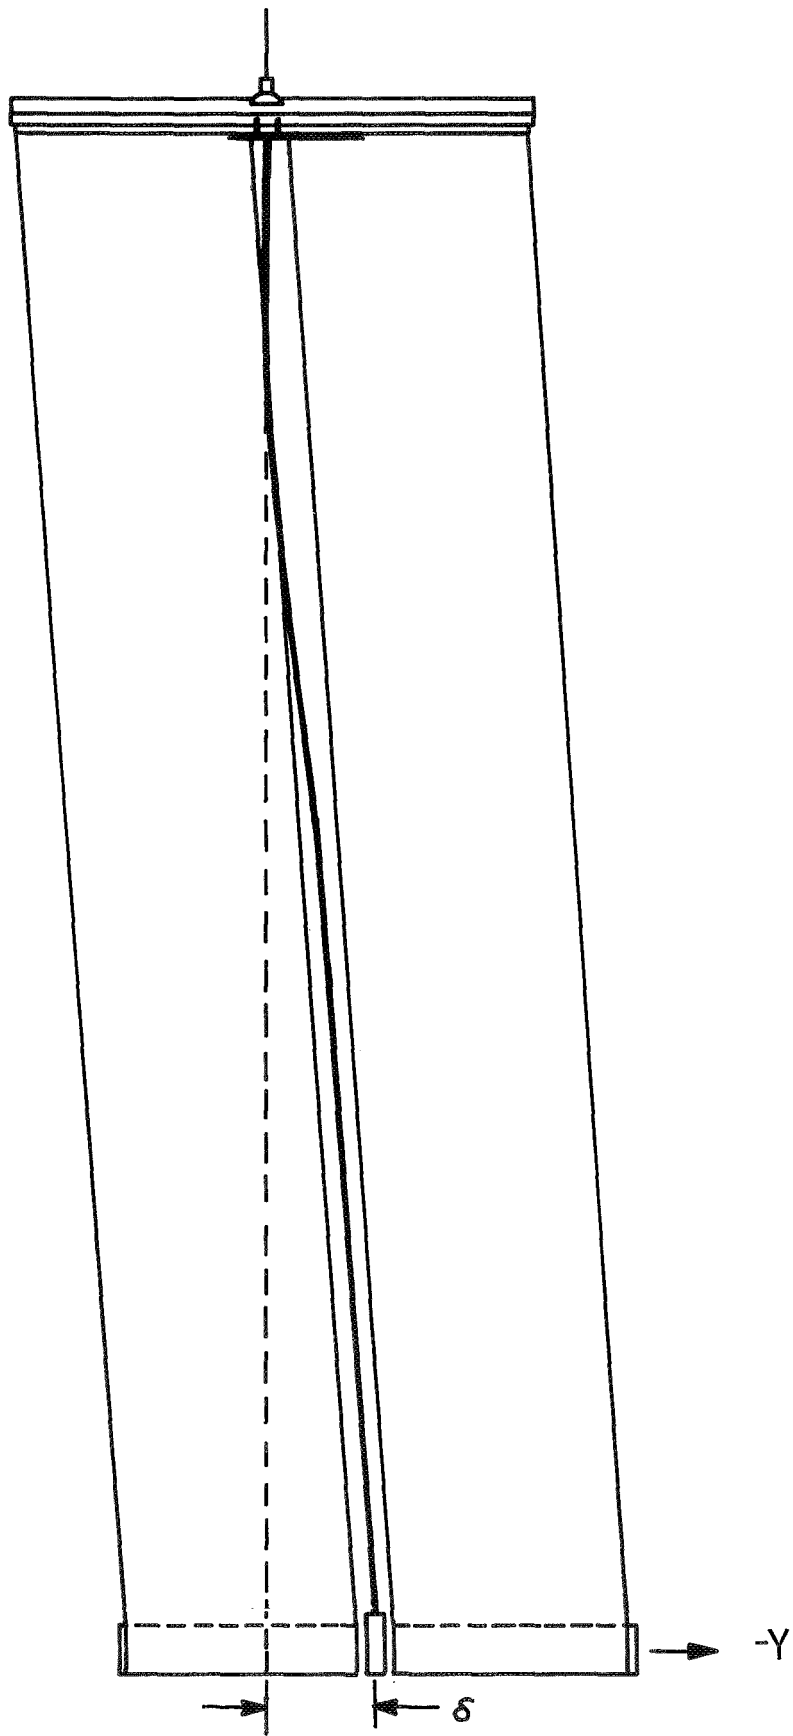
Figure 3.4-6. Schematic of Tracking Demonstration Test Set-Up

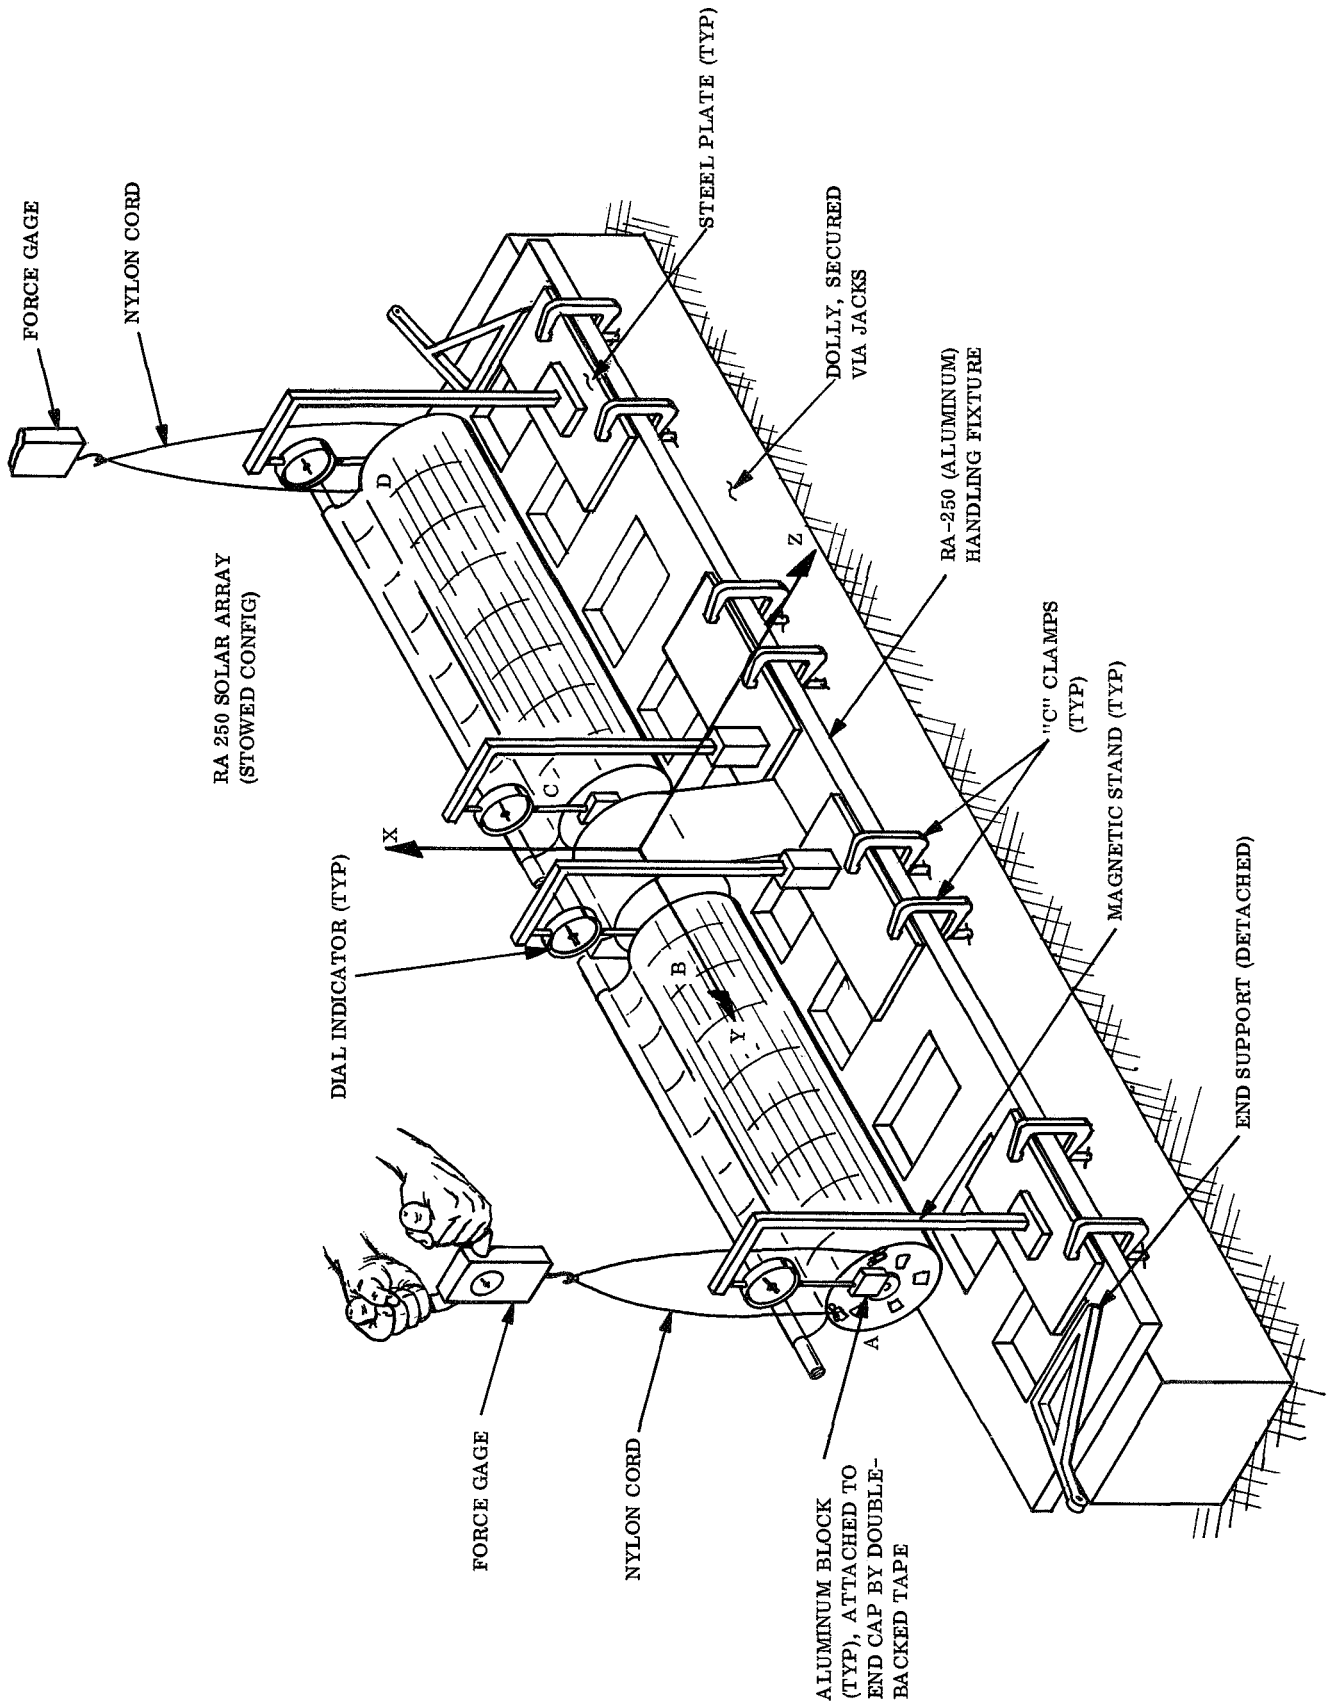
Figure 3.4-9. Test Arrangements

The objectives of this test was to determine array drum bearing flexibility coefficients for incorporation in the analytical mode of the stowed RA250 solar array assembly. Flexibility coefficients were obtained for the bearing assembly, center support assembly and end support caging arms. Figure 3.4-8 presents a list of loading tests performed and Figure 3.4-9 presents a sketch of the test setup. Loads were applied in 5 lb. increments from zero to ± 20 lbs. and deflections measured by dial indicators located as shown in Figure 3.4-9. All data was published in Reference 1-6.

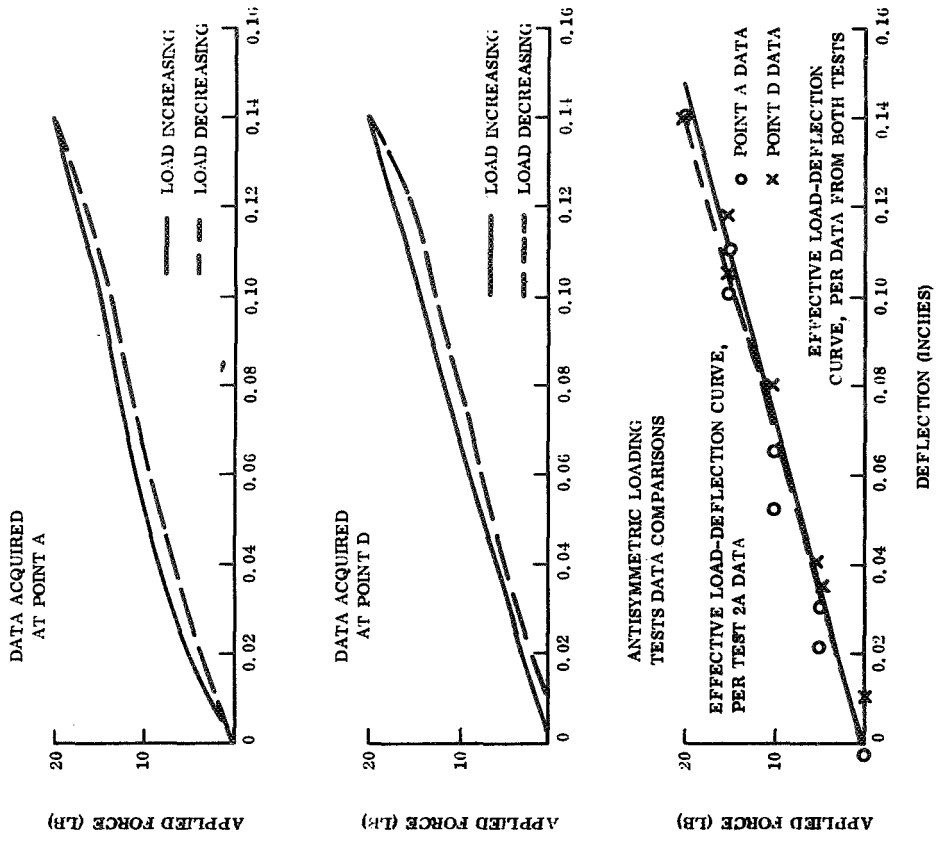
Figure 3.4-11. Results of Test 2A, Antisymmetric Loading in X Direction

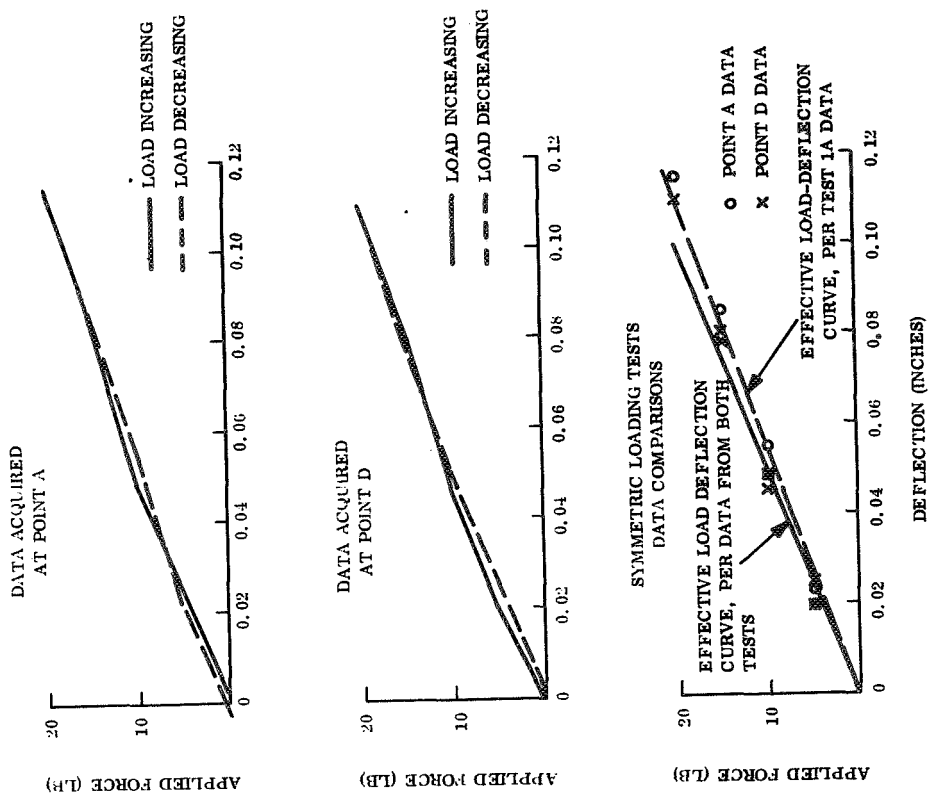
Figure 3.4-10. Results of Test 1A, Symmetric Loading in X Direction

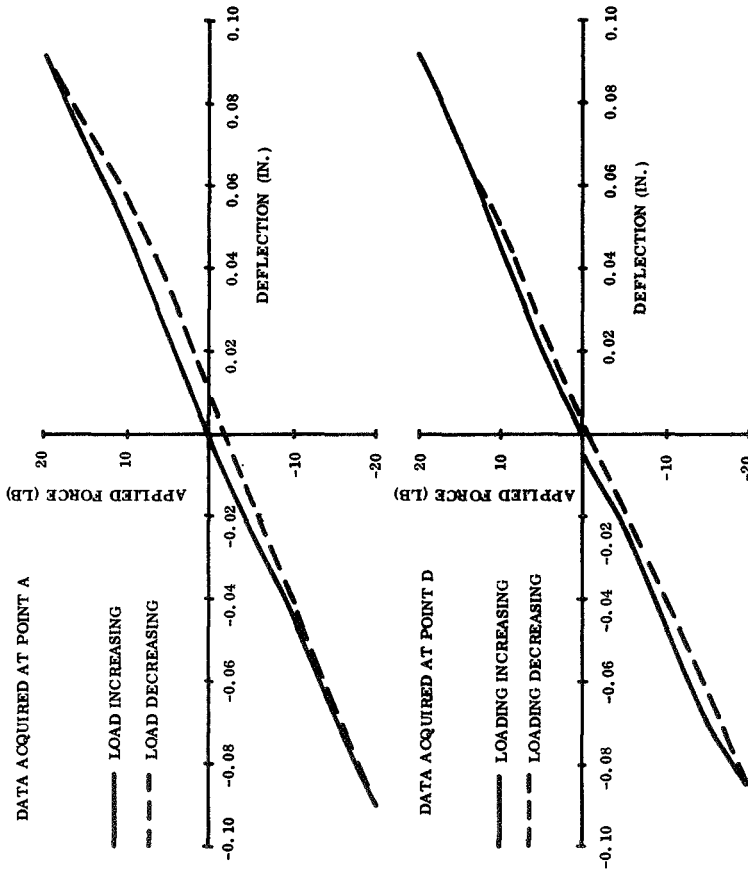
Figure 3.4-12. Results of Test 3A, Symmetric Loading in Z Direction

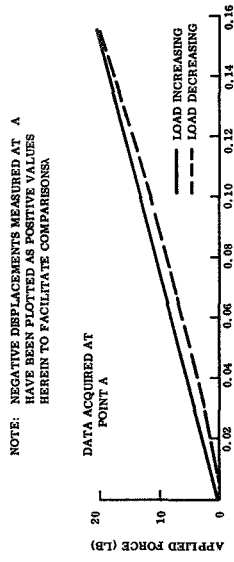
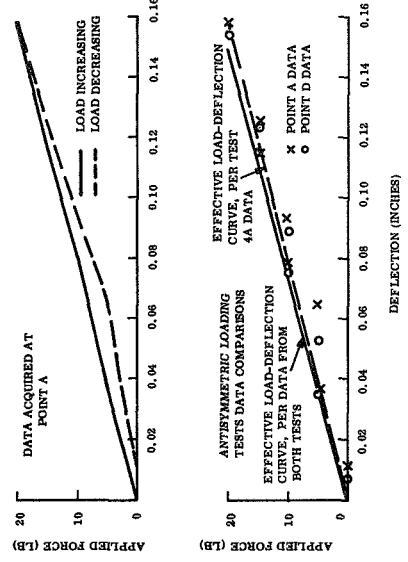
Figure 3.4-13. Results of Test 4A, Antisymmetric Loading in Z Direction

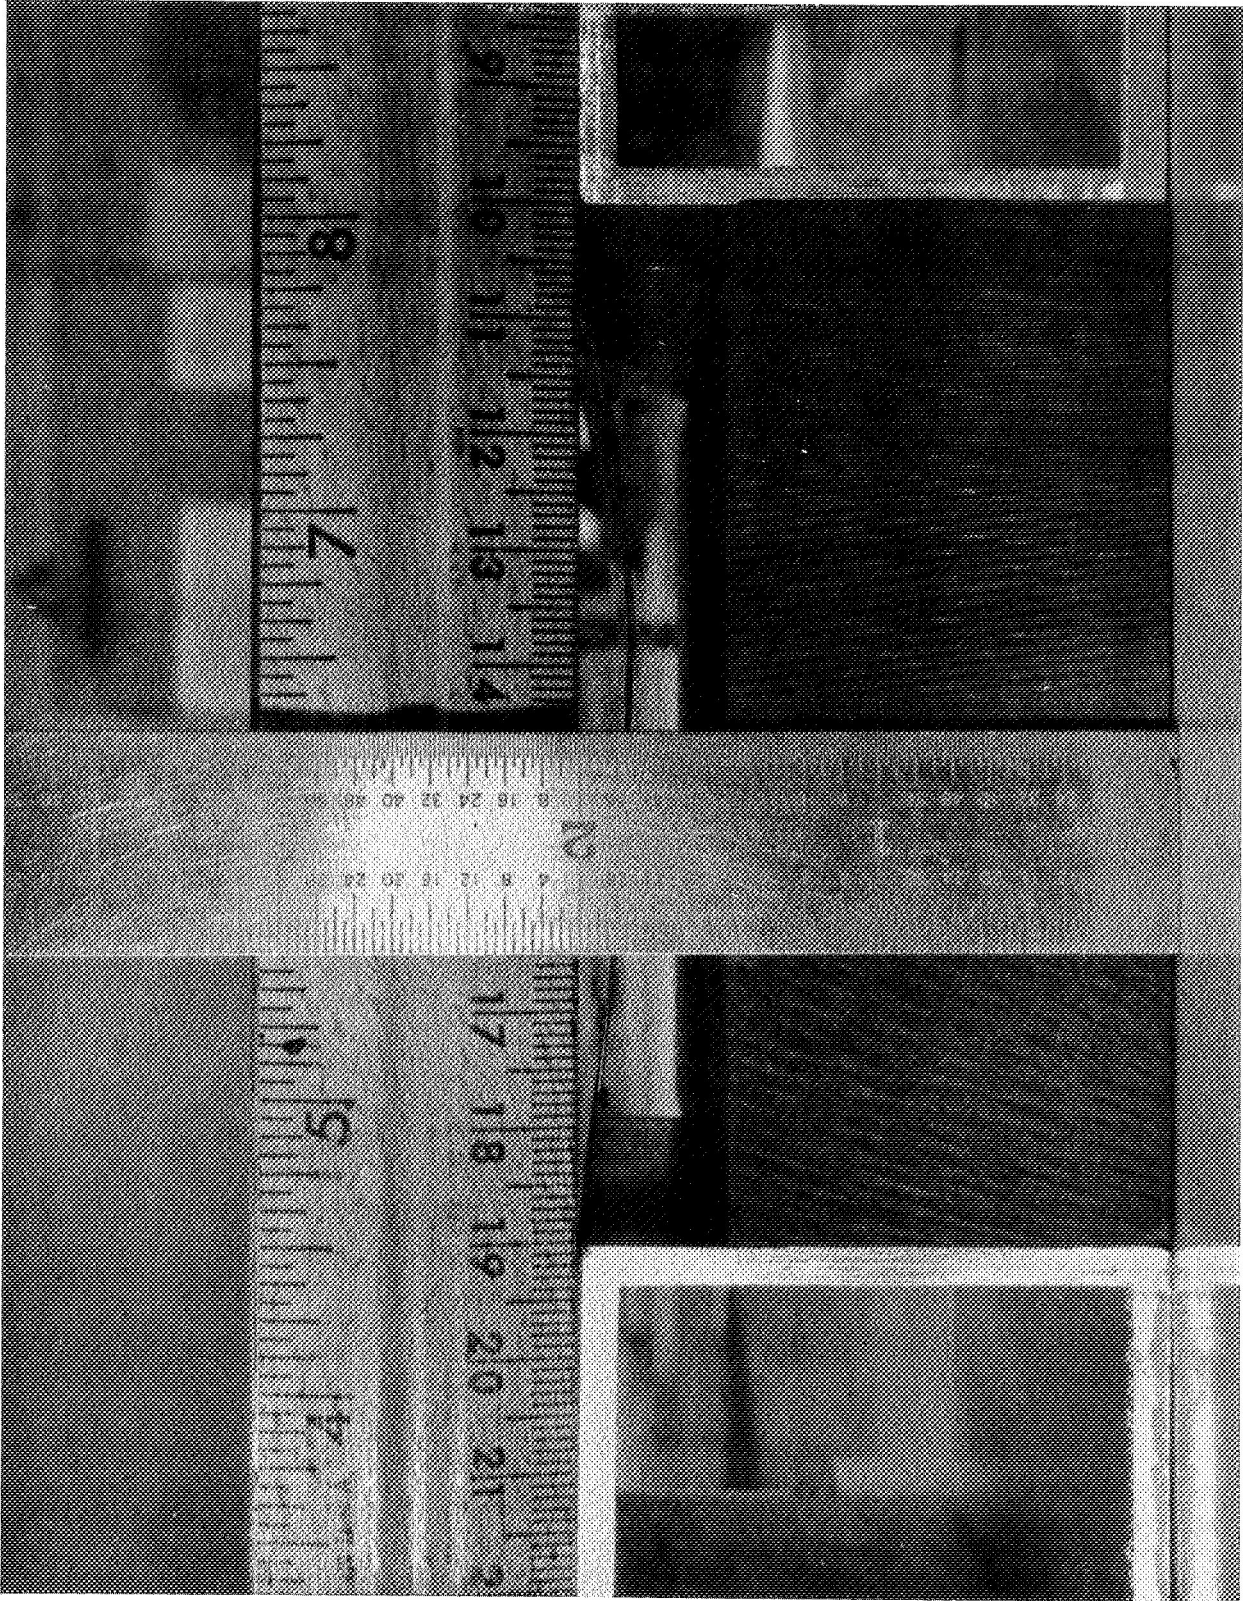
Figure 3.4-14. Solar Cell Module Deflection Test Set-Up

Figures 3.4-14, -15, and -16 show the deflection test set up and modules undergoing deflection testing in both the "face up" and "face down" directions. Figure 3.4-17 and -18 are graphs of the data obtained during the deflection tests. The area of most relevance is along the "0" grams load line where the units were being supported at the edges and deflected only by their own weight. Both dummy configurations approximate the no-load stiffness of the solar cell assemblies, and the wide

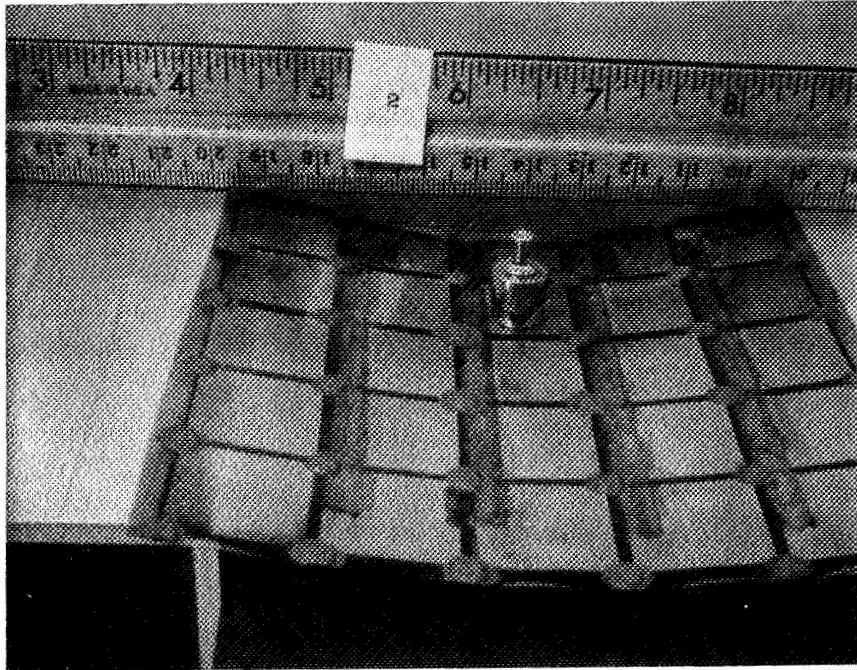
Figure 3.4-15. Face-Down Deflection Test - Active Solar Cell Module No. 1
With 5 gram load.

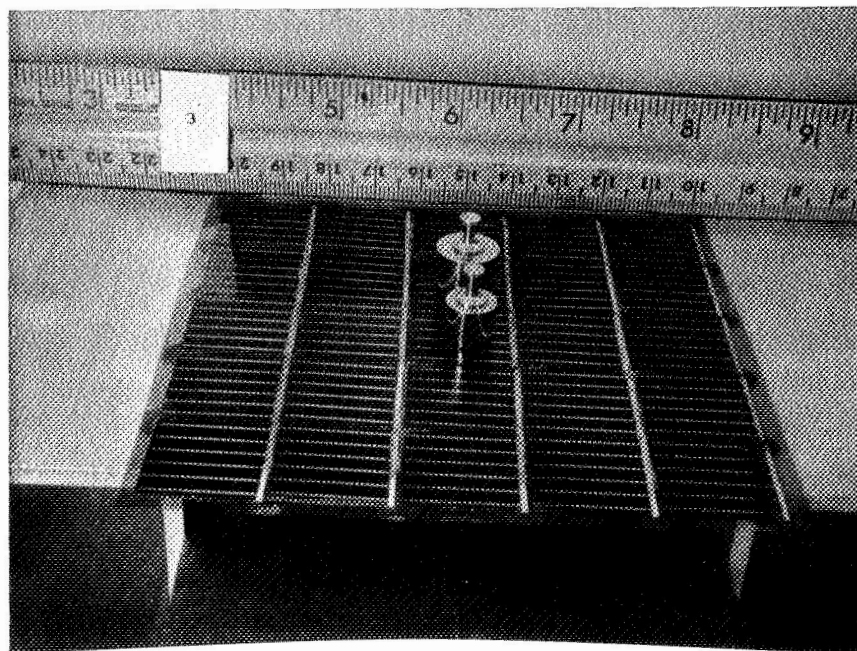
Figure 3.4-16. Face Up Deflection Test - Active Solar Cell Module No. 1
With 15 gram load.

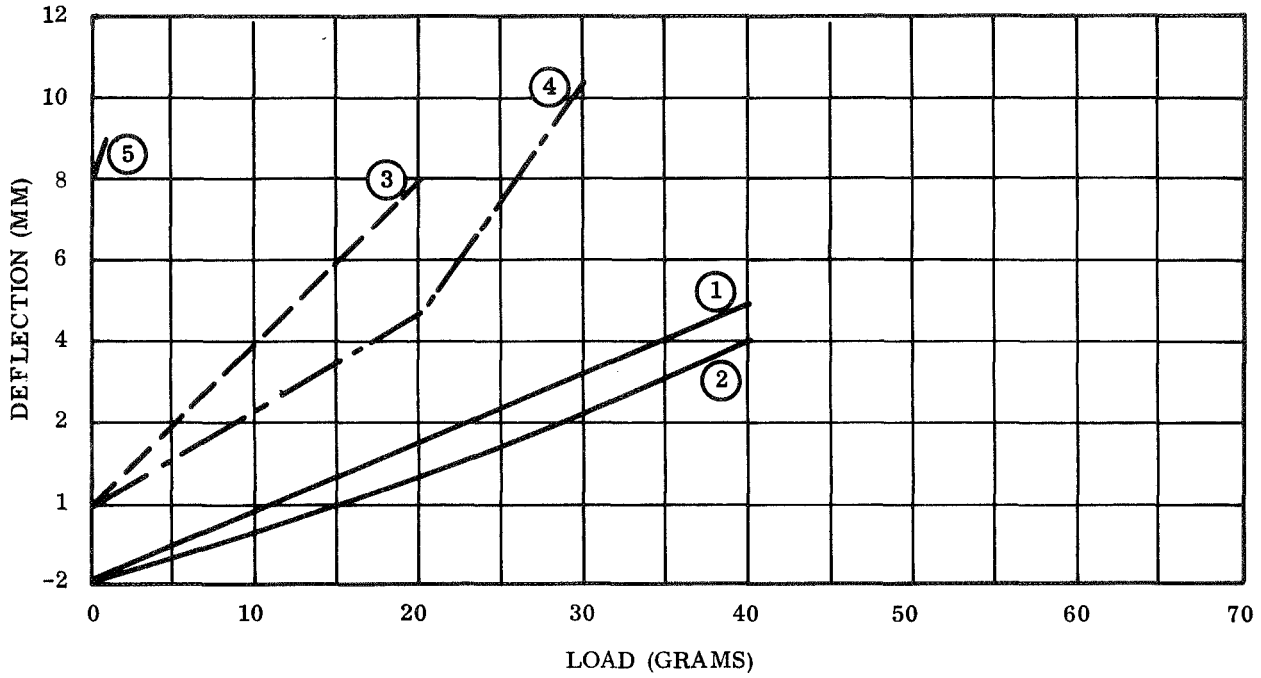
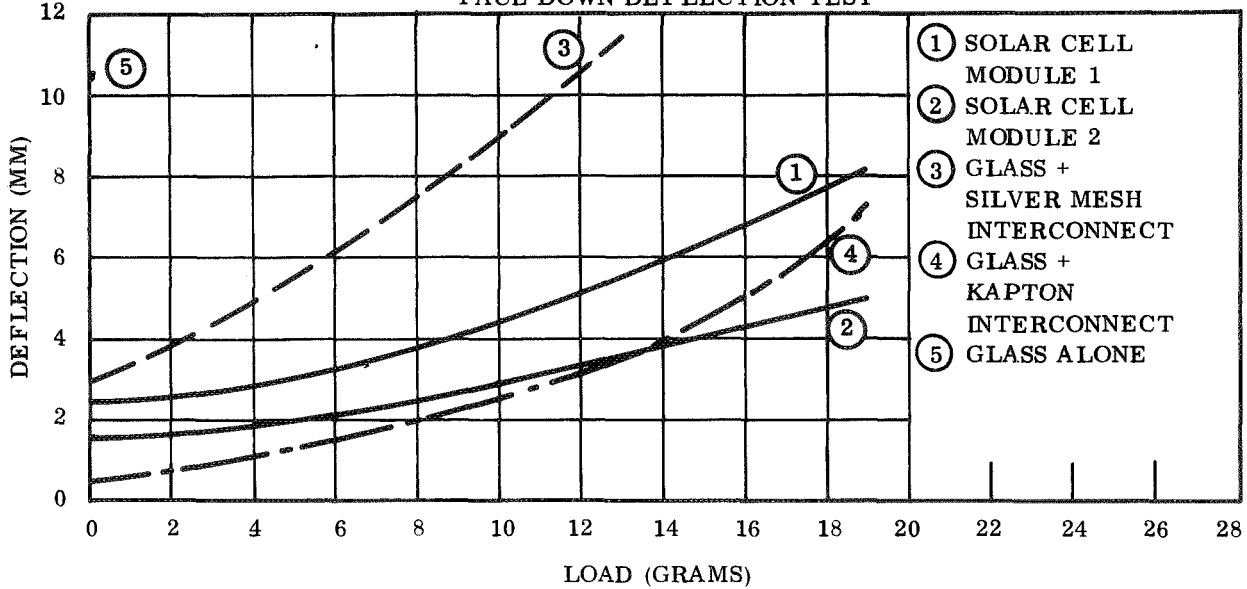
FACE UP DEFLECTION TEST

FACE DOWN DEFLECTION TEST

- ① SOLAR CELL MODULE 1
- ② SOLAR CELL MODULE 2
- ③ GLASS + SILVER MESH INTERCONNECT
- ④ GLASS + KAPTON INTERCONNECT
- ⑤ GLASS ALONE

Figure 3,4-17 Load Deflection Curves

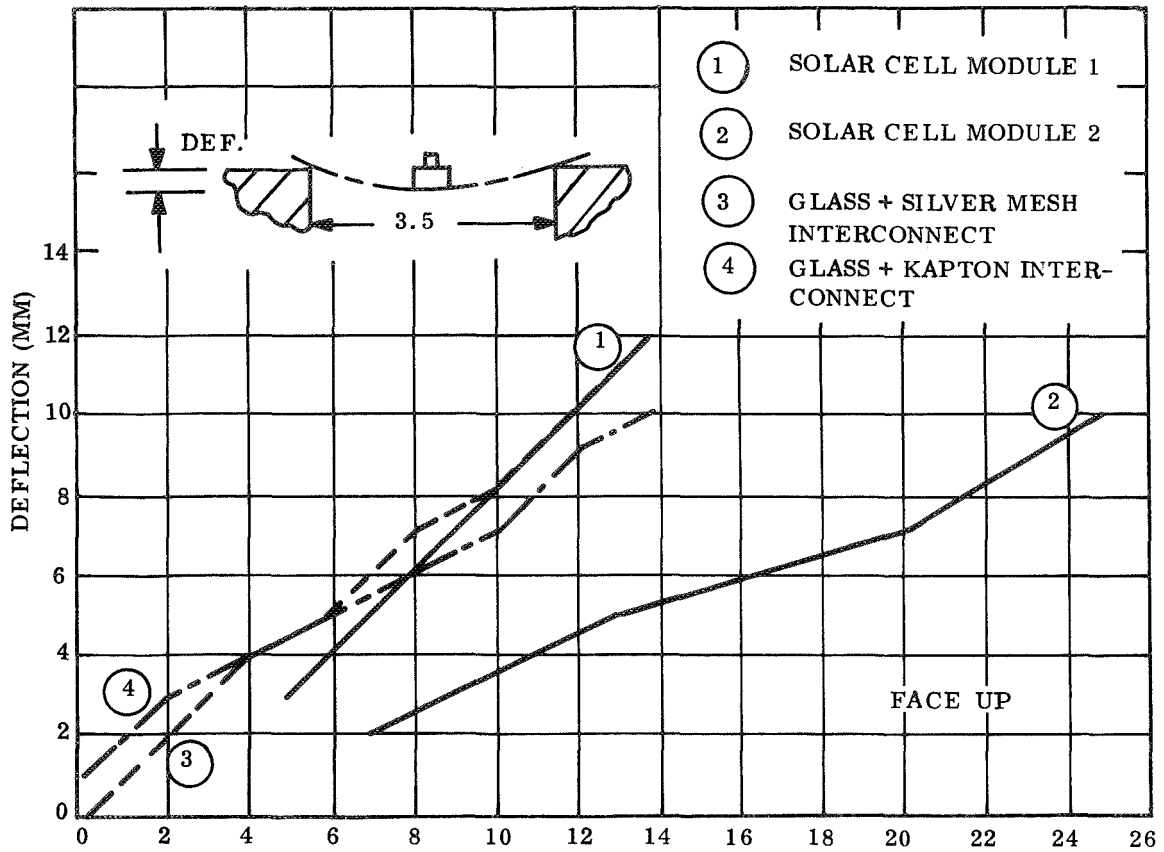
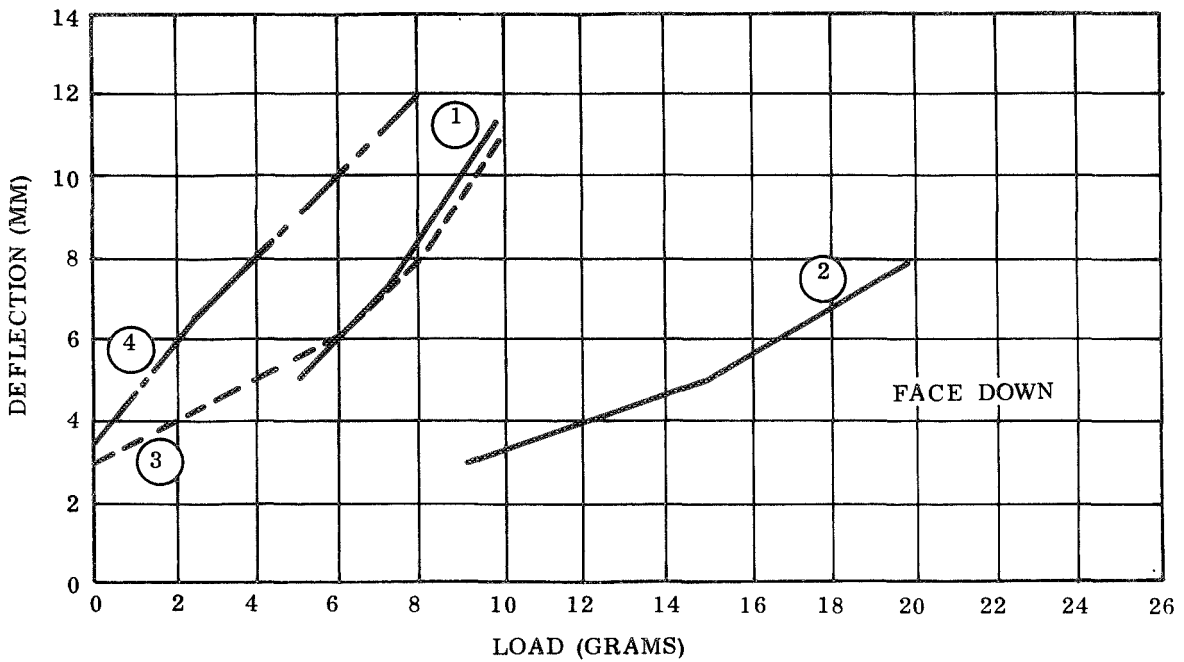
Figure 3.4-18 Load Deflection Curves - Transverse Curvature
