Aerospace Systems Pyrotechnic Shock Data (Ground Test and Flight)

Final
Report

Volume II
Data

Aerospace Systems Pyrotechnic Shock Data
(Ground Test and Flight)

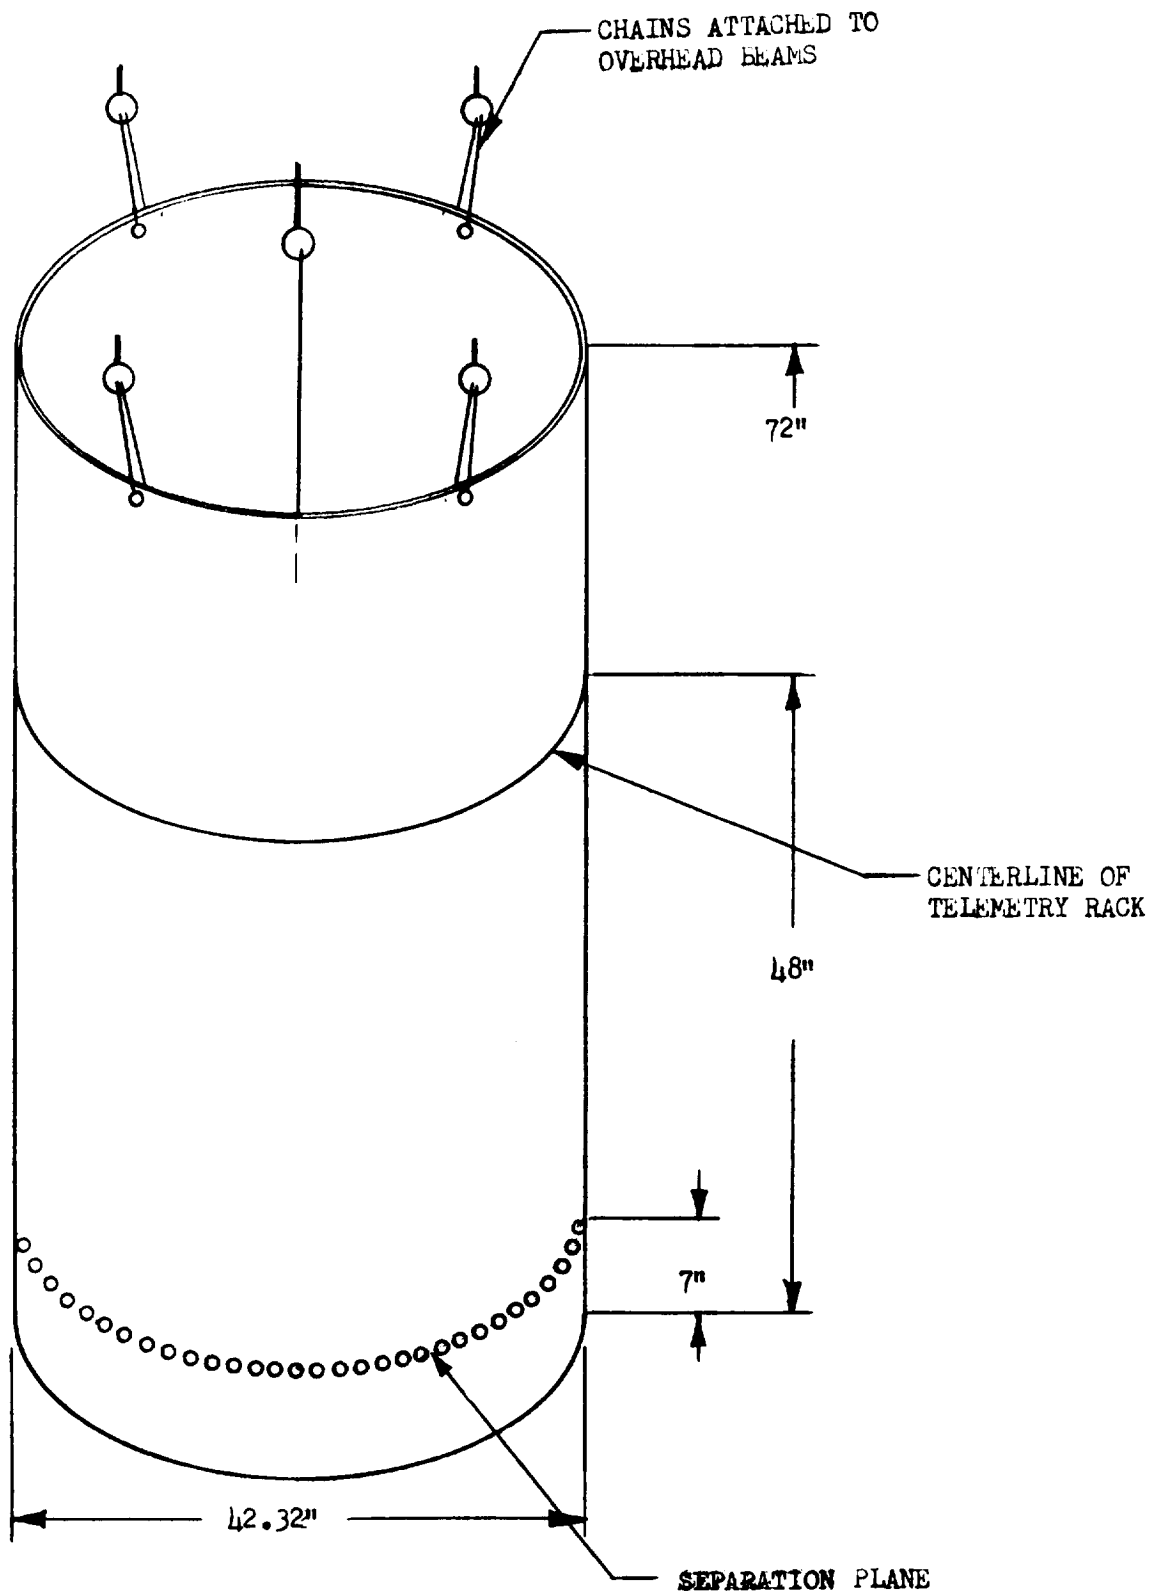
FIGURE I.A.1-3
 DIAGRAM OF SPARTAN SHORT CYLINDER TEST SET-UP

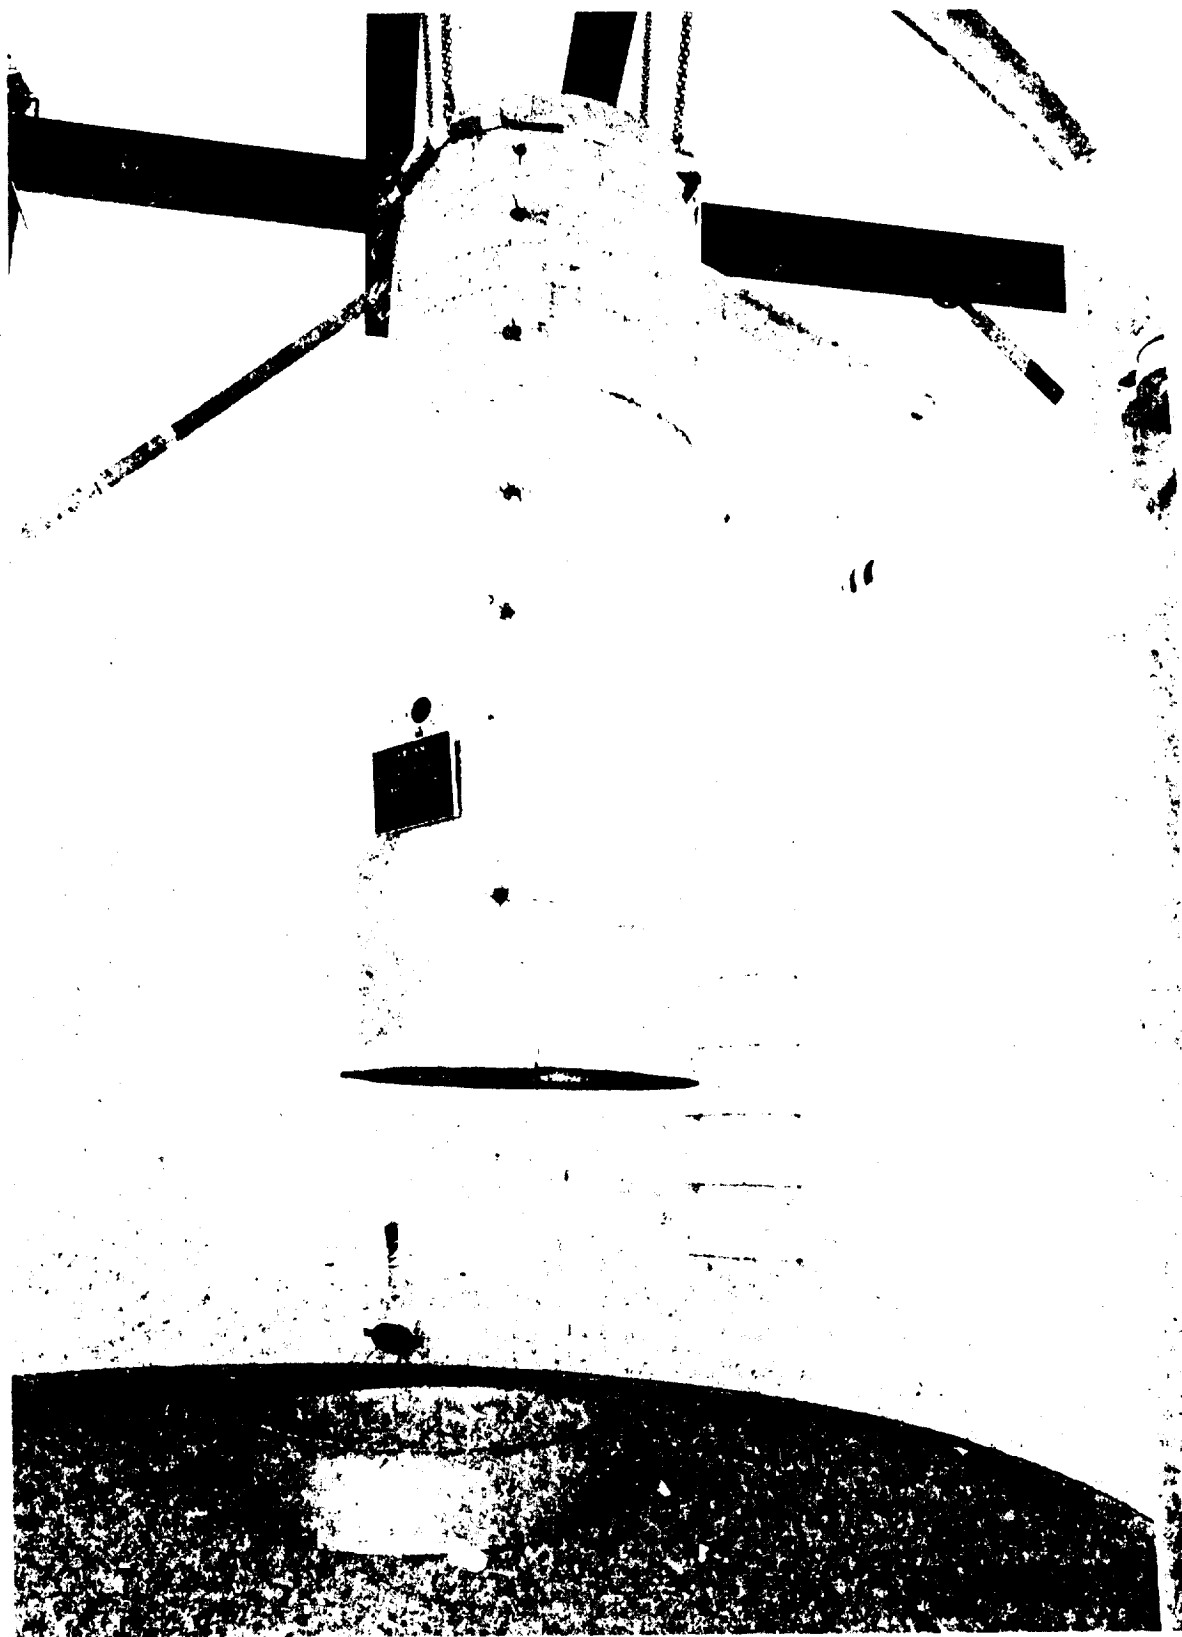
FIGURE I.A.2-2 SPARTAN LONG CYLINDER AFTER SEPARATION

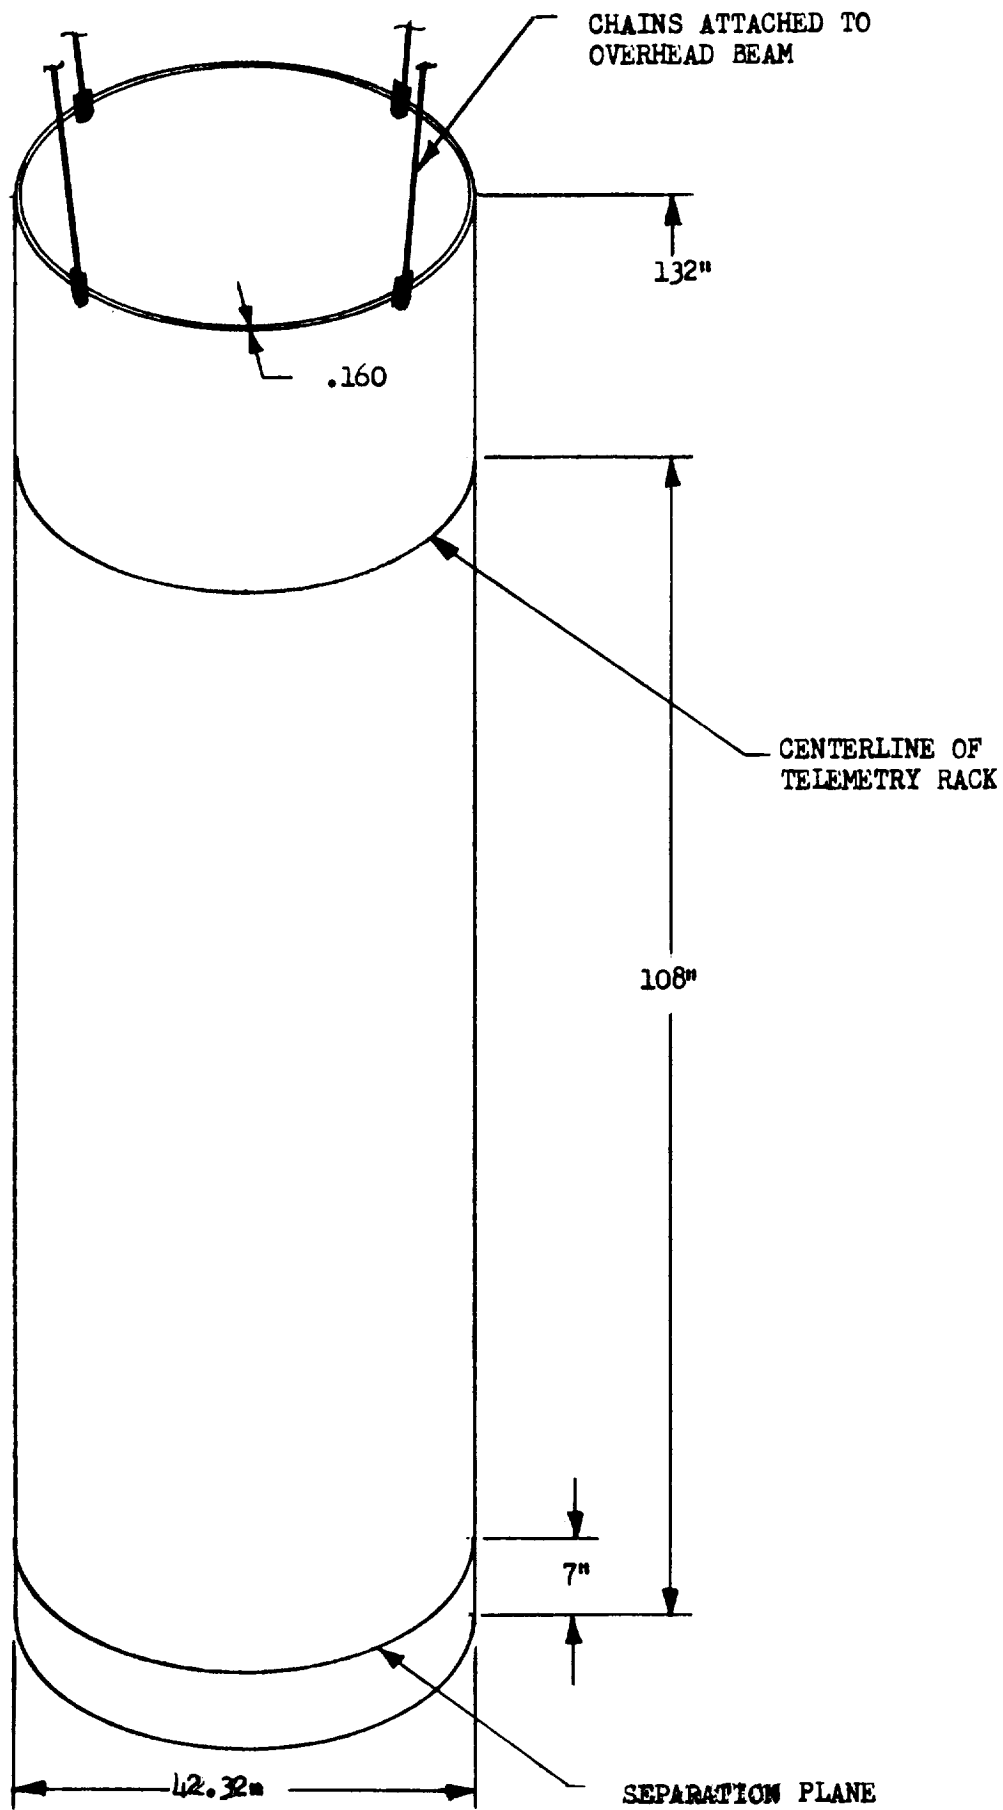
FIGURE I.A.2-3 DIAGRAM OF SPARTAN LONG CYLINDER TEST SET-UP

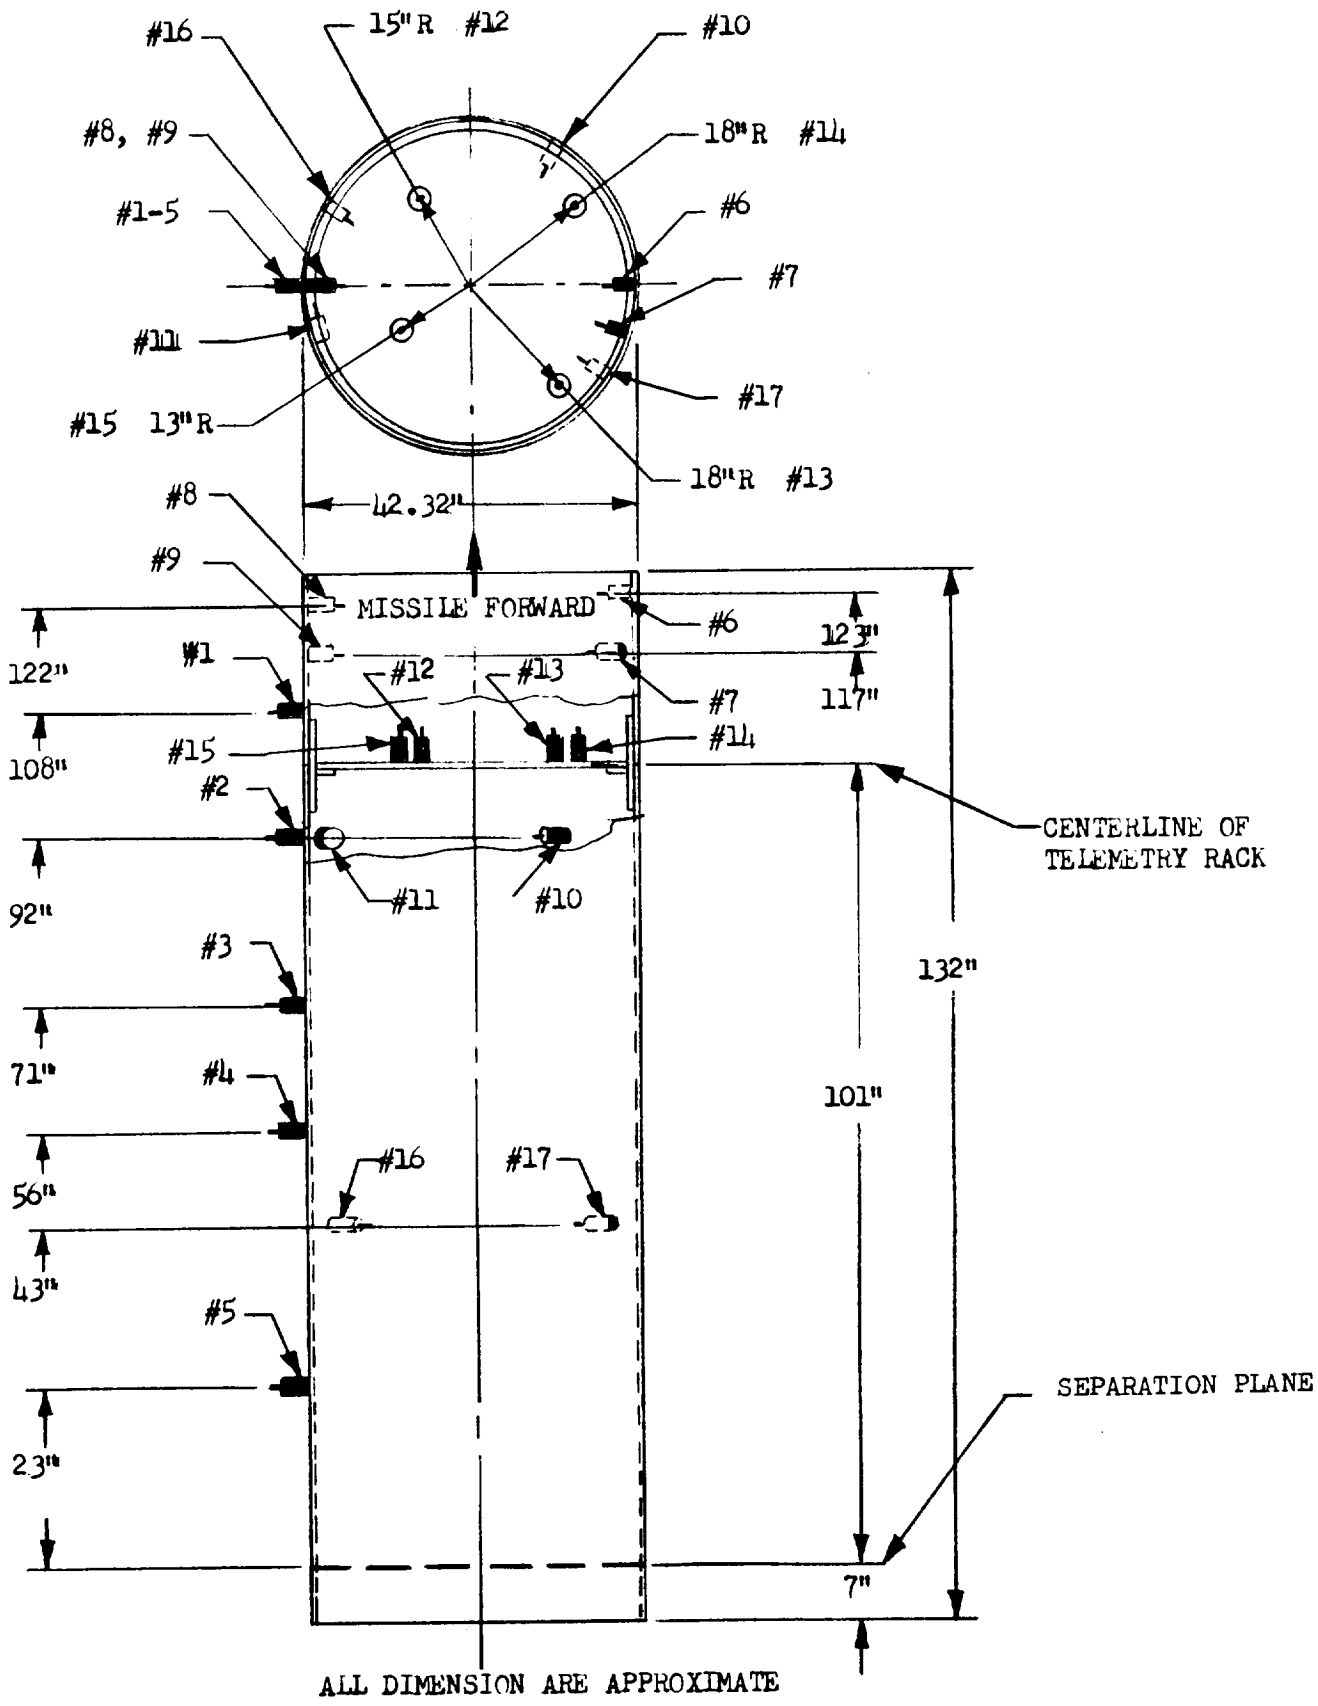
Figure I.A.2-4. Accelerometer Locations

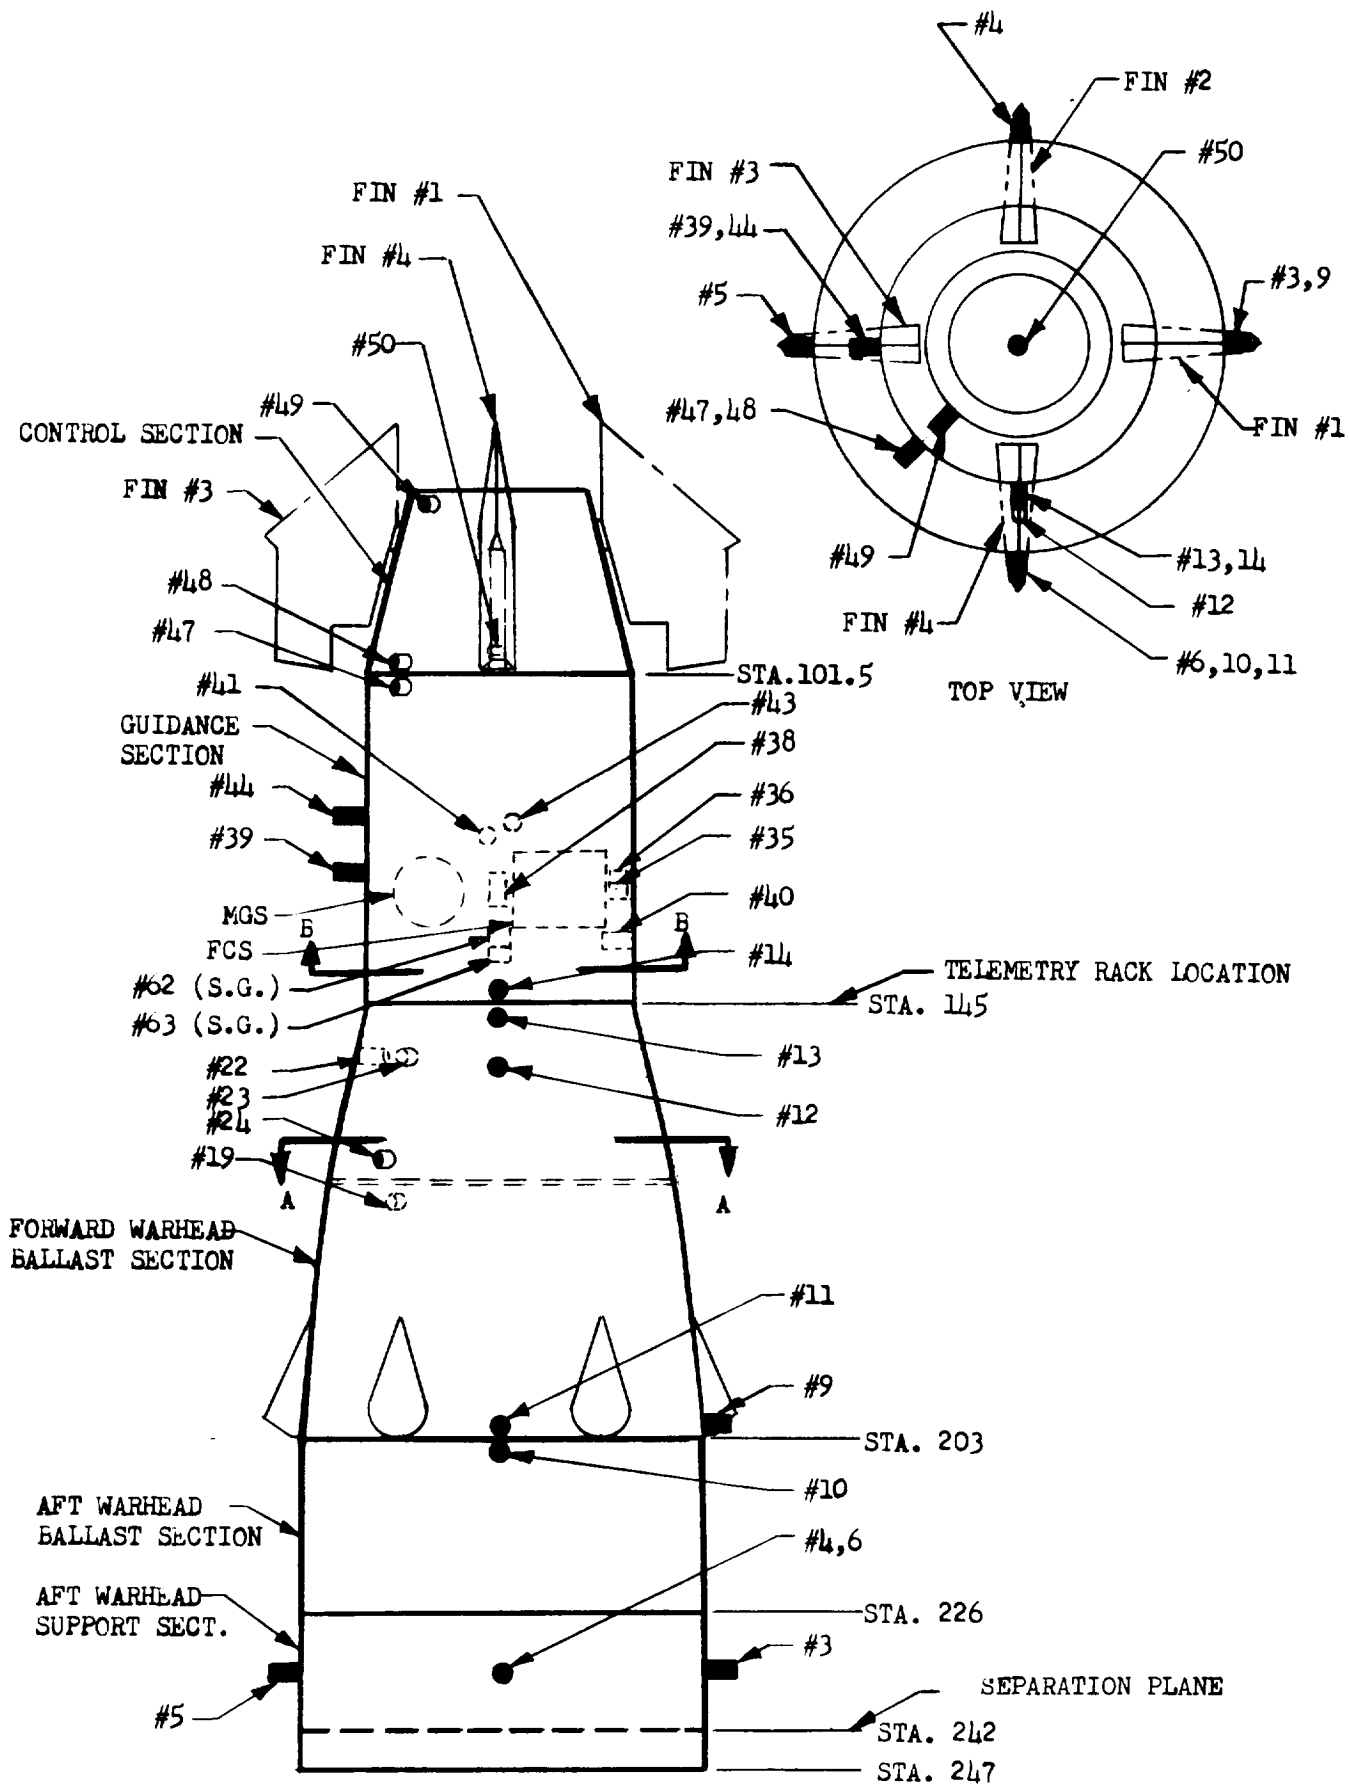
Figure I.A.3-4. Accelerometer Locations

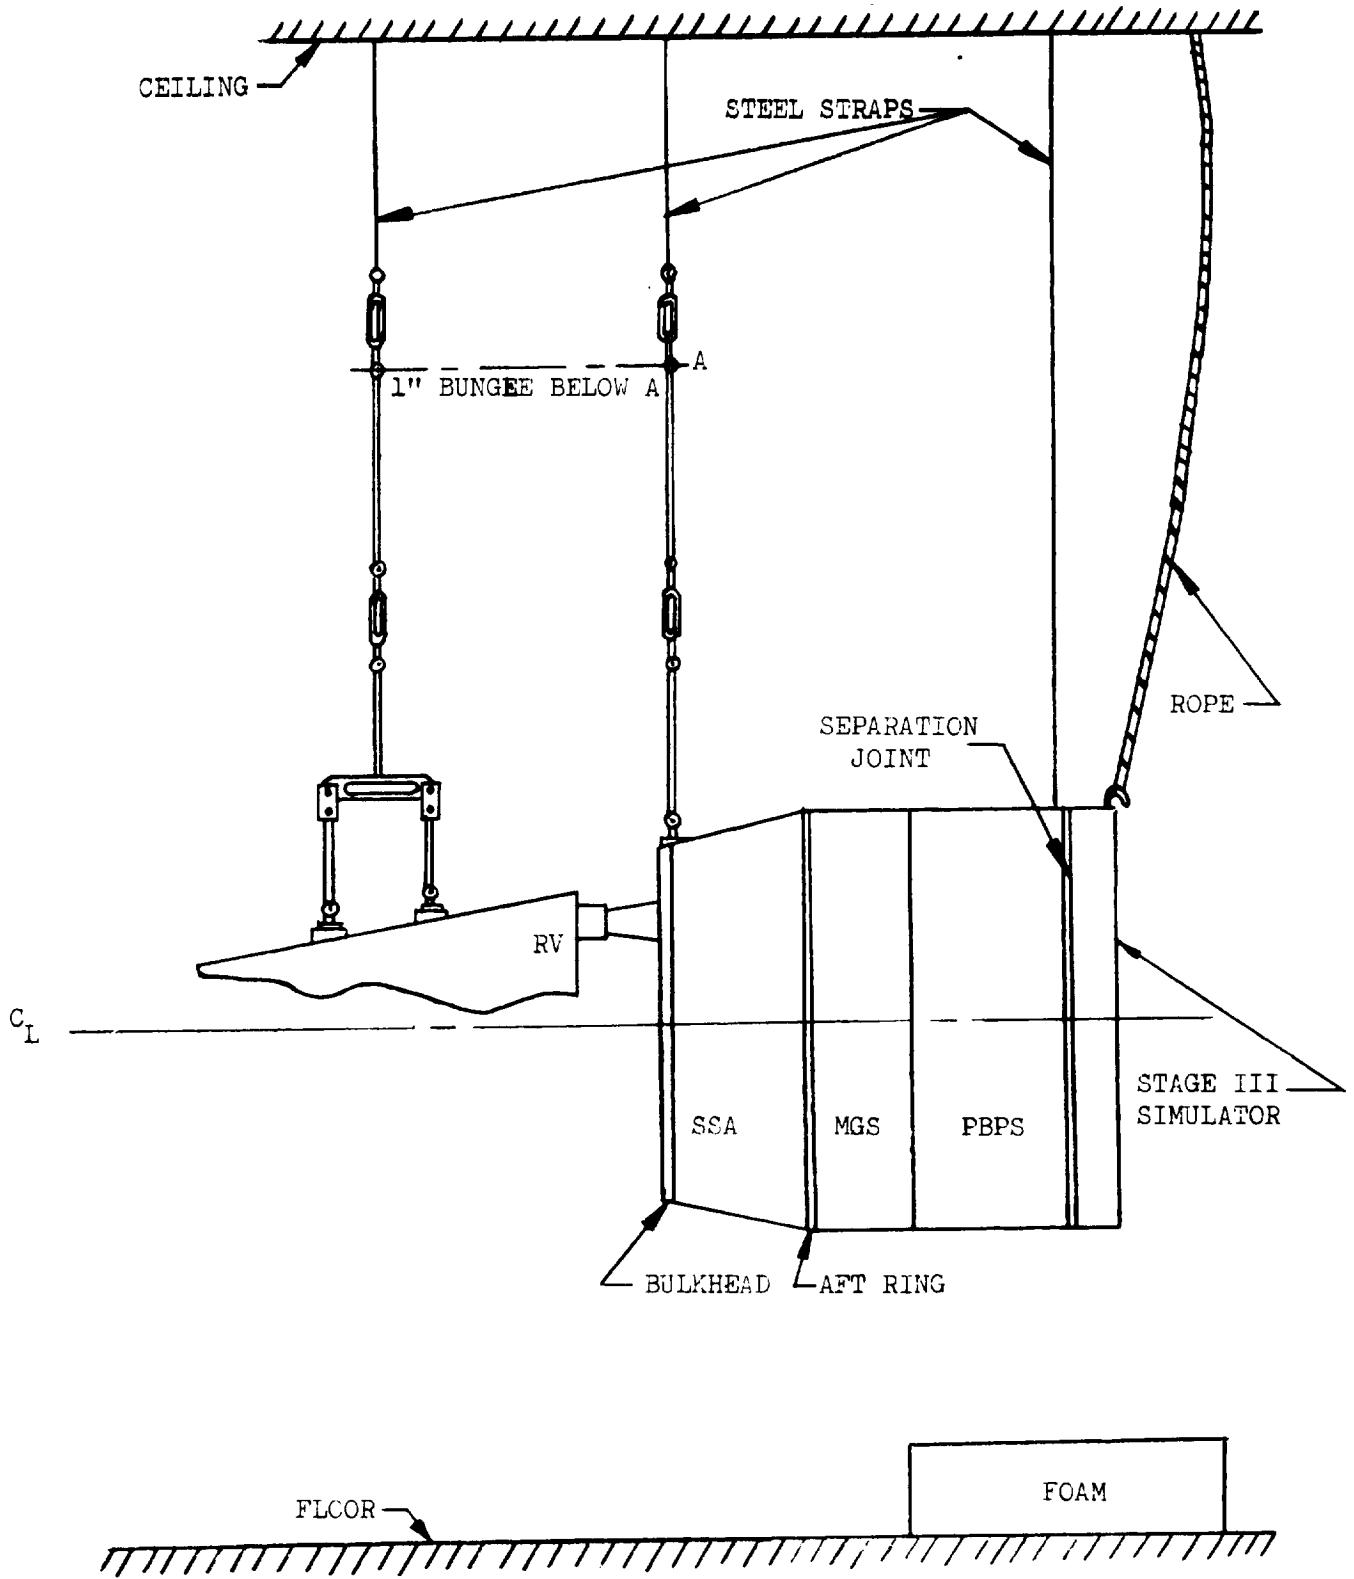
FIGURE I.A.4-1. TEST CONFIGURATION

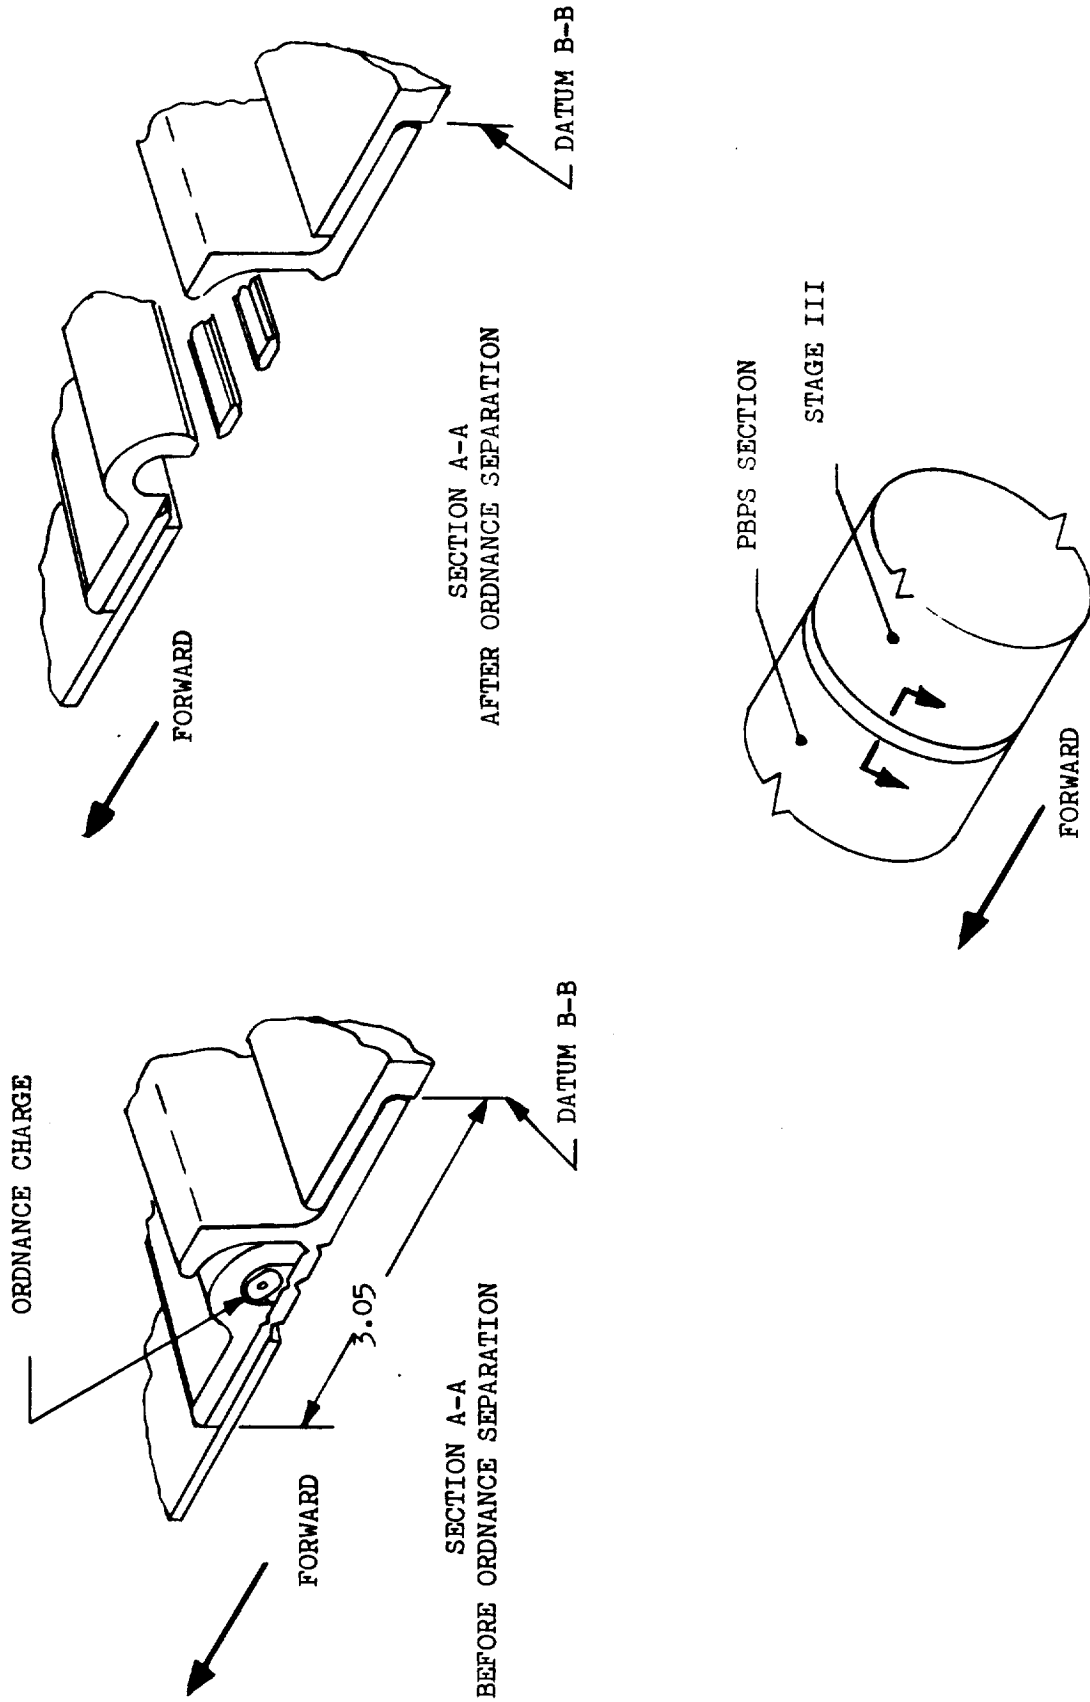
FIGURE I.A.4-2. SCHEMATIC DIAGRAM OF STAGE III/PBV SEPARATION JOINT

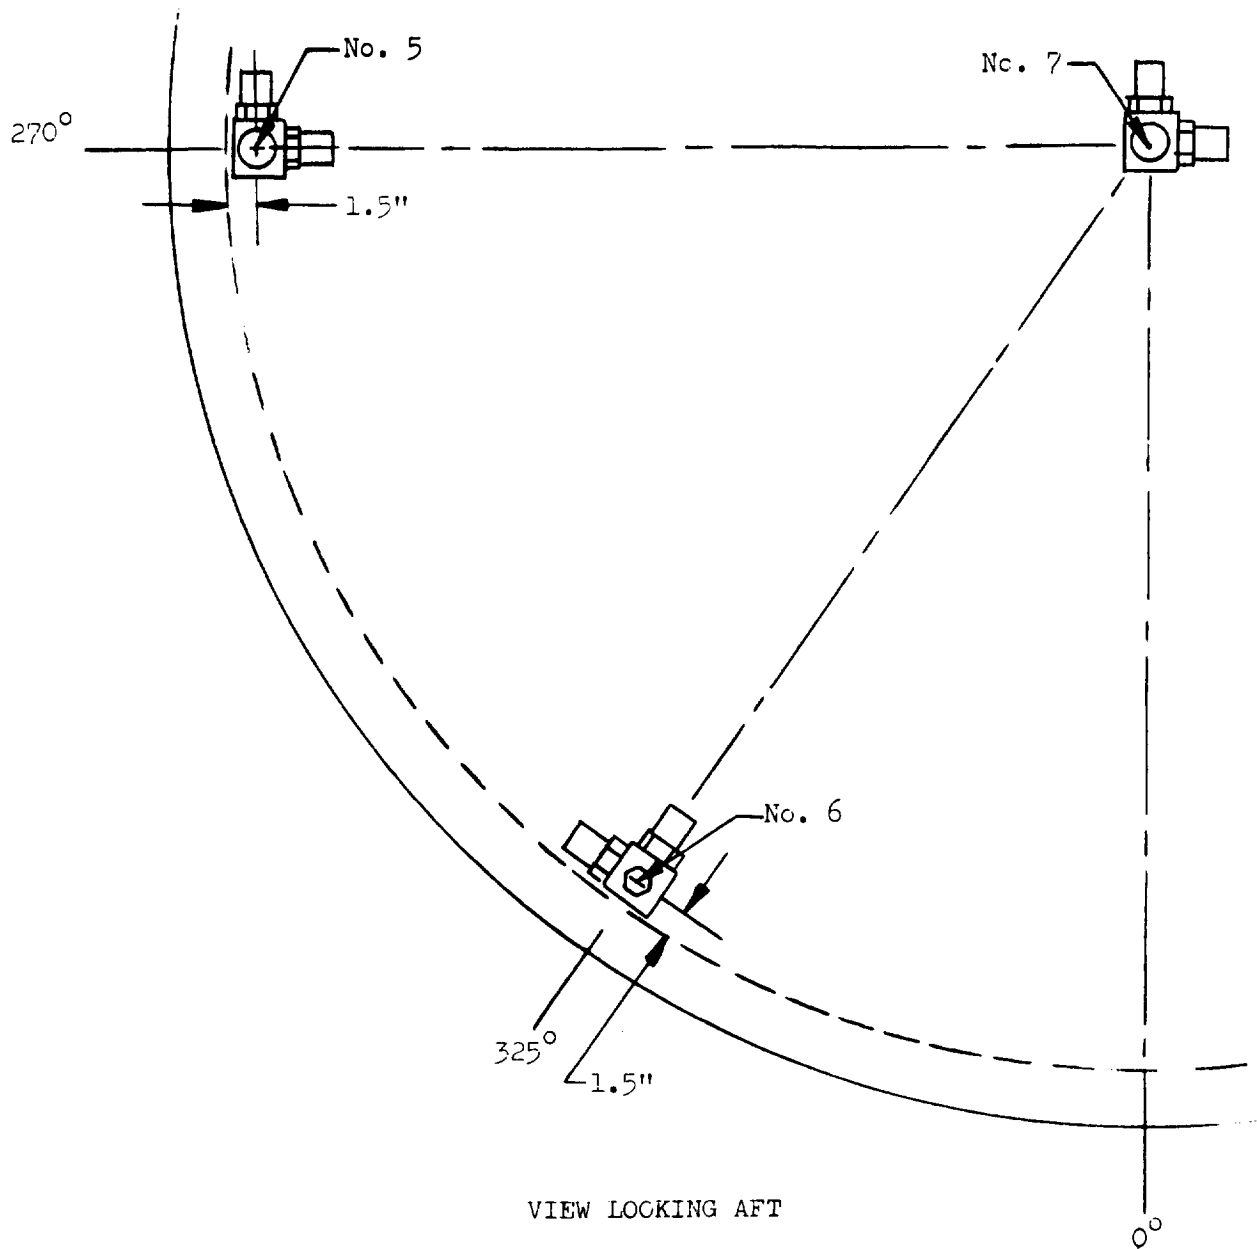
Figure I.A.4-3. Accelerometer Locations on Bulkhead - Topside

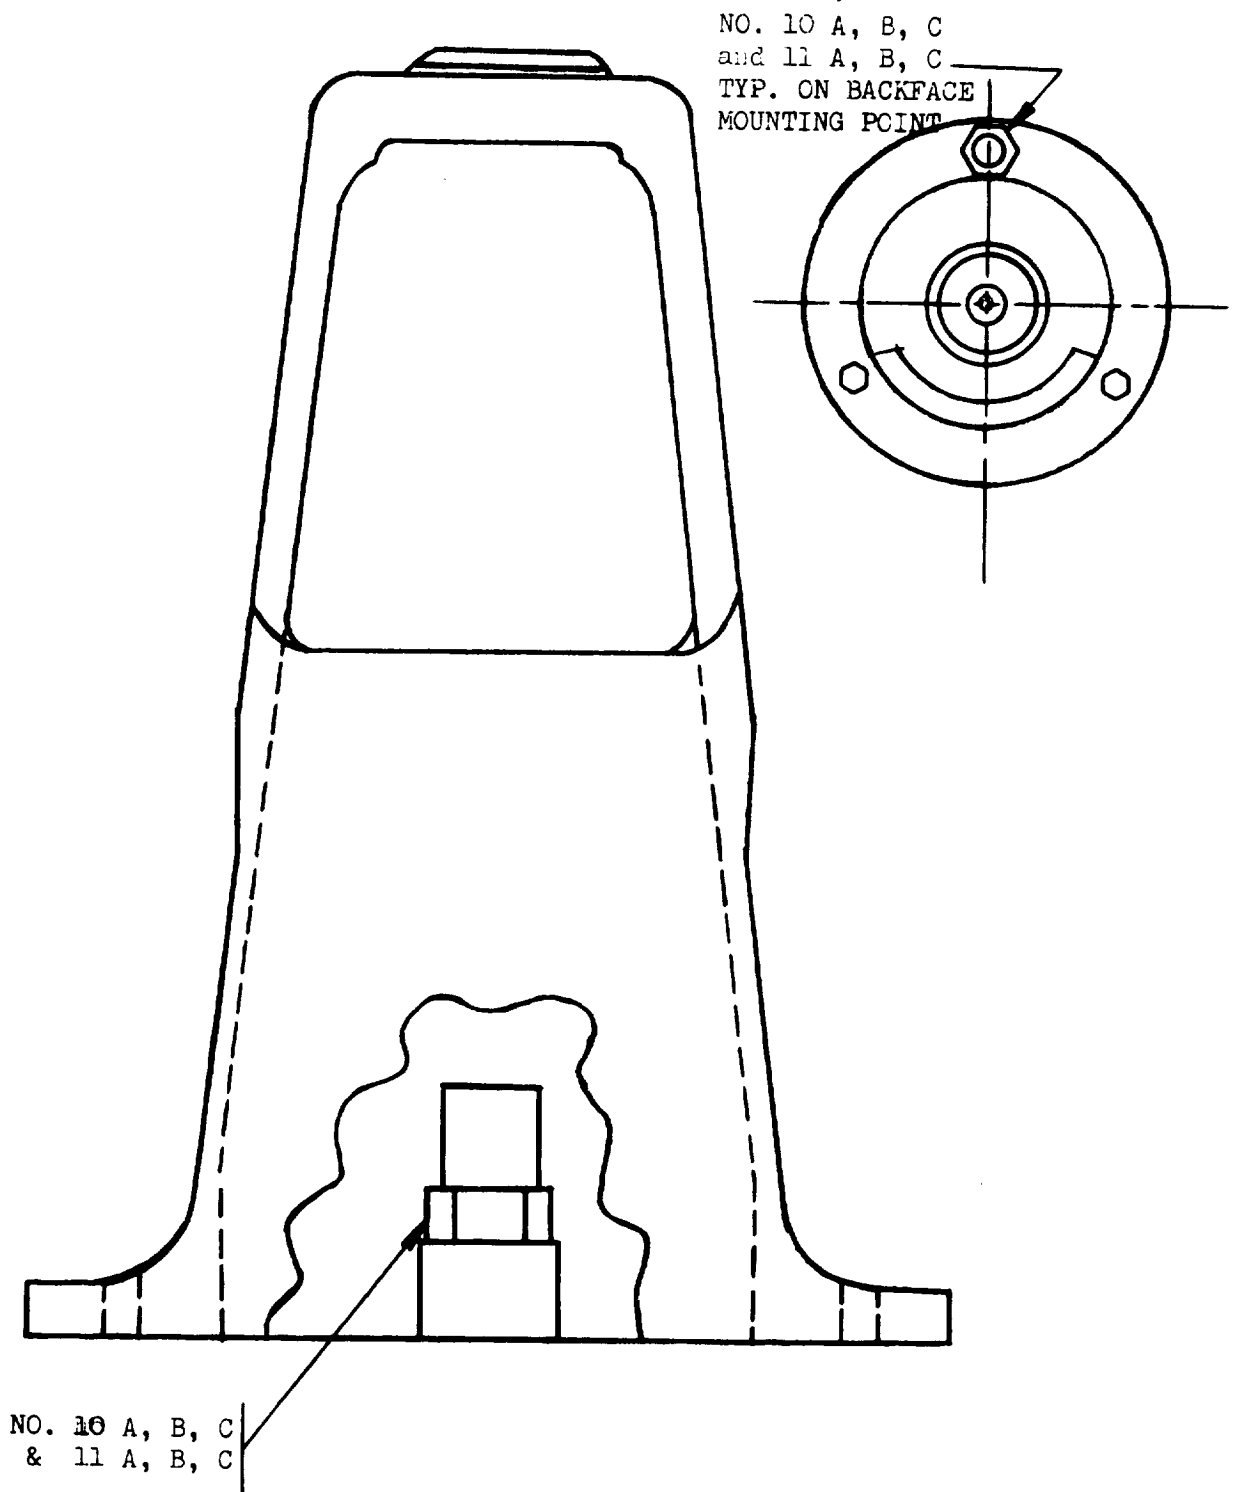
Figure I.A.4-4. Accelerometer Locations on Pedestal
(Pedestal mounted to topside of Bulkhead)

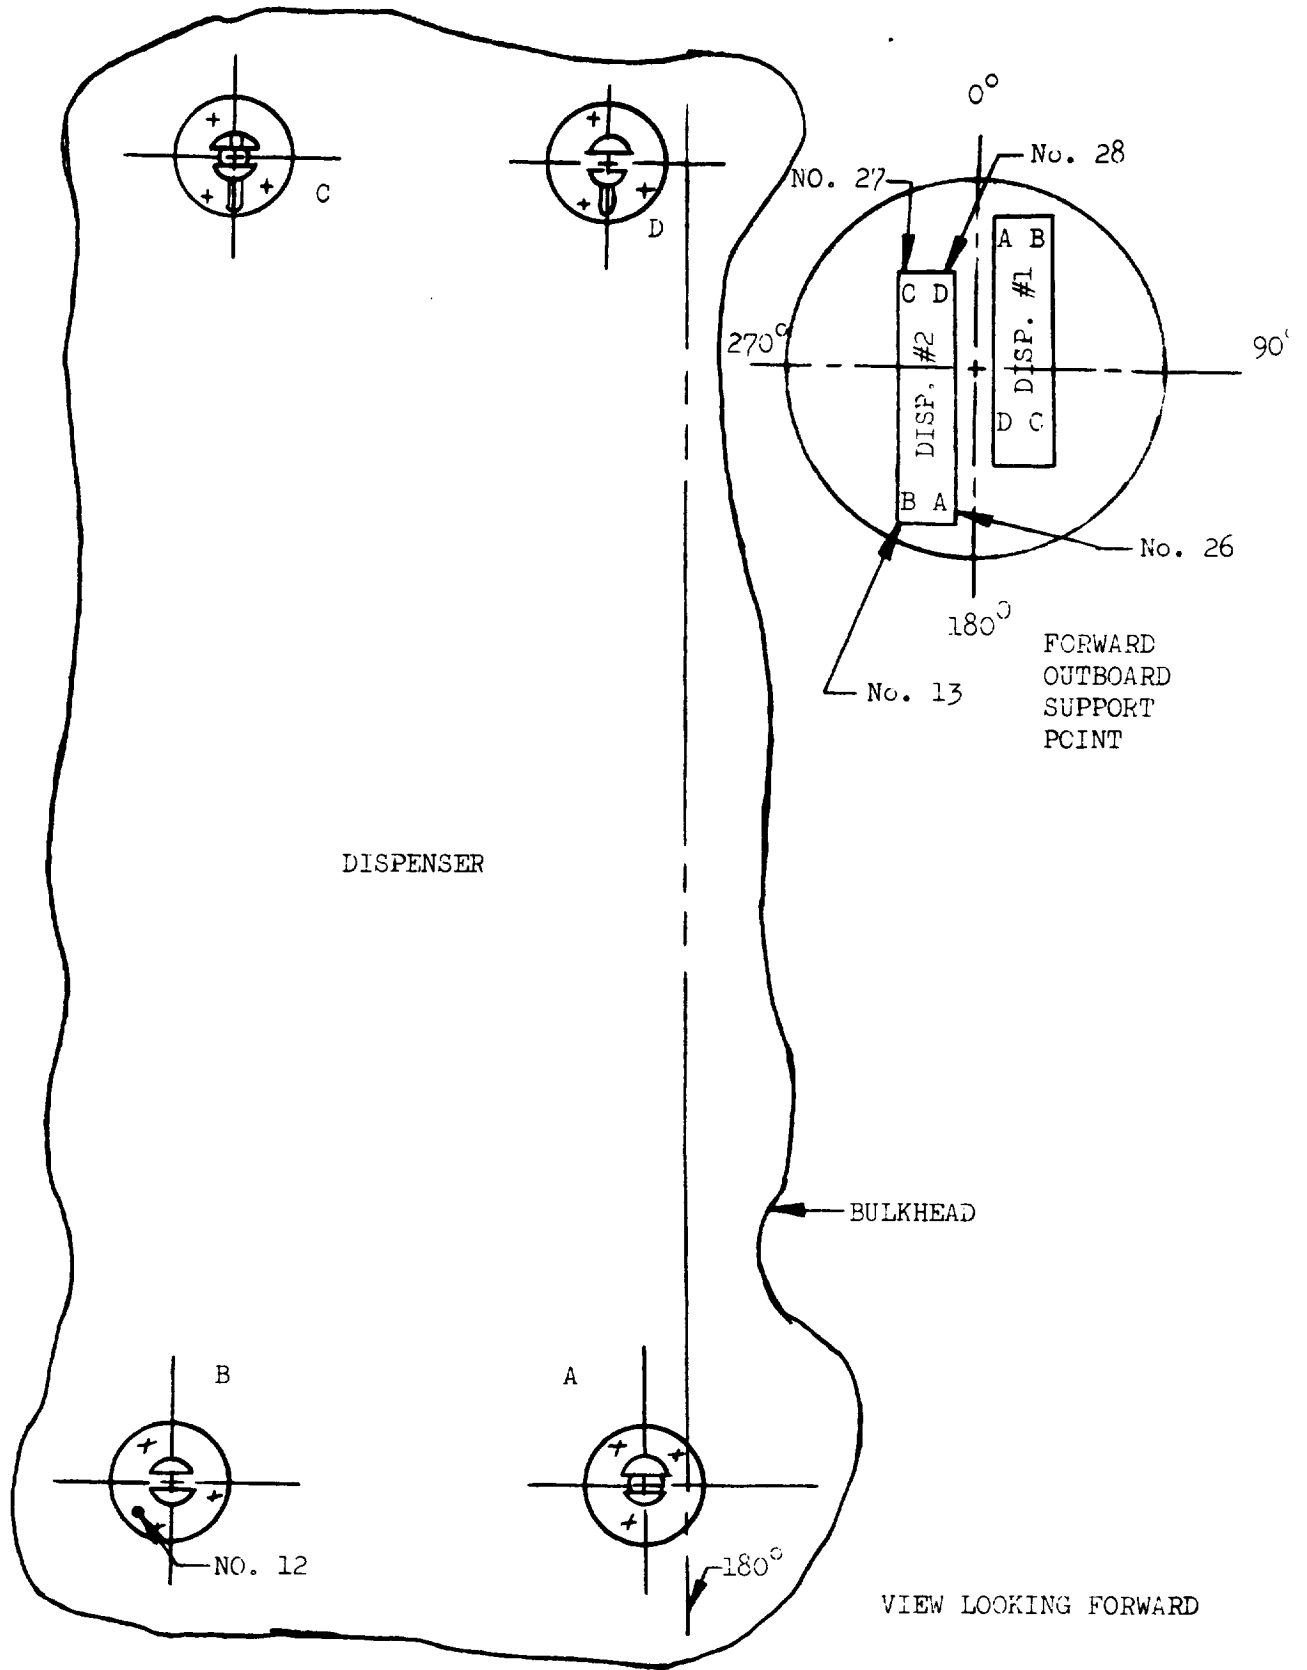
Figure I.A.4-5. Accelerometer Locations on Bulkhead - Aft Side

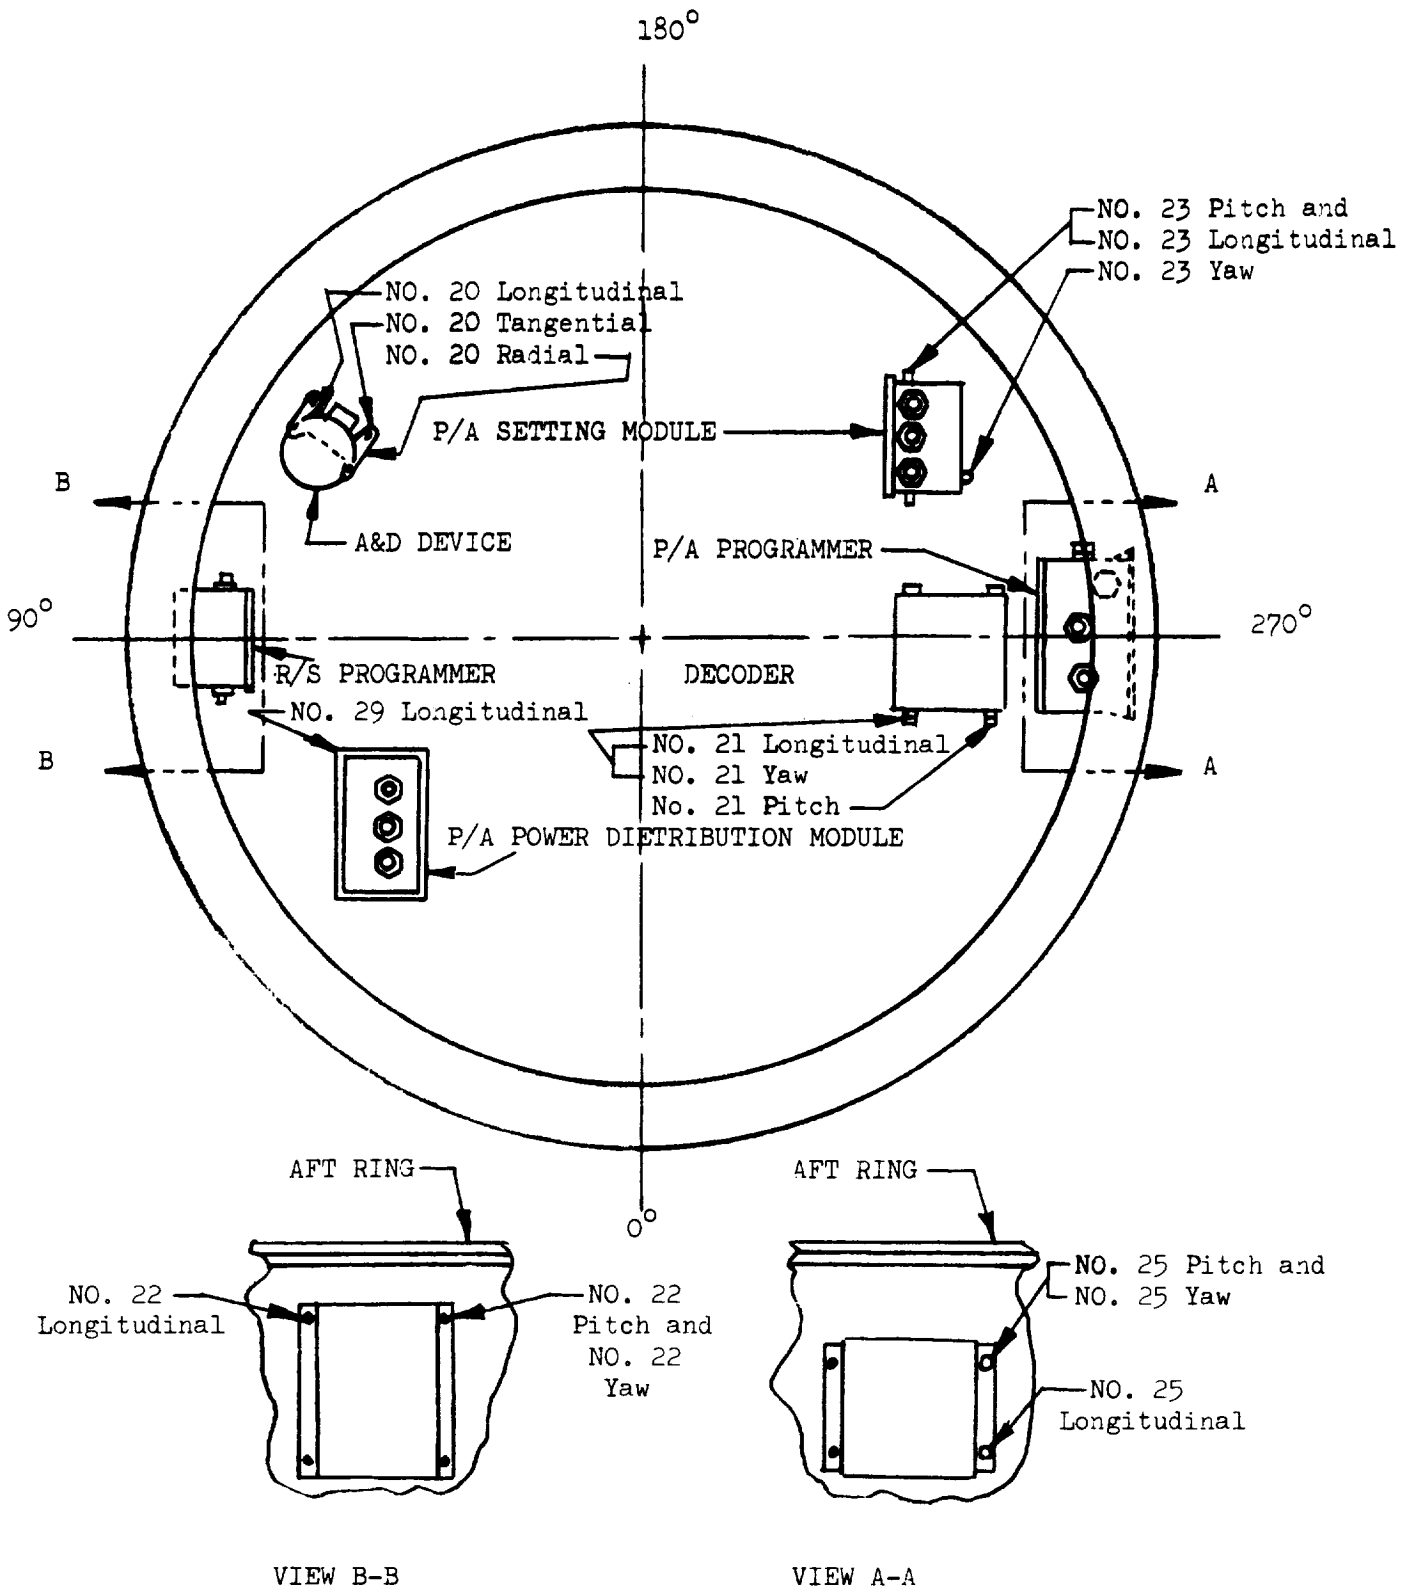
Figure I.A.4-8. Accelerometer Locations on Components in MGS Section

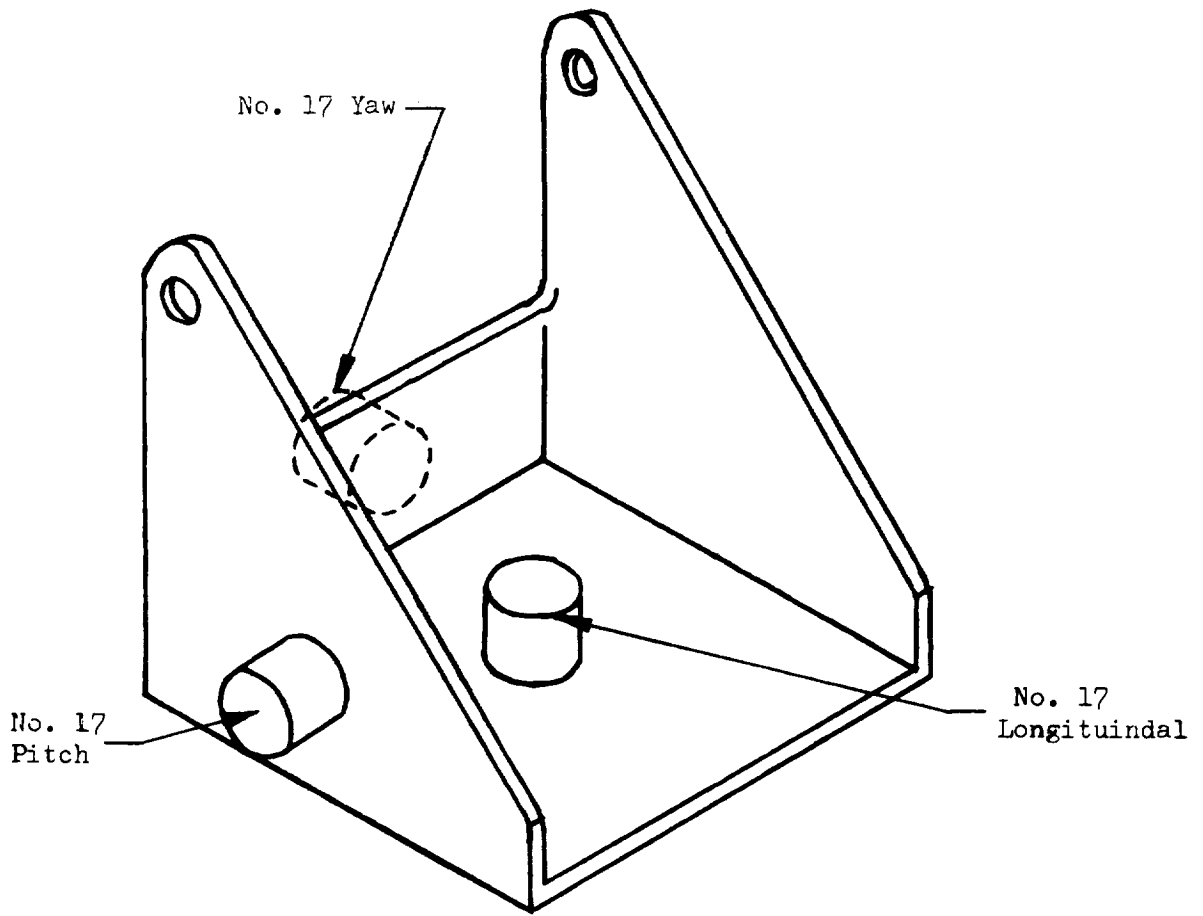
Figure I.A.4-10. Accelerometer Locations on Decoy Bracket
