Aerospace Systems Pyrotechnic Shock Data (Ground Test and Flight)

Final
Report

Volume II
Data

Aerospace Systems Pyrotechnic Shock Data
(Ground Test and Flight)

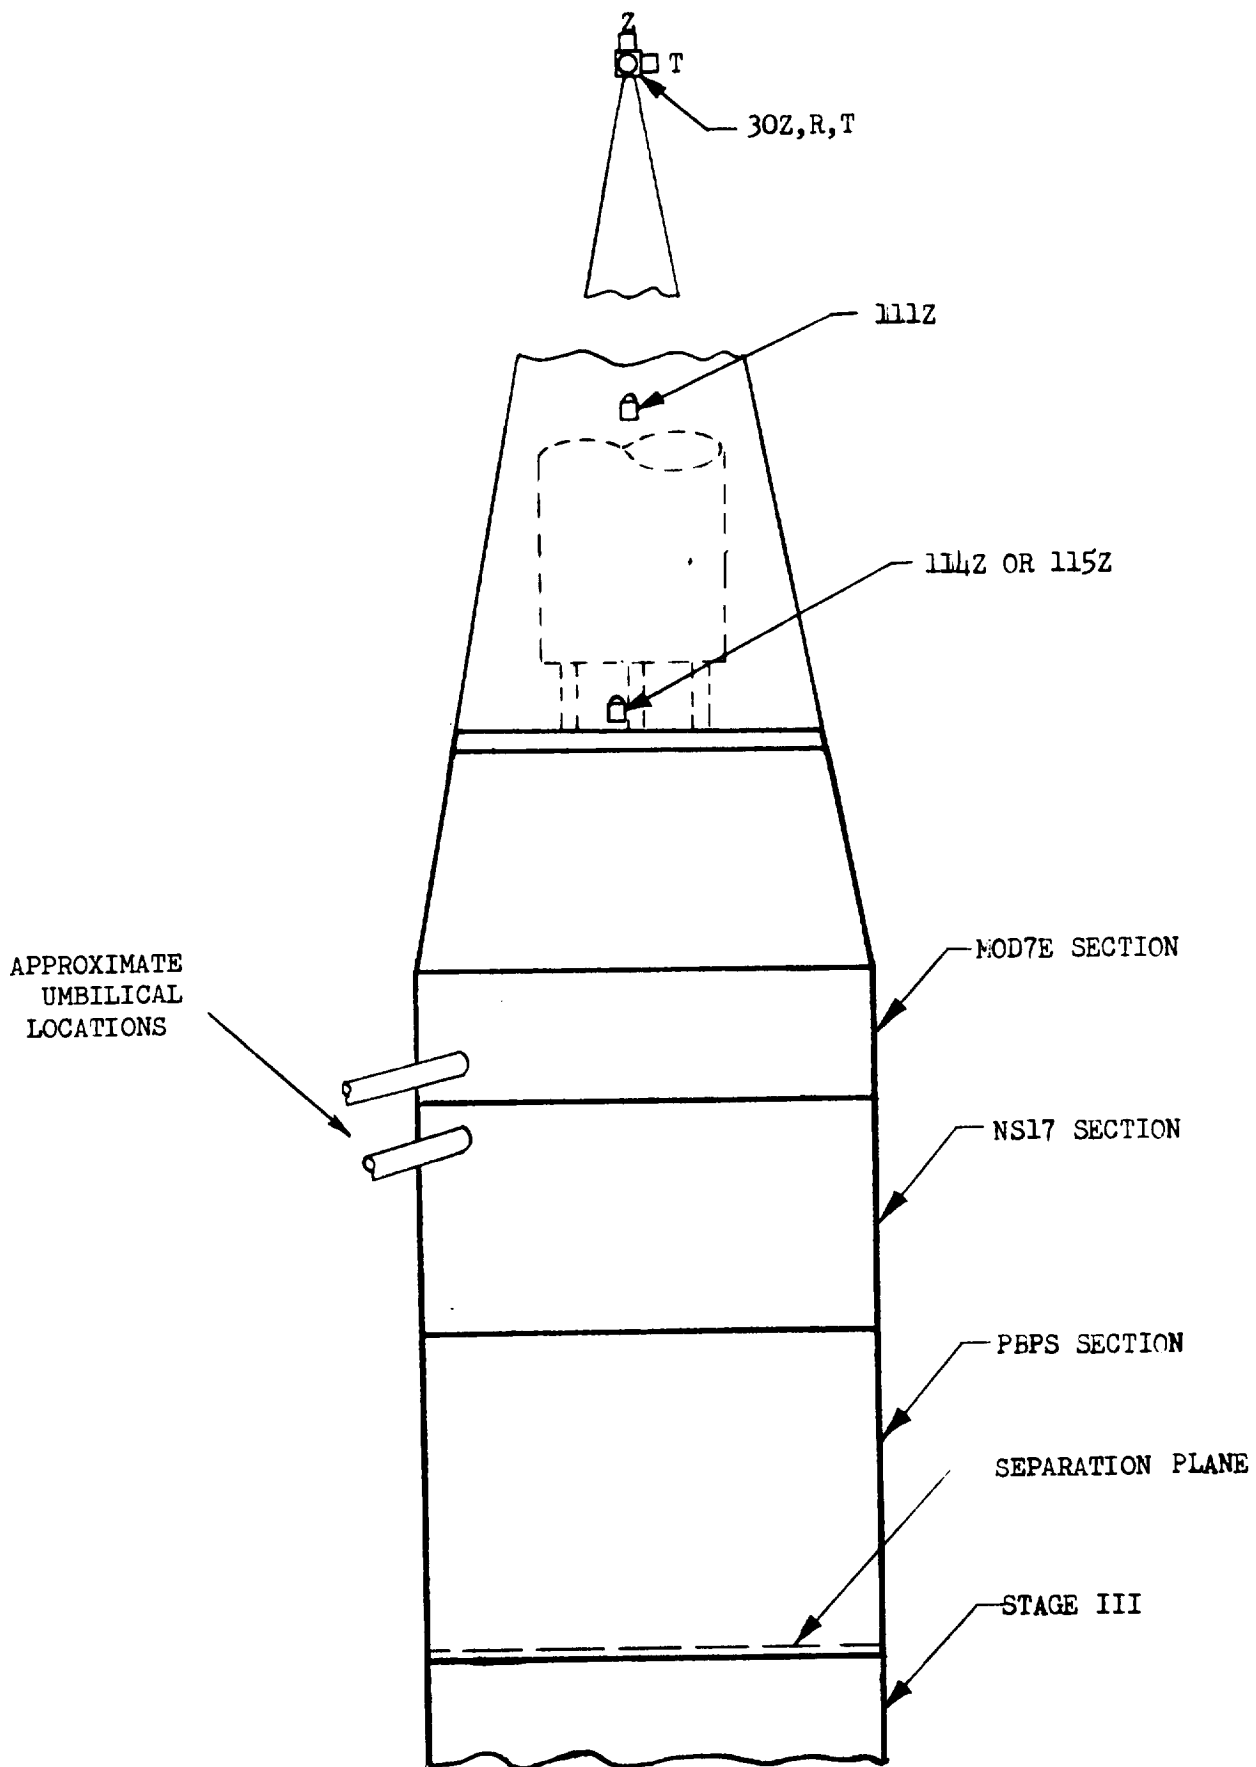
FIGURE I.A.5-1 CONFIGURATION OF PBV SEPARATION TESTS

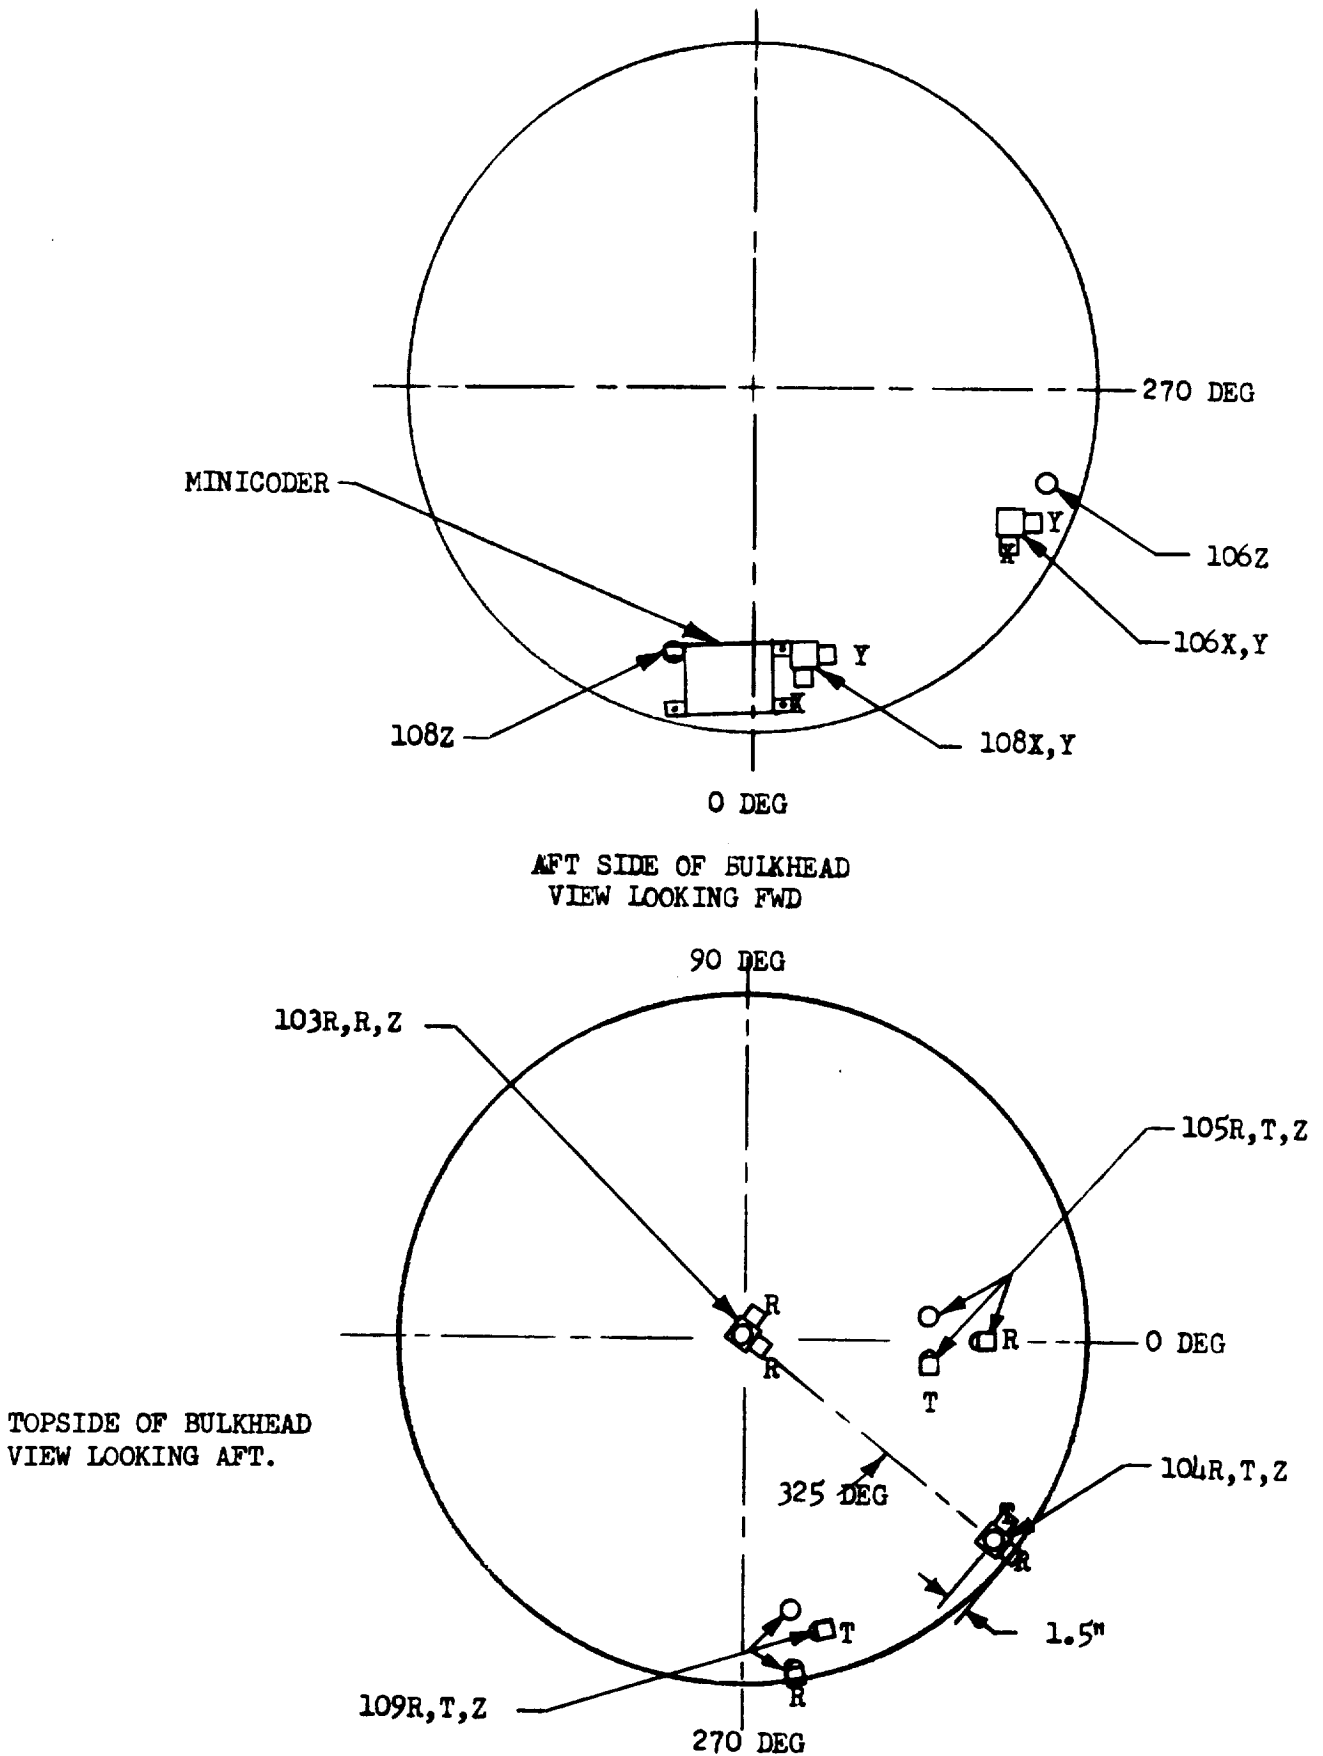
Figure I.A.5-6. Accelerometer Locations
220

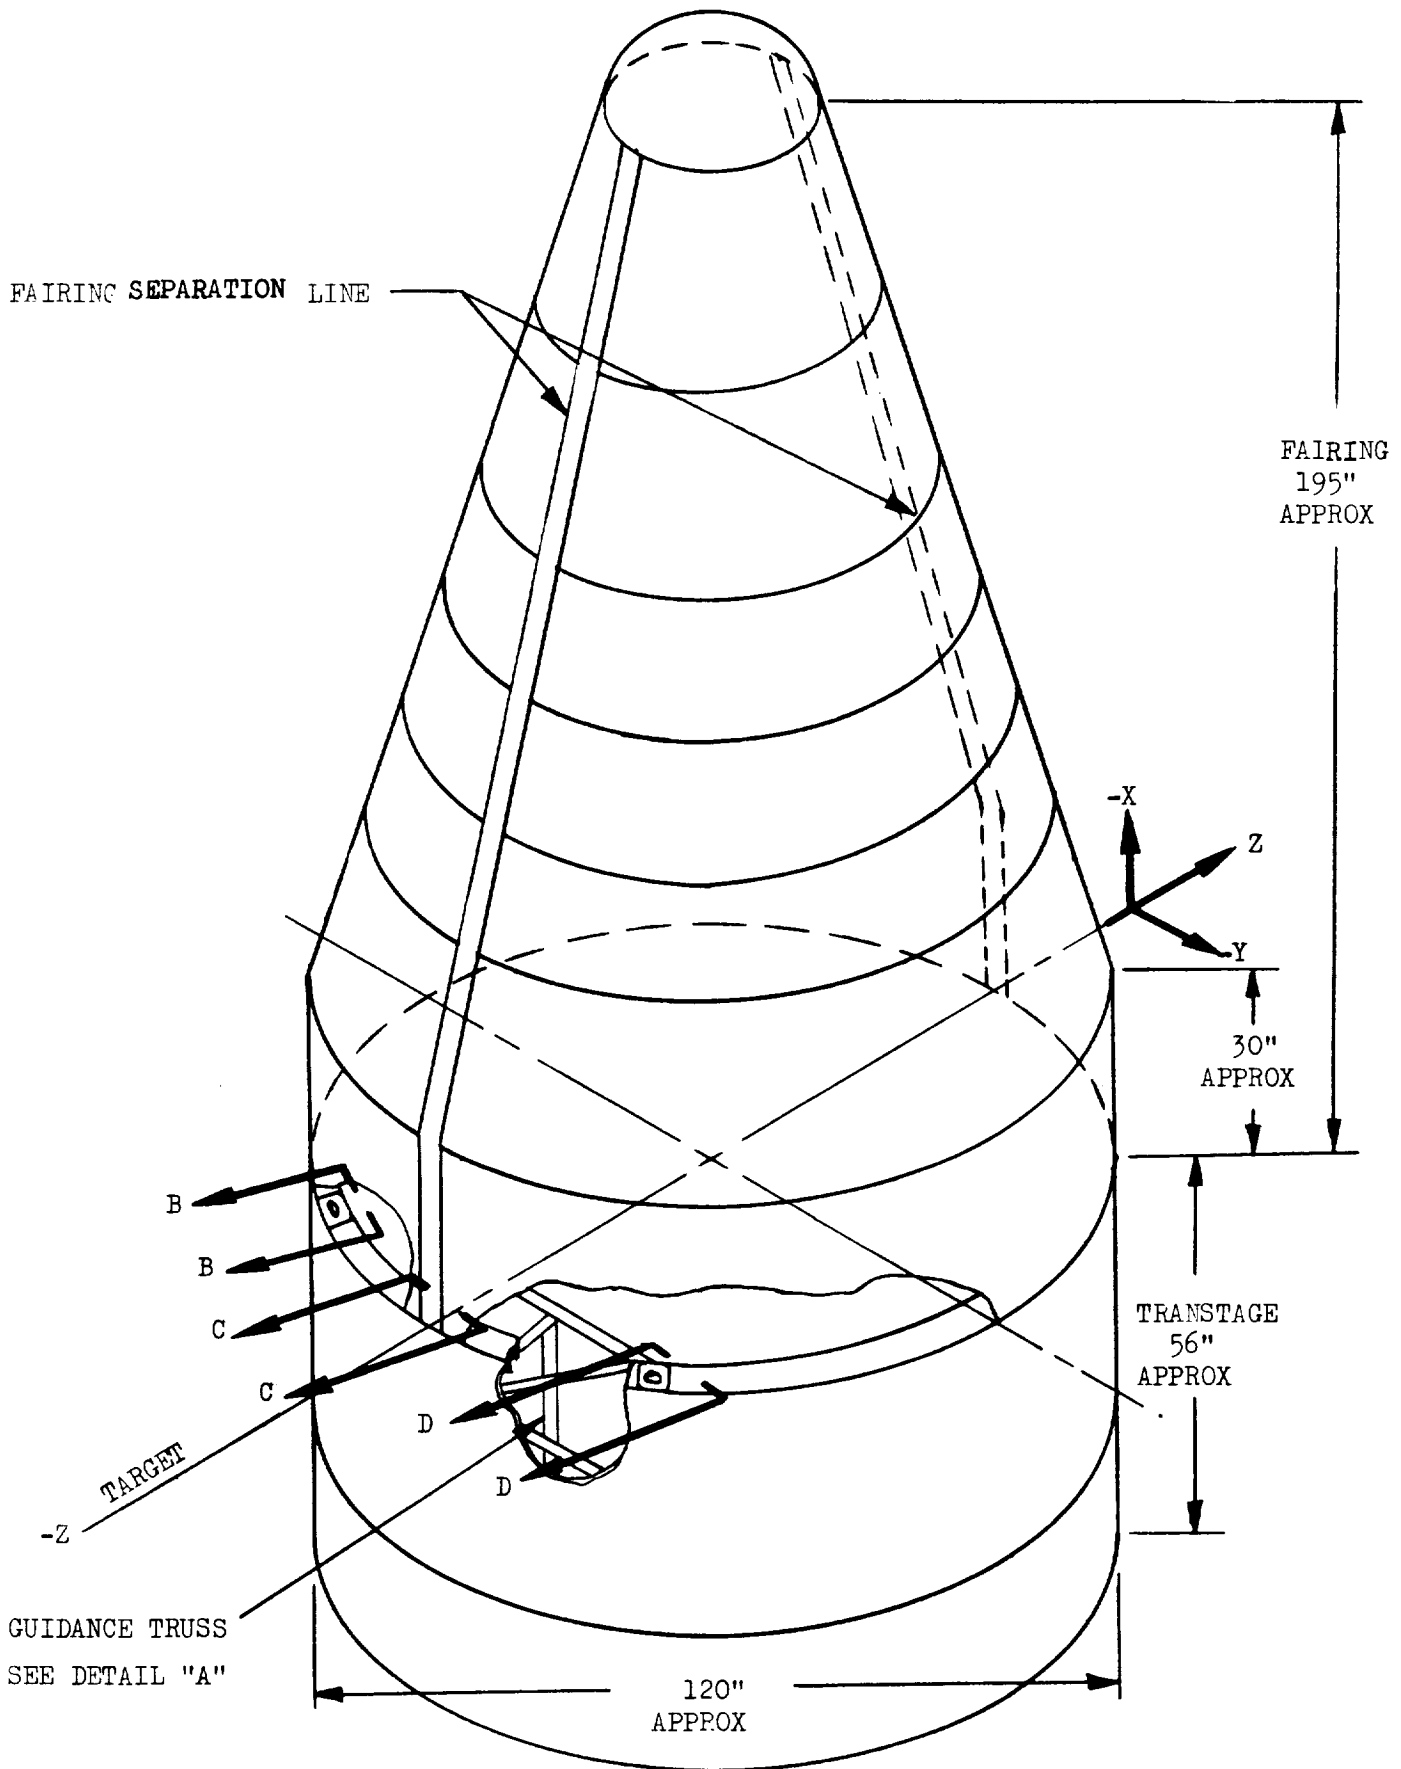
Figure I.B.1-2. Titan III-C Transtage with Standard Payload Fairing

In both tests the Douglas Standard Payload Fairing was mounted over a dummy payload atop a Titan IIIC transtage in the vertical orientation as illustrated in Figures I.B.1-1 and I.B.1-2. The fairing was then separated into two longitudinal segments by means of twin strands of primaline at four grains per foot housed within a bellows assembly. The expanding bellows then caused the rivets in the separation joint to shear, and continued expansion of the bellows forced the fairing halves to drop away from the instrumented transtage where the data were recorded.

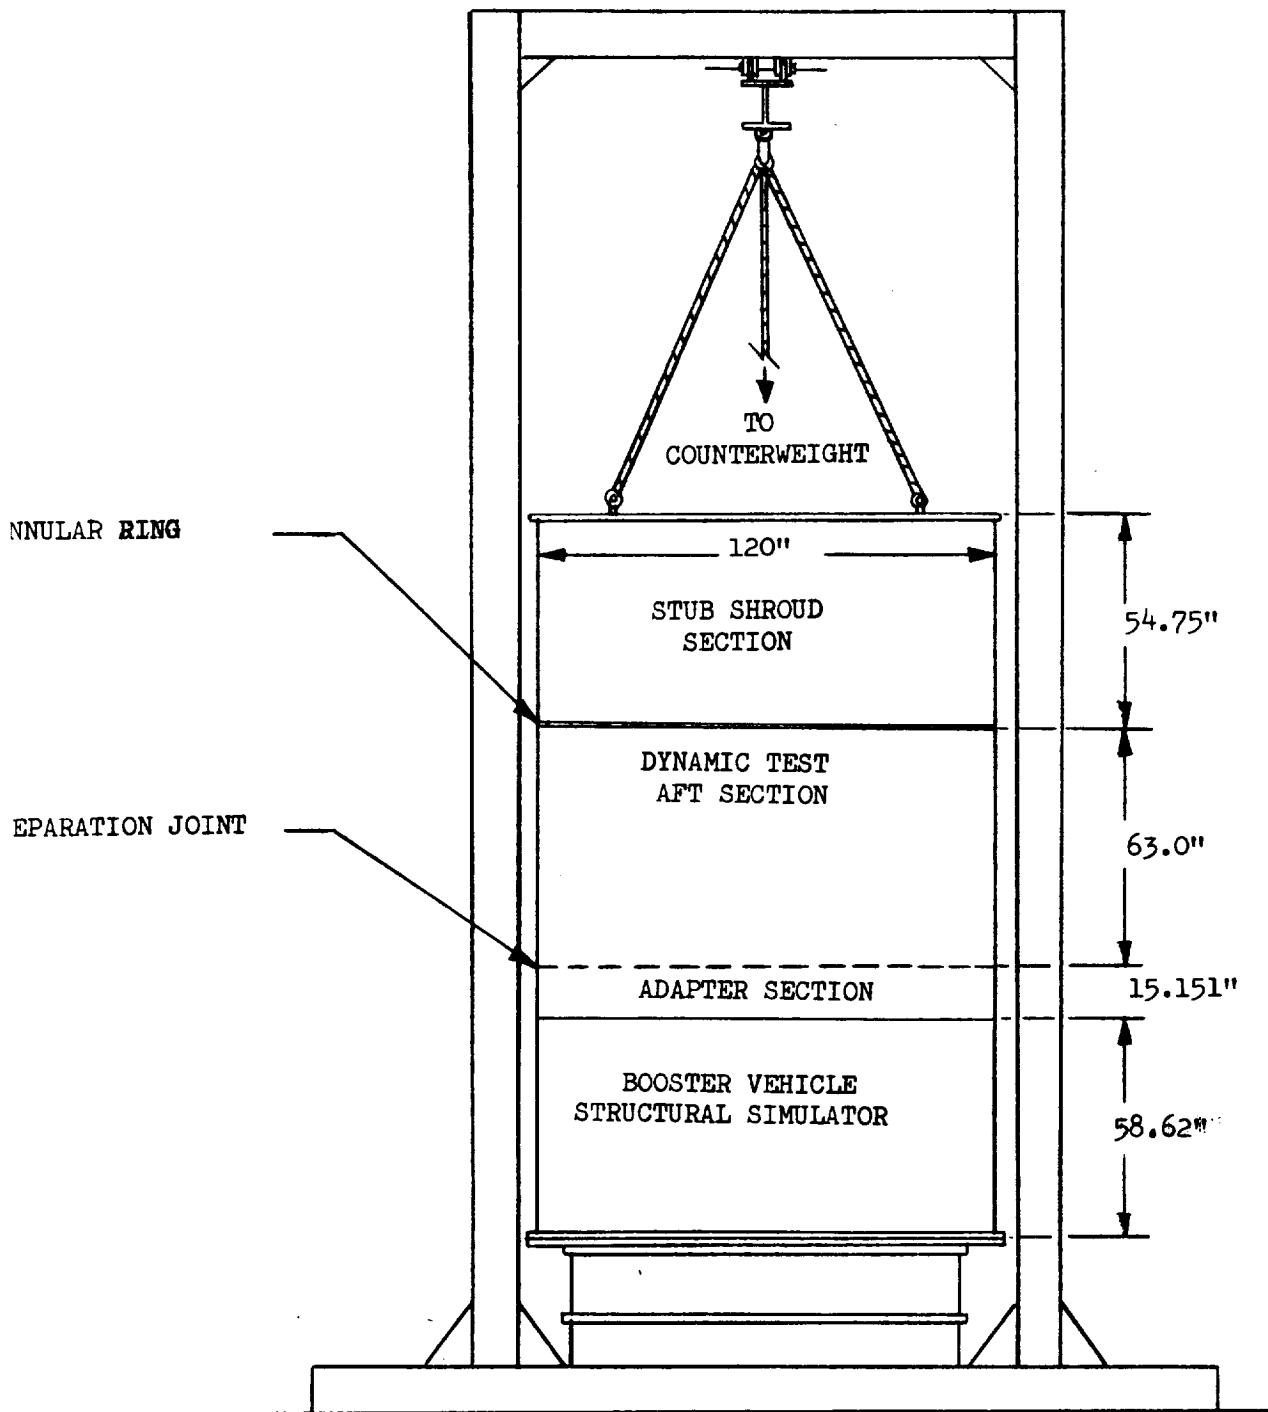
FIGURE I.A.7-4. TEST SET-UP

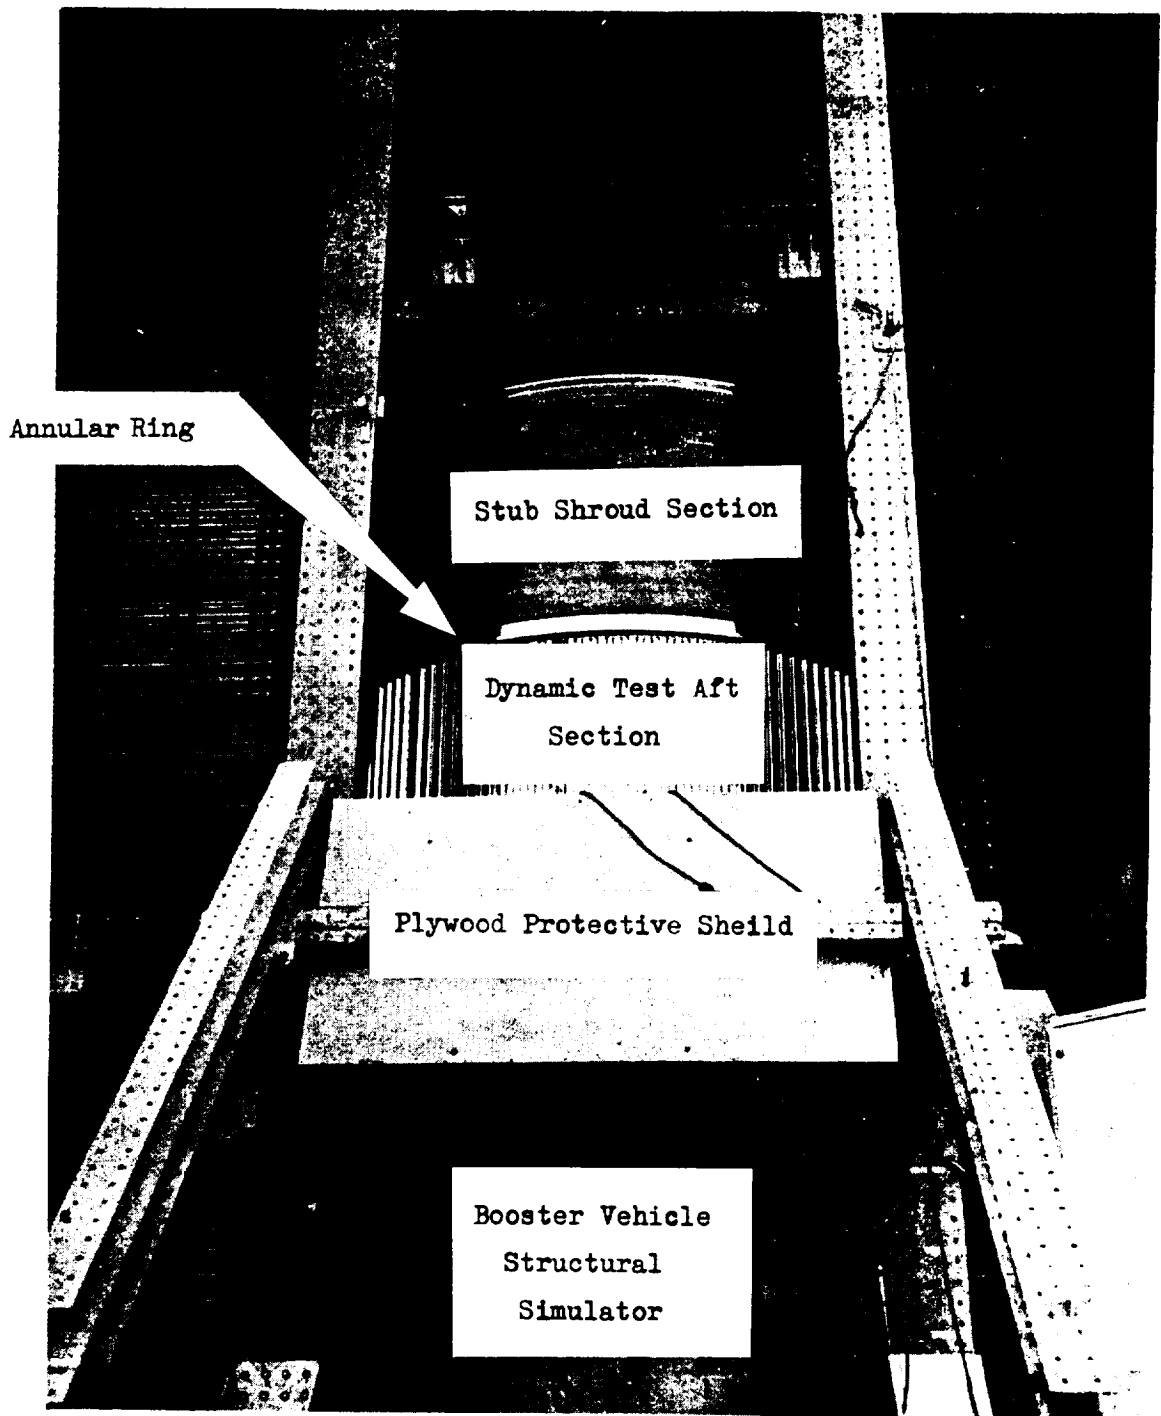
FIGURE I.A.7-1. TEST CONFIGURATION PRIOR TO SEPARATION

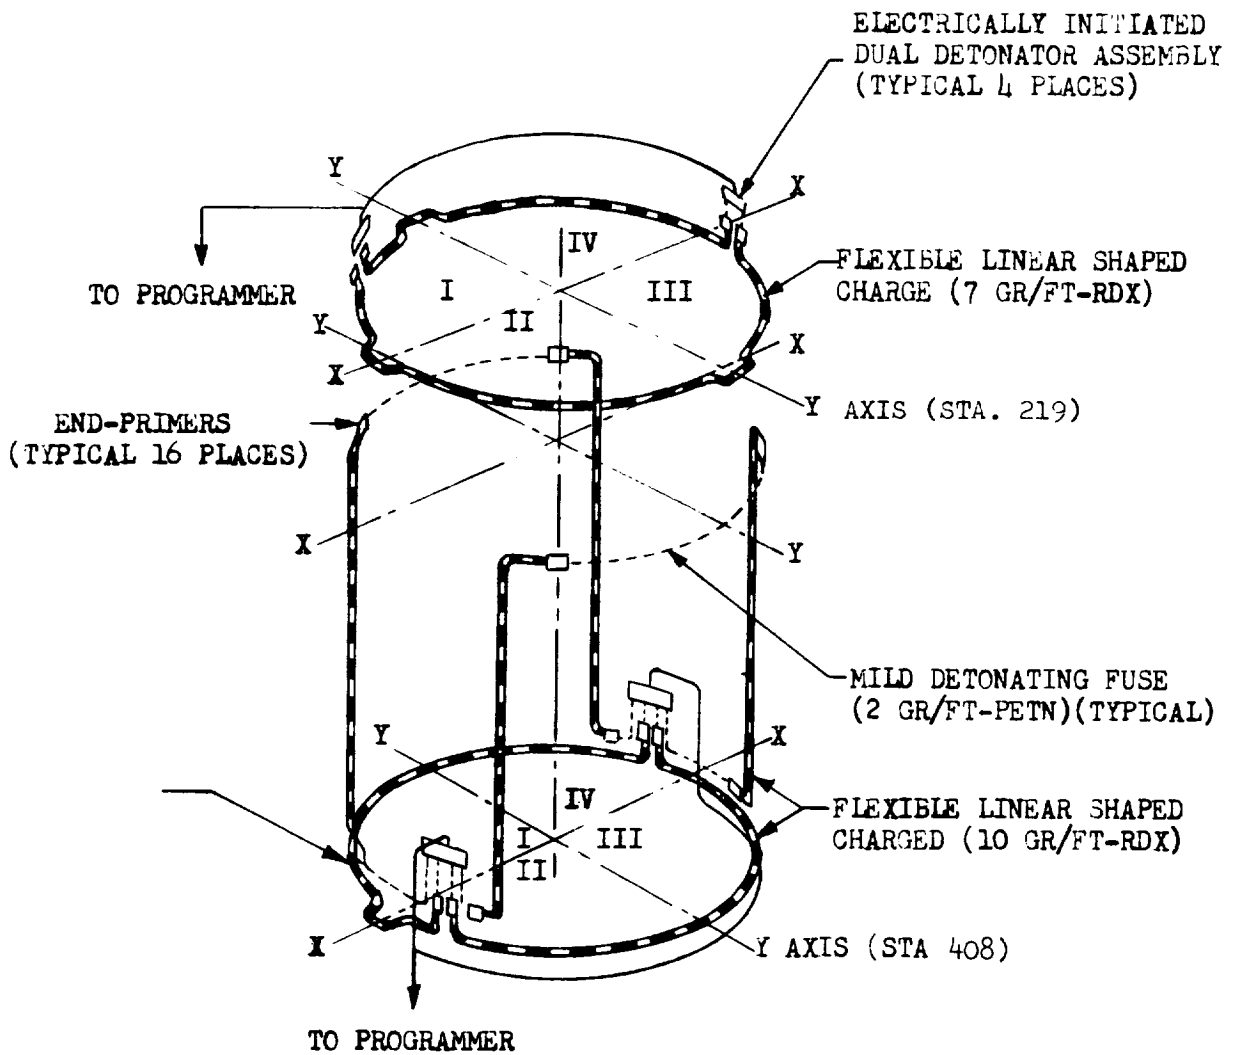
Figure I.A.6-2. Shaped Charge Separation System
for Centaur Panel Jettison

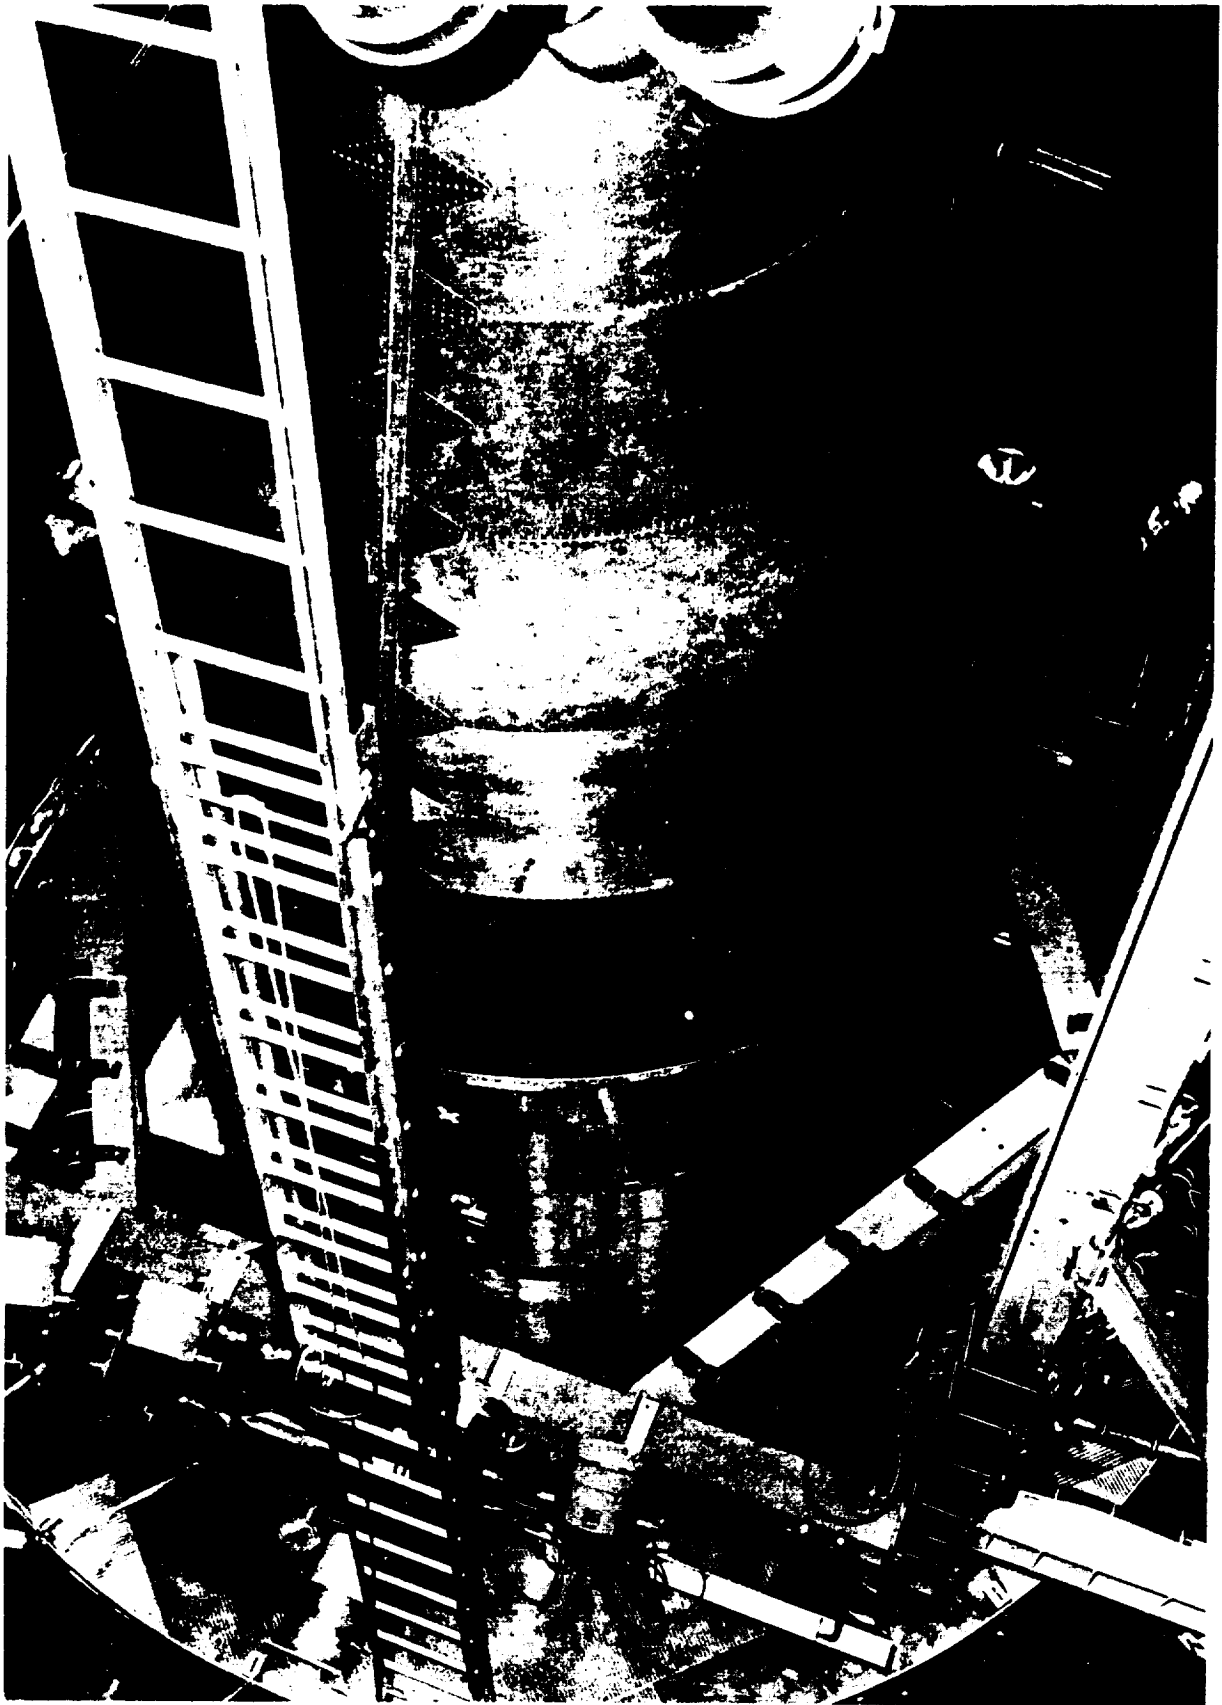
FIGURE I.B.2-1. FAIRING MOUNTED TO TRANSTAGE

In this test the Douglas Metal Fairing was mounted over a dummy payload atop a Titan IIIC transtage in the vertical orientation as illustrated in Figures I.B.2-1 and I.B.2-2. The fairing was then separated into two longitudinal segments by means of twin strands of primaline at four grains per foot housed within a bellows assembly. The expanding bellows then caused the rivets in the separation joint to shear, and continued expansion of the bellows forced the fairing halves to drop away from the instrumented transtage where the data were recorded.

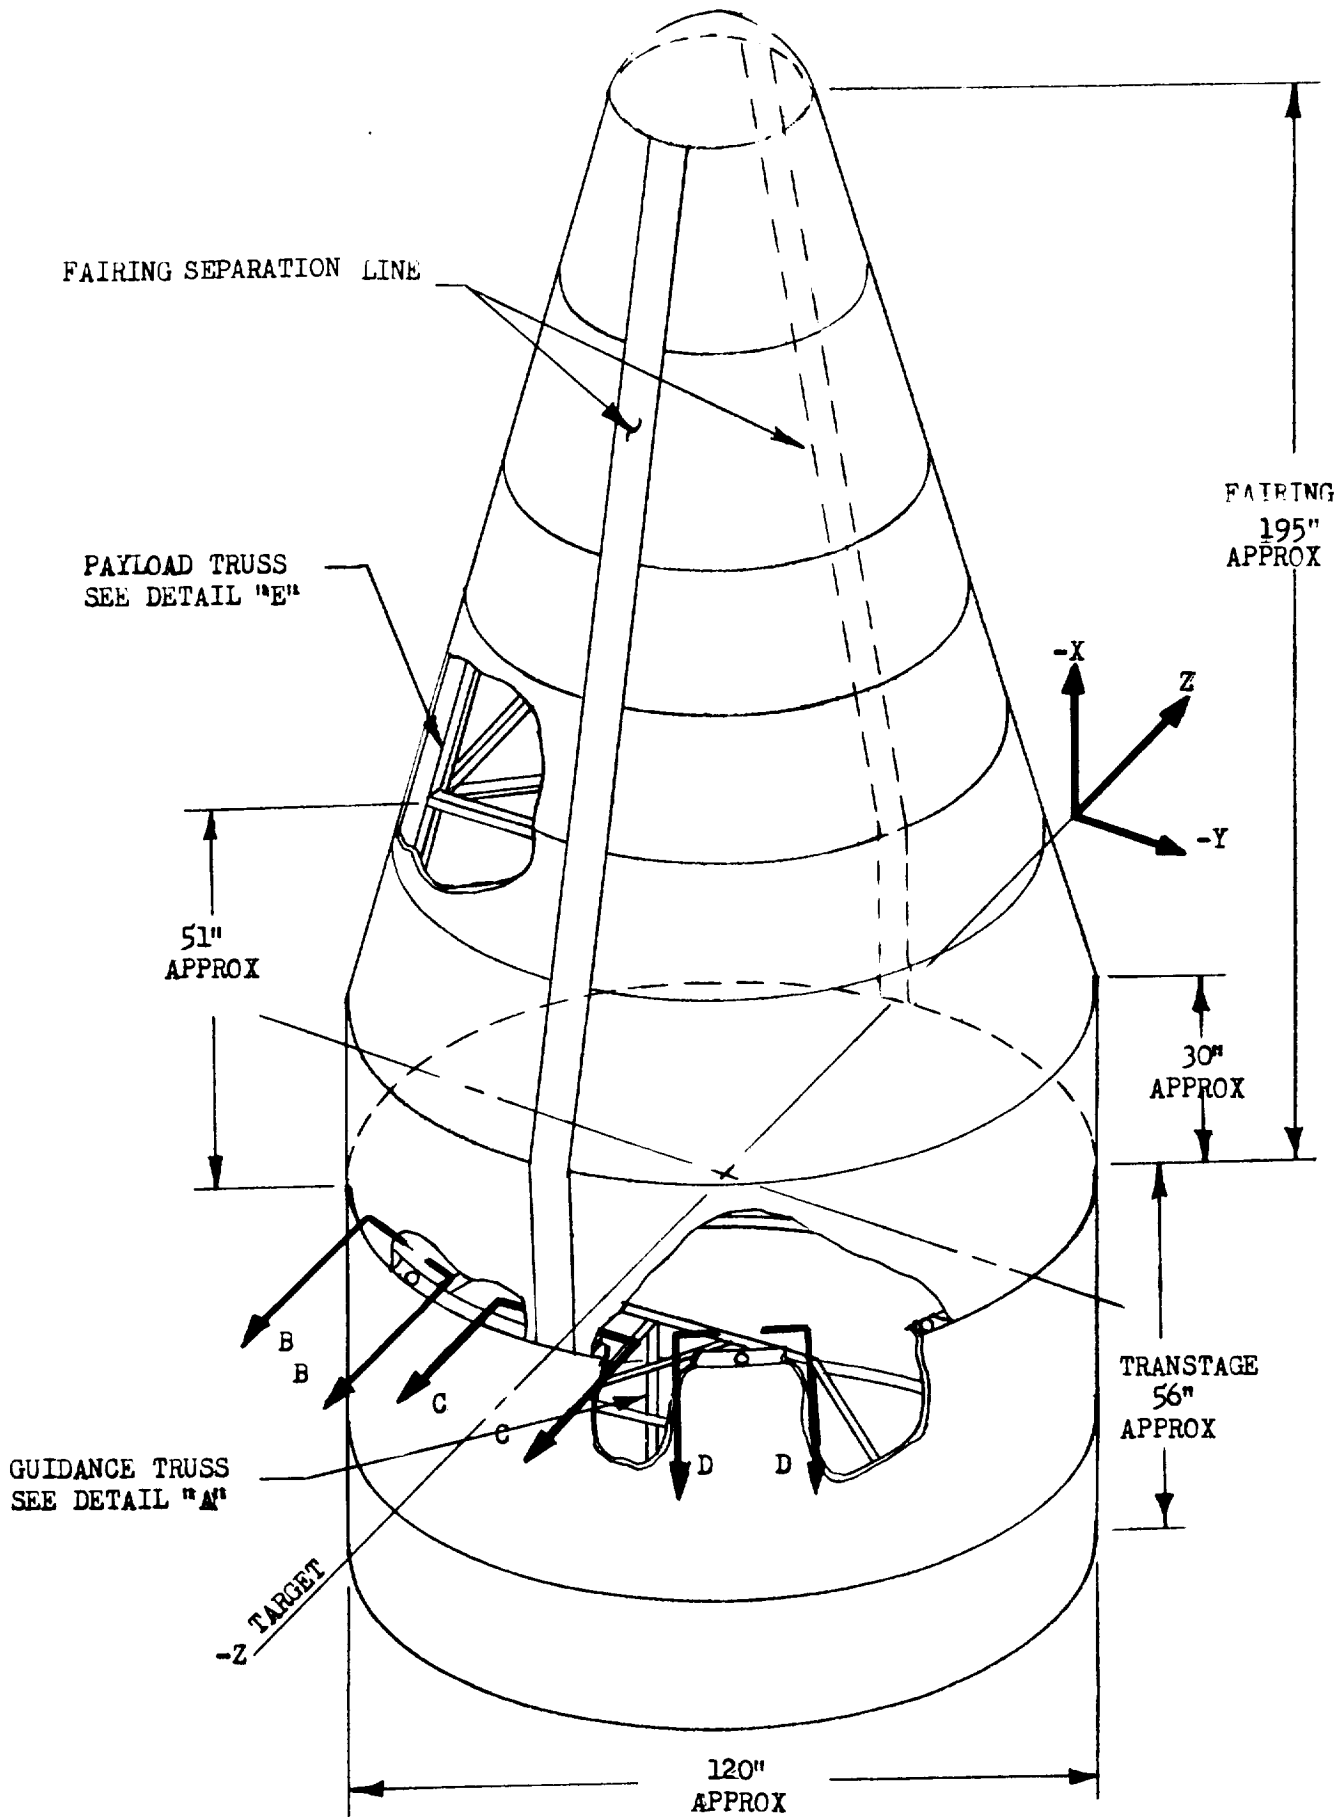
Figure I.B.2-2. Titan III-C Transtage with Metal Fairing

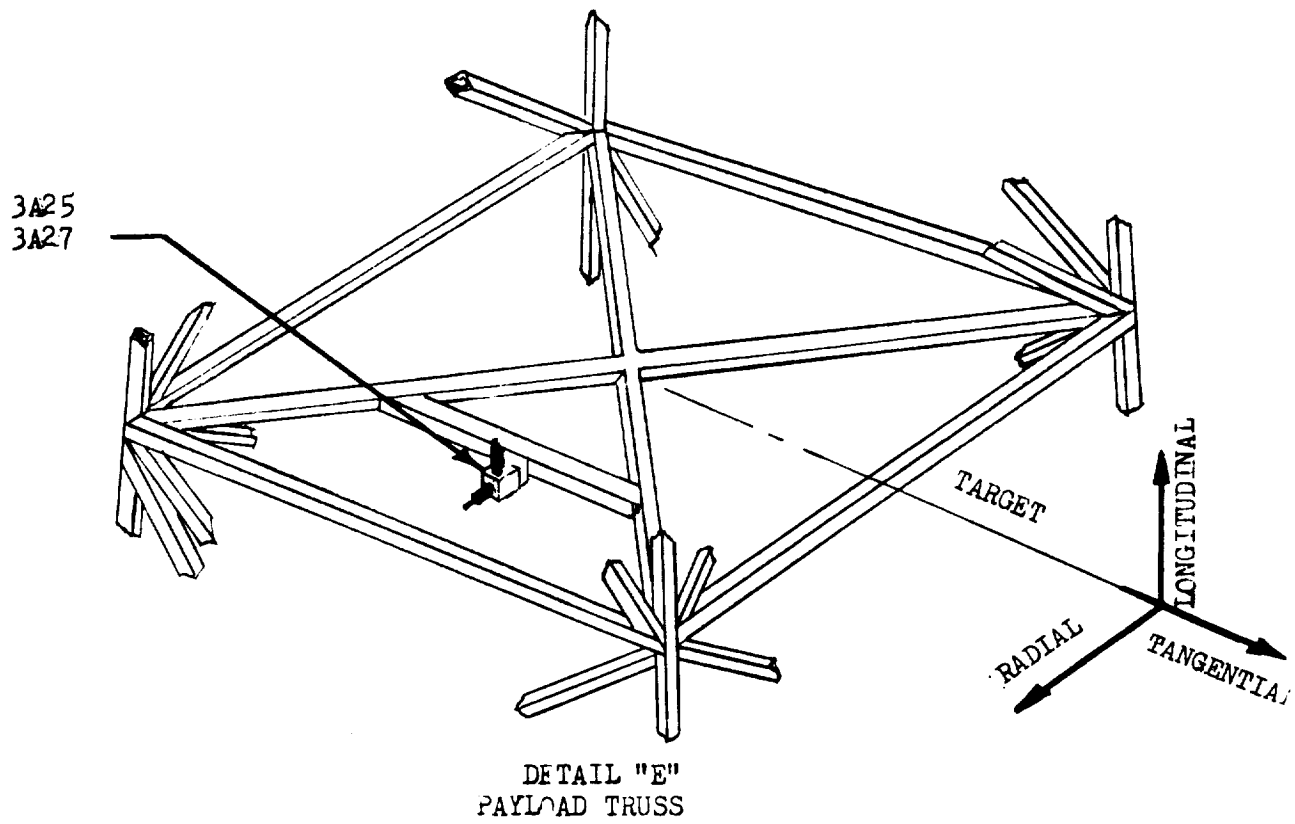
Figure I.B.2-5. Accelerometer Locations

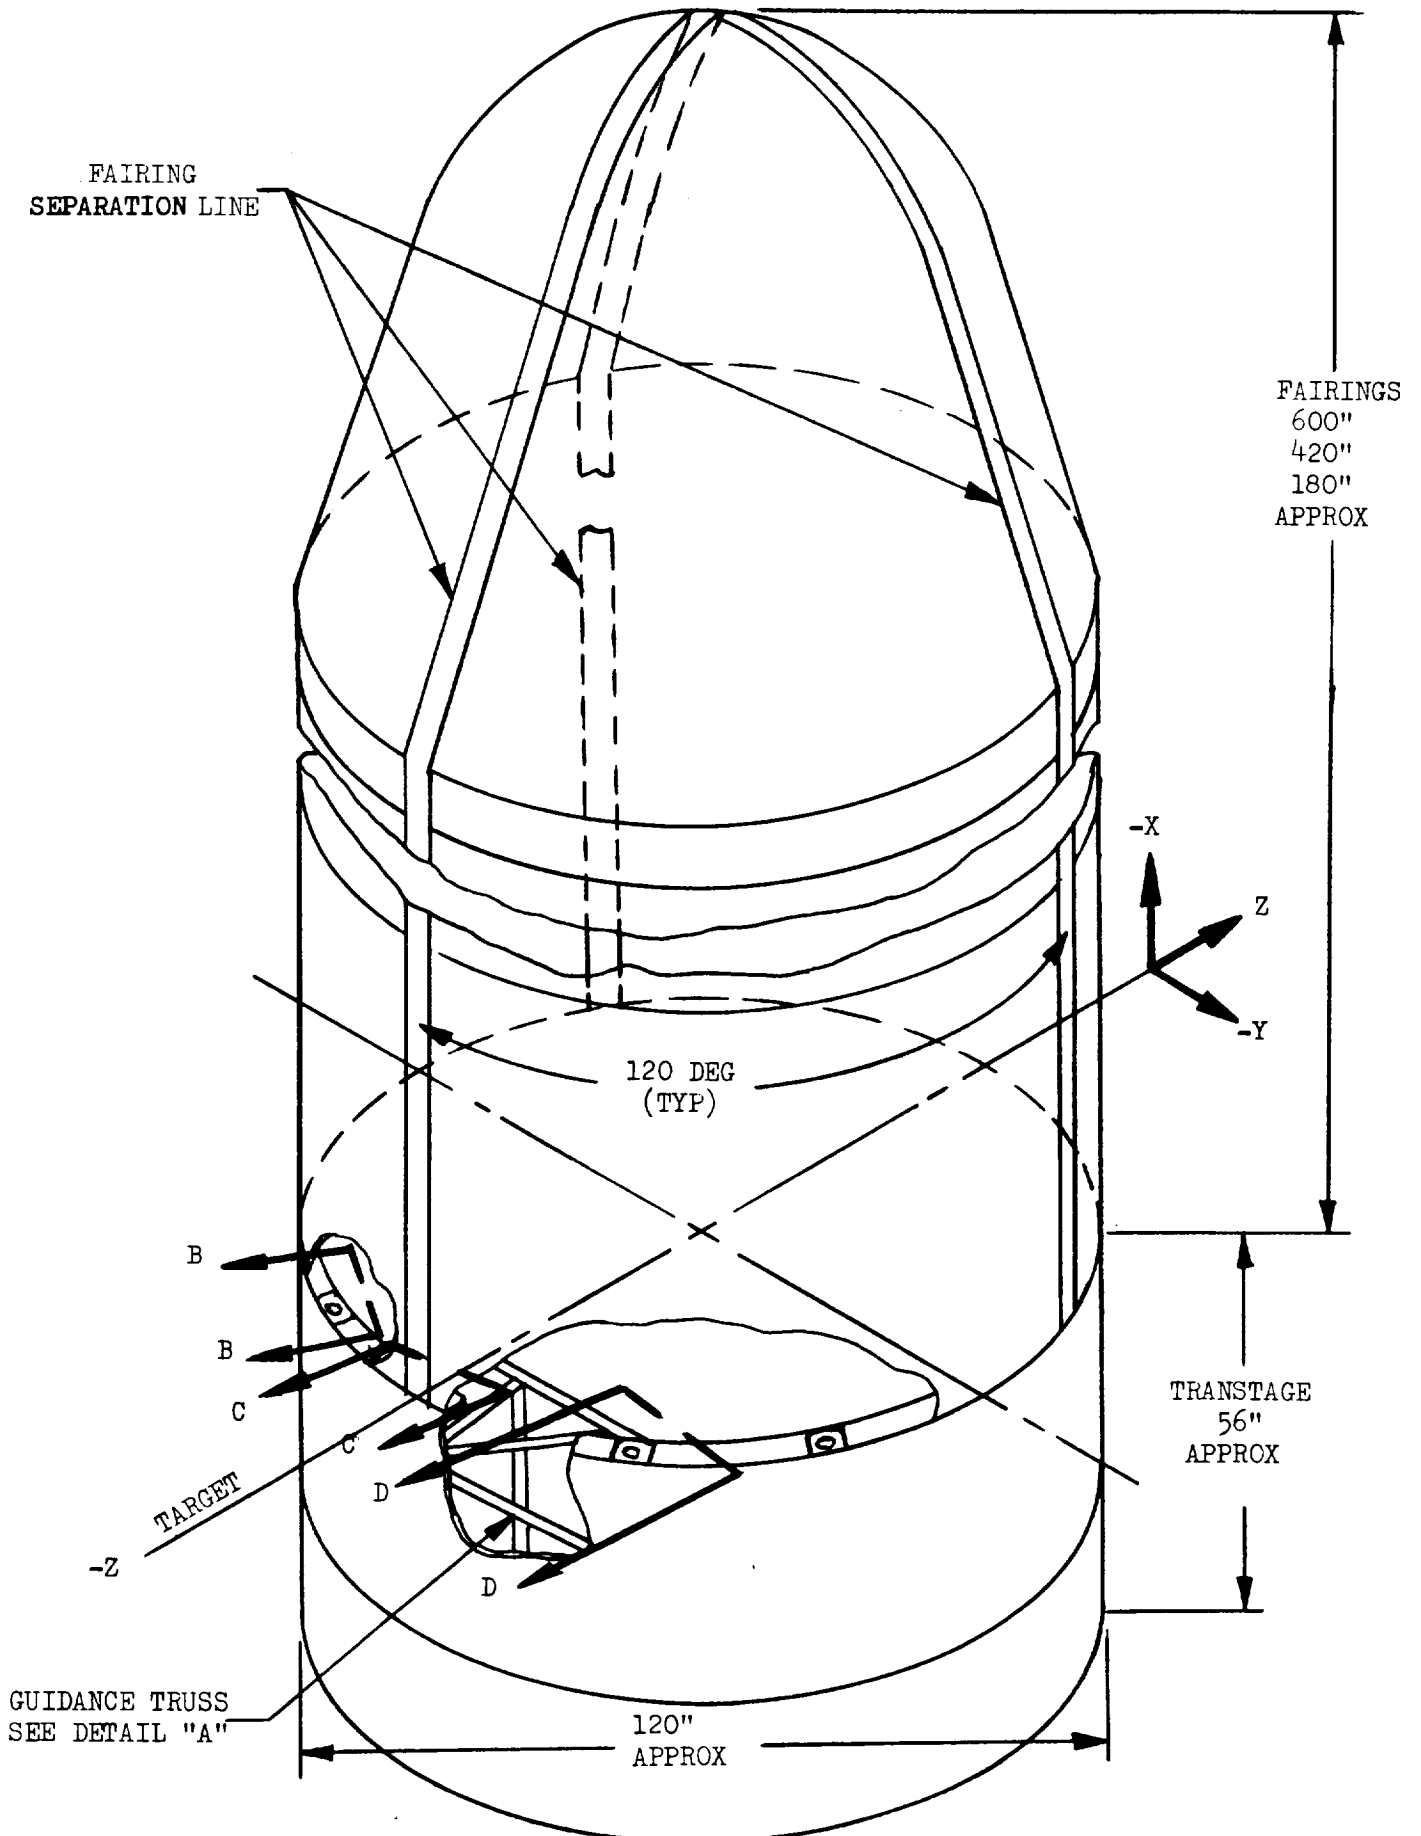
Figure I.B.3-1. Titan III-C Transtage with Universal Fairing
500

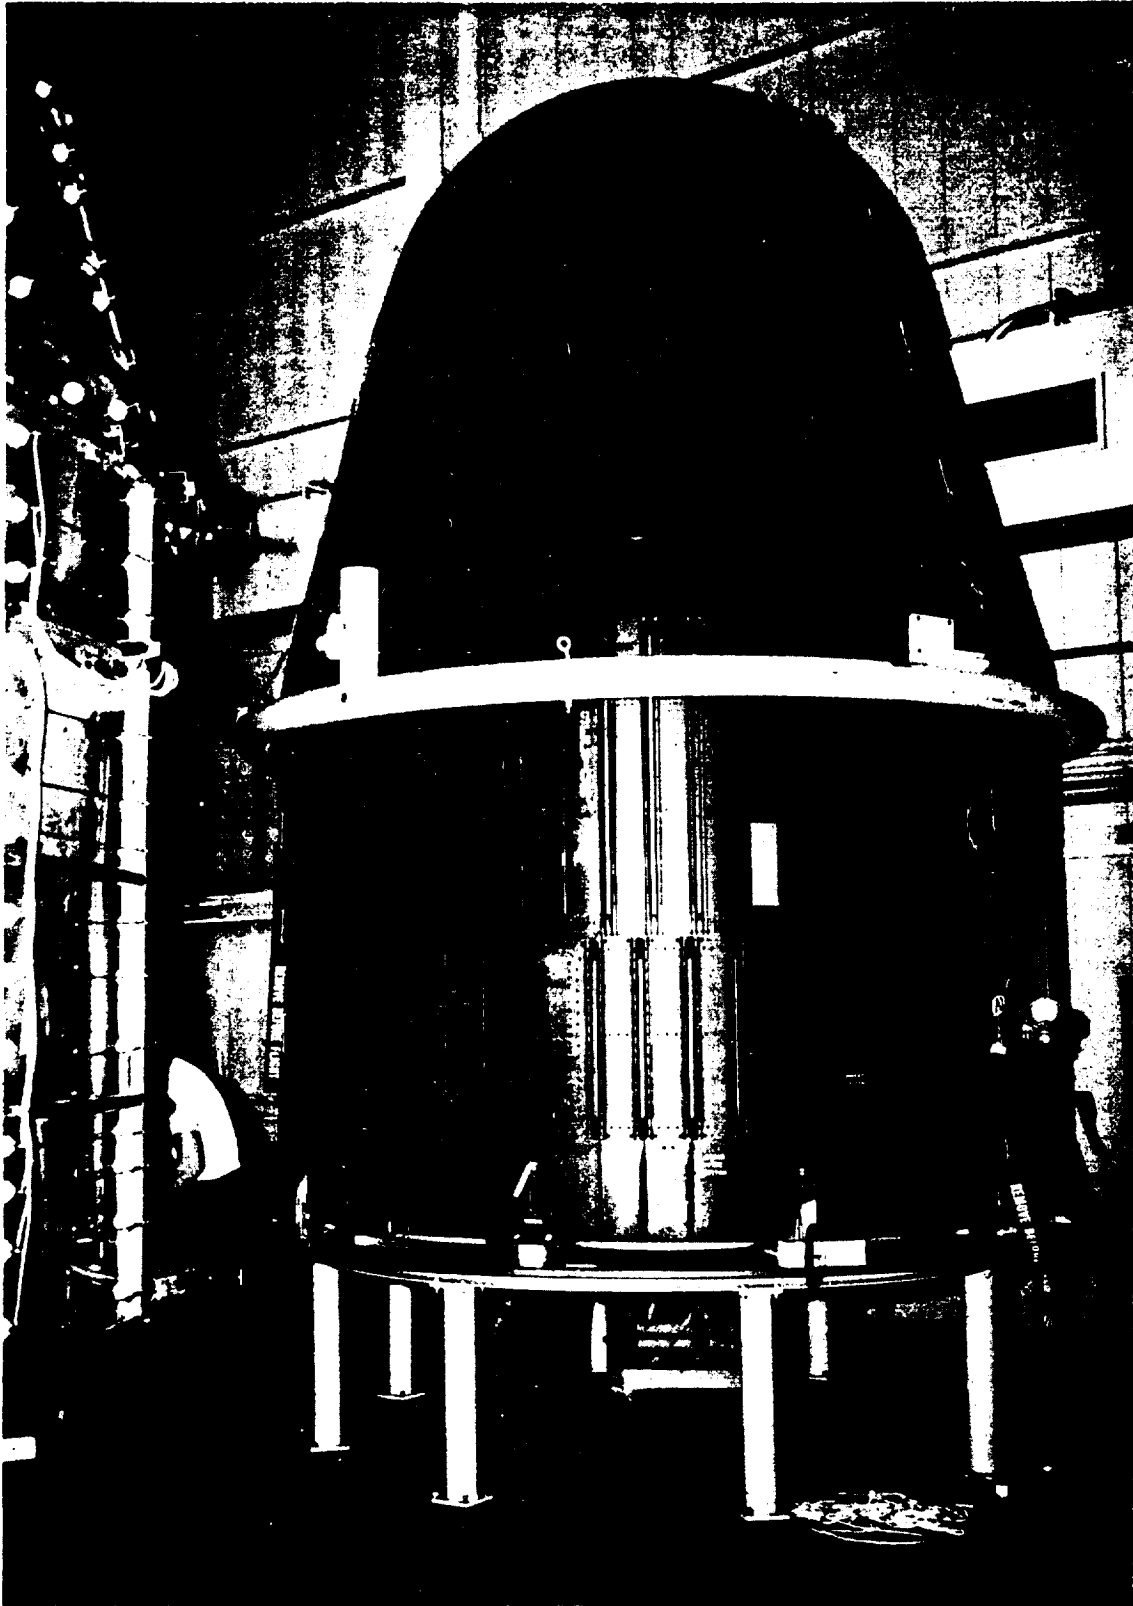
FIGURE I.B.3-2. 15 FOOT FAIRING
