Aerospace Systems Pyrotechnic Shock Data (Ground Test and Flight)

Final
Report

Volume II
Data

Aerospace Systems Pyrotechnic Shock Data
(Ground Test and Flight)

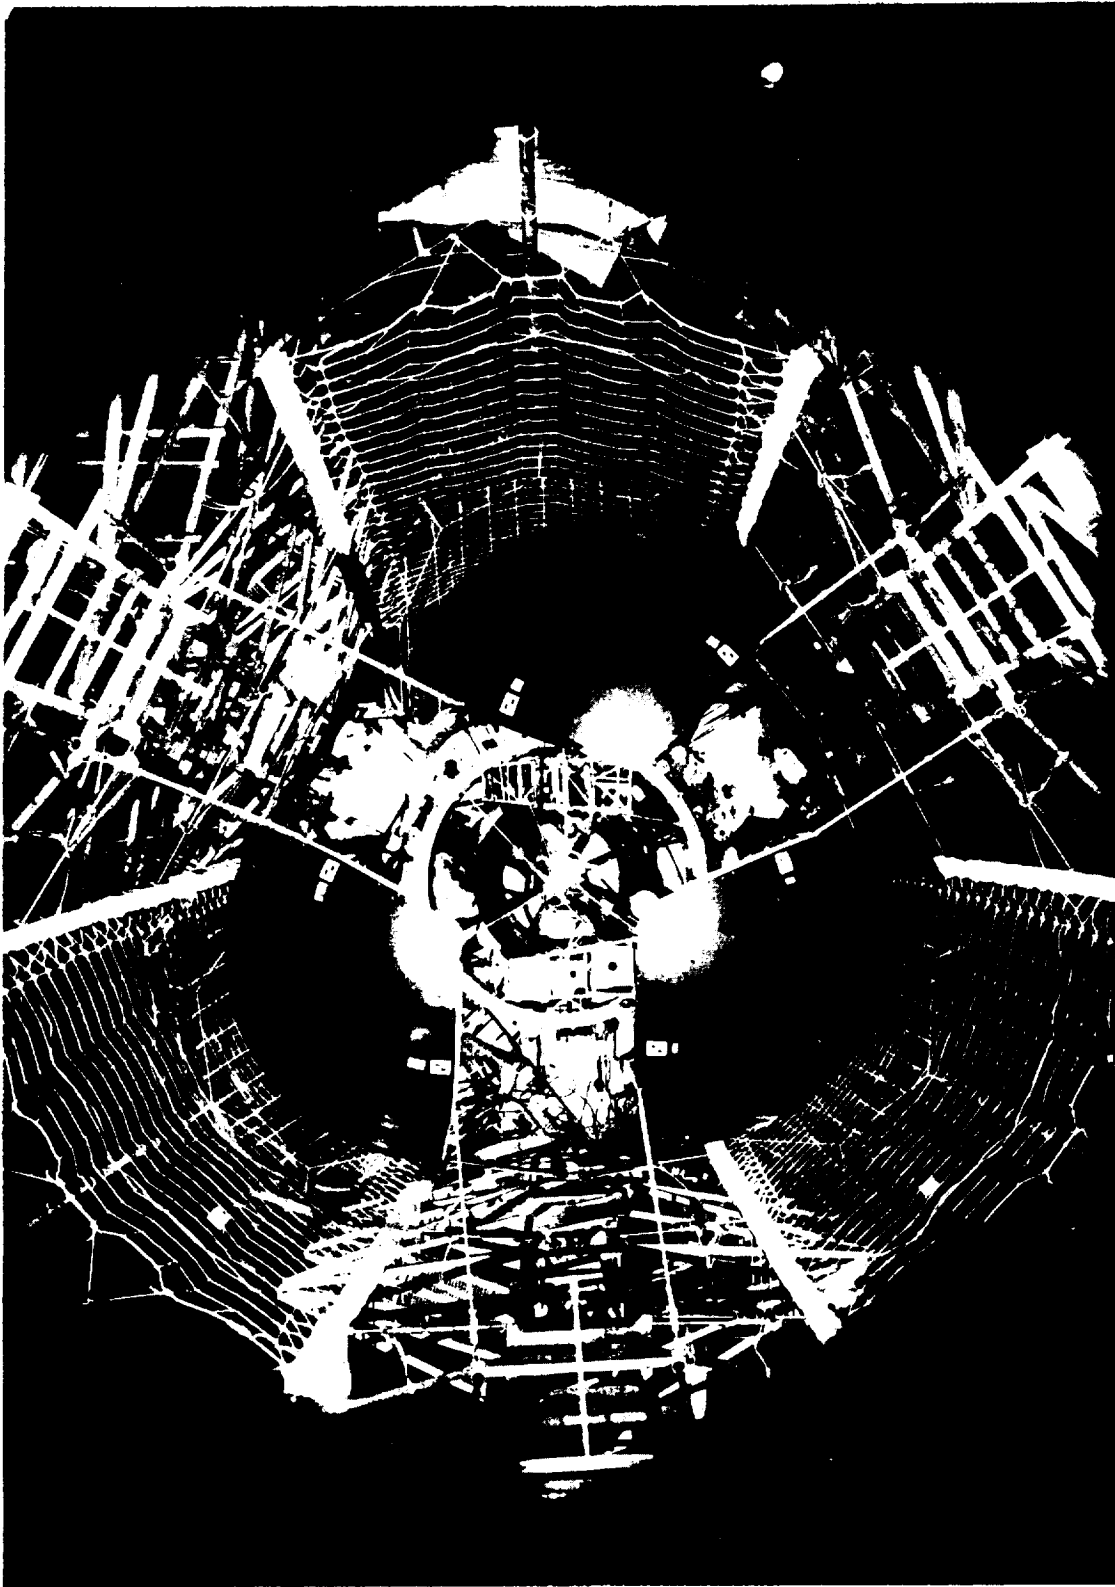
FIGURE I.B.3-4. SEPARATED TRI-SECTIONS

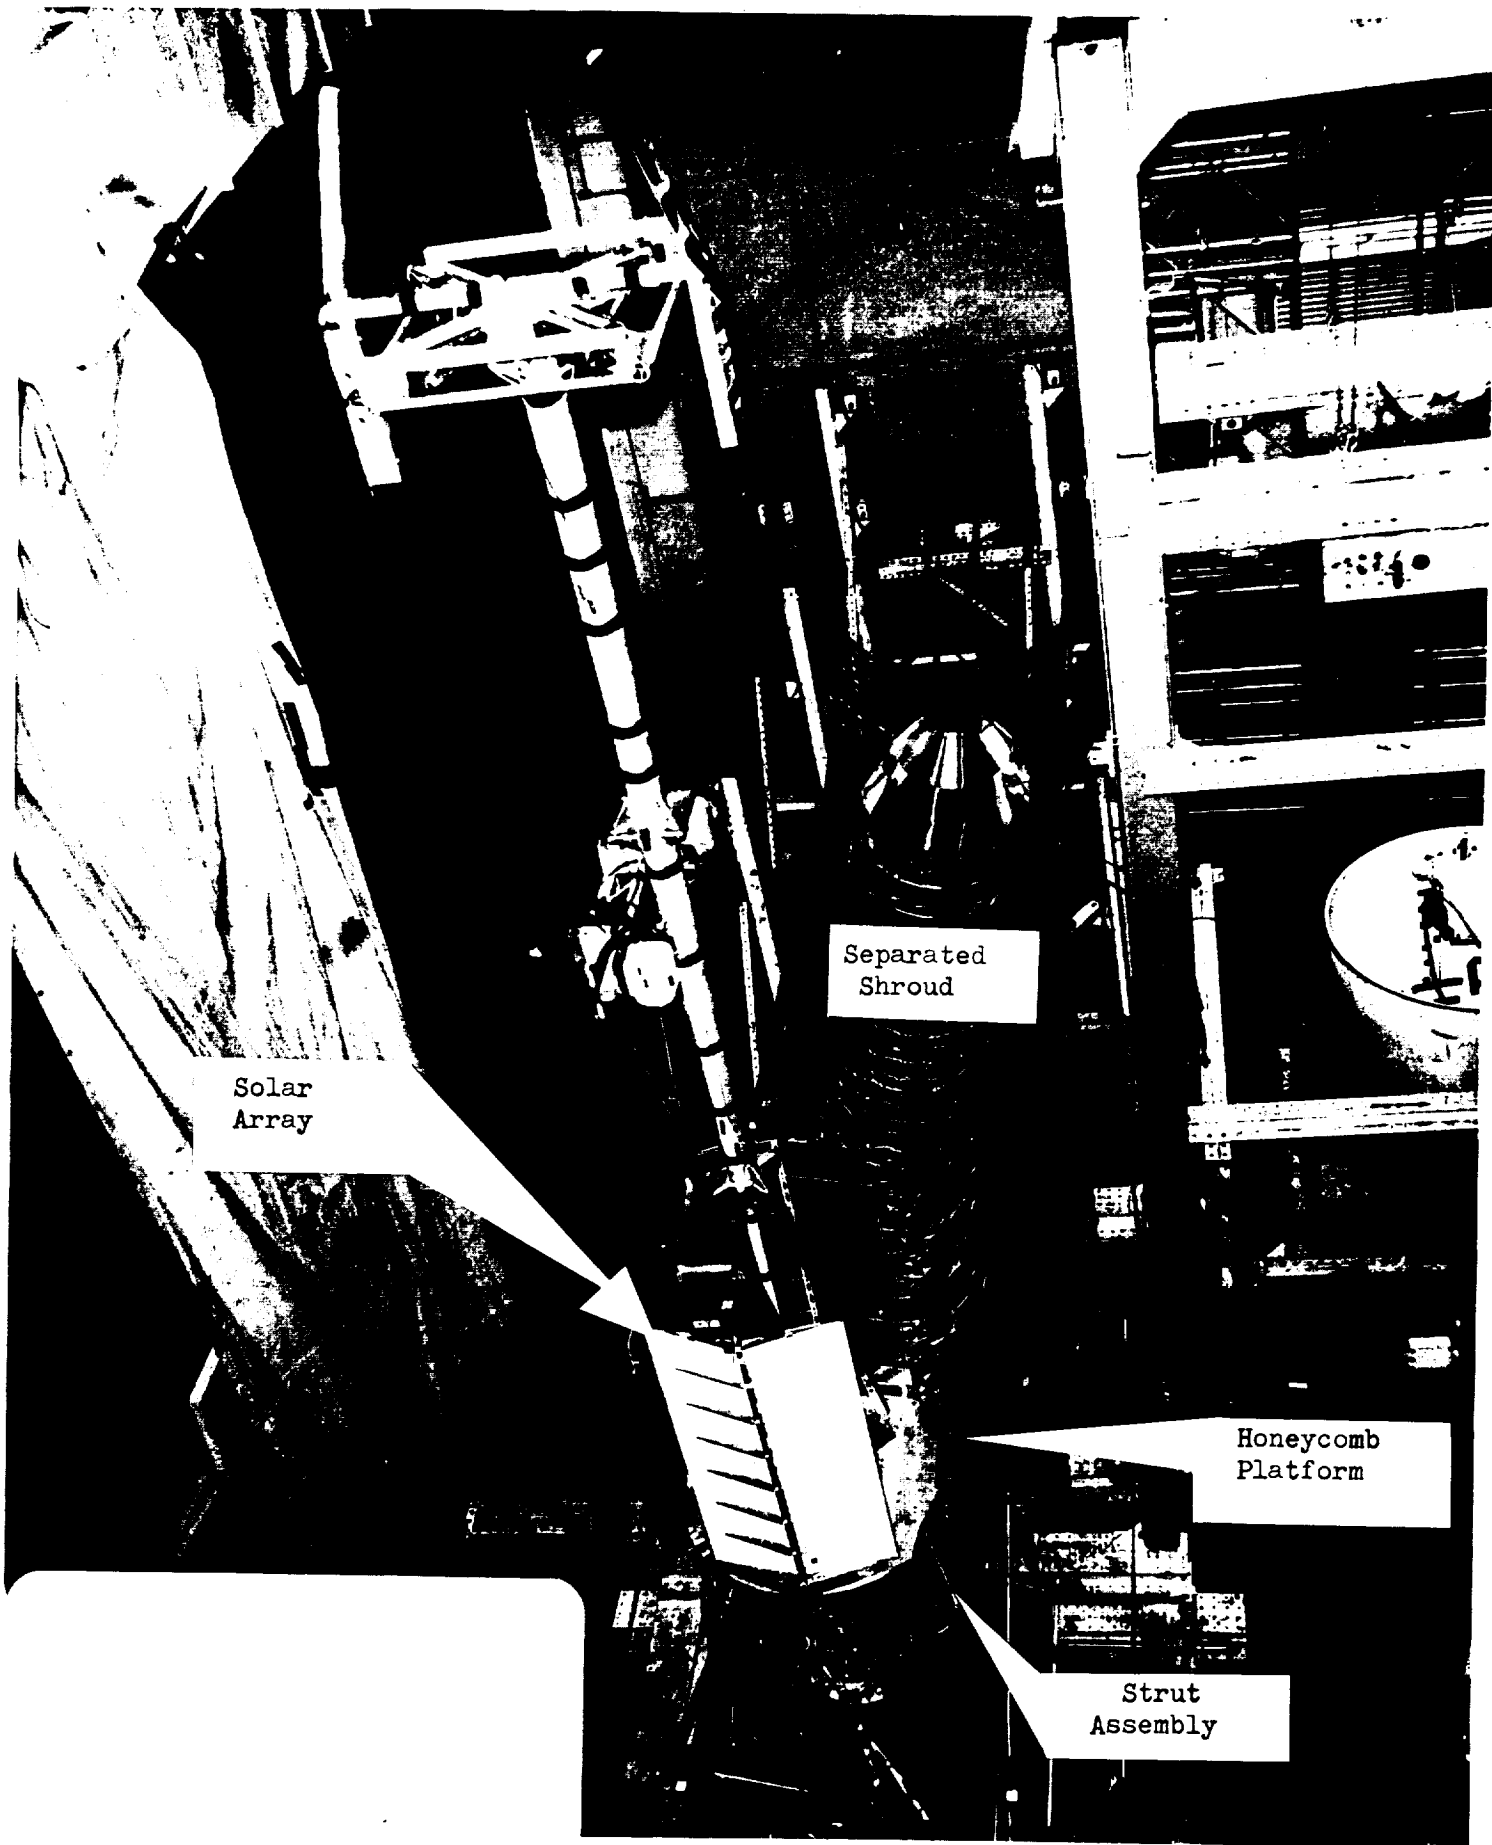
FIGURE I.C.1-1. Photograph of Shroud Separation Test Assembly

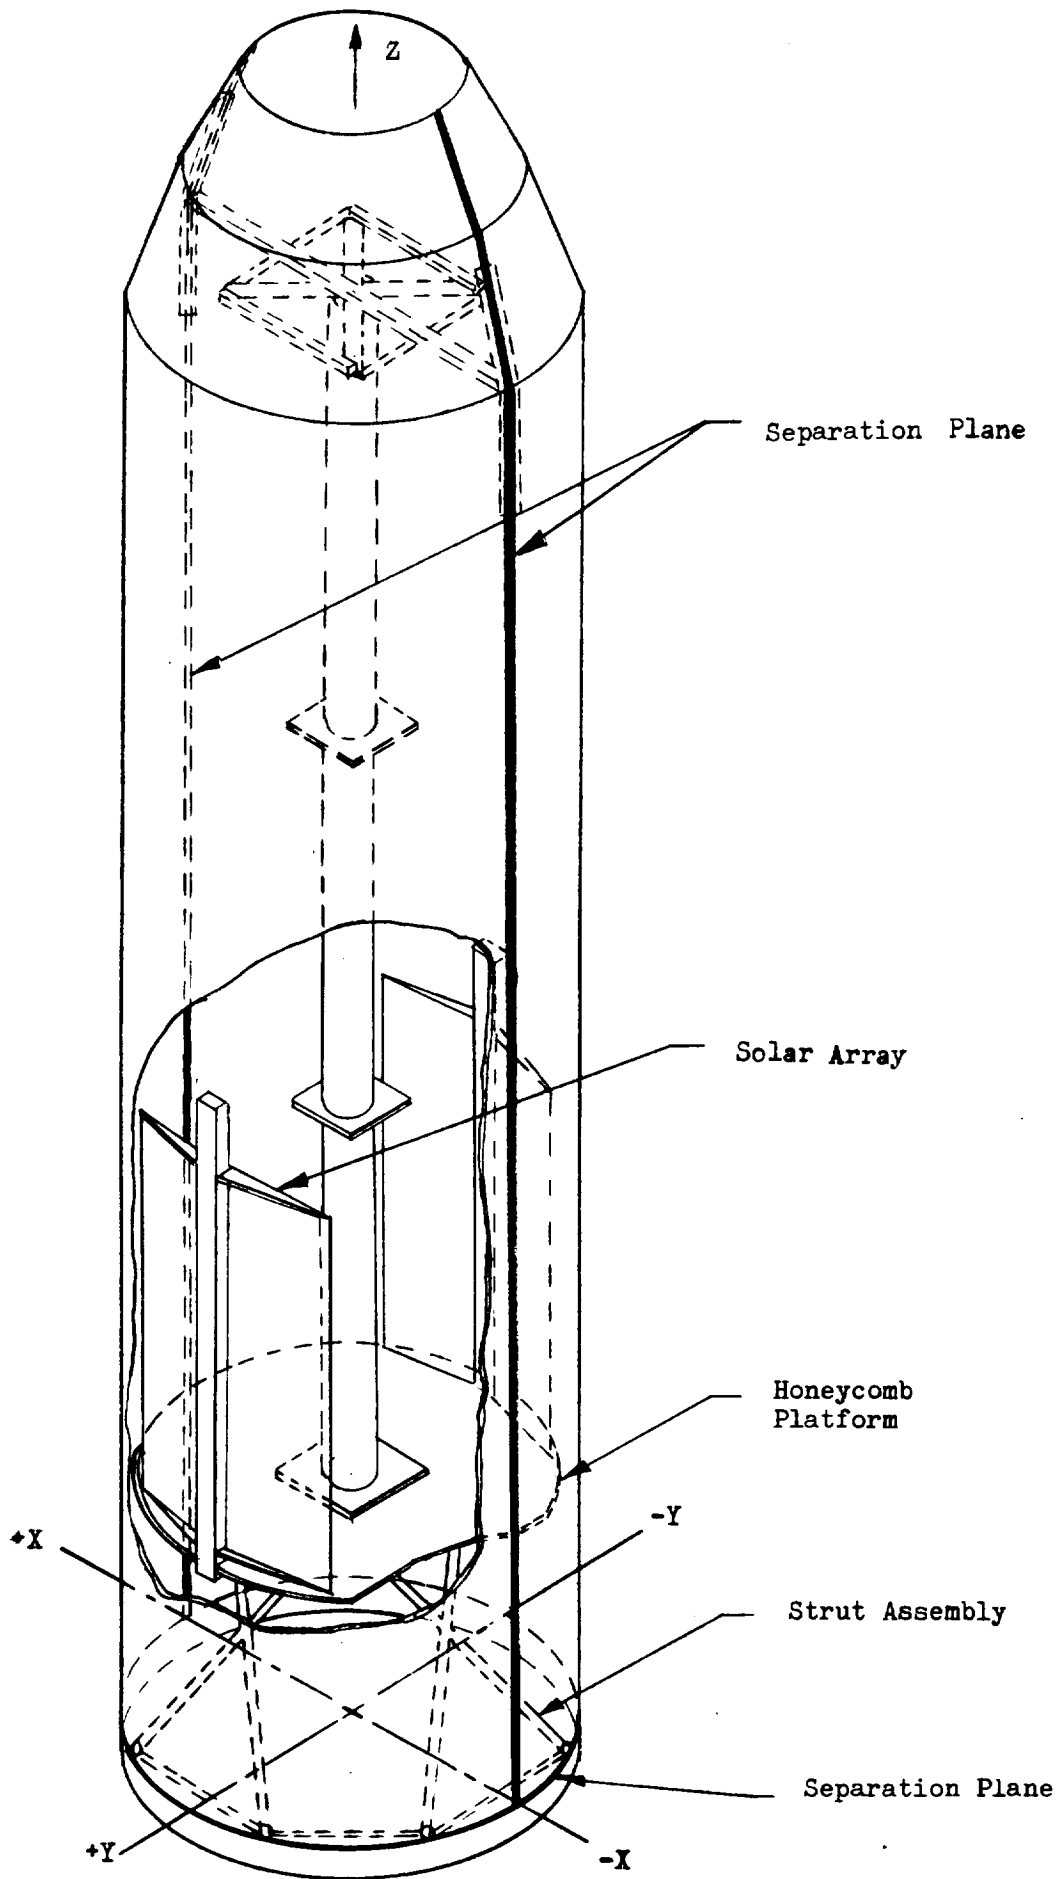
Figure I.C.1-2. Configuration of Shroud Separation

Test Assembly

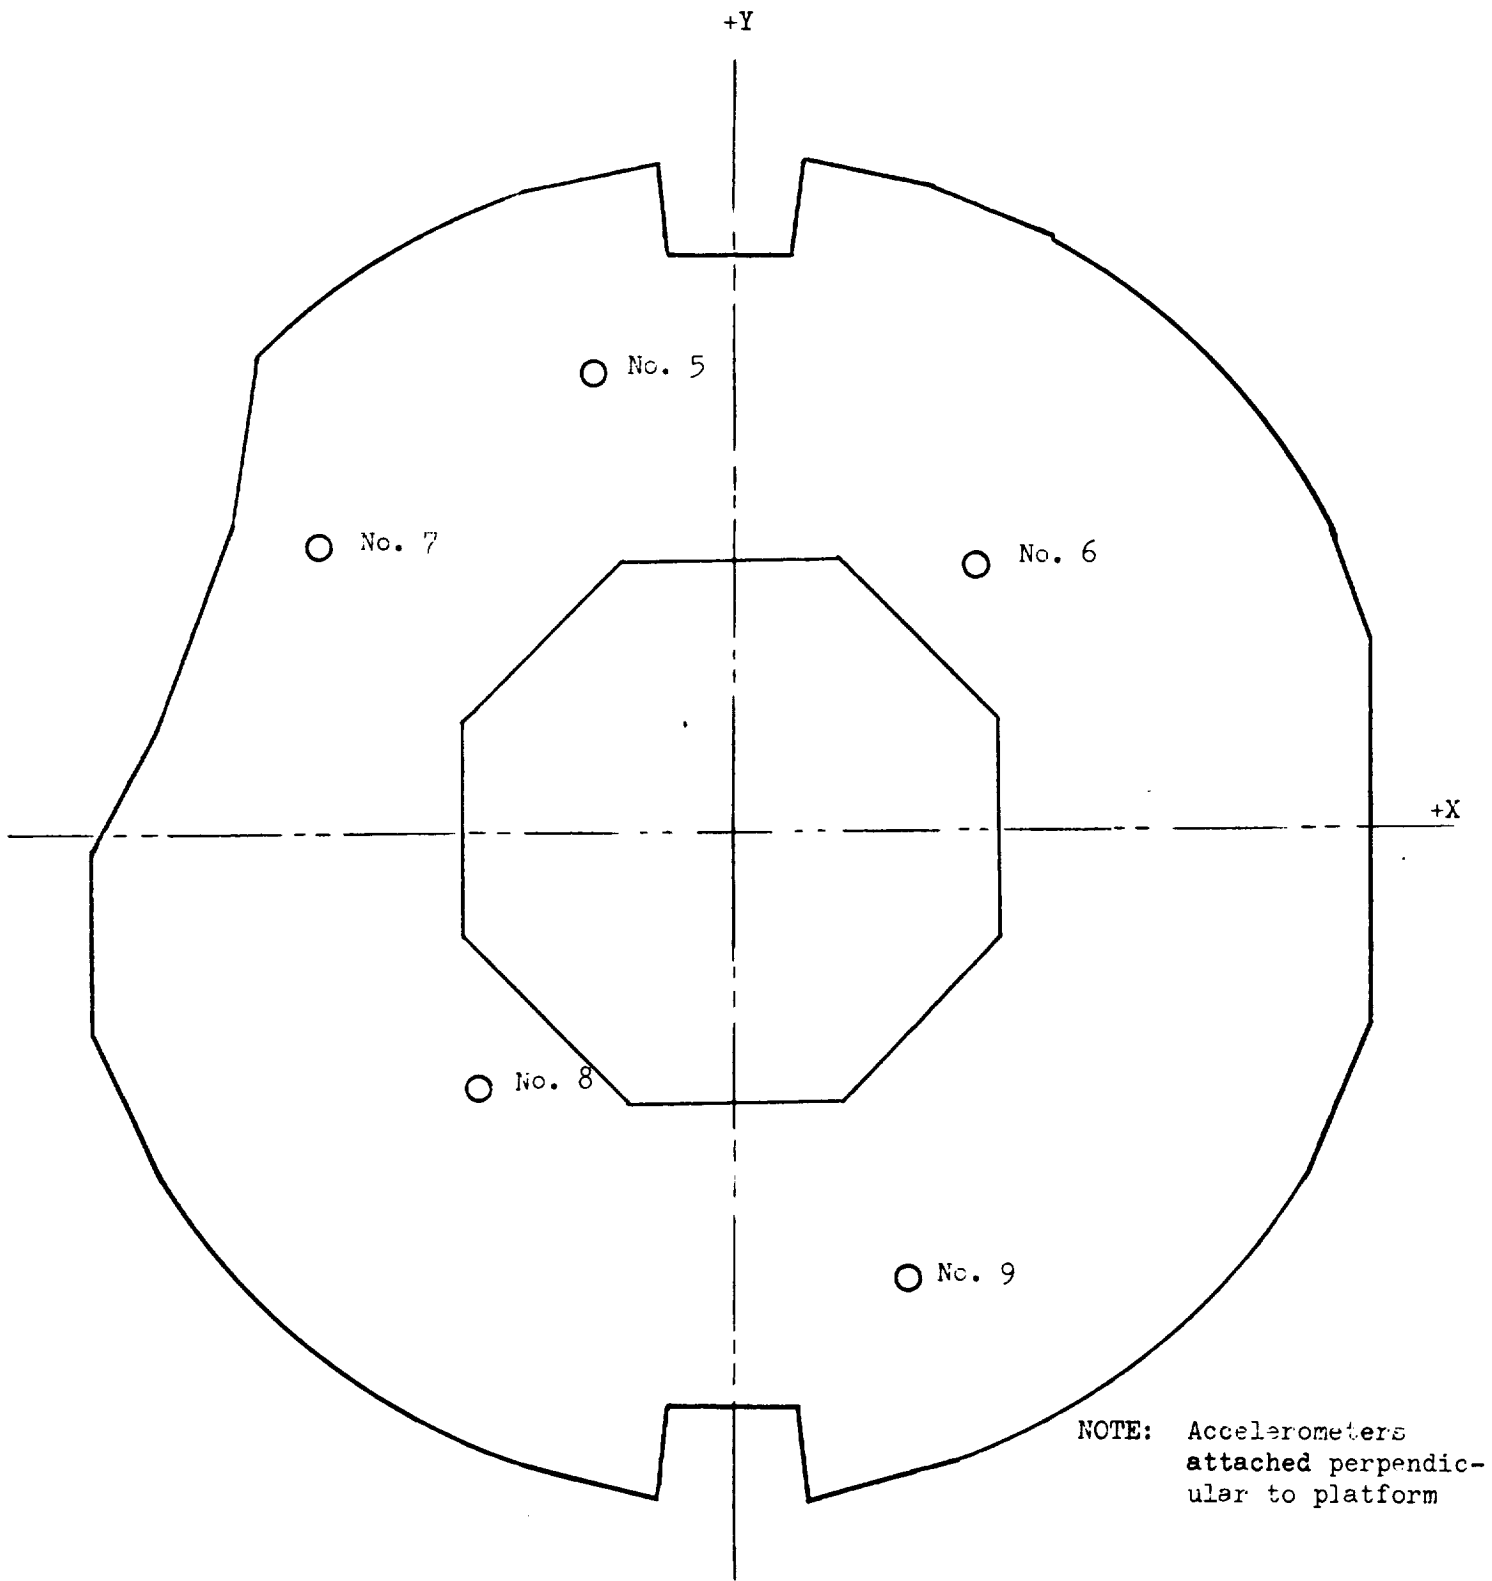
FIGURE I.C.1-3. Honeycomb Platform Accelerometer Locations

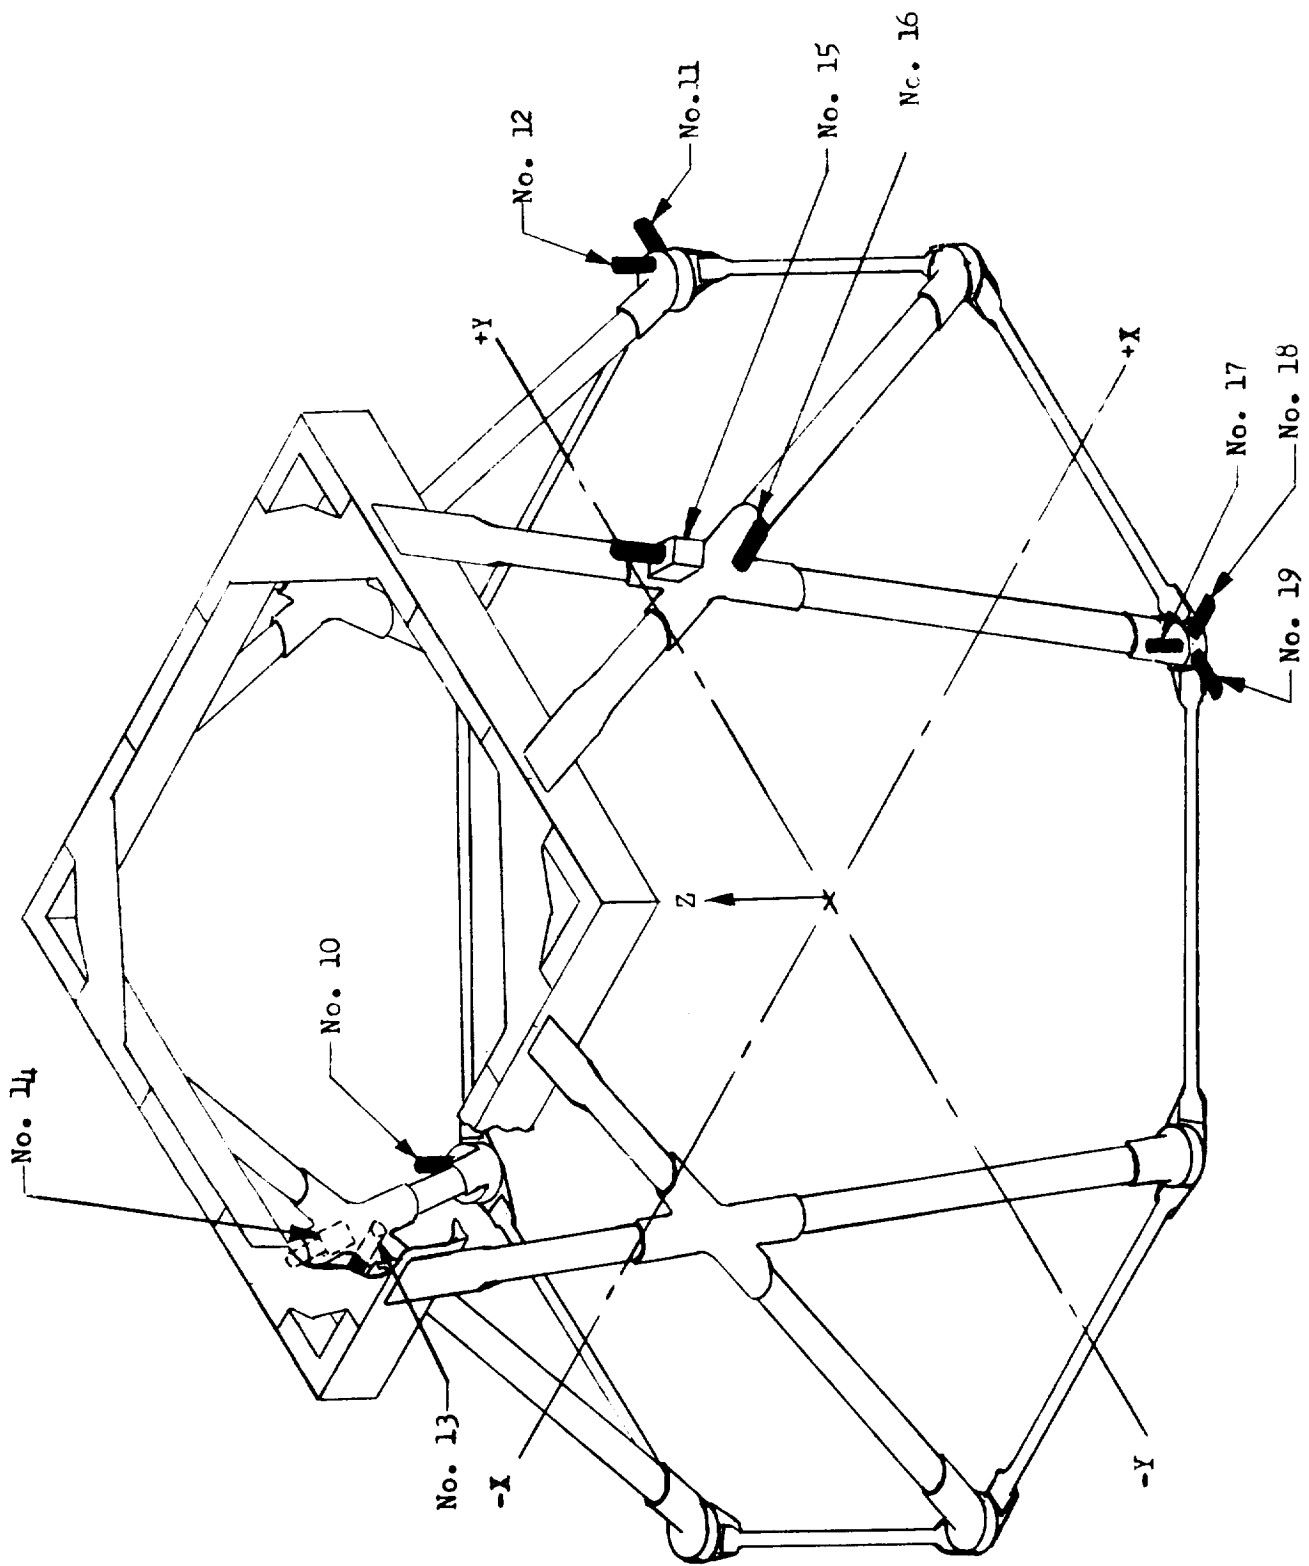
Figure I.C.1-4. Accelerometer Locations on Strut Assembly

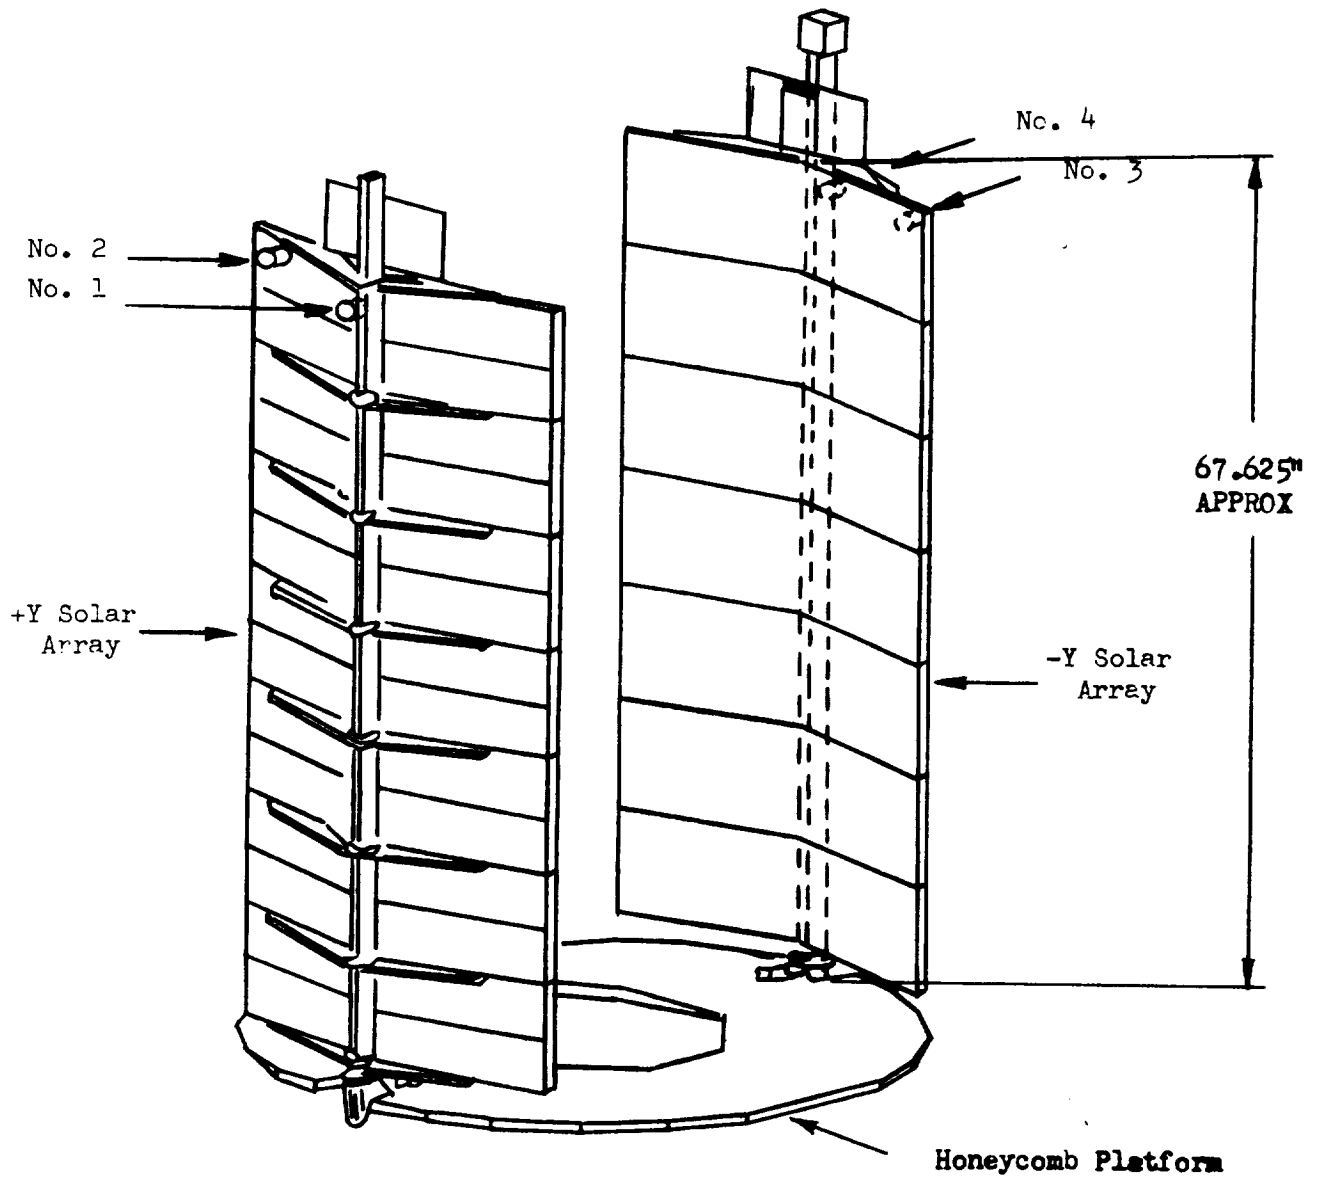
Figure I.C.1-5. Accelerometer Locations on Solar Arrays

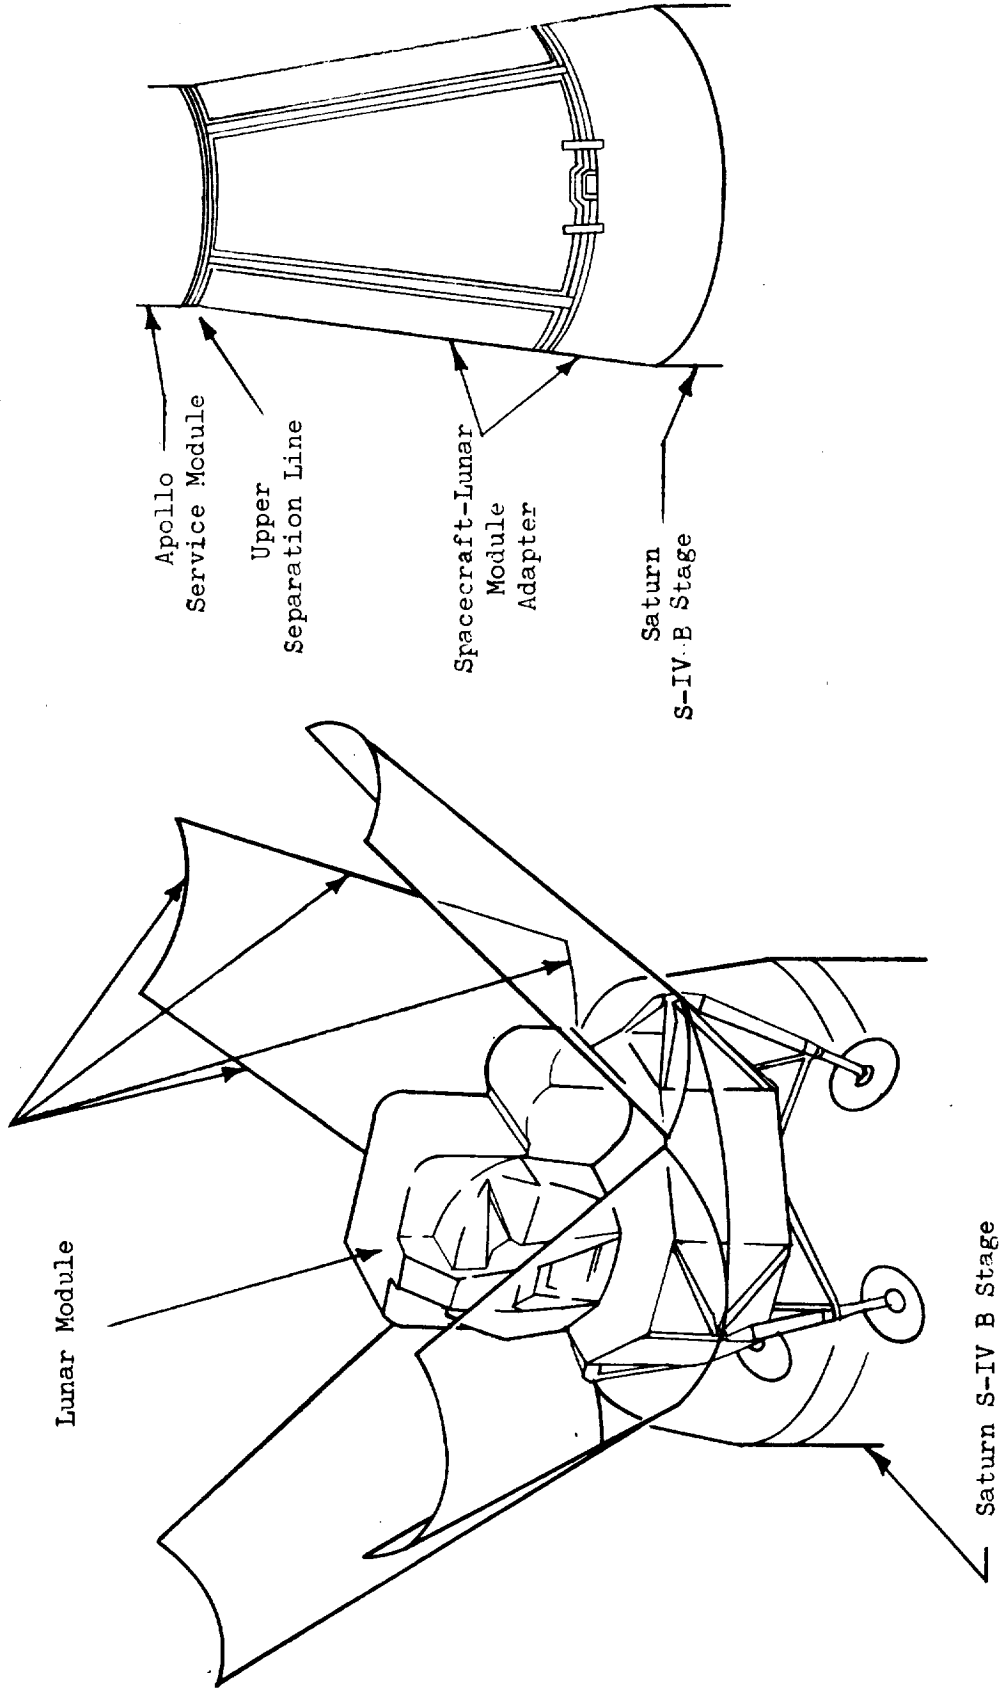
Panel Separation By Explosive Charges
(MDF), Typical for Each Panel

Details of Separation Lines and
Spacecraft

Spacecraft - Lunar Module Panels
In Deployed Position

Figure I.C.2-1. Schematic Illustrating Actual
Panel Separation Event

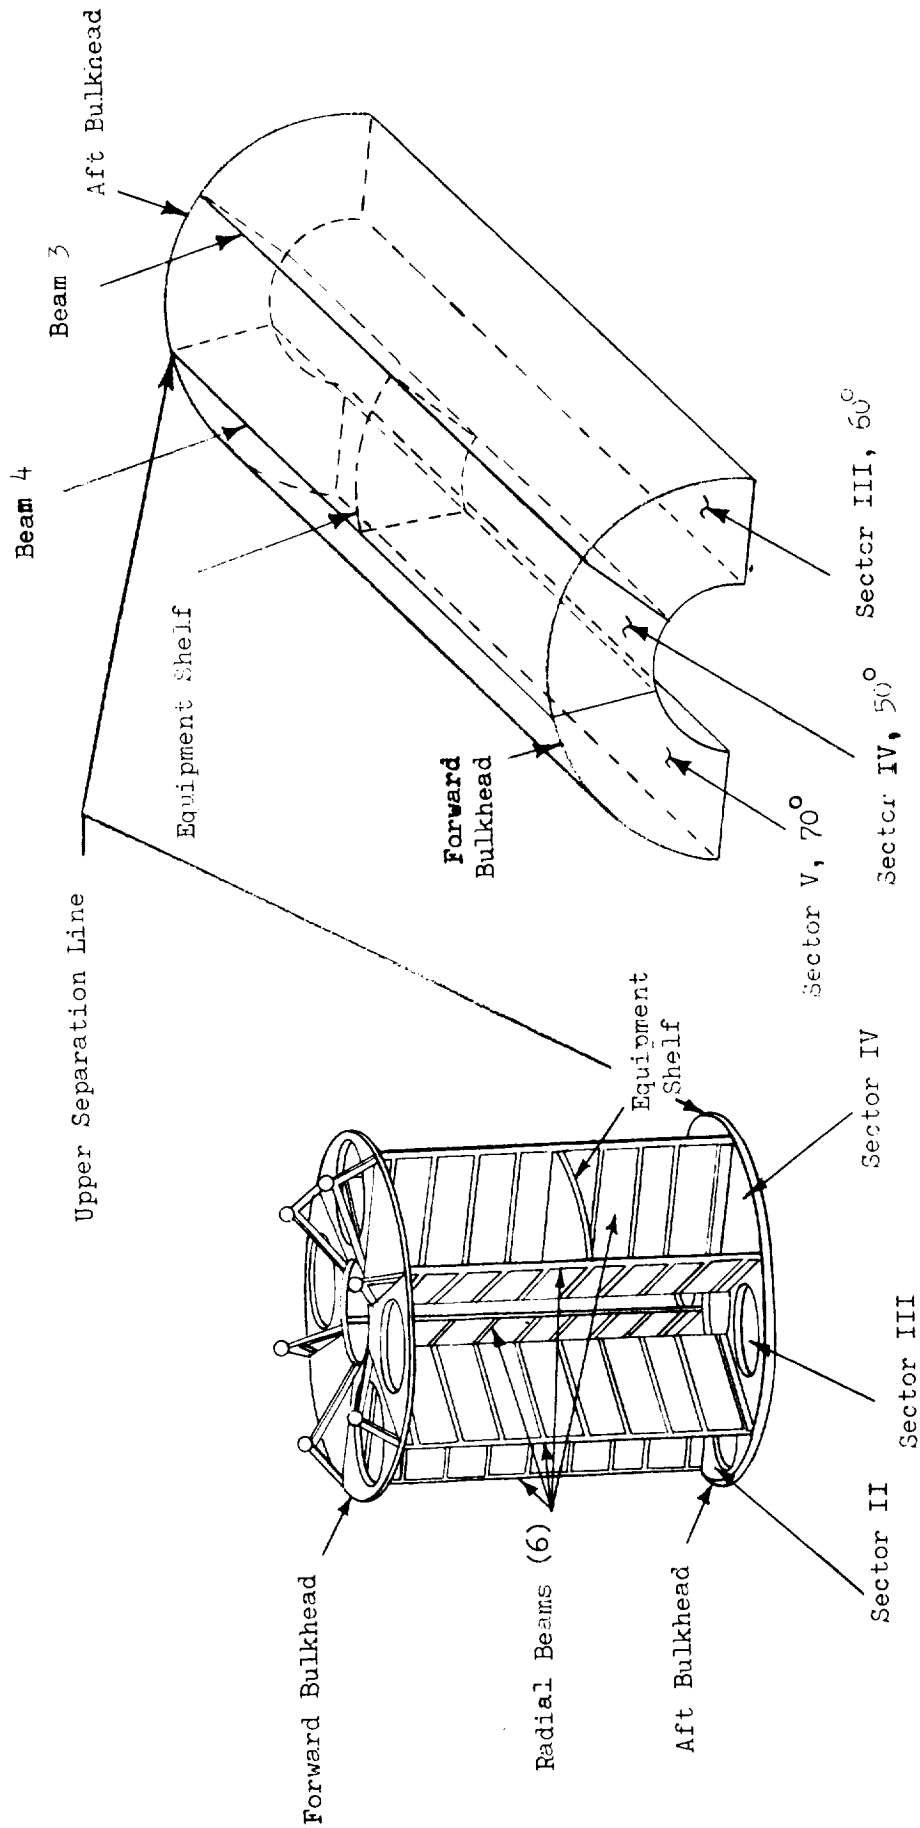
Half of Service Module Used for
Panel Separation Test.

Service Module with Engine, Equipment, and
Skin Removed for Clarity.

Figure I.C.2-2. Illustration Actual Service Module Compared
with the Half Module Used for Shock Testing

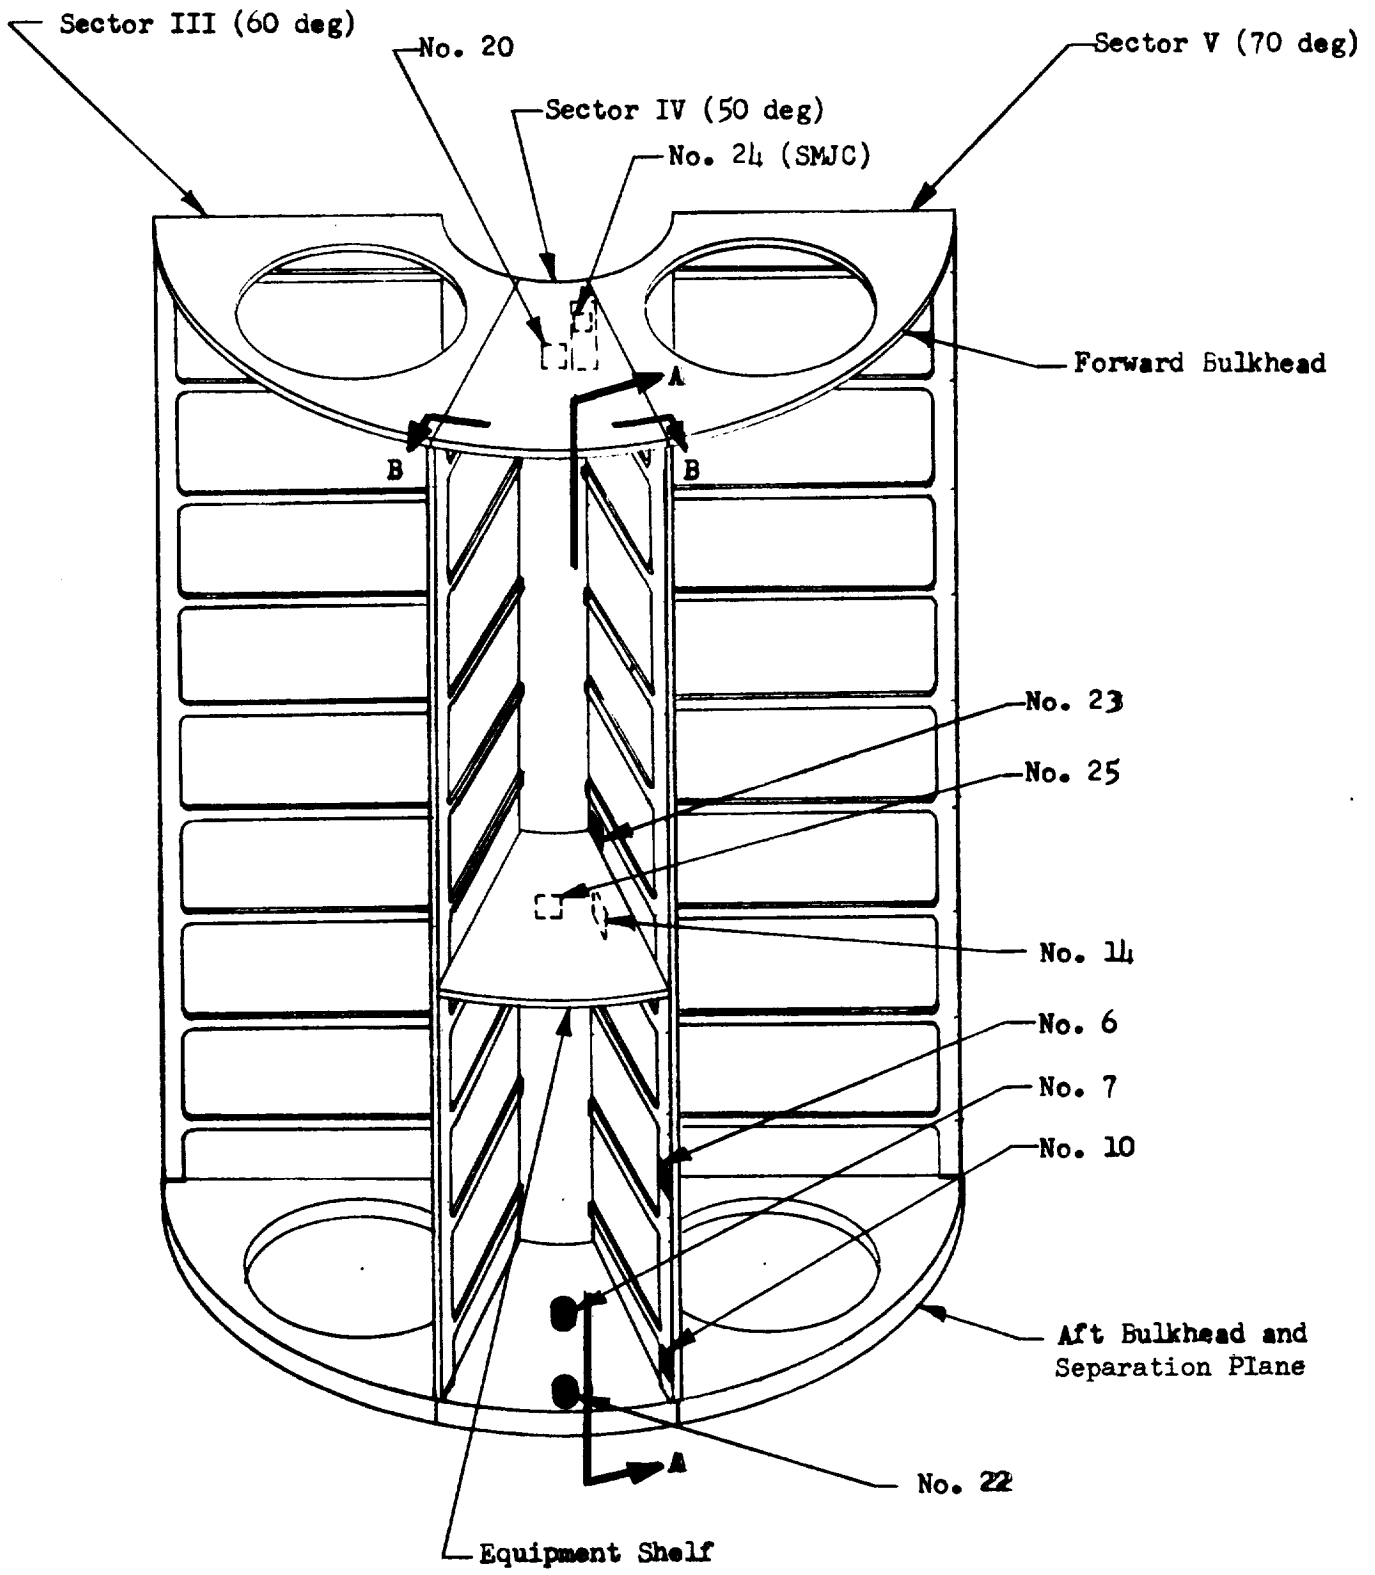
Figure I.C.2-3. Accelerometer Locations (Outer Panels Removed)

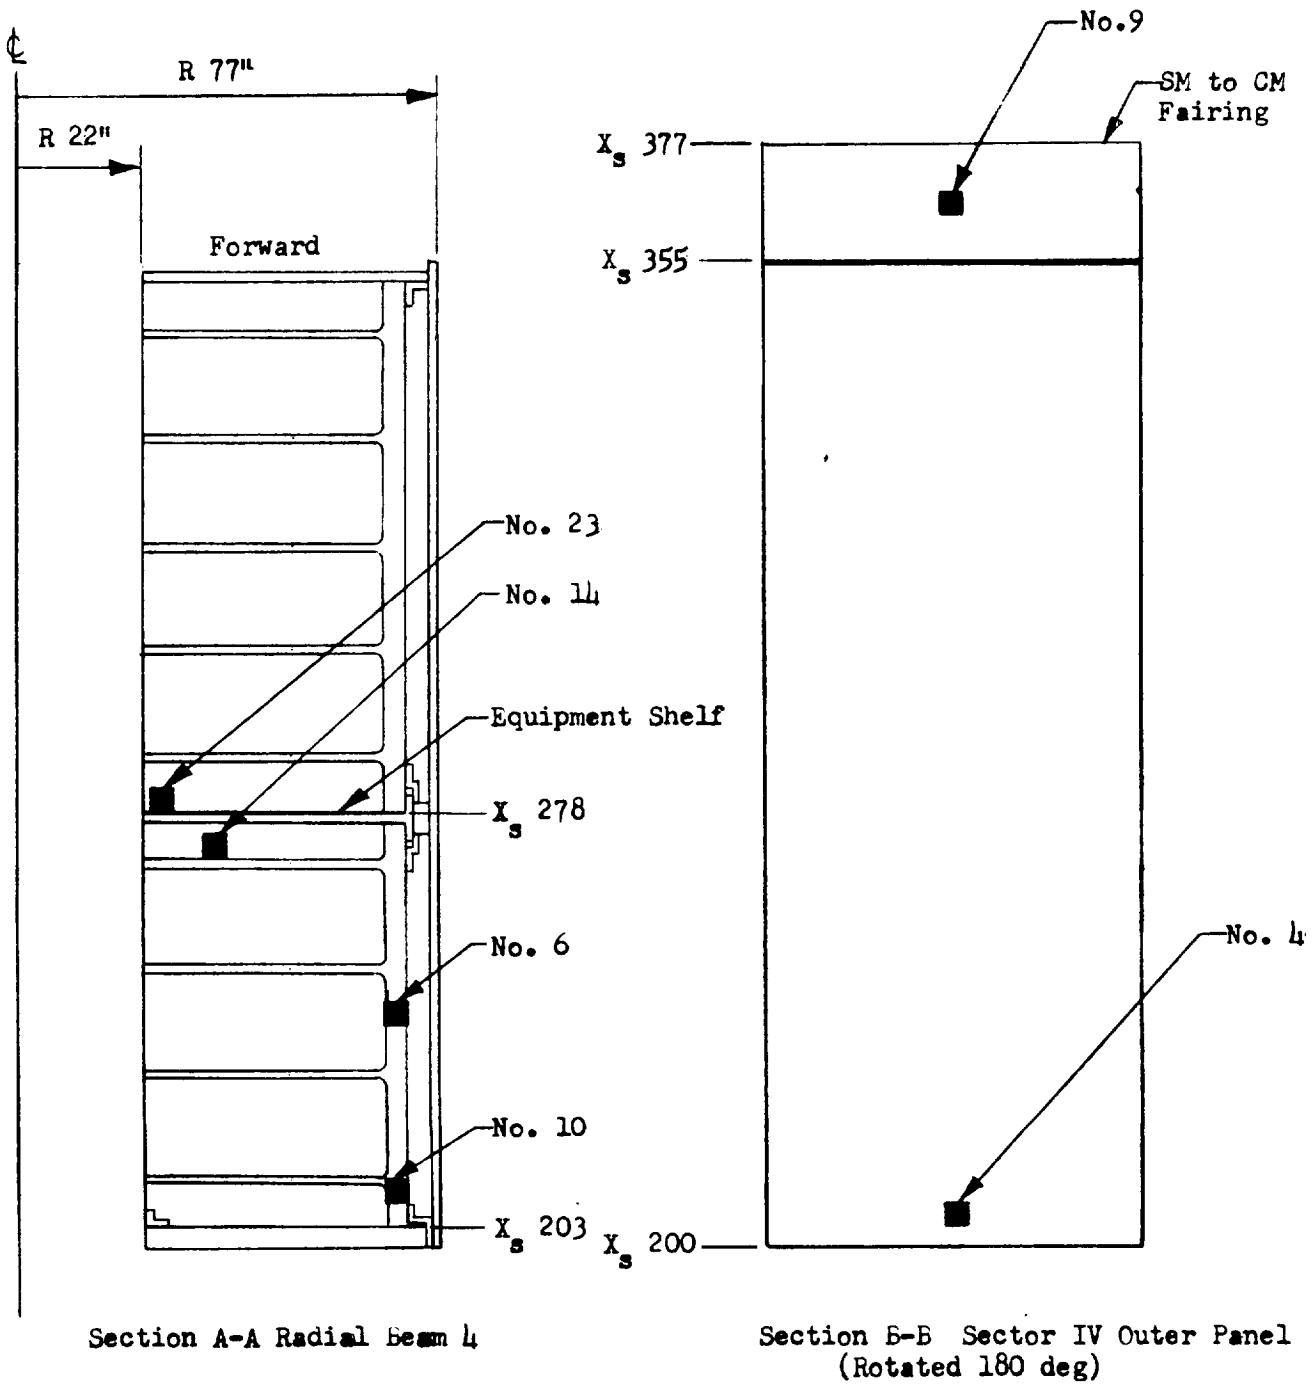
Figure I.C.2-4. Accelerometer Locations on Radial Beam and Outer Panel

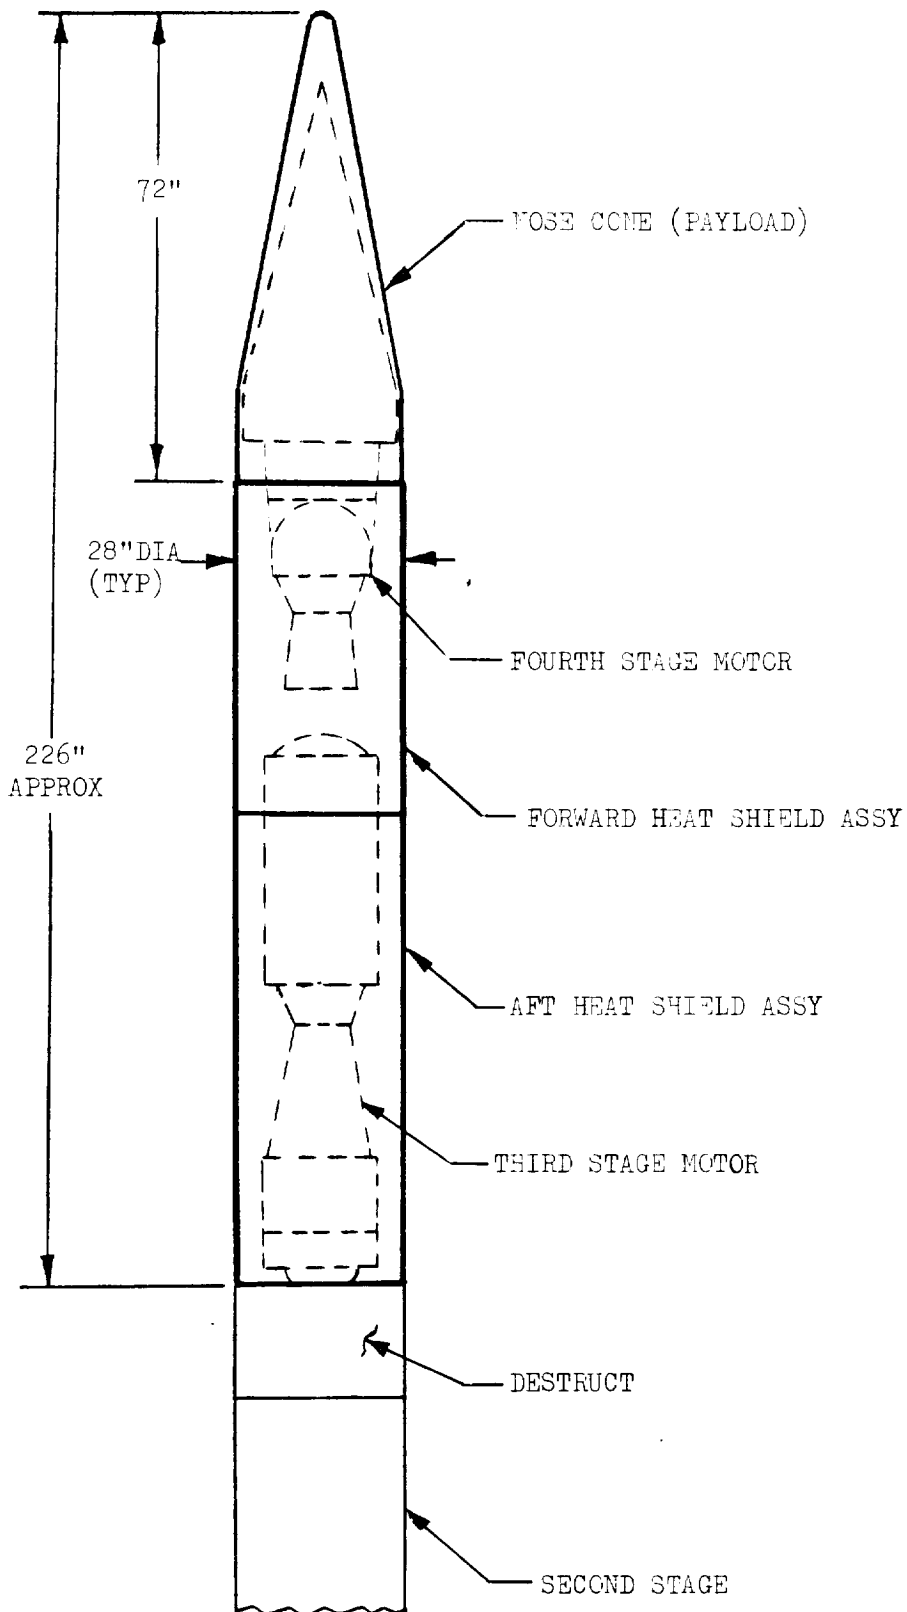
Figure I.C.3-1

HEAT SHIELD AND NOSE CONE ASSEMBLY OF ATHENA VEHICLE
