NASA CR 54578

FINAL SUMMARY REPORT  
DEVELOPMENT OF PROTECTIVE COATINGS  
FOR TANTALUM T-222 ALLOY

December 1966

***Vitro* LABORATORIES** DIVISION OF VITRO CORPORATION OF AMERICA  
WEST ORANGE LABORATORY • 200 Pleasant Valley Way, West Orange, N. J.

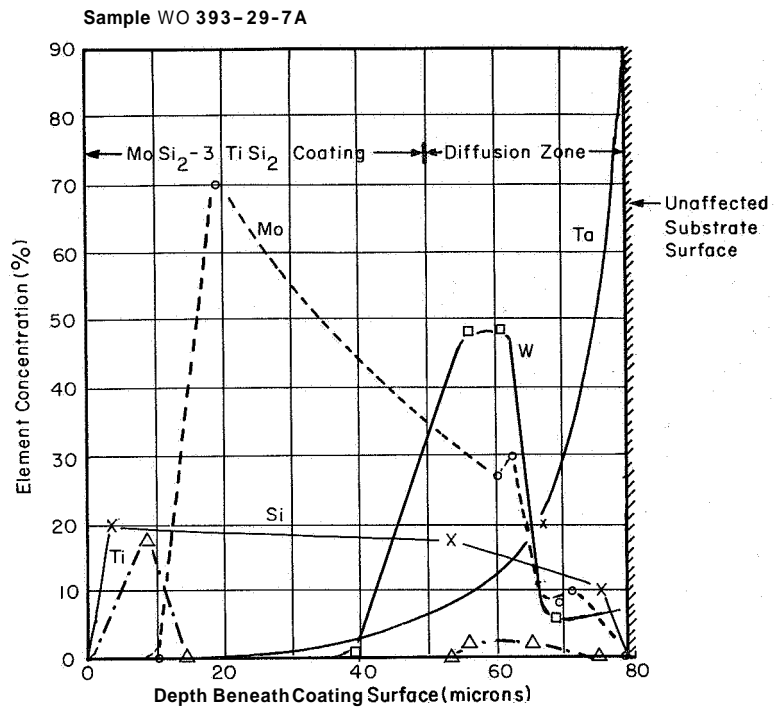
FIGURE 41

ELECTRON MICROPROBE ANALYSIS OF MoSi<sub>2</sub>-3TiSi<sub>2</sub> ON W/T-222 BEFORE OXIDATION (SAMPLE WO-393-29-7)
