AN INVESTIGATION OF THE REACTION OF  
TITANIUM WITH HYDROGEN

NASA - MANNED SPACECRAFT CENTER  
STRUCTURES AND MECHANICS DIVISION

Contract No. NAS 9-5298

BATTELLE MEMORIAL INSTITUTE  
Columbus Laboratories  
505 King Avenue  
Columbus, Ohio 43201

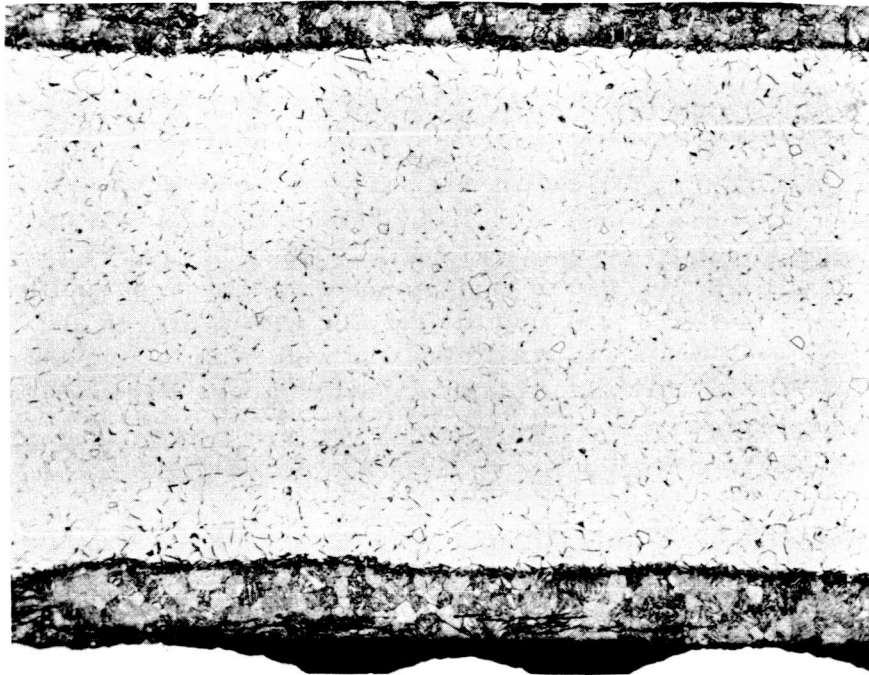
FIGURE 1. MILL-ANNEALED Ti-50A AFTER 10-HOUR EXPOSURE TO HYDROGEN AT 300 F AND 315 PSIA

As-received material, previously vacuum annealed 2 hr at 1500 F. Note uniformity of hydride coating.

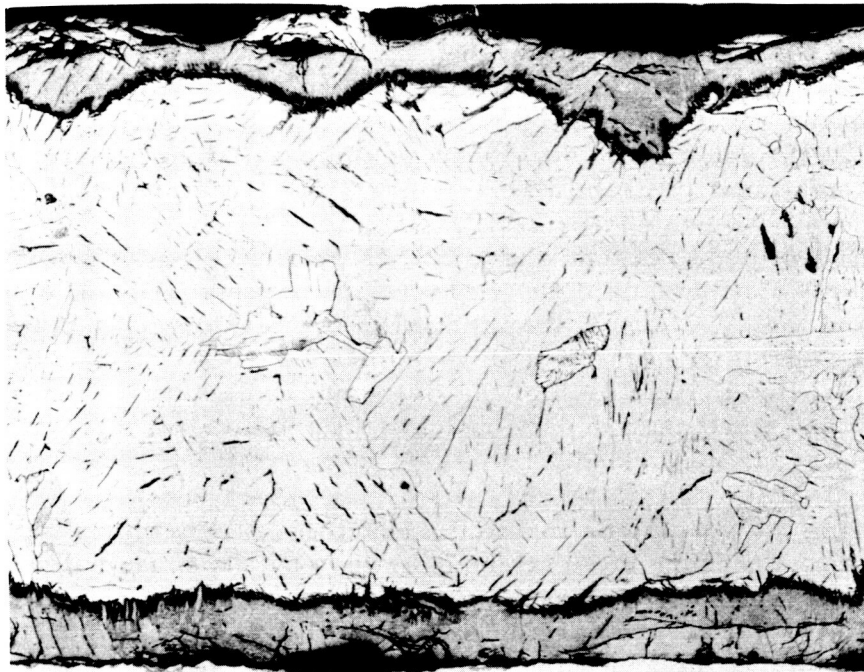
FIGURE 2. Ti-50A SLOW COOLED FROM ABOVE BETA TRANSUS, AFTER 10-HOUR EXPOSURE TO HYDROGEN AT 300 F AND 315 PSIA

Note uneven penetration and tendency of hydride to spall. This structure is similar to that found in the heat-affected zone of a weld.

A reasonably consistent microstructural trend was observed in this program. Unalloyed titanium specimens having an acicular microstructure developed by heating into the beta region showed a greater tendency for reaction to occur, and thicker hydride scales were formed. This probably is related to the distribution of beta in the alloy. Hydrogen diffusion is considerably more rapid in beta than in alpha titanium. The differences among the various alloys studied also appear related to beta content, these alloys having more beta tending to react more easily. Thus Ti-6Al-4V and B120VCA reacted with hydrogen more readily than unalloyed titanium, while Ti-5Al-2.5Sn (ELI) reacted less readily.

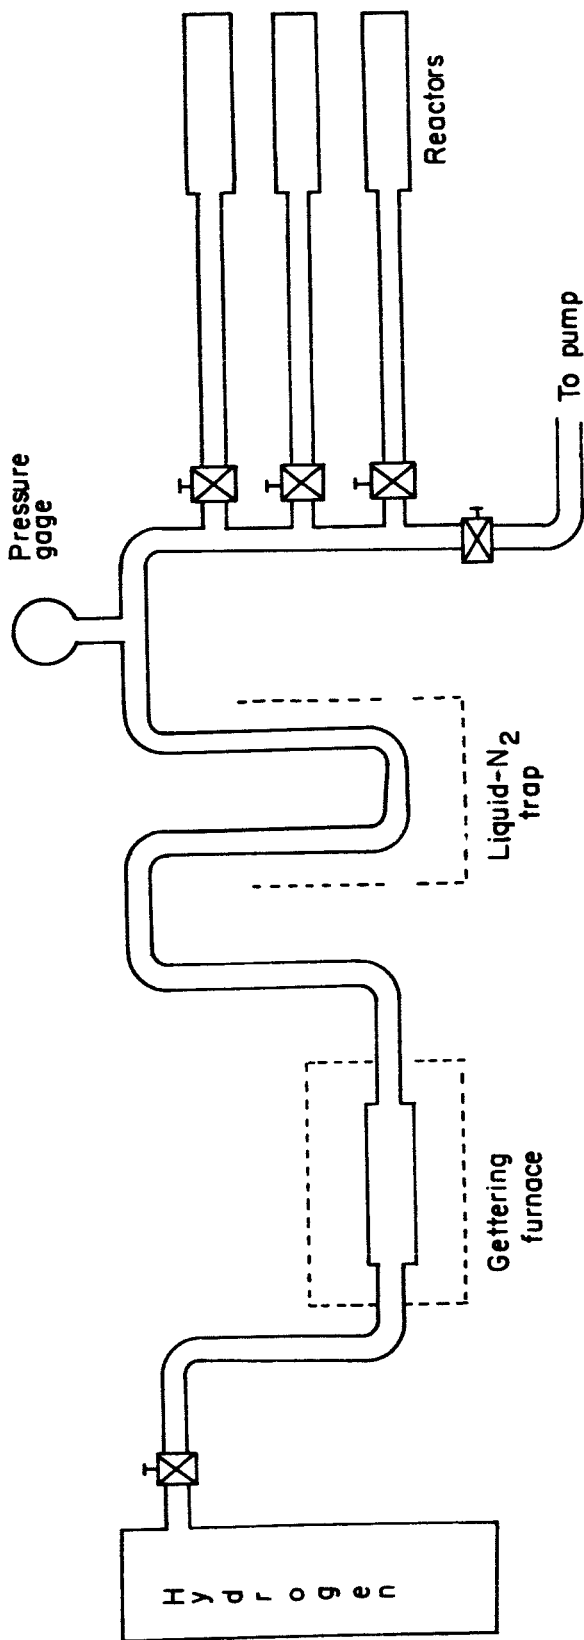
FIGURE 4. DIAGRAM OF MANIFOLD FOR FILLING REACTORS WITH HYDROGEN

The manifold used for filling the reactors with hydrogen was constructed of high-pressure, 1/4-inch ID stainless steel tubing, high-pressure valves, a gage, and "Ermeto" high-pressure fittings. A U-shaped bend in the tubing was utilized as a cold trap. Later, a stainless steel reactor filled with zirconium turnings was connected in the line and when heated to ~1560 F acted as a getter for the hydrogen (Figure 4).

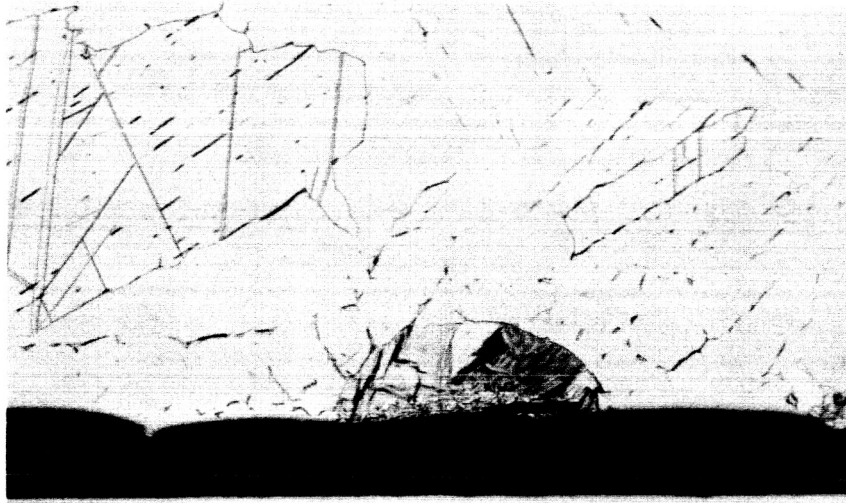
FIGURE 5. Ti-50A SPECIMEN CONTAMINATED WITH IRON AFTER 112-HOUR EXPOSURE TO HYDROGEN AT 300 F AND 315 PSIA

Only Specimen 88 in Reactor 1 showed any evidence of hydriding. The hydride was quite spotty, on one side of the specimen only (Figures 5 and 6). The reaction observed in this run suggests that iron contamination may favor the initiation of the hydriding reaction. Further investigation of the role played by iron and nickel galling is reported in a subsequent section of this report.

Hydride has formed in contaminated areas.

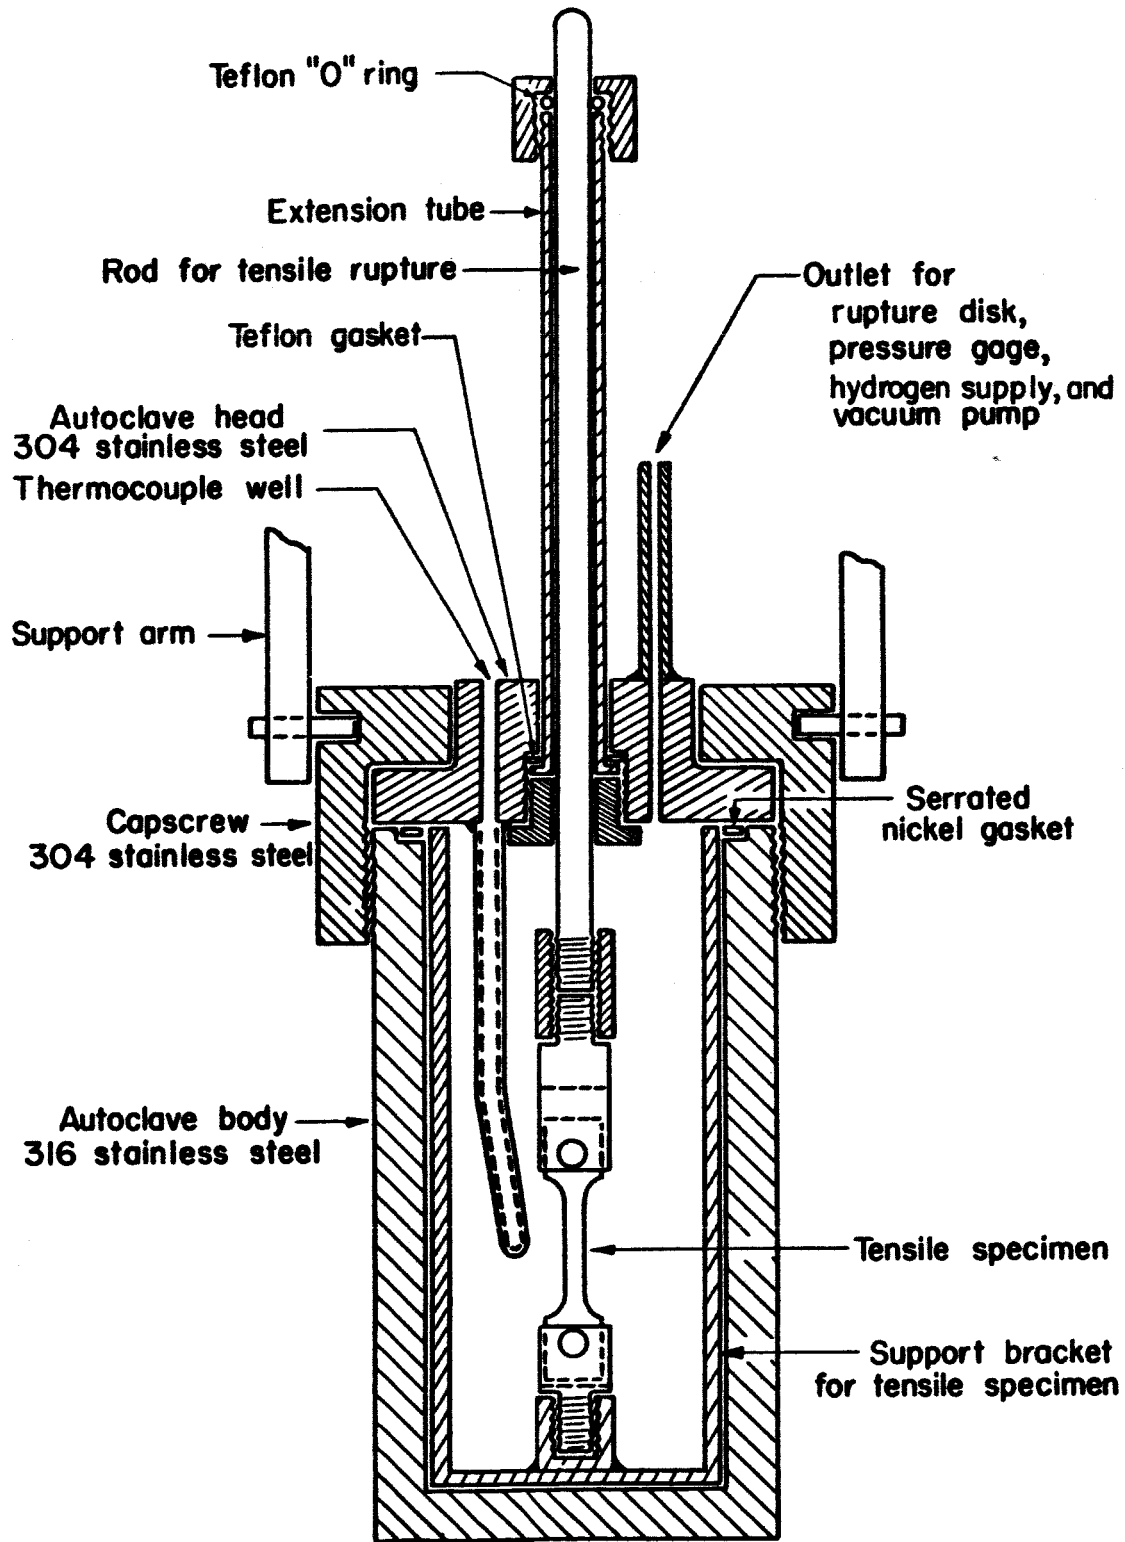
FIGURE 7. DIAGRAM OF STRESS ASSEMBLY

The experiments were carried out in a standard high-pressure autoclave that had been modified so that a known load could be placed on the specimen by a small, hand-operated, hydraulic pump. The force was applied to a piston that in turn applied a load to the specimen through a stainless steel rod connected to the specimen. This rod passed through a Teflon-gasketed hole in the autoclave cover. A drawing of the autoclave is shown in Figure 7.

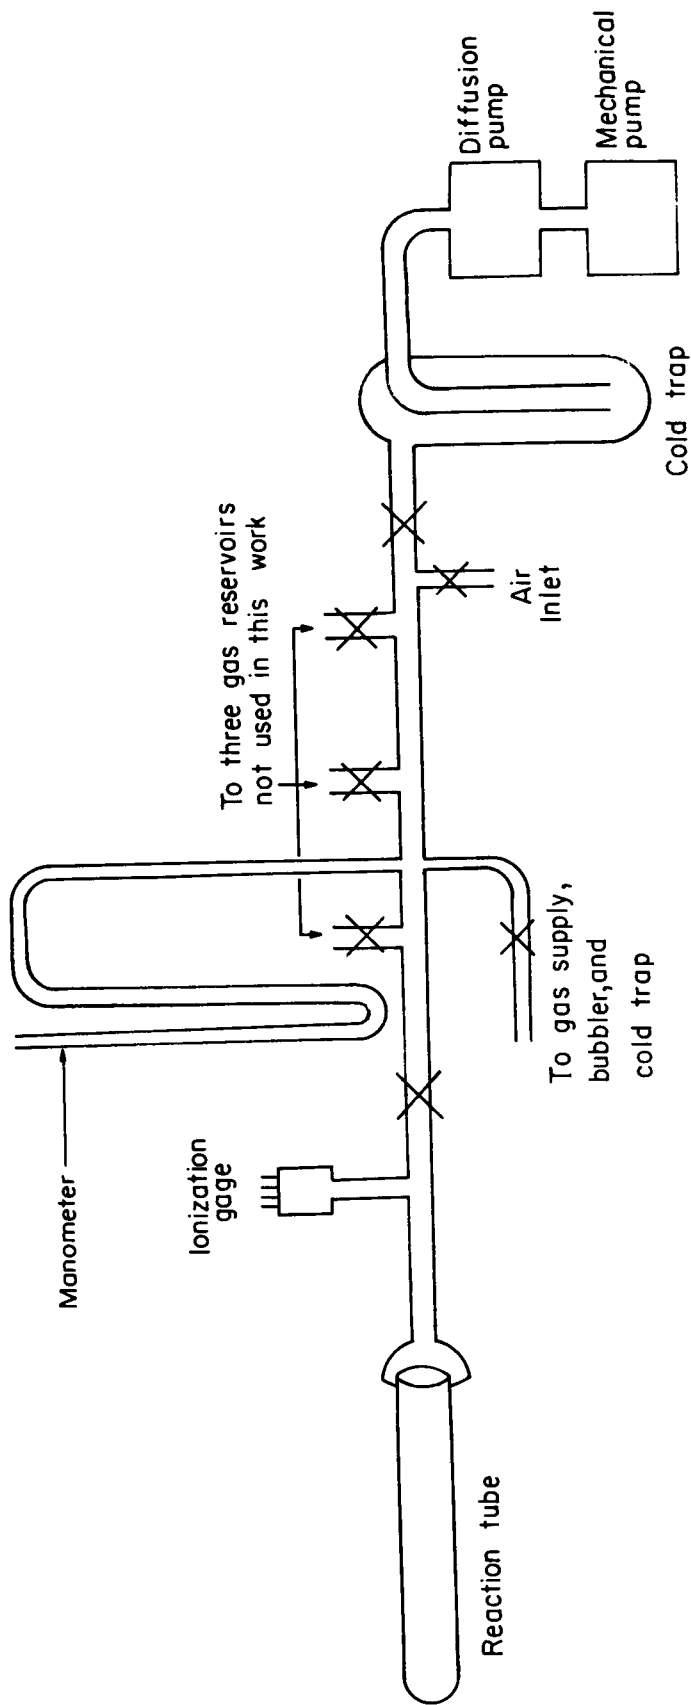
FIGURE 9. DIAGRAM OF GLASS SYSTEM

The glass system consists of a mechanical pump, glass mercury diffusion pump, and a cold trap, which together made up the pumping system. Three large gas-storage reservoirs are attached to the main pump-out line. These were not used in this work and were closed-off by means of large stopcocks. A full-length, open-end mercury manometer was connected in the line and used to measure pressure change during the experiment. Knowing the calibrated volume of the system (493 ml STP) and the pressure change, the quantity of hydrogen absorbed during a run was easily calculated. An ionization gage was used to monitor the system pressure during evacuation and annealing. The reaction tube was constructed of 25-mm Vycor and was about 12 inches in length. It was heated by a resistance-wound furnace that was monitored by a

Foxboro Controller. The main pump-out line was constructed of 12-mm Pyrex tubing, except for the portion just preceding the reaction tube, which was 25 mm ID. Hydrogen was admitted to the system after first passing through a mercury safety bubbler and a liquid-nitrogen cold trap. Any departures from this procedure are noted in the tabulated data.

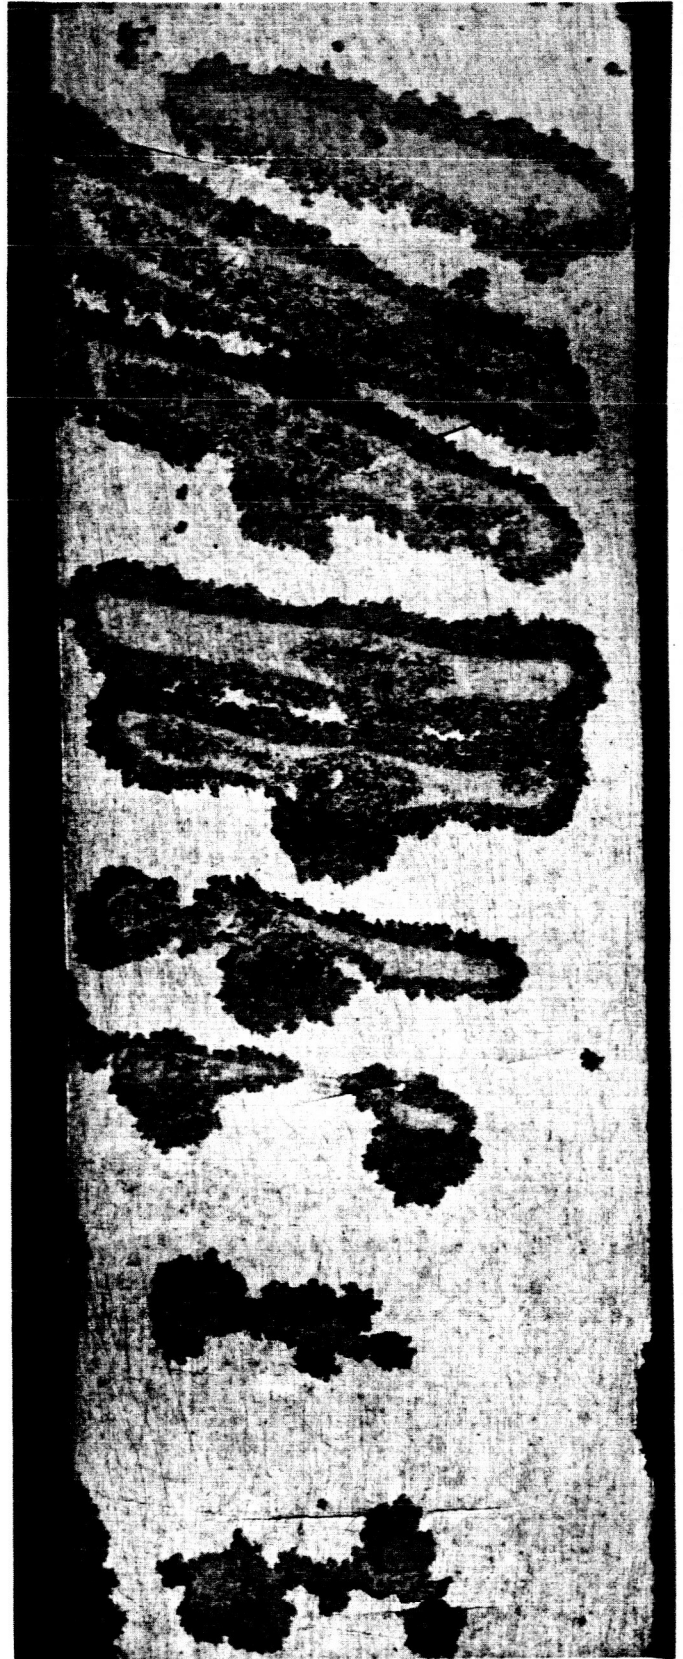
Titanium hydride formed under turns of nickel ribbon during 22-hr exposure to 1 atm of  $H_2$  at 300 F.

Cracks indicating embrittlement of the titanium appeared when the specimen was flattened slightly for photographing.

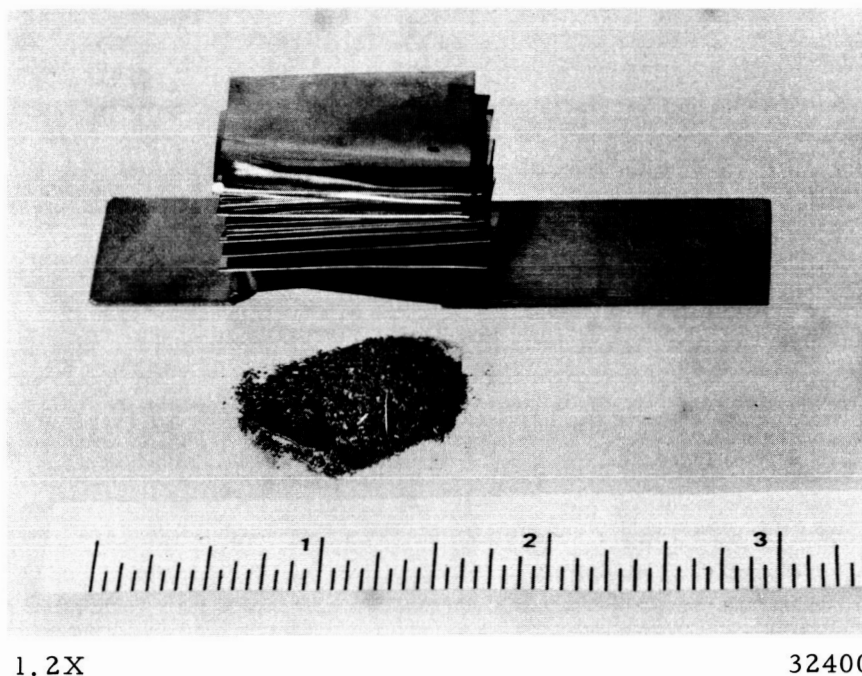
a portion of the powder from the reaction tube into another section of the pumping system. The specimen after reaction is shown in Figure 11. The titanium foil getter was found to be hydrided, but very little hydride was found on a Ti-5Al-2.5Sn alloy specimen also present in the reaction tube. In fact, one sample cut from the Ti-5Al-2.5Sn alloy exhibited no hydride layer whatsoever. In this run, the foil had been placed in direct contact with both alloys, which in some manner may have been a factor in producing such a violent reaction. In a repeat run with the B120VCA alloy only (Run 37), and the foil not in direct contact with the specimen, a rapid reaction did take place. Although 9970 ppm hydrogen (average of two determinations) was absorbed, there was no evidence of the specimen's disintegrating as it did in the previous run.

FIGURE 11. MATERIAL REMAINING IN REACTION TUBE AT CONCLUSION OF RUN 32  
Specimen C-52 (B120VCA) on left, Specimen C-53 (Ti-5Al-2.5Sn) on right. All but 5/8 inch of original 1-1/2 inches of C-52 disintegrated into pile at front center. Specimen C-53 showed little or no reaction. Foil was heavily hydrided.

A possible explanation of this is found in the difference in specimen size. The specimen in Run 32 (the former run) was 1-1/2 x 3/4 inches and weighed 2.5 grams, while the specimen in Run 37 (the latter run) was about 2 x 3/4 inches and weighed 3.4 grams. Apparently, a fairly large quantity of hydrogen must be absorbed in solid solution before hydriding and disintegration can take place. Because of the larger size of the specimen in Run 37, this critical point had not been reached. That is, an inadequate supply of hydrogen may have been present.
