Structural health monitoring for wind turbine foundations

Energy 166 November 2013 Issue EN4

Keywords: failures/foundations/renewable energy

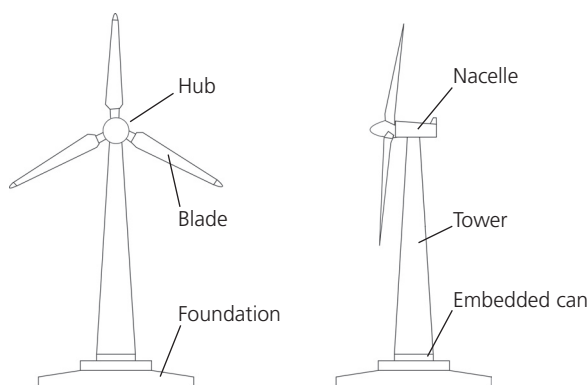
Figure 1. Components of large-scale wind turbine

Figure 1 shows a typical onshore wind turbine, with blades, tower and gravity concrete foundations. The main types of foundation–tower interface used for large onshore turbines include the use of an embedded steel can or a ring of bolts. This paper will focus on the embedded can style, which has been showing the most serious signs of failure.

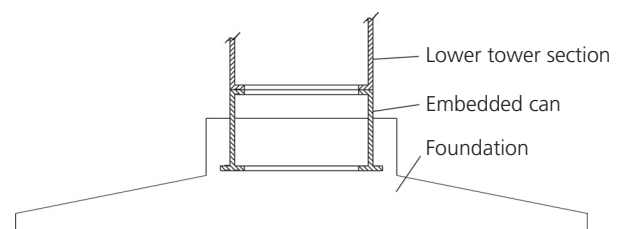
The embedded can foundation is illustrated in Figure 2. The steel can is embedded within the concrete foundations then the tower section is attached to the top flange of the can.

Figure 2. Cross-section of an embedded can foundation (not to scale)

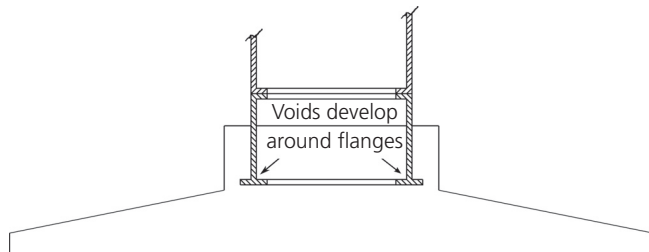
Figure 3. Area where voids develop around embedded can bottom flange

Figure 3 shows the area where voids can develop in concrete foundations for embedded can-type connections when the turbine is subjected to eccentric and cyclic loading. Erosion around the flange can occur as the embedded can moves against the concrete, with sediments being removed through hydraulic action.

The presence of voids around the embedded can allows the whole tower to move significantly in the vertical direction as well as to a smaller extent in the horizontal direction. There has been little published work relating to this type of displacement, but movements of approximately 5 mm were noted during a site visit, with reports of movement up to 20 mm on other turbines at the same site.

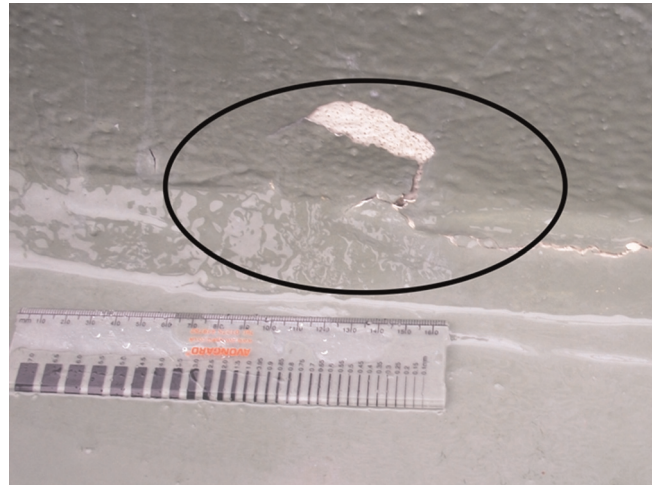
(a) Small movements of the tower are possible due to the low level of friction between the painted can and the concrete. As the tower moves during operation the green plasticised waterproof membrane eventually cracks. Cracking occurs principally around the area between the pedestal and the penetrating steel can. This is shown in Figure 4. There was no evidence that cracking was only occurring in a uniform manner. Some turbines had only small single cracks, whereas others had cracks extending to approximately 2 m around the circumference of the foundation–tower connection.

Figure 4. Cracking in the waterproof membrane between tower and foundation

- (b) With the waterproof membrane cracked, water is able to penetrate the foundations, migrating down the gap between the steel can and the concrete. Water migrates between pores within the concrete as well as finding pathways along construction joints. However, with the waterproofing breached, much greater volumes of water can penetrate the entire way around the foundations even if there is only cracking at one location. During the site visit it was noted that the water ingress was compounded by ponding on several pedestals and also the constant flow of water running down from the tower during precipitation.

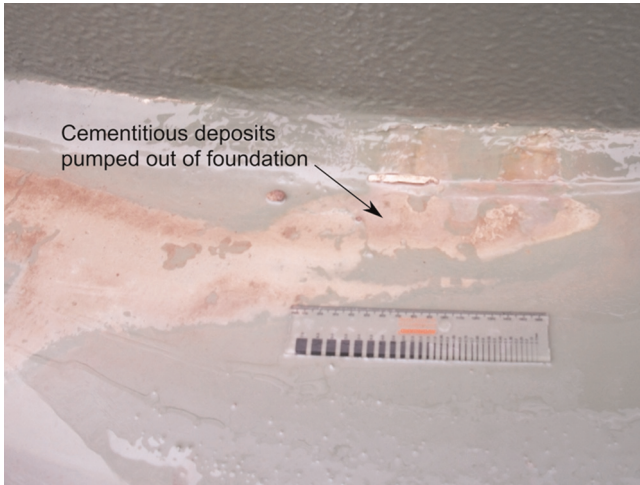
- (d) Evidence of internal foundation erosion is visible at the surface in the form of cementitious deposits being pumped through the cracks at the top of the foundation pedestal (see Figure 5). Larger particles that become dislodged such as aggregate are broken up inside the foundations.

Figure 5. Cementitious deposits flowing from the foundations through cracks in the waterproof membrane

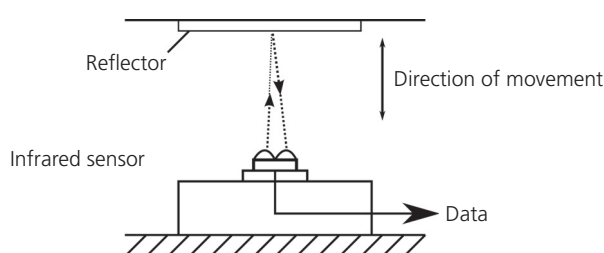
Off-the-shelf infrared sensors have an integrated position-sensitive detector and infrared emitting diode (http://www.sharpsme.com/webfm_send/1476). The operating layout of the sensor is illustrated in Figure 6. All other sensors considered measure this same distance.

The sensor functions by sending an infrared signal towards a reflective surface. The signal is then reflected back to the sensor where it is picked up by the receiver. As the displacement between the sensor and the target reflector increases, the voltage output of the device reduces. The components for the sensor are low cost and low power. If they are installed in the turbine they will need to be protected to prevent the sensor and receiver becoming covered by dust and residues. This can easily be achieved using a flexible sheath between the sensor and reflector. High reflectance material, such as aluminium tape, can easily be applied to the target surface in order to ensure a

Figure 6. Sensing displacement between the concrete foundation (bottom) and the flange of the embedded can (top)

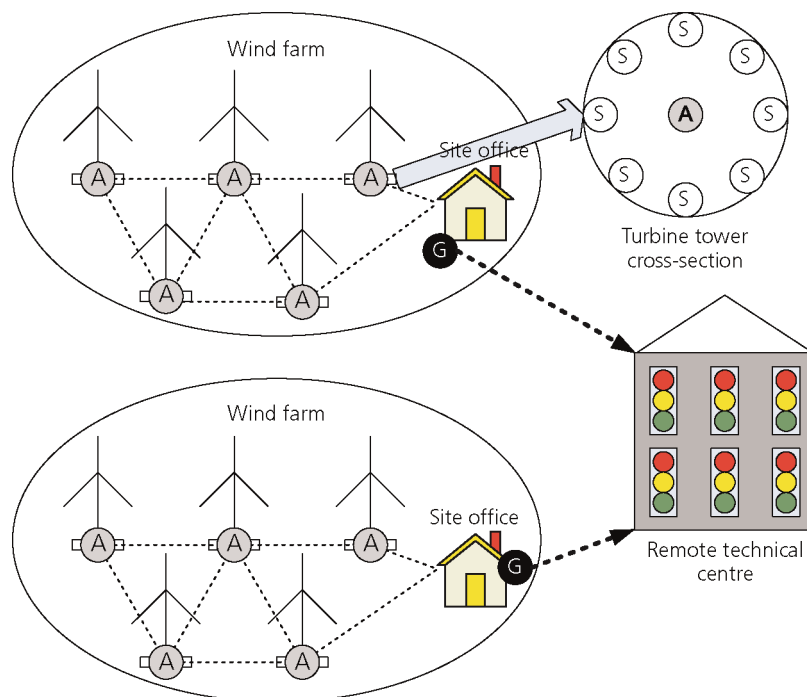
The proposed communications system architecture is shown in Figure 7. Multiple sensors (S) will be deployed on the turbine

foundations, sampling continuously for displacement and reporting the measurements to a data aggregator device (A) located in the turbine. The communications between the sensors and the data aggregation device could be either wired or wireless.

Figure 7. Sensor communication architecture. A: aggregator device, G: gateway device, S: sensor

Aggregator devices are used to combine measurements from the displacement sensors in order to create a displacement profile of the tower as a whole. Also correlation of displacement readings and measurement verification can be achieved at this level. For example, ambiguous readings from sensors placed at the same proximity can be identified and either excluded from processing (i.e. when the sensor readings disagree) or using correlation

After initial processing, the aggregator devices transmit the combined measurements over the existing supervisory control and data acquisition infrastructure to the RTC for further processing and classification using a traffic light system (green, amber, red). The classification and processing will be performed by BIP and will allow the human-machine interface to display the status of each individual turbine in an easy-to-understand format. For wind farms where supervisory control and data acquisition infrastructure is restricted or not available due to warranty issues, an autonomous communications solution will be provided. In this scenario, aggregator devices will transmit aggregate measurements to a gateway device (G), which is physically located in the site office. The gateway device will have two communication interfaces.

- (a) A wireless interface to communicate with the aggregators. This interface will be based on IEEE 802.15.4 and enlist the aid of aggregators to route measurements from remote locations of the wind farm (i.e. turbines that do not have a direct link to the site office due to limited range).
- (b) An internet-capable interface (i.e. GPRS/HSDPA, WiMAX, ethernet, ADSL, cable) for communications with the RTC.
