Virtex-5 CN Package Daisy Chain Evaluation Test Report

JPL Publication 16-3 01/16

NASA Electronic Parts and Packaging (NEPP) Program
Office of Safety and Mission Assurance

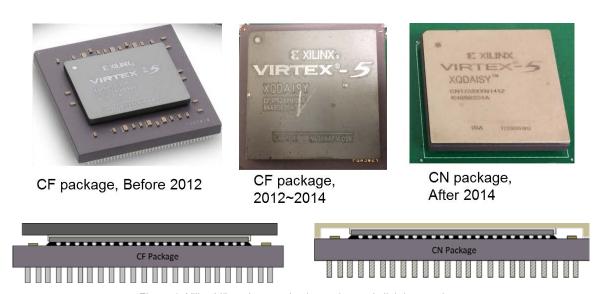
Figure 1. Xilinx V5 package styles have changed slightly over time.

The CF package was packaged at IBM's Bromont facility. The first design change, in 2012, was to increase the size of the heat spreader to cover the capacitors around the die. The major package design change happened in 2014, when IBM shut down the Bromont facility and Xilinx selected Kyocera as the packaging service provider. Since most of the packaging materials in the CF package were IBM proprietary, the package design went through major changes, including the board-level interconnect. The CGA solder columns were changed from IBM CLASP columns to Six Sigma columns. The IBM CLASP columns are composed of 90Pb10Sn and are attached to the package with Pd-doped Sn63 solder. The Six Sigma columns are made of 80Pb10Sn with a copper spiral around the column and are attached to the package with Sn63 solder.

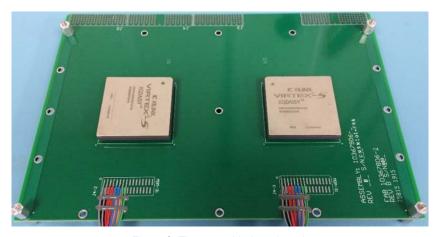
The test board had 7 daisy chains (Figure 2), located at columns at each of the 4 corners, the outer 2 rows, the next 3 rows, and all internal rows (Figure 3). The resistance of each daisy chain was continuously monitored.

Figure 3. The assembled test board.

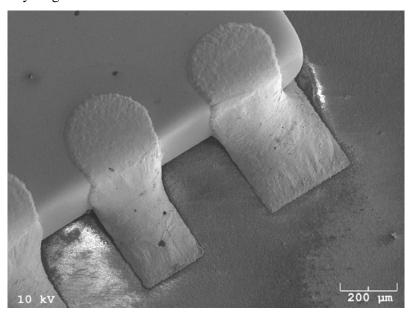
The heat spreader of one of the parts was removed to investigate the solder joints of the BME capacitors. Figure 4 shows an SEM image of solder joints at one of the capacitors after the removal of the heat spreader, without temperature cycling.

Figure 4. Solder joints of a decoupling BME capacitor before temperature cycling.

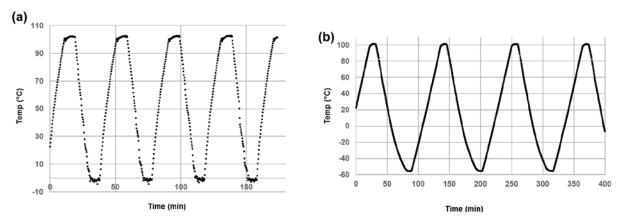
During the temperature cycling tests, both ambient temperature and the resistances of daisy chains were continuously monitored. Figure 5 shows the measured ambient temperatures of the chambers during temperature cycling. Figure 6 shows the resistances of daisy chains during the temperature cycling.

Figure 5. Ambient temperature profiles of (a) 0/100 and (b) -55/100 temperature cycling.

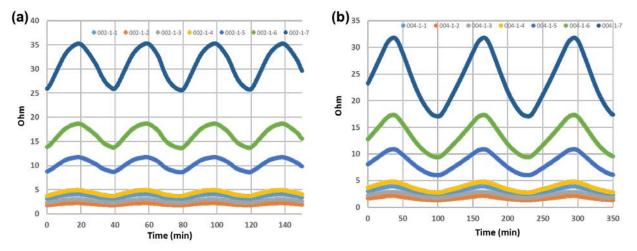
Figure 6. Resistances of daisy chains during (a) 0/100 and (b) -55/100 temperature cycling.

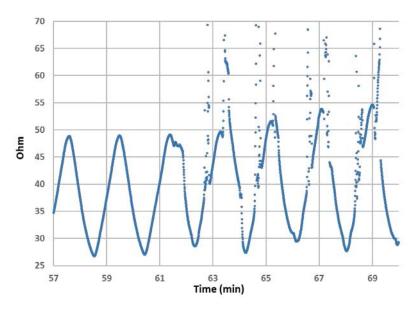
At the conclusion of testing, 0/100 cycling had completed 6586 cycles, -55/100 temperature cycling had completed 1705 cycles, and -55/100 dual-zone chamber temperature cycling had completed 3389. No part failed during the 0/100 temperature cycling. One part failed during the -55/100 temperature cycling, at 1236 cycles at the innermost daisy chain. One of part failed at 2097 cycled during dual-zone -55/100 thermal cycling, at the second innermost daisy chain. Since the corner columns with a large distance to neutral point (DNP) generally fail first, these failure modes were unexpected. Potential causes included a workmanship issue, a part defect, or a board via failure. As shown in Figure 7, the failed parts exhibited discontinuity only within a certain range of temperatures. The test boards had probing pads on the back side, each of them connected to a solder column land pad, so any failed solder column could be located by electrically probing the back-side pads. However, this approach did not work because the backside probing pads could only be probed outside the chamber at room temperature and the two failed parts exhibited continuity at room temperature for the duration of testing. A thorough failure analysis would be necessary to identify the mode and cause of failure. Table 4 summarizes the overall test results and Figure 7 illustrates how the resistance of the failed innermost daisy chain changed.

Figure 7. Resistance change of the first failed daisy chain during -55/100 temperature cycling.

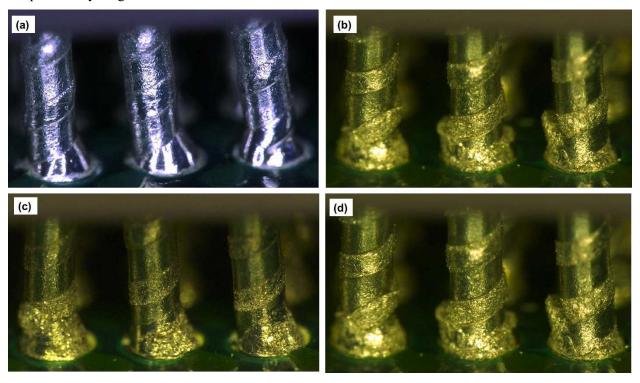
Solder columns were also visually inspected. Figure 8 shows optical microscope images of solder columns before and after the temperature cycling tests. The initially shiny surface of the solder columns and fillet

became dull and gray due to fatigue. Microcracks can also be observed on solder columns that went through temperature cycling tests.

Figure 8. Optical microscope images of solder columns: (a) before temperature cycling; (b) after 1705 cycles at -55/100°C temperature cycling in a single-zone chamber; (c) after 6586 cycles at 0/100°C temperature cycling in a single-zone chamber; and (d) after 3389 cycles of -55/100°C temperature cycling in a dual-zone chamber with a high ramp rate.

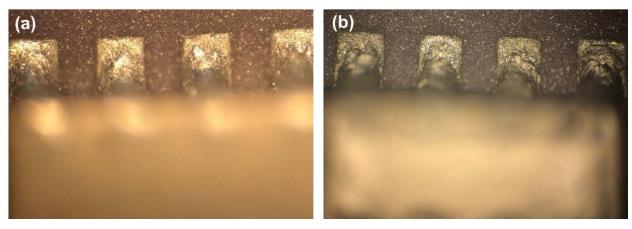
Figure 9. Shows optical microscope images of solder joints at the decoupling capacitors. The solder joints became dull due to fatigue. The inspected capacitor solder joints did not have cracks. However, only two V5s were inspected for capacitor solder joints and whether all capacitor solder joints survived temperature cycling is inconclusive.

Figure 9. Solder joints of a decoupling BME capacitor (a) after 6586 cycles of 0/100 temperature cycling and (b) after 1705 cycles of -55/100 temperature cycling.

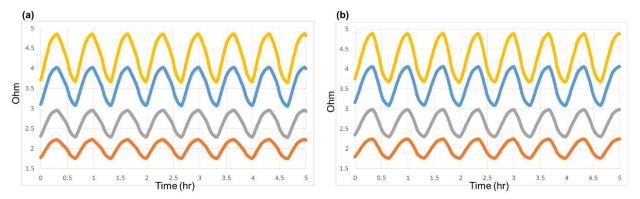
The resistances of all daisy chains were continuously monitored during temperature cycling. Per IPC-9701A, a 20% increase in resistance was the criteria for failure. Figure 10 shows the resistances of the corner daisy chains at the beginning of the test and after 6500 cycles of 0/100 temperature cycling. Even after 6586 cycles, there is no obvious resistance increase, indicating no solder column failures. Figure 11 shows resistances of the corner daisy chains of a part measured during -55/100 temperature cycling. During -55/100 temperature cycling, one part failed at the 1236 cycle. However, this failure took place within the innermost daisy chain, which suggests the failure was likely due to a part defect or via failure. Other parts did not show any increase in resistance, as measured up to 1705 cycles. One of the two parts temperature-cycled from -55 to +100°C in a dual-zone chamber showed a failure at 2097 cycles, but this failure also happened within an internal daisy chain. In other words, no obvious solder fatigue failure took place during any test.

Figure 10. Resistances of 4 corner daisy chains of a part, measured during 0/100 temperature cycling: (a) at the beginning of the test, and (b) after 6300 cycles.

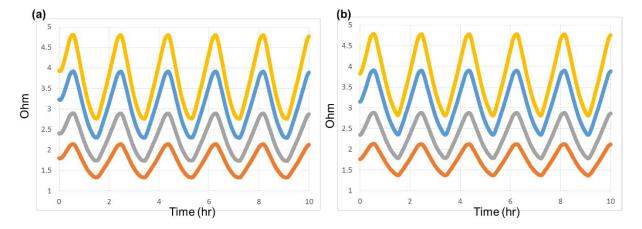
Figure 11. Resistances of 4 corner daisy chains of a part, measured during -55/100 temperature cycling: (a) at the beginning of the test, and (b) after 1600 cycles.
