## Hydrologic Effectiveness and Plant Survivability in the Holmes Lake Rain Garden Pilot Program: Year Three

**Hydrologic Effectiveness and Plant Survivability  
in the Holmes Lake Rain Garden Pilot Program:  
Year Three  
Lincoln, Nebraska**

Masters Horticulture Project  
University of Nebraska–Lincoln  
August 2011

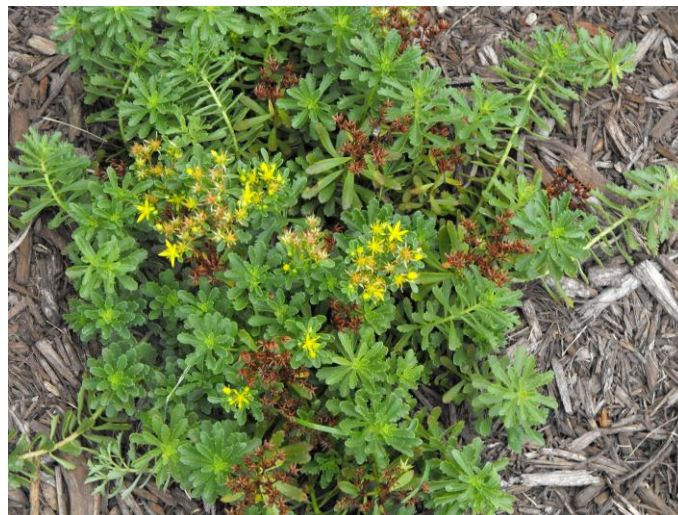
(Fig. 6) *Sedum floriferum* 'Bailey's Gold' used for bank stabilization.

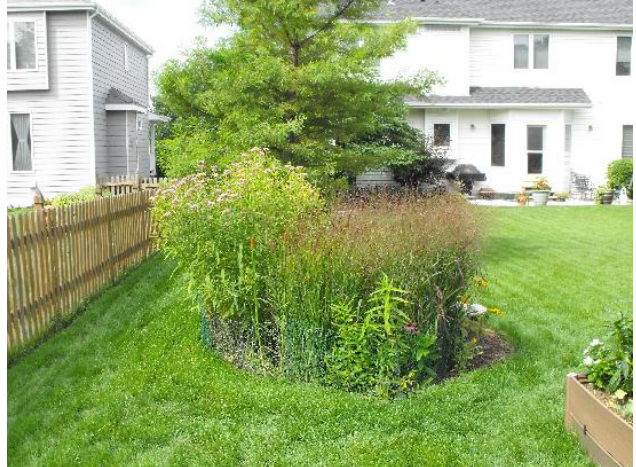
East bed

East – Rushes are flopping over. Solidago, Aster, and Obedient Plant overcrowded by surrounding plant material. Culver’s Root overcrowded as well, if needed in the bed to aid with water infiltration, then it should have replaced original plant material. No sign of disease.

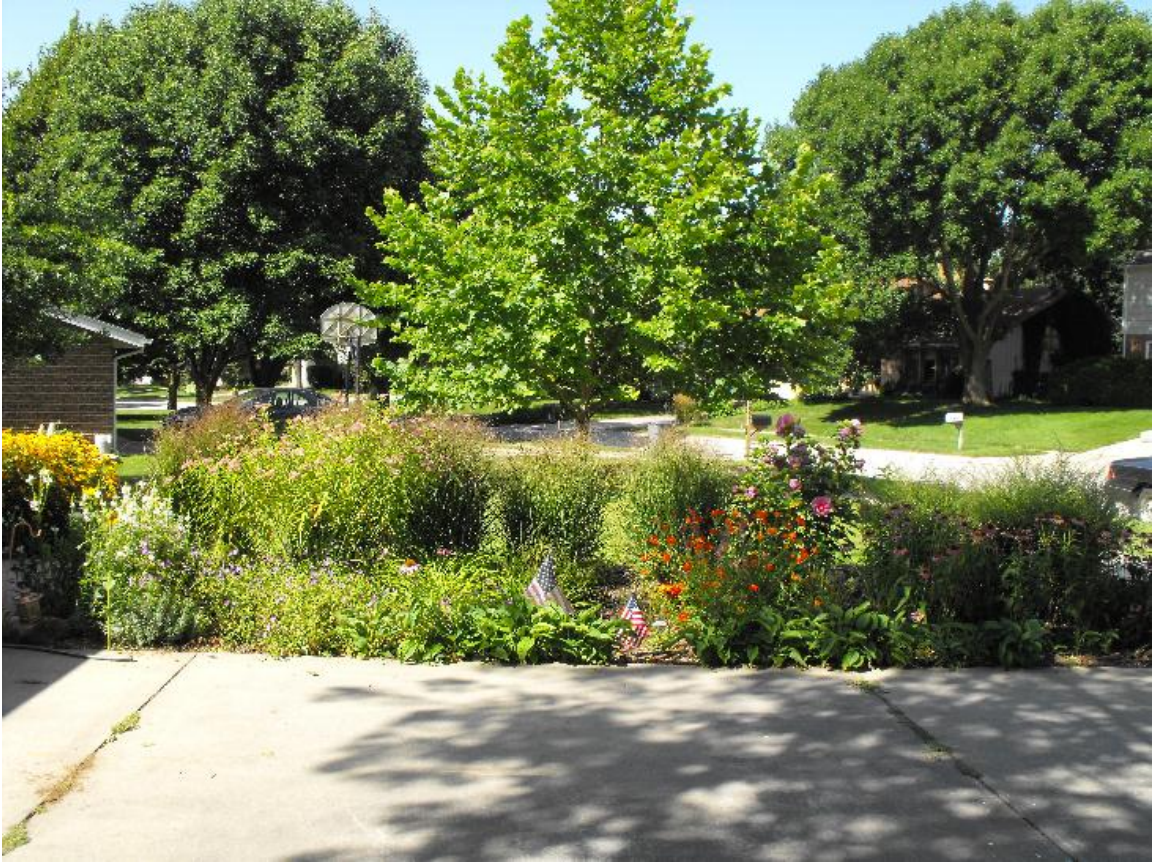
close to being  
 overfilled
