**ESTIMATION OF MALFUNCTION
OF A HEALTHCARE FACILITY IN
CASE OF EARTHQUAKE**

Nebil Achour

March, 2007

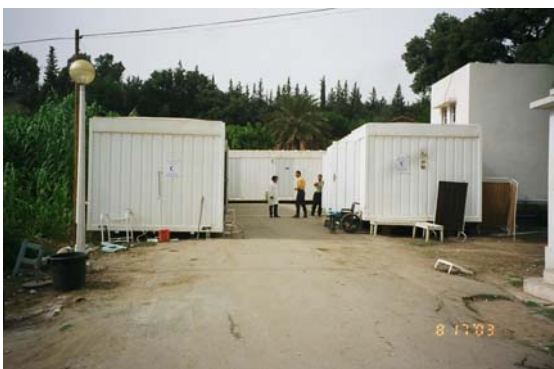
elements were totally collapsed throughout the majority of the facility. Non-structural elements had fallen, became broken and made the area inaccessible from all wings. The damage obliged the government to supply prefabricated buildings that were used instead of the actual facility, as is shown in Photo 3.18. The prefabricated buildings were used as the actual facility in which patients were being treated. Those prefabs were equipped with electricity and air conditioners to make life easier for the medical staff as well as the patients. The structural damage had a clear impact on the patients since they had difficulty being treated. The staff could not access or move the inpatients and many patients had to be transferred to other hospitals because their treatment became impossible in that hospital.

Photo 3.18- Prefabricated buildings used instead of the actual building

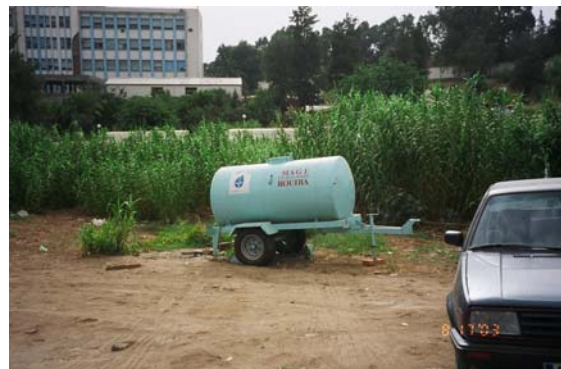
Photo 3.19- Reservoir of water used as alternative source

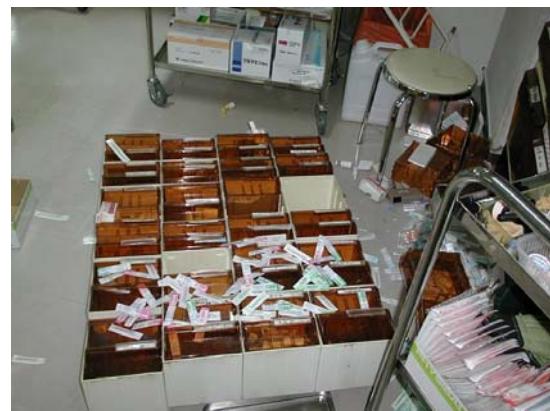
The damage was found to vary from one hospital to another, which may be as a result of the age of the structures, or with the site effect which needs more investigation to find the main cause. Lifeline malfunction was found to be one of the main problems faced during the events. Hospitals were equipped with alternative sources for water supply, electric power; these spare sources were used during the shortage of the main sources until total restoration was achieved. On the other hand, the facilities were experiencing mis-telecommunication given that there was no alternative source for such a lifeline component. A study has shown that, within the first 10 hours more than 95% of the hospitals had their lifelines restored (Achour et al., 2004b). Again, the problem of displacement occurred in many hospitals; equipment toppled and/or turned over causing inaccessibility in the facilities, see photos 3.20 through 3.22. The analysis of the questionnaire will be done in the next chapter.

Photo 3.22- Turning over of medicine shelves, Kushiro Urinary Clinics

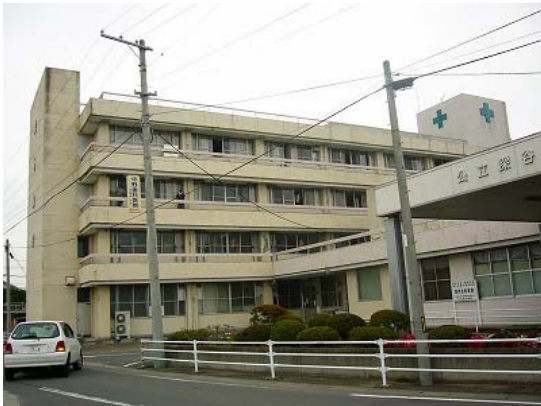
The facility was built in 1968 and it suffered very severe damage to its columns, see Photos 3.23 and Photo 3.24. One building collapsed, which obliged the staff to transfer patients. One member of the personnel was injured and some others couldn't reach the hospital. As well as structural damage the facility suffered damage to its lifeline. The electric power was cut for about two hours but the emergency electric generators were sufficient. The water pipelines were damaged and caused the outage of water for about four days. A mobile water supply was used instead of the local water system. All forms of telecommunication; landlines, mobiles and PHS were cut for about one hour.

Photo 3.23- Fukaya Hospital

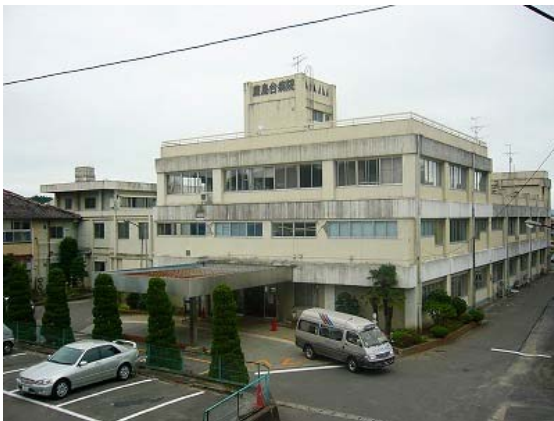
The Kashimadai hospital, shown in Photo 3.25, was built in 1969 and just like the previous institute it suffered very severe damage to its structure. Columns suffered severe cracks as seen in Photo 3.26. As a result of the structural damage some patients were transferred to other hospitals. The 113 bed facility lost its electric power and when the engines stopped, a company representative went and did all the necessary repairs. There was a shortage in the water supply since a water pipe was broken; this too was later repaired.

Photo 3.25- Kashimadai Hospital

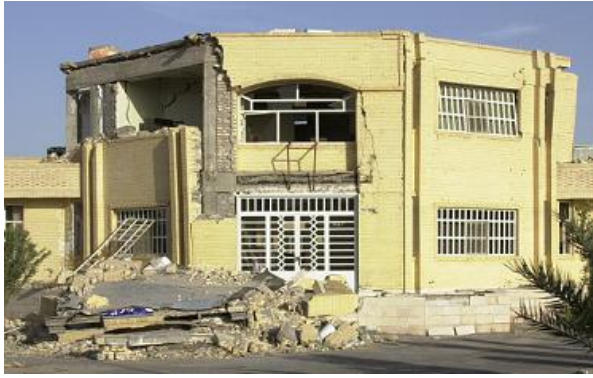
Photo 3.30- Aflatoonian Hospital, February 2004

The hospital suffered severe structural damage; some columns tilted, some others cracked and some parts collapsed, see Photo 3.30. According to one member of the hospital, the structural damage cost 5 billion IRR, *Iranian Rials* (65 Million JPY, *Japanese Yen*) of the cost of the entire building which is about 12 billion IRR (155.6 Million JPY). It should be noted that the cost of construction has become more expensive than a few years ago, in other words the damage to the facility is less than 41.6% of repair cost of entire building. The facility suffered malfunction to its lifelines; electric power was cut for about two days, there was no landline telecommunication until February 2004, there was no mobile telecommunication for at least 12 days following the quake. With regard to concerning the water supply the facility was provided with two reservoirs that were used as alternative sources. The tanks are able to store 13m³ of water which can be used for about two days, see Photo 3.36 and Photo 3.37. The damage to lifelines caused malfunction of medical equipment which caused delay in treatment. International aid teams provided the facility with some equipment which helped it to re-open and provide necessary care. Nevertheless, some medical equipment has not been used since it fell or was displaced causing its damage, see Photo 3.38 and Photo 3.39. At the time of the earthquake the facility did not have any alternative source except the water tanks shown in photos 3.36 and 3.37. Later, a 32KW electric power generator was brought to be used in case of emergency, as Photo 3.40 illustrates. The generator is used only for the operation room. However, the engine is able to make the majority of the equipment function; it can produce 768KWh/day, thus it produces 23,808KWh in 31 days which is 80% of the consumption of August 2005.

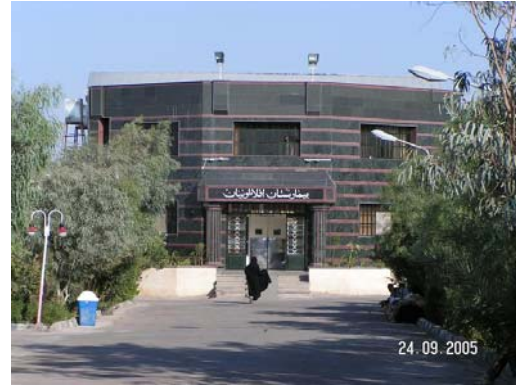
Photo 3.31- Aflatoonian Hospital, September 2005

The Aflatoonian hospital is a private hospital; the 2-story building was built about six years before the earthquake 5km from the centre of Bam. The facility has a capacity of 70 beds which can be extended to 120 beds in case of emergency. Between 25 and 30 patients are treated every day in the hospital in addition to 70 inpatients which makes the facility full without being in emergency mode. The medical service is composed of 57 people; 17 of them are doctors, 40 nurses. A problem with the facility's insurance forced it to close on January 5th 2004; after that the facility partially opened to provide treatment in its garden and parking lot, where the international teams setup their tents, the personnel stated. The actual building was totally closed until July 2004, then opened again and started treating patients. The government of Kerman helped in repairing the facility, which was exempted from paying water supply fees until October 2005. Photo 3.30 and Photo 3.31 show the front of the facility before and after being repaired, respectively.

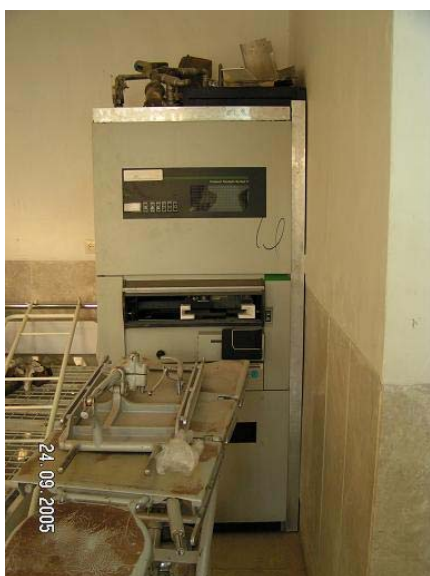
Photo 3.41- Radiology unit

Unit	Severity of damage	Remarks
X-Ray	10%	
Sterilizer (CSR)	10%	Damage to the water pipes because of the displacement, Photo 3.42 and Photo 3.39
Radiology	100%	Photo 3.41

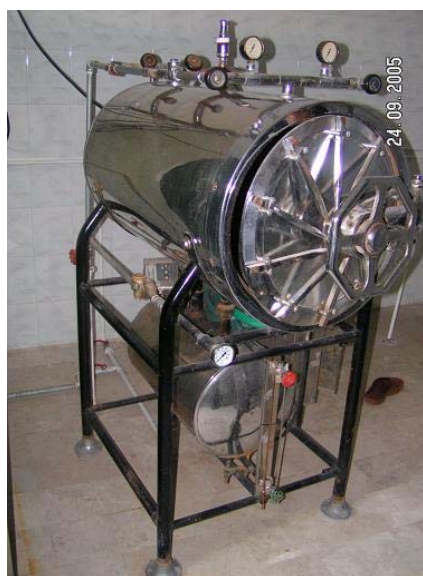
As a result of the shaking many pieces of equipment got damaged which may be the result of displacement, topple, rocking or displacement-rocking. The personnel of the Aflatoonian Hospital stated that almost all the equipment was damaged with various degrees of severity; the cost of repairing the damage was between 10-100% of the price of the equipment itself. For instance, Table 3.13 shows some of the equipment and the severity of its damage. Some of them were fixed and some others were disposed, such as the radiology unit shown in Photo 3.41. As a result of the displacement the pipelines to the water supply attached to the Central Sterilization Room (CSR), shown in Photo 3.42, were damaged rendering the equipment useless.

Photo 3.42- CSR unit

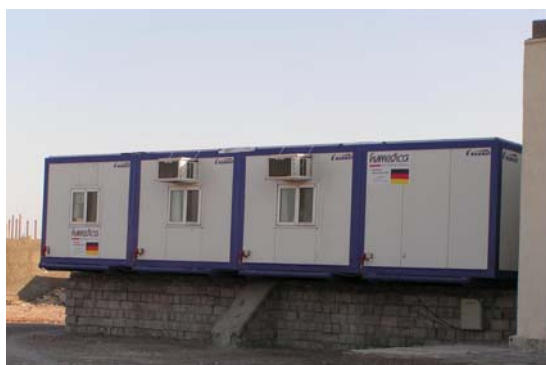
Some services are still operating in prefabricated buildings, such as the operation room and women’s ward. The prefabs are located on small masonry walls without being attached to any support which may make them unstable in case of strong shaking, see Photo 3.43 and Photo 3.44. The masonry is not capable of resisting horizontal loads, which is the case of earthquakes; this may result in their damage during an earthquake. The damage to walls leads to the total malfunction of the service provided in the prefabricated building.

Photo 3.43- Operation room, Women’s ward

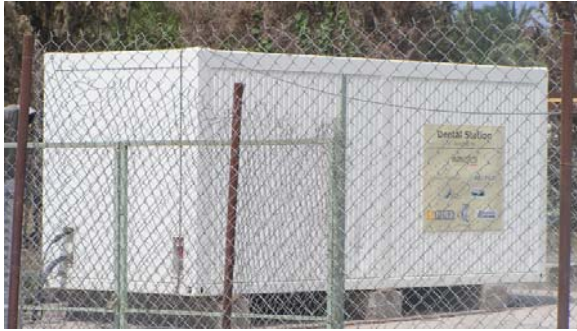
Photo 3.49- Dental Station donated by some companies

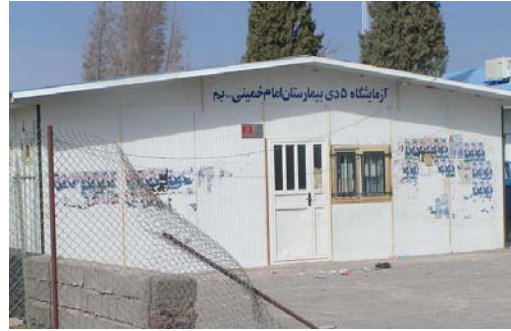
Photo 3.50- Building donated by Save the Children Society Japan

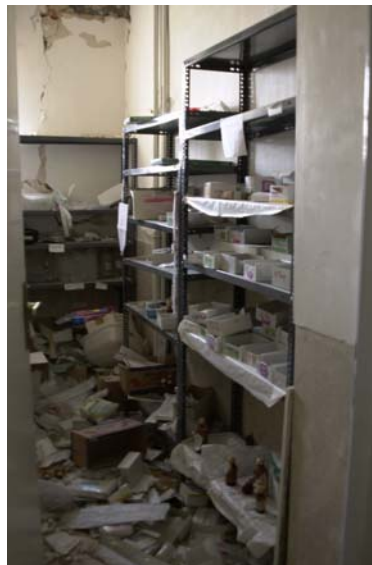
Photo II. 3- Topple of medical equipment
