Commonwealth of Kentucky
Department of Highways

TEN RURAL HIGHWAY BASE STABILIZATION PROJECTS

James H. Havens
Senior Research Engineer

August , 1957

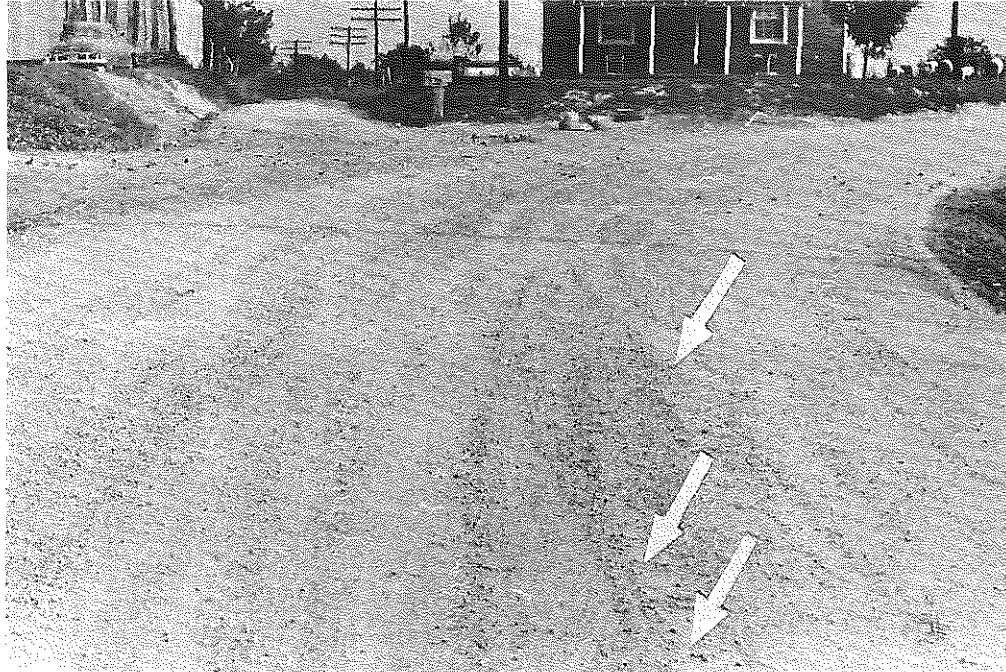
Fig. 6: Breckinridge Co.: Curve at Middle of Project, after Sealing. Arrows point to spots where single seal failed to stick. (10-17-56)

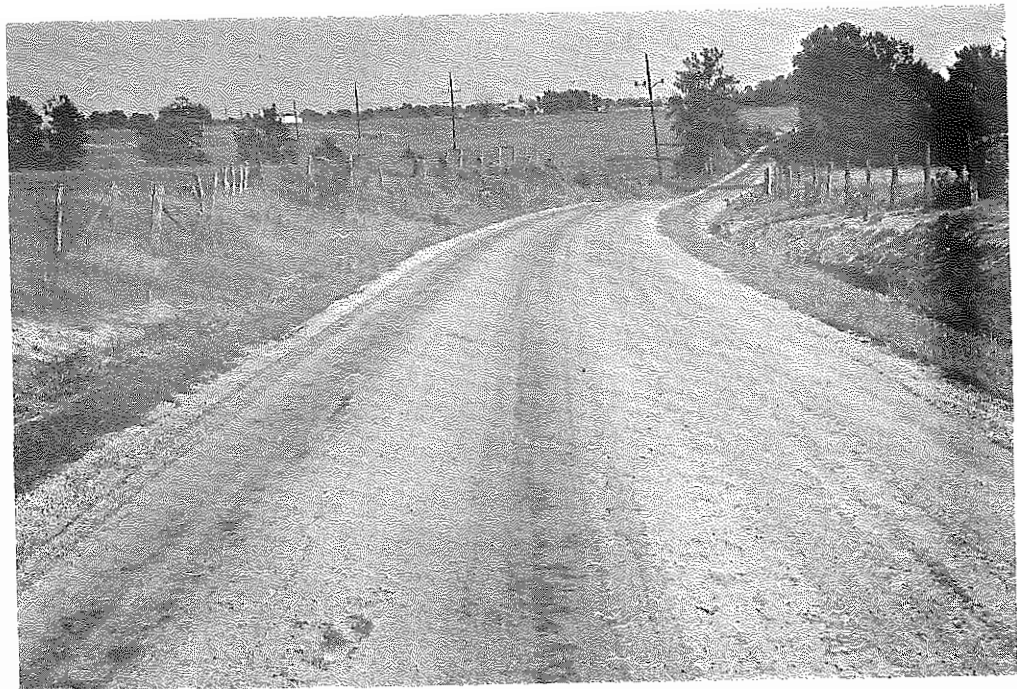
Fig. 13: Breckinridge Co.: Same Road as above, Different View, after 10 Months. (8-4-57)

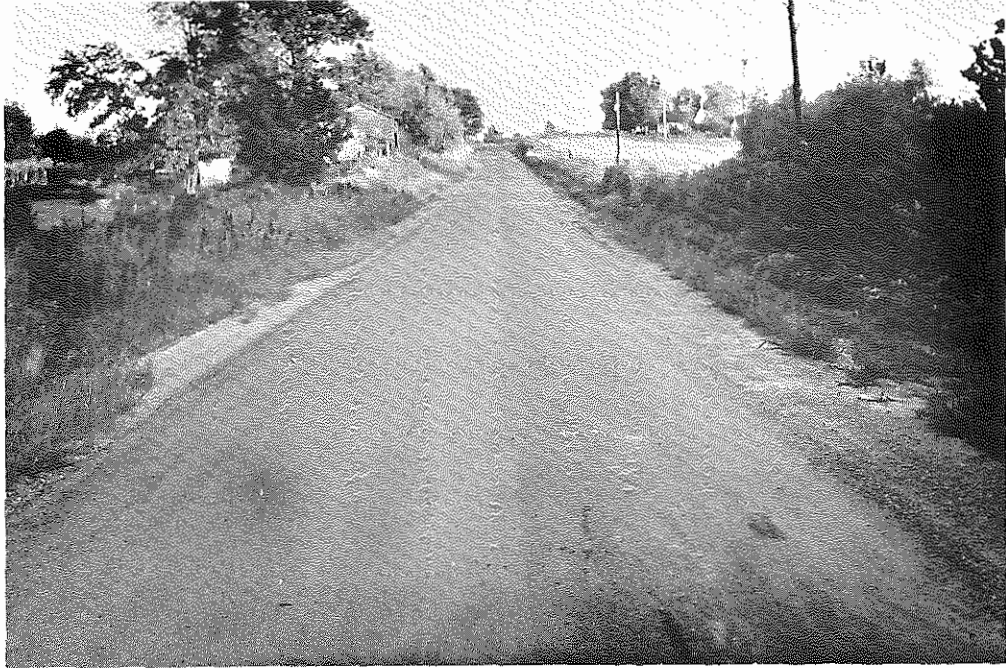
**Fig. 16: Webster Co.: Soil-Cement Section after 10 Months.
(8-4-57)**

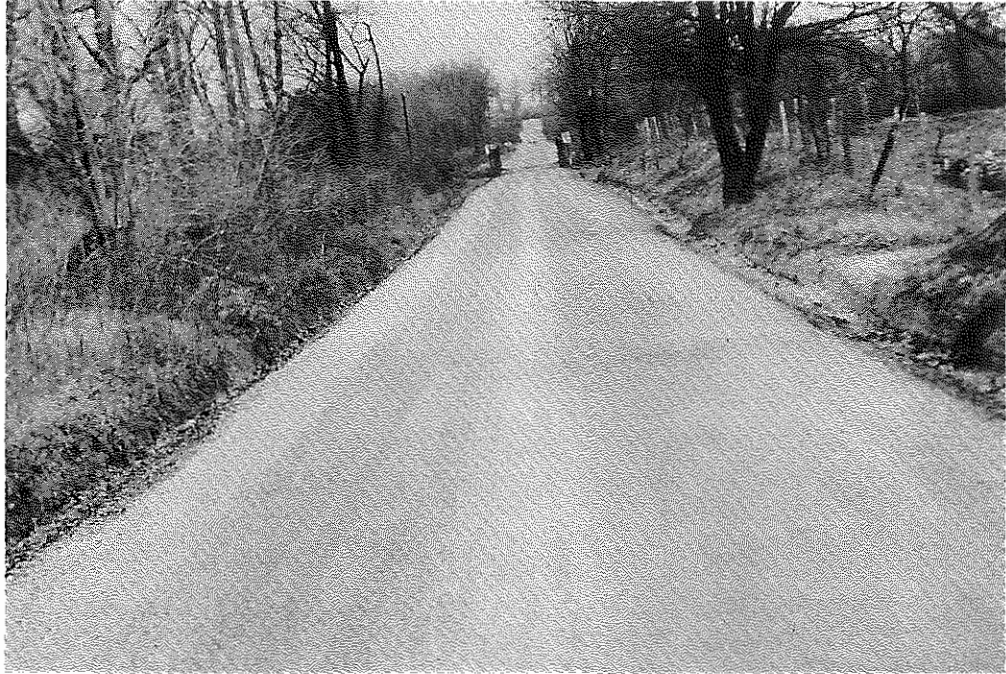
Fig. 24: Ballard Co.: General Appearance of Road after 2-1/2 Months. (1-3-57)

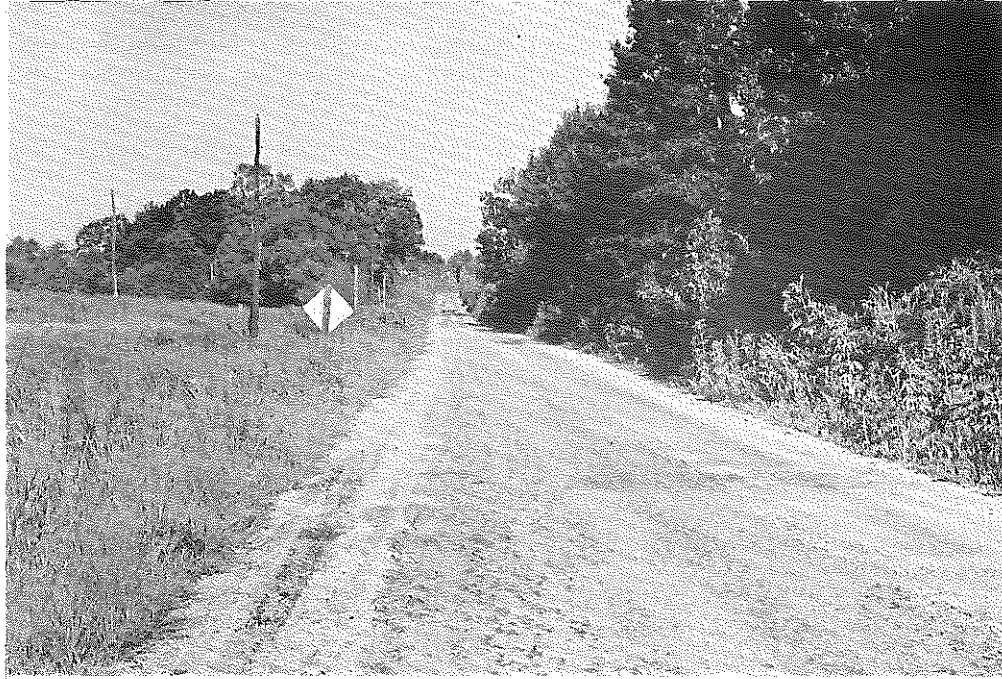
3. Ballard County - The performance of this road has not been entirely satisfactory. Several rich spots were observed during construction, and these have remained soft and unstable. While there has been very little tendency for the asphalt to bleed to the surface, some sections are deeply marked and re-marked by each passing vehicle. In some sections this continued masticating action has caused the seal to crack and check. Some of the sections are soft enough to create a noticeable drag or deceleration on an automobile. The instability is obviously in the base. The coarse gravel particles have a rather oily appearance and are not at all coated with asphalt, while the mortar portion is black and sticky with asphalt.

Fig. 26: Ballard Co.: Dark Mottling Resulting from a Tendency of the Seal Asphalt to Bleed. Seal is badly cracked from instability and movement within the base. (8-4-57)

The road will be in need of some kind of repair in the near future, but correcting instability of this type may prove difficult. There

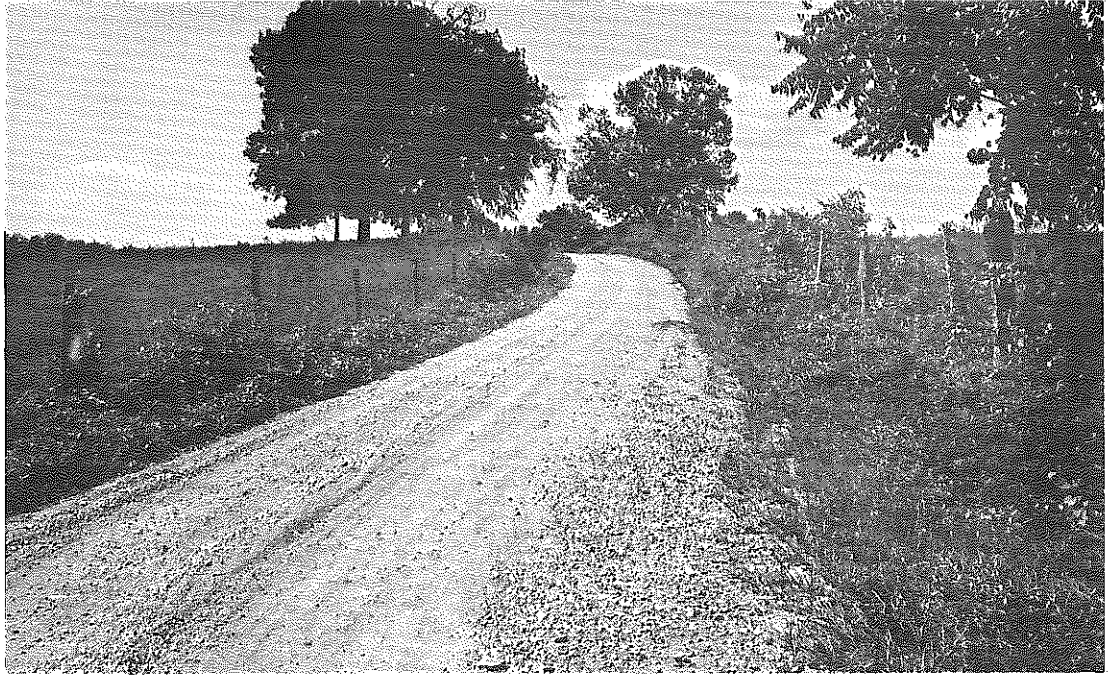
Fig. 37: Barren Co.: Typical Appearance before Stabilization Work Began.

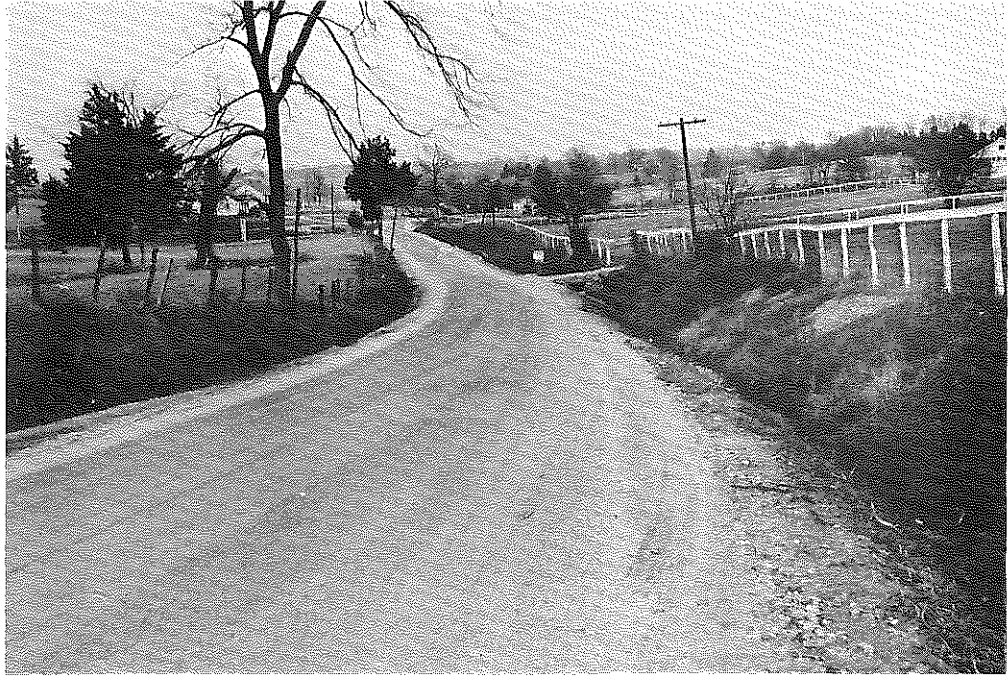
5. Barren County - Performance here has been very good. Some maintenance has been performed on the seal, but the base seems quite stable, and the road is in excellent condition.

Fig. 38: Barren Co.: Appearance after 2-1/2 Months. (1-3-57)

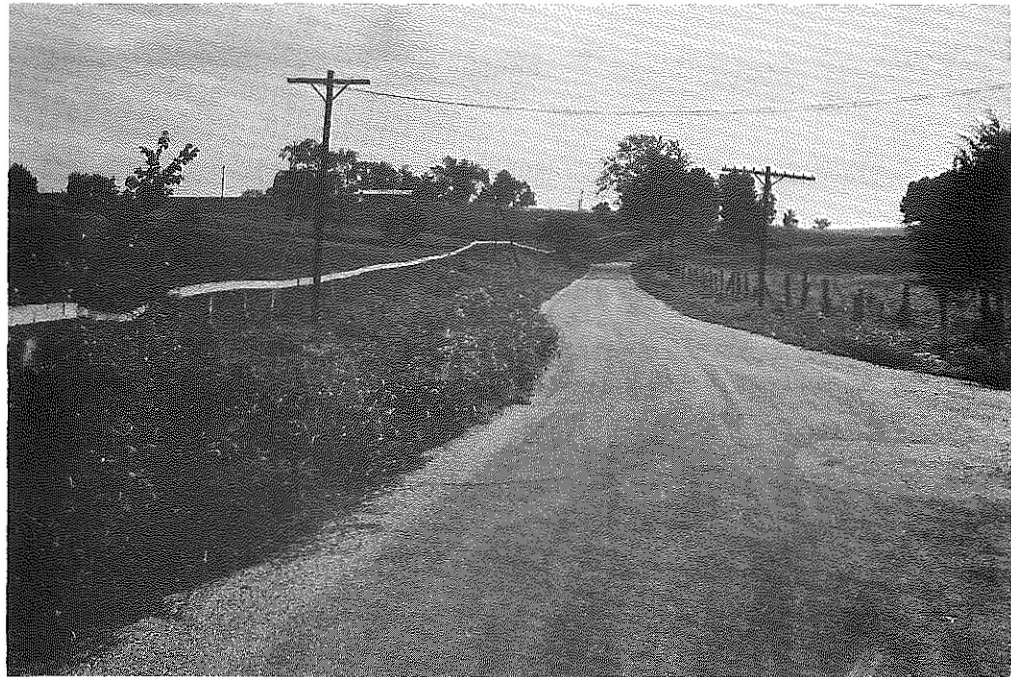
Fig. 41: Barren Co.: Similar Section after 7 Months. (4-24-57)

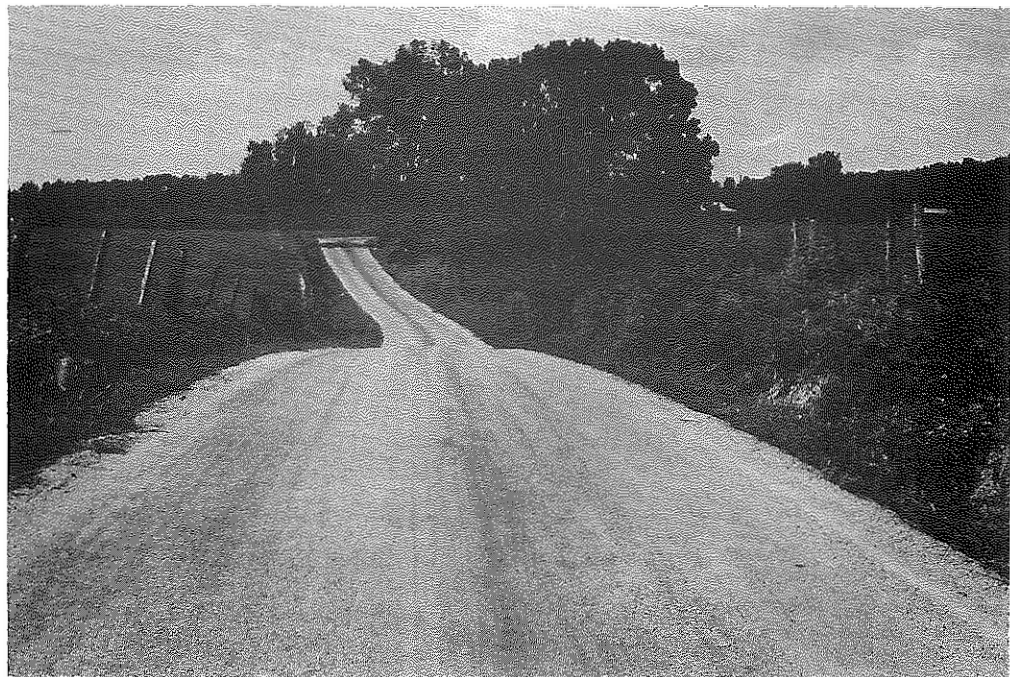
Fig. 42: Barren Co.: After 10 Months. (8-5-57)

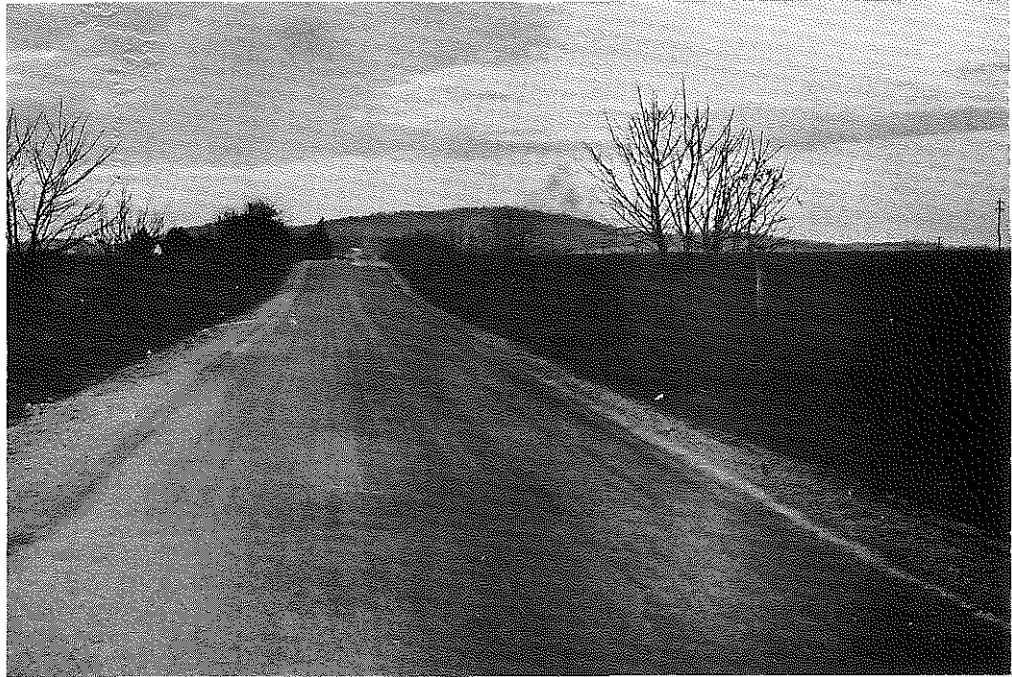
Fig. 43: Barren Co.: After 10 Months. (8-5-57)

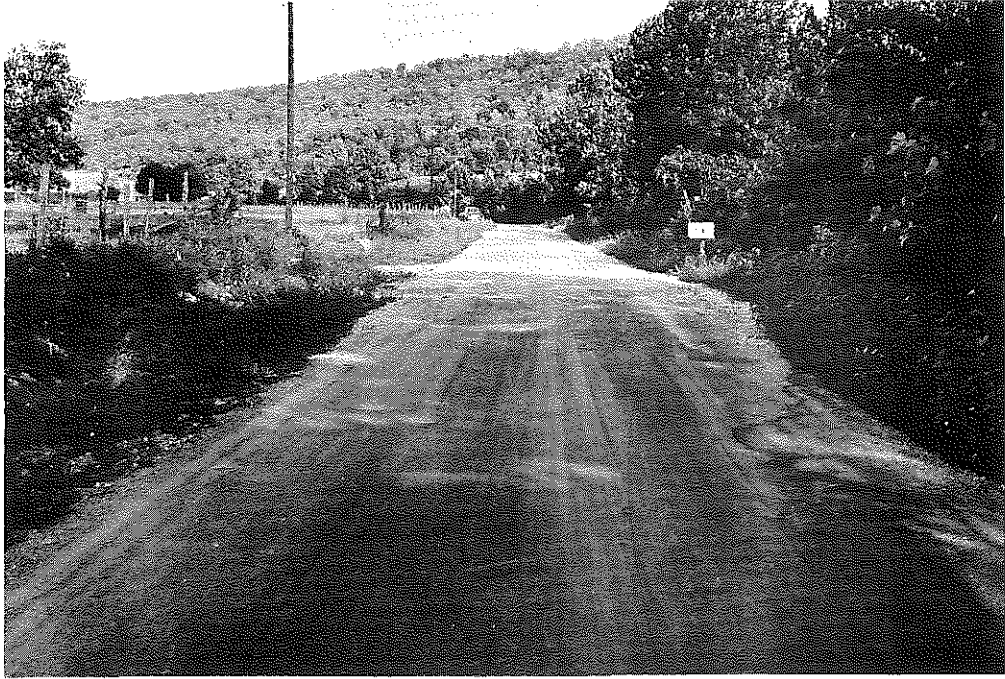
Fig. 47: Wayne Co.: One of the Better Sections, after 10 Months. (8-5-57)

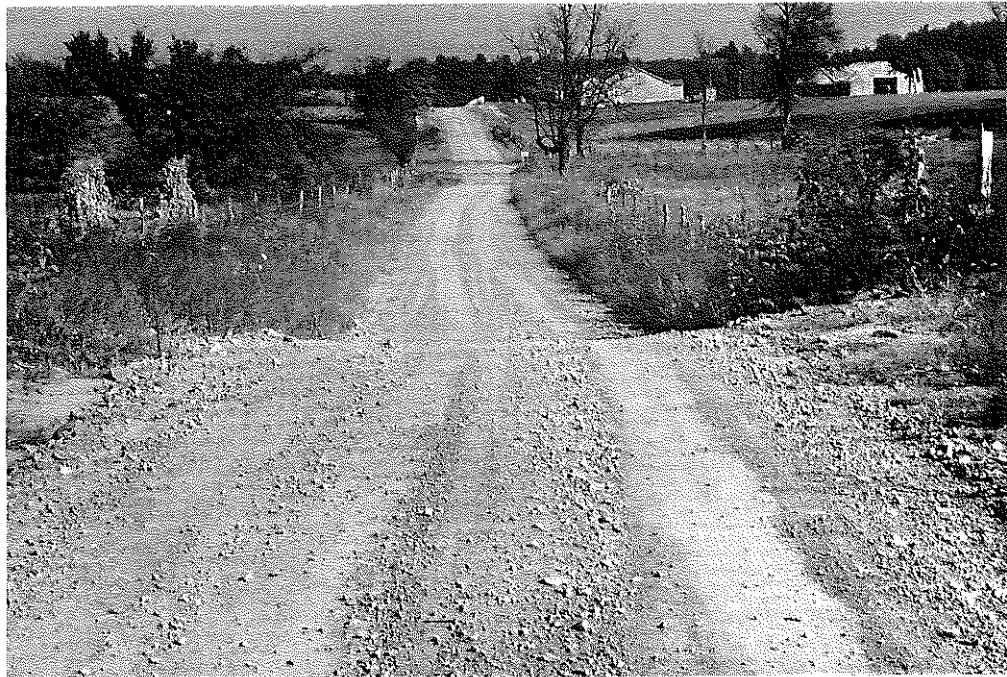
Fig. 54: Madison Co.: One of the Better Sections, after 10 Months. (8-5-57)

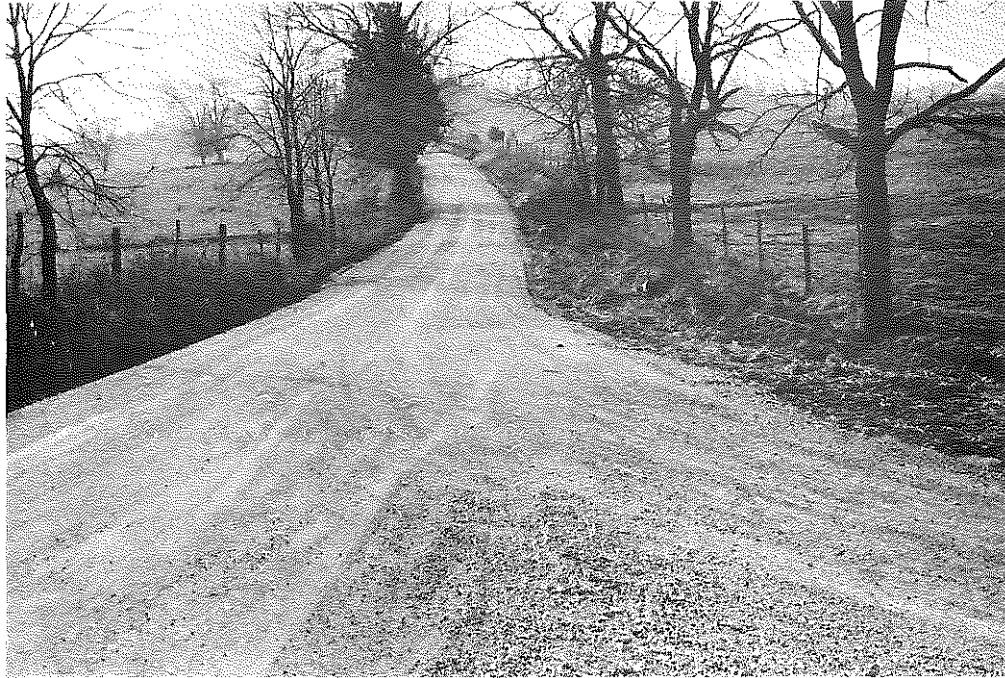
Fig. 55: Montgomery Co.: Typical Section before Stabilization. Bench in foreground is ledge of bedrock covered by black shale.

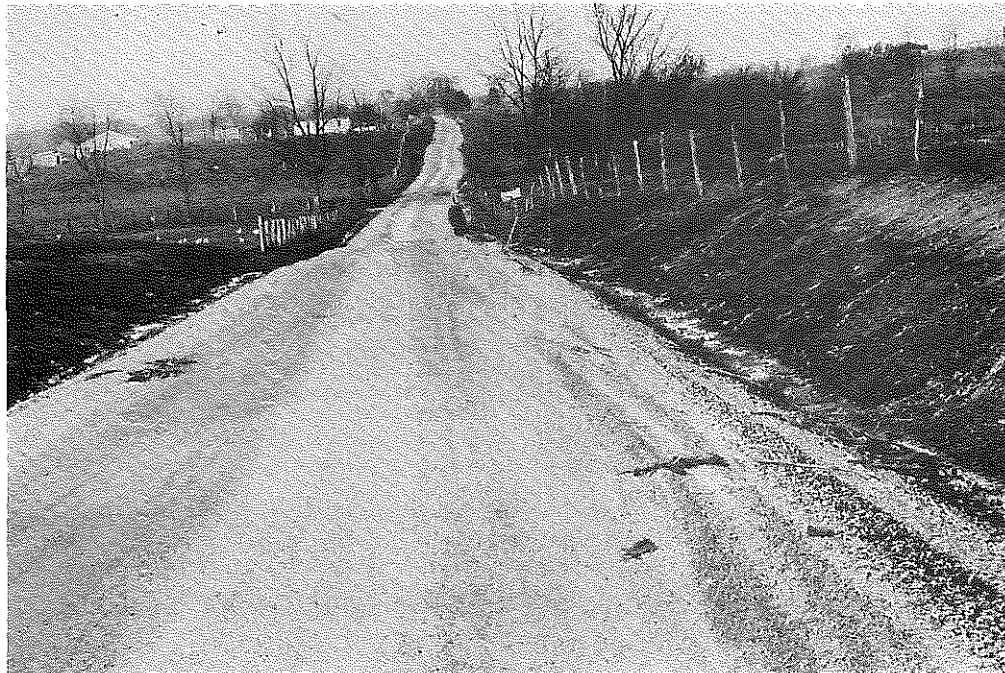
Fig. 56: Montgomery Co.: Granular Stabilization, Single Seal, after 6 Months. (3-13-57)

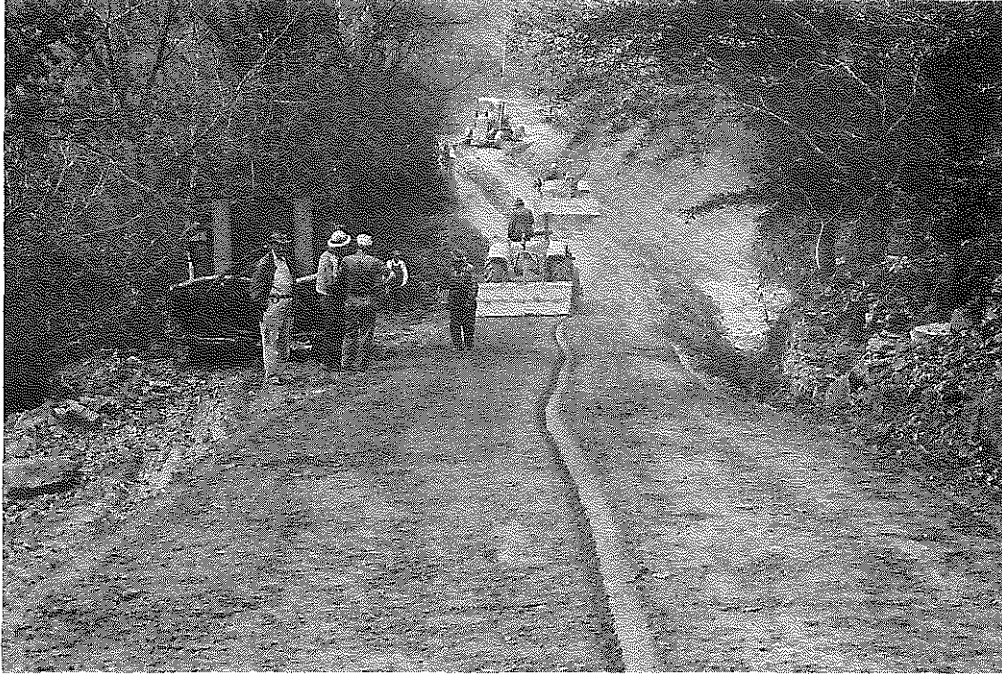
Fig. 63: Montgomery Co.: Same Section as Above Foreground, but Looking in Opposite Direction. (8-20-57)

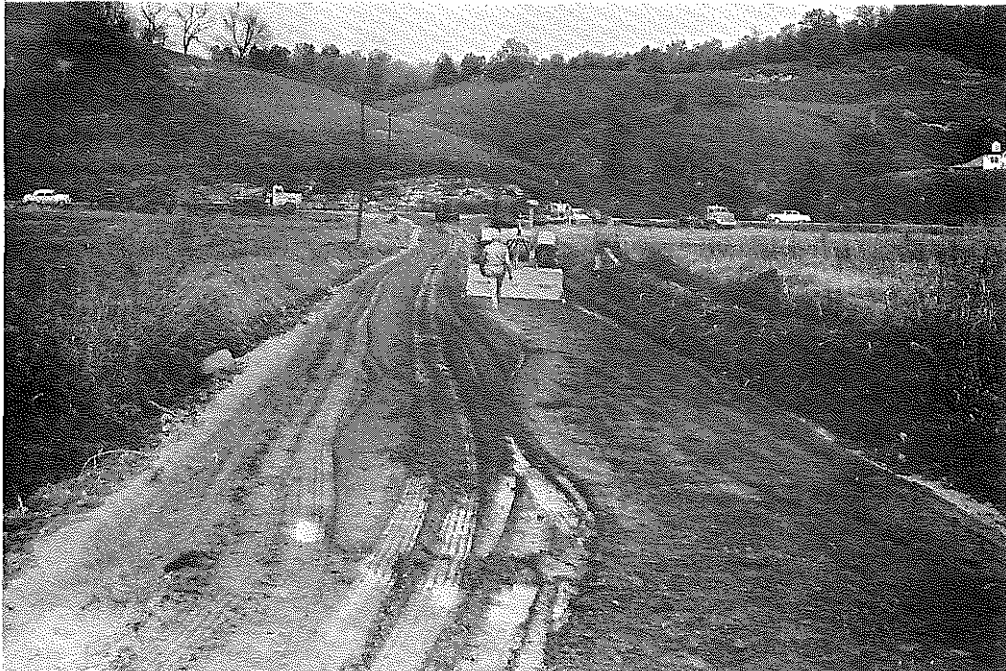
Fig. 64: Lawrence Co.: Soil-Cement, Single Seal. Section was narrow, with bedrock outcropping through subgrade on hill in foreground. (10-24-56)

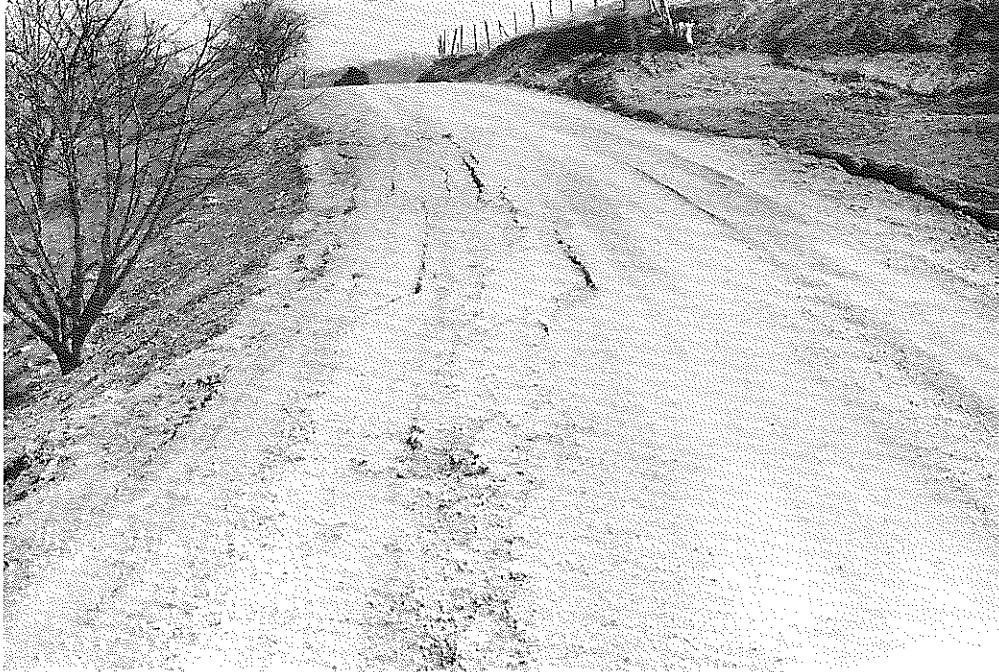
Fig. 65: Lawrence Co.: Across Upper Laurel Creek Bottom. Section in middle foreground remained unstable. (10-24-56)
