Phase I Inspection of the Stay Cable System on the US 231 William H. Natcher Bridge over the Ohio River

Kentucky Transportation Center Research Report — KTC16-01/KHIT77-1F

Research Report
KTC-16-01/KHIT77-1F

January 2016

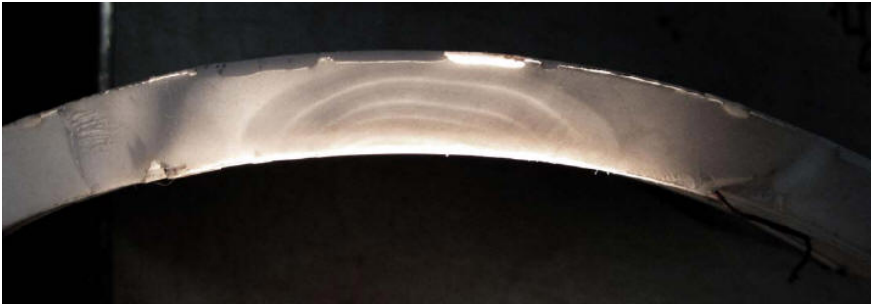
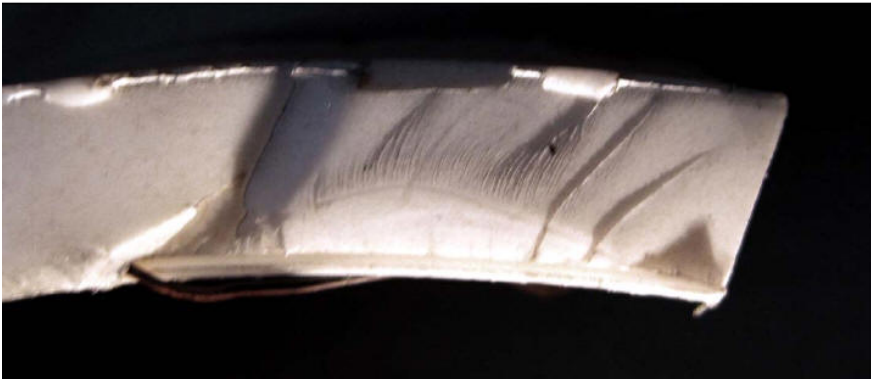
KTC intended to conduct ultrasonic tests of the piping butt welds and electrofusion welds. The testing of the butt welds was intended to detect any subsurface cracking that might be forming. The HDPE piping was being subjected to variable stresses that caused fatigue cracking in the welds. In 2009, KTC extracted a fractured coupler segment that contained a fatigue crack that initiated at a heating wire within the electrofusion welds growing from the inside of the coupler to its outer surface before travelling in both directions around the coupler (Ref. Figure 15). The fracture mechanism of the butt welds, generally appeared to initiate at or near the top of the piping and grow in visible steps typical of low-cycle fatigue.

Figure 15. Fatigue Fracture Surfaces. Note Concentric Beach Marks in Top View.

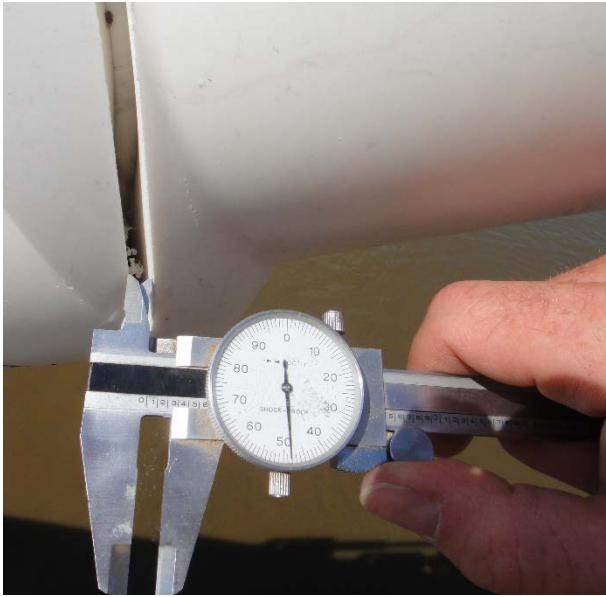
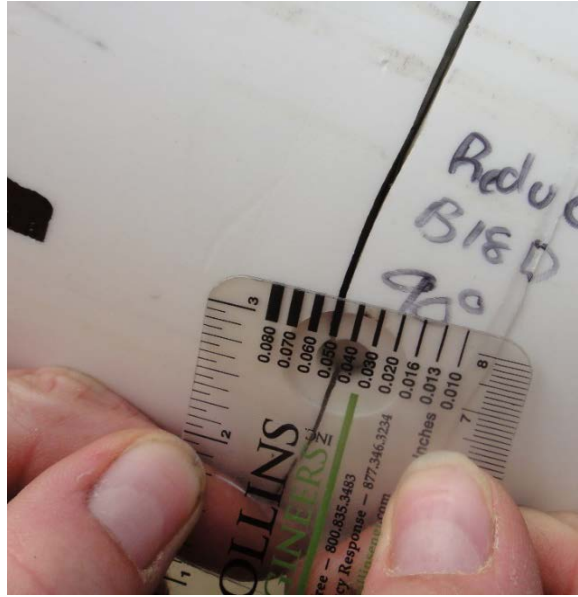
Figure 50. (a) Measuring Large Crack Opening with a Vernier Caliper; (b) Measuring Small Crack Opening with a Comparator Gage.

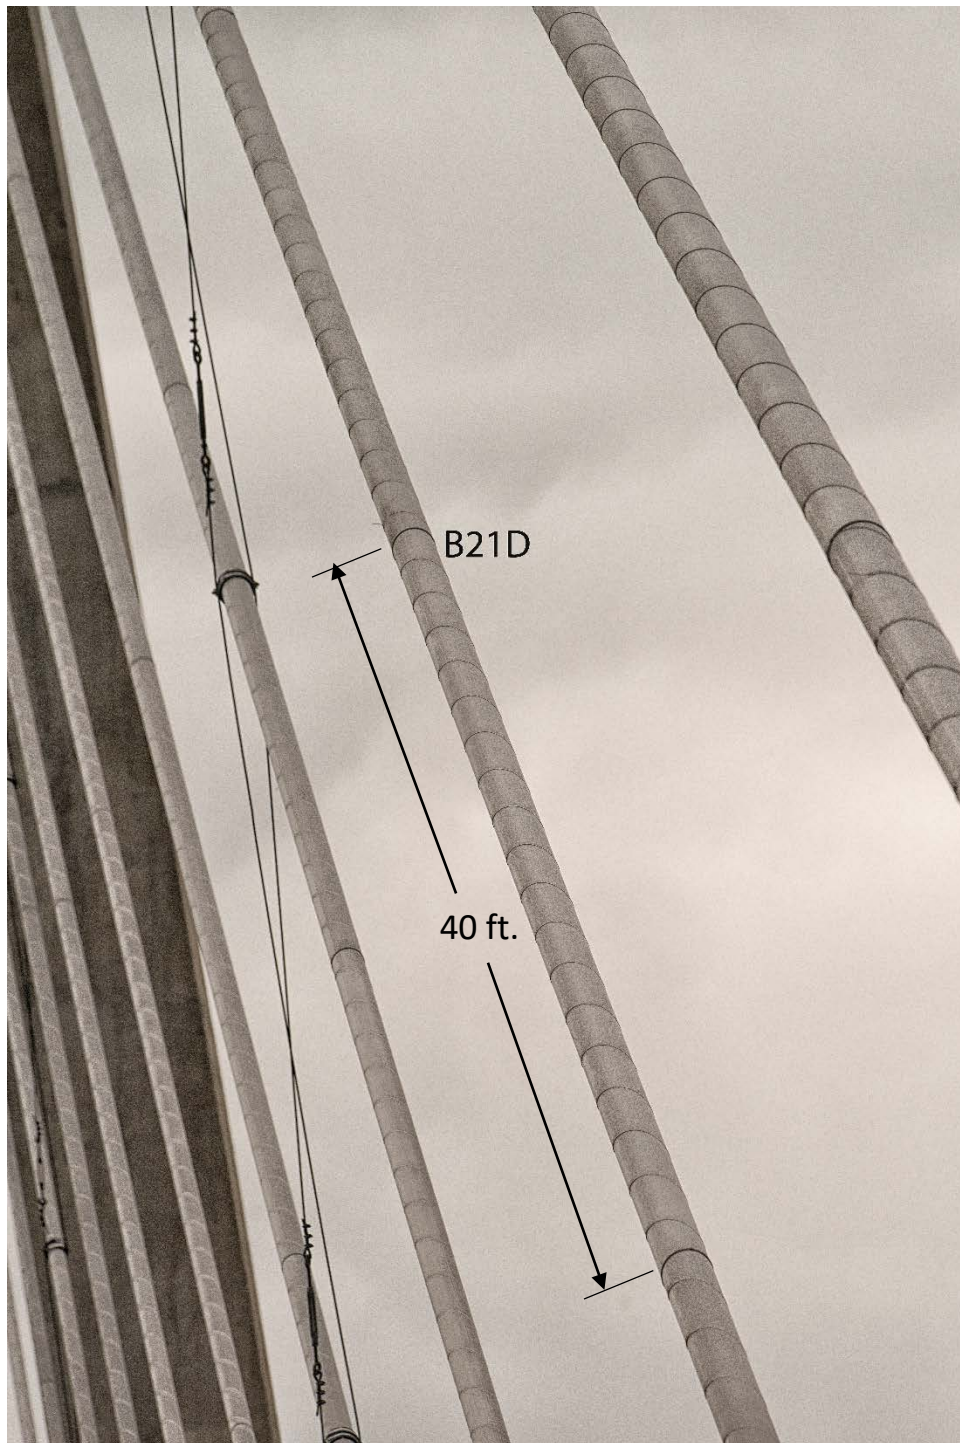
Figure 61. Typical 40 ft. Stay Pipe Segment with Helical Ribbing Intact.

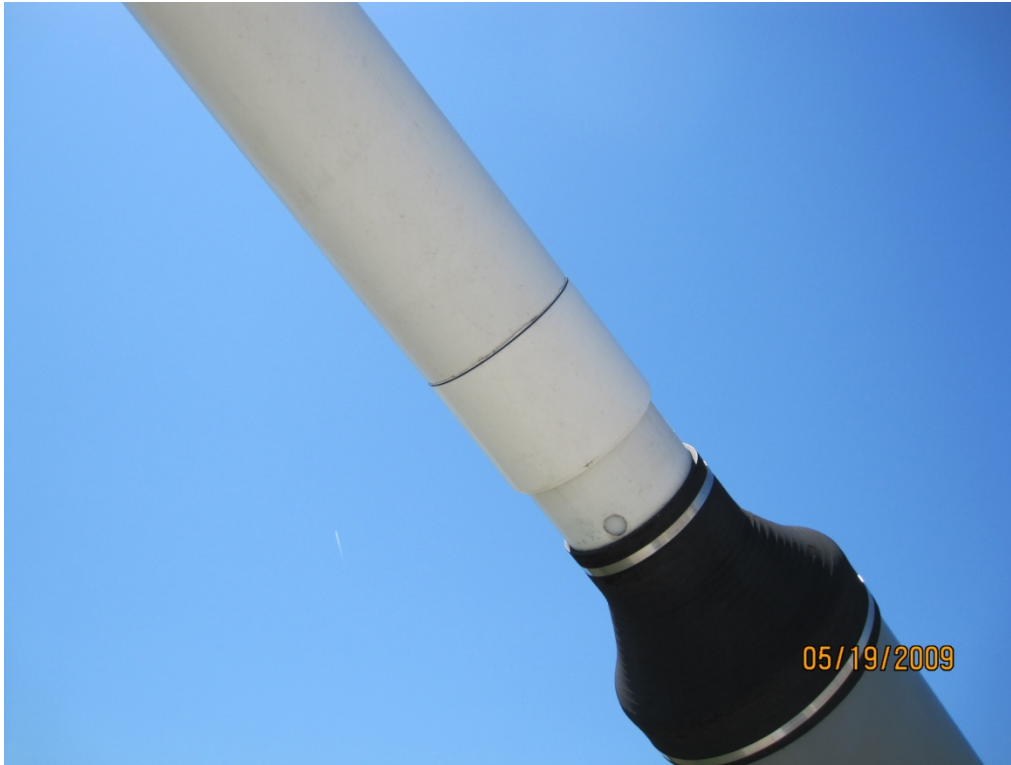
Condition Category 0:- No Cracking (Applies to Both Connection Sleeve Couplers and Reducers).

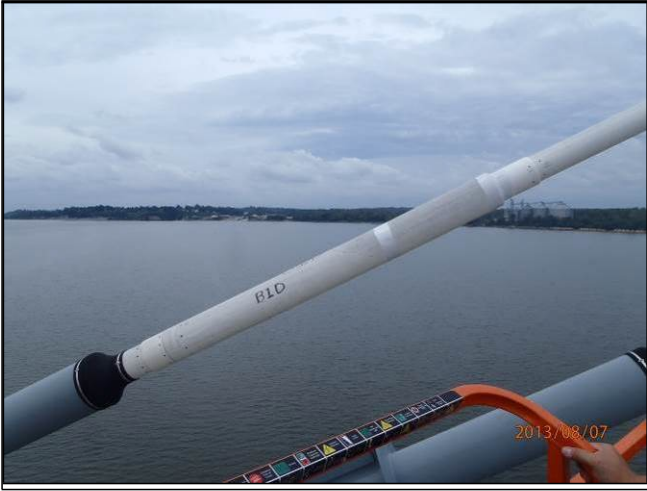
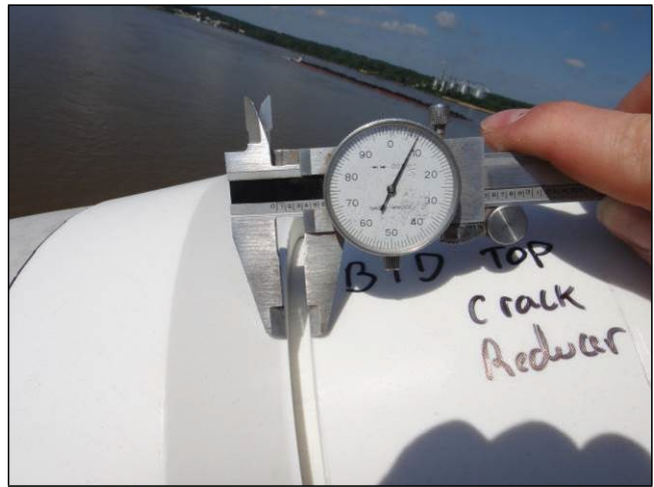
Figure 3: B1D: Reducer Crack at Notch Located at Diameter Transition

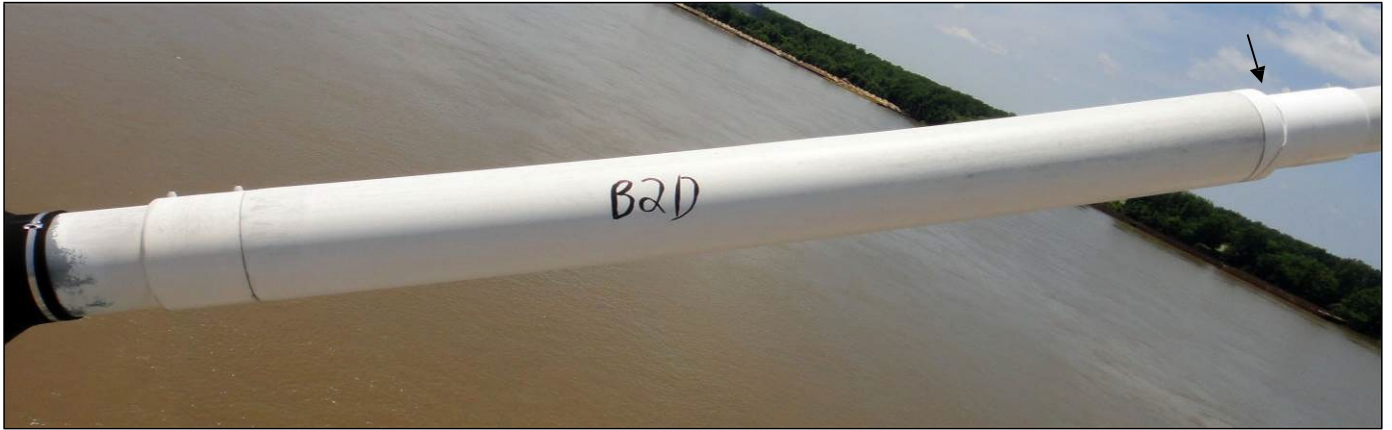
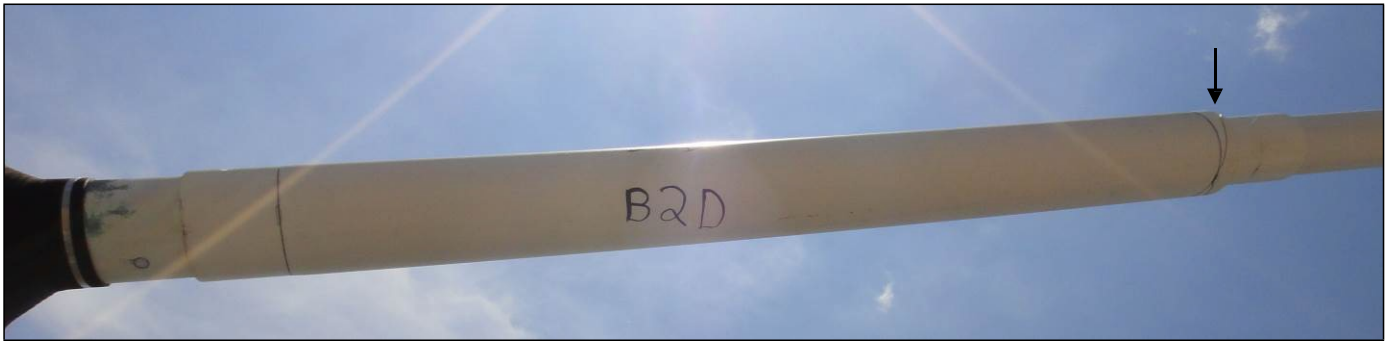
Figure 4: B2D: Reducer Crack at Notch Located at Diameter Transition

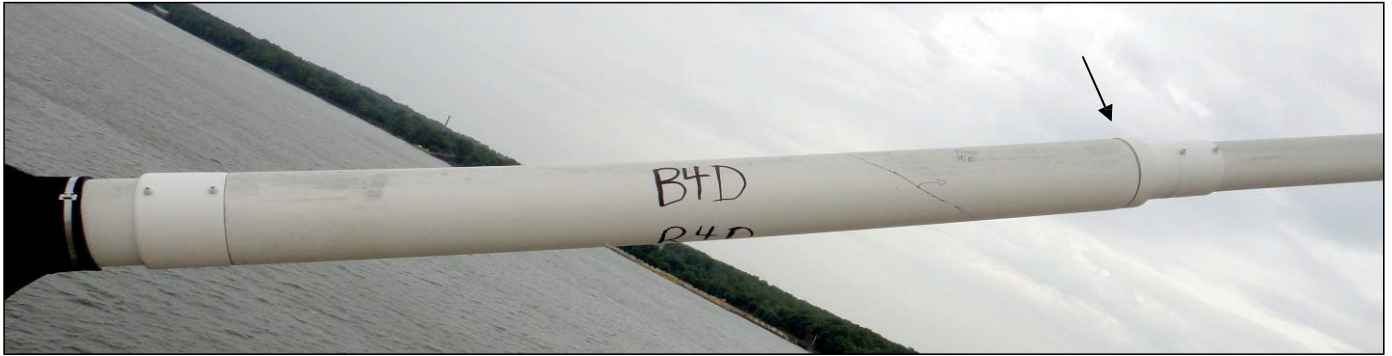
Figure 6: B4D: Reducer Crack Adjacent to Stay Pipe Butt Weld

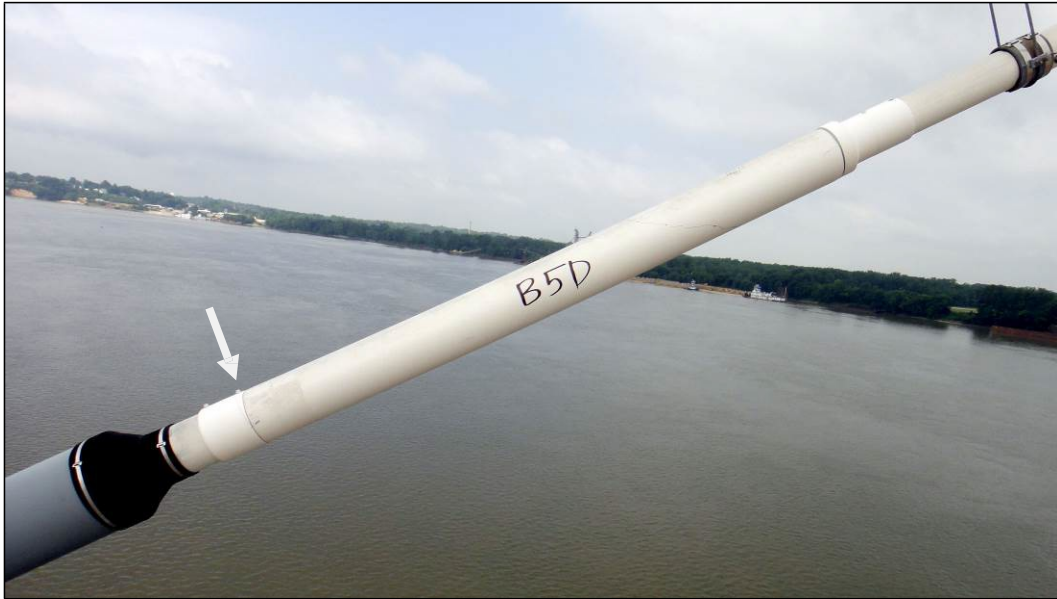
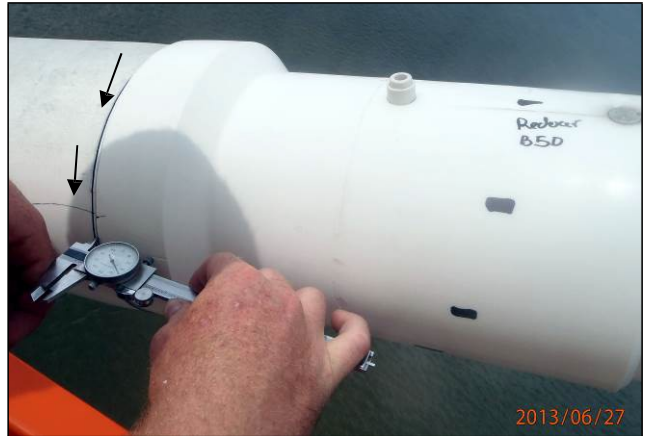
Figure 7: B5D: Reducer Crack Adjacent to Transition Pipe Butt Weld

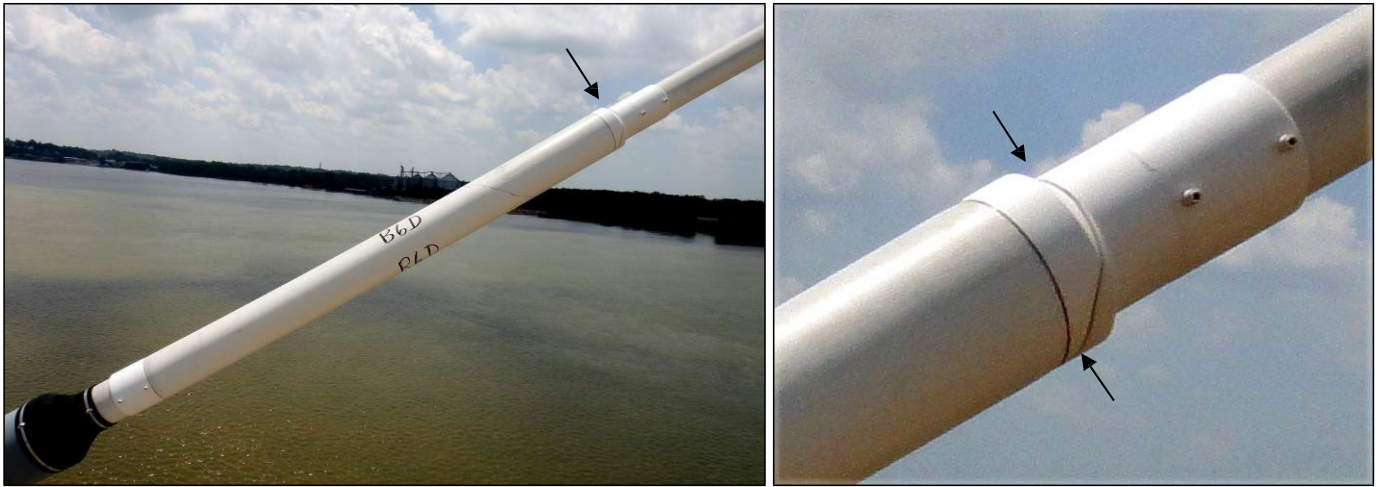
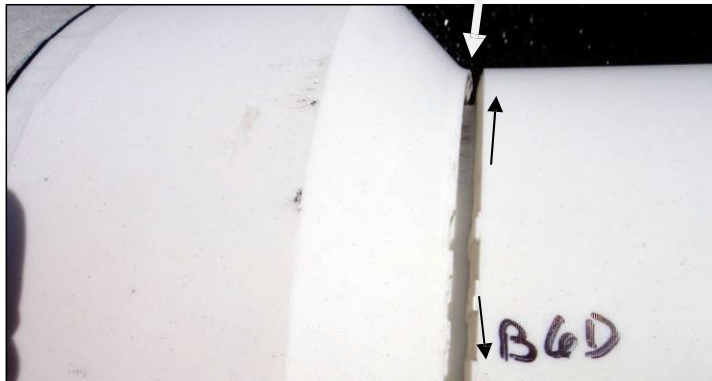
Figure 8: B6D: Reducer Crack at Notch Located at Diameter Transition

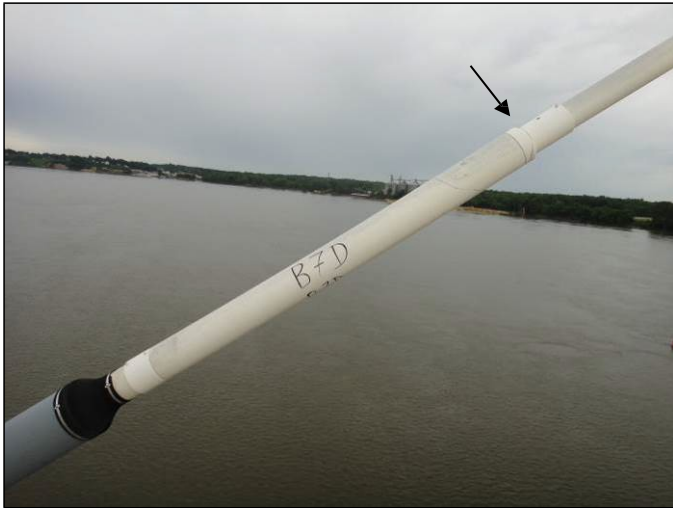
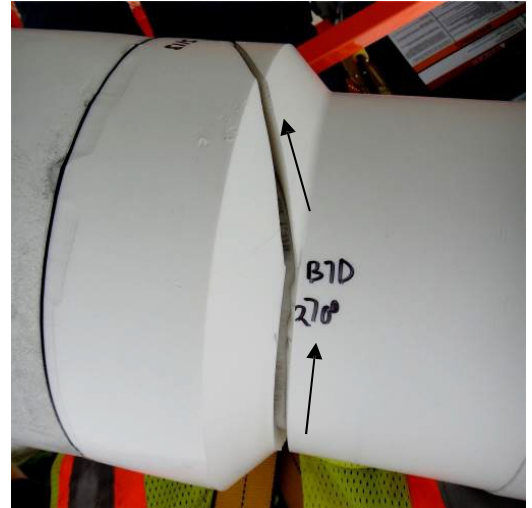
Figure 9: B7D: Reducer Crack at Notch Located at Diameter Transition

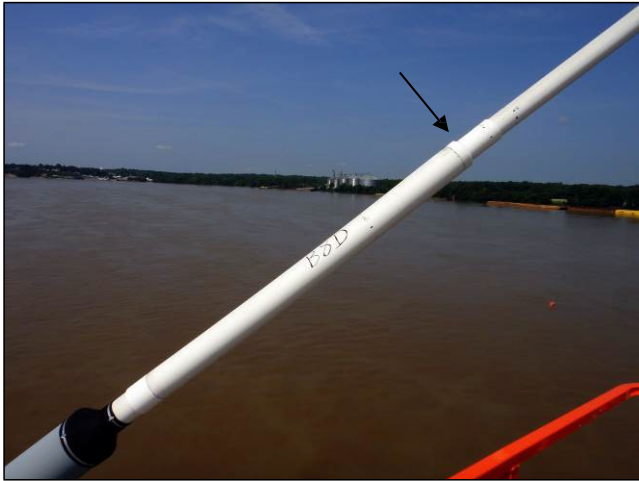
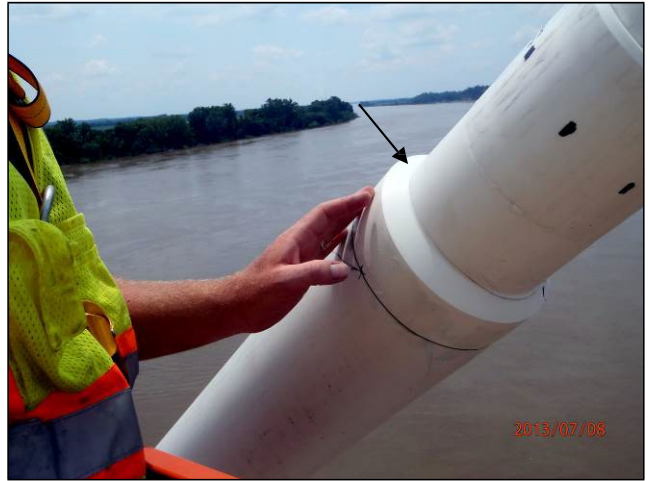
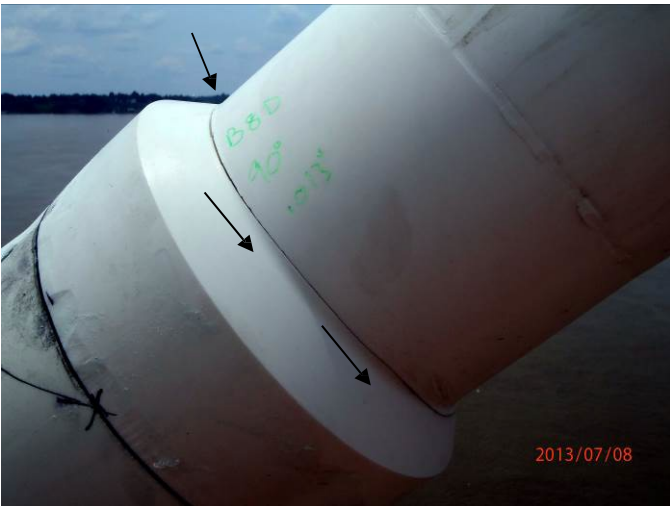
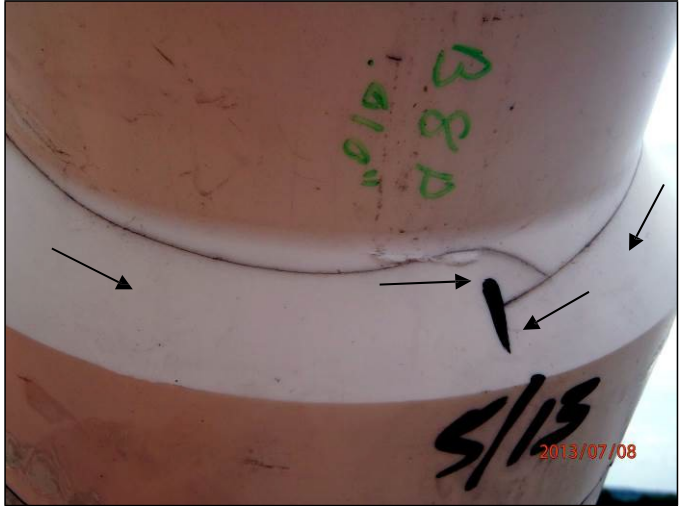
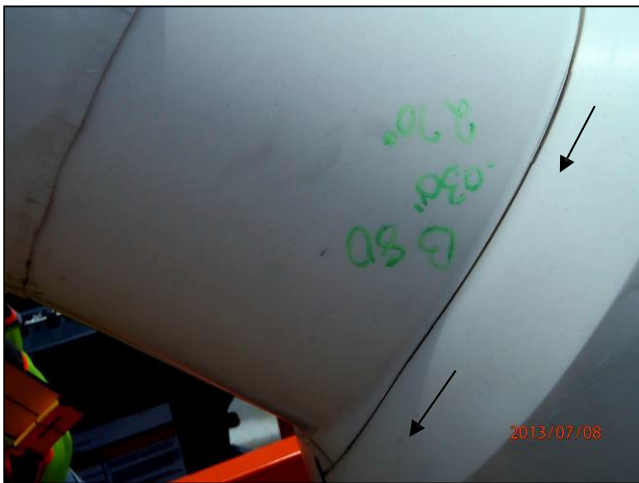
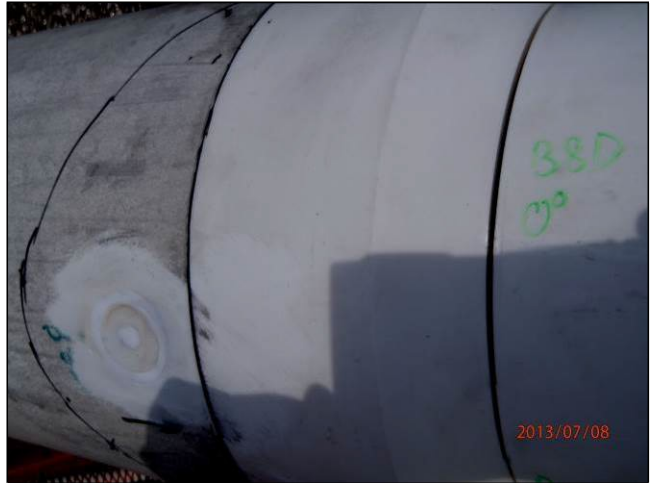
Figure 10: B8D: Reducer Crack at Notch Located at Diameter Transition

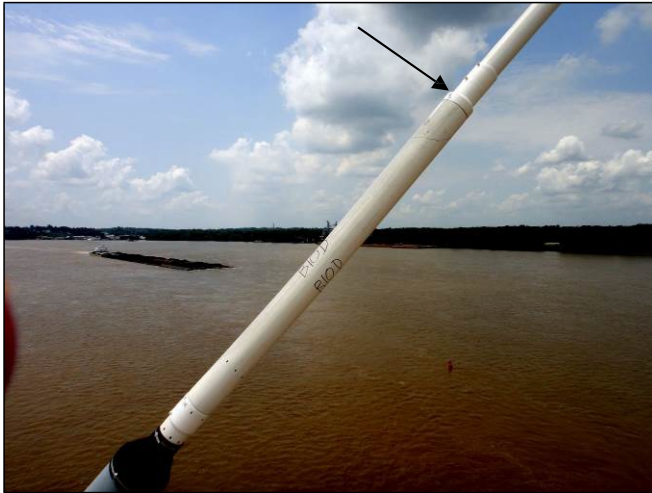
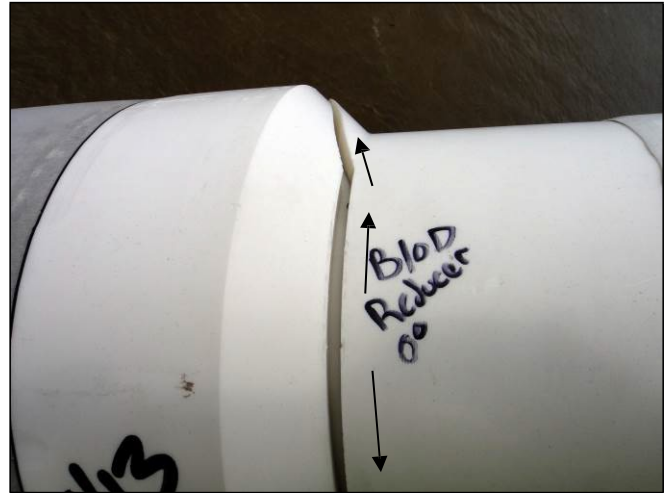
Figure 11: B9D: Reducer Crack at Notch Located at Diameter Transition

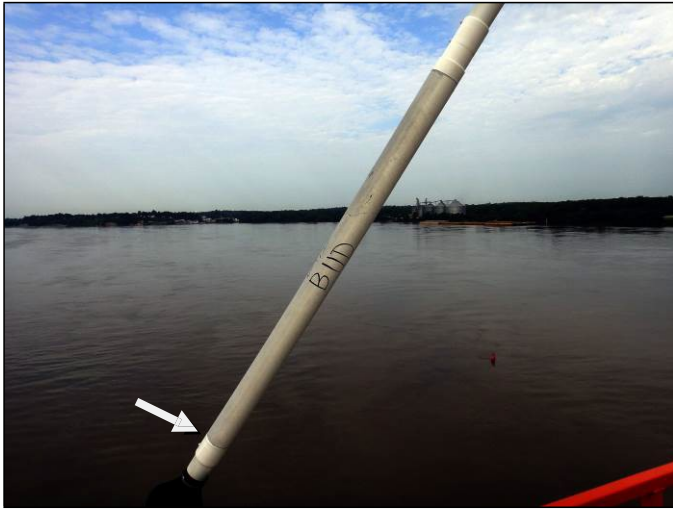
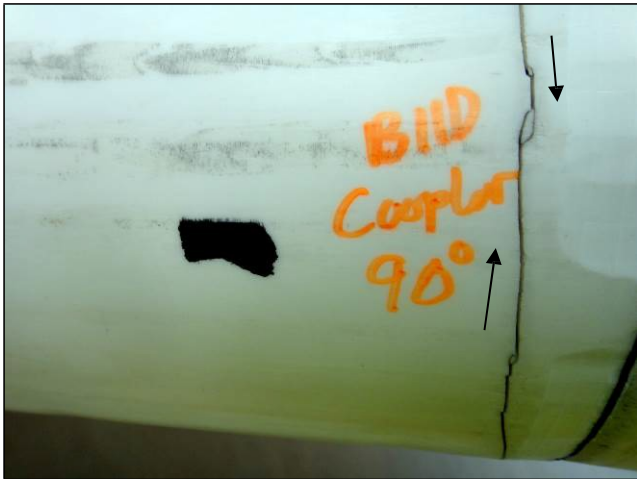
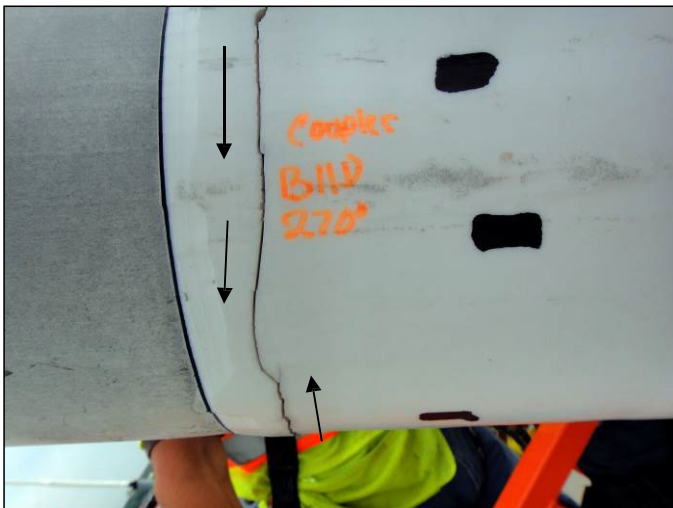
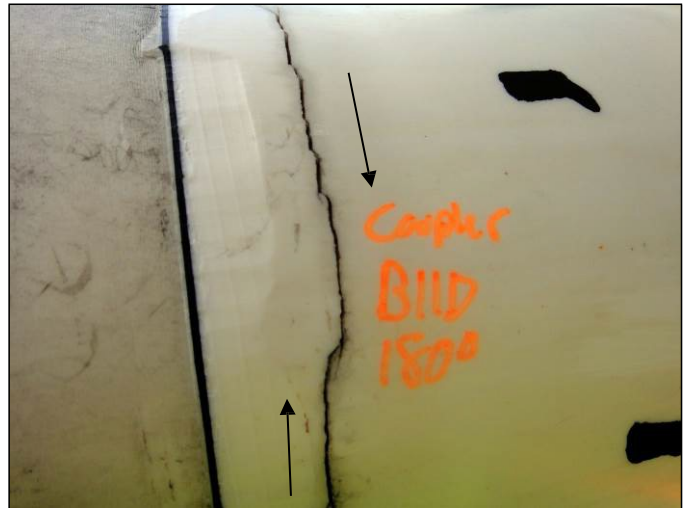
Figure 12: B10D: Reducer Crack at Notch Located at Diameter Transition

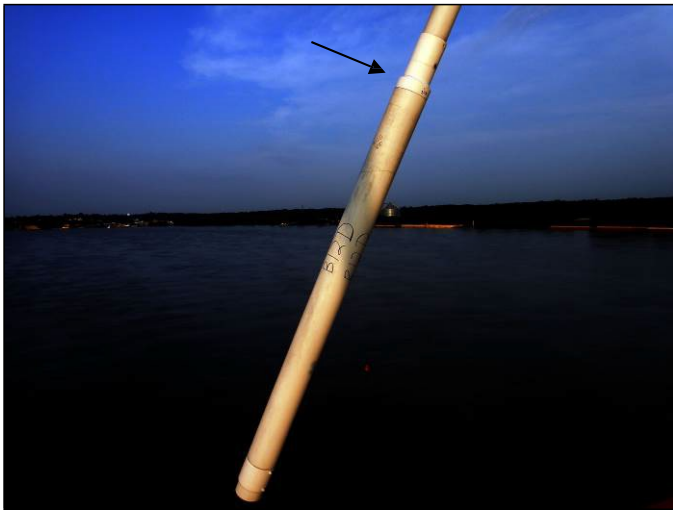
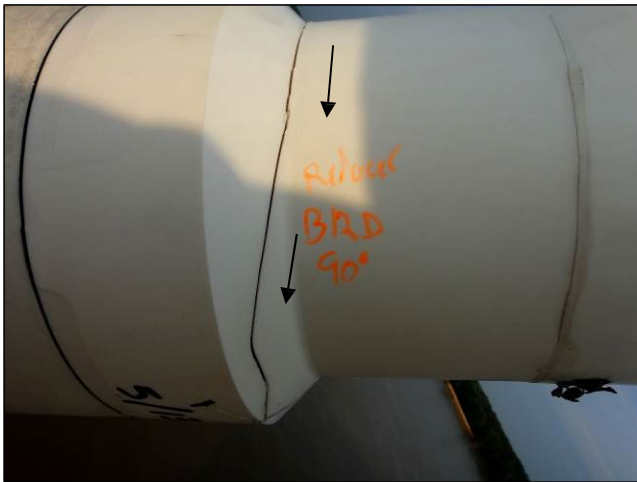
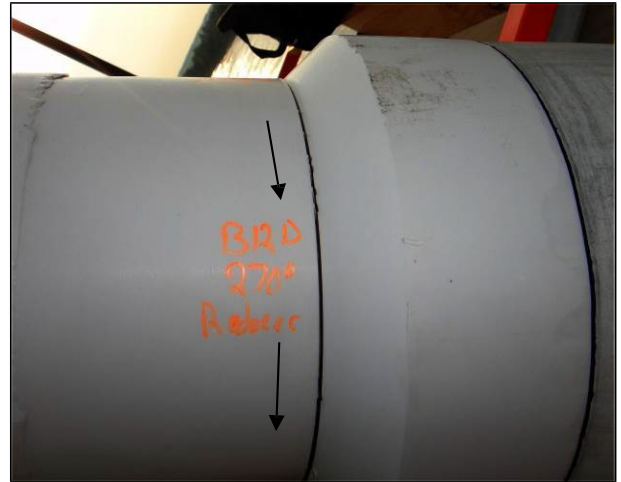
Figure 13: B11D: Reducer Crack at Coupler Hole Used For Electro-Fusion Weld

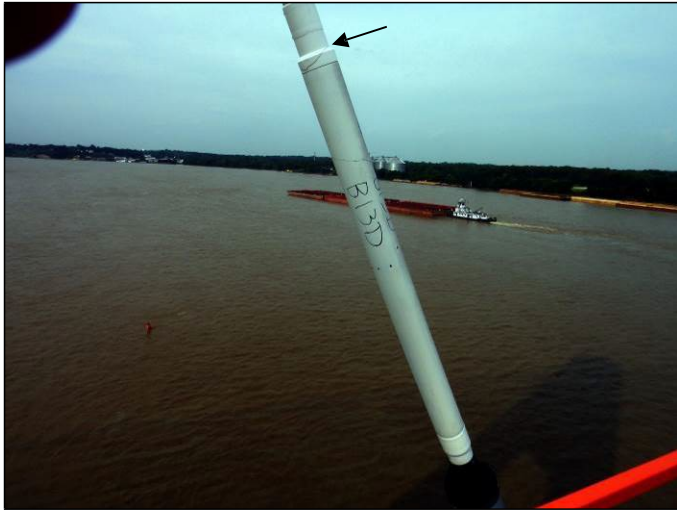
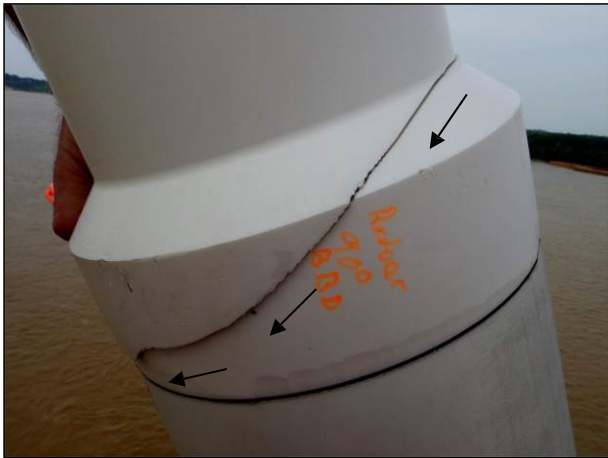
Figure 14: B12D: Reducer Crack at Notch Located at Diameter Transition

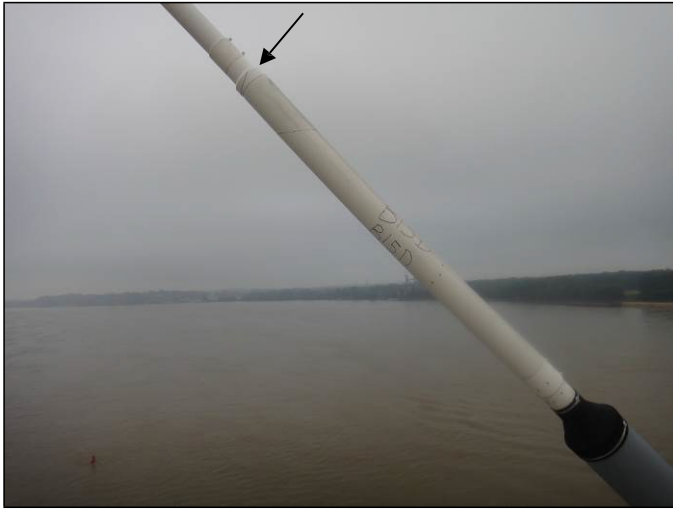
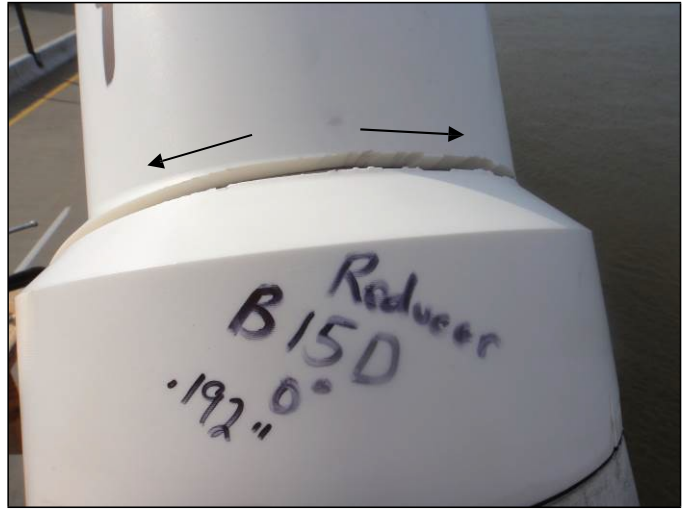
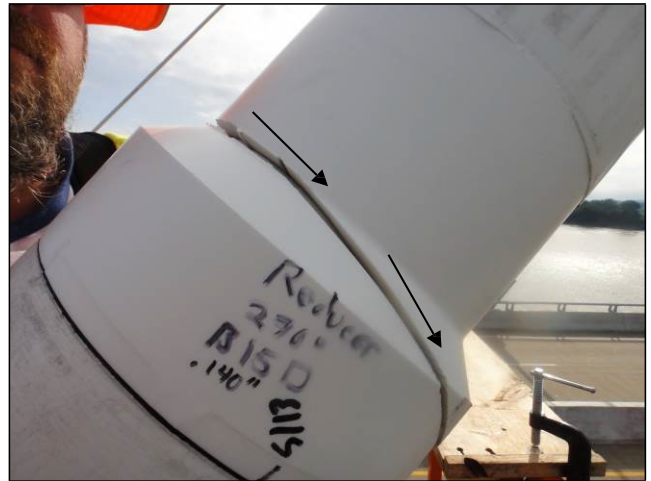
Figure 15: B13D: Reducer Crack at Notch Located at Diameter Transition

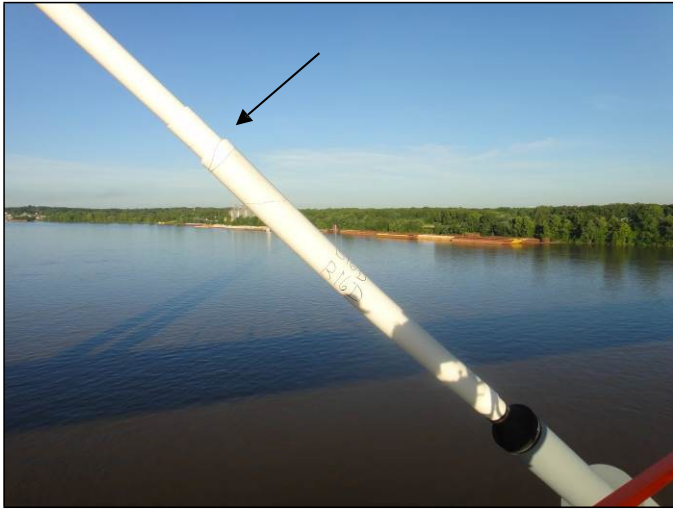
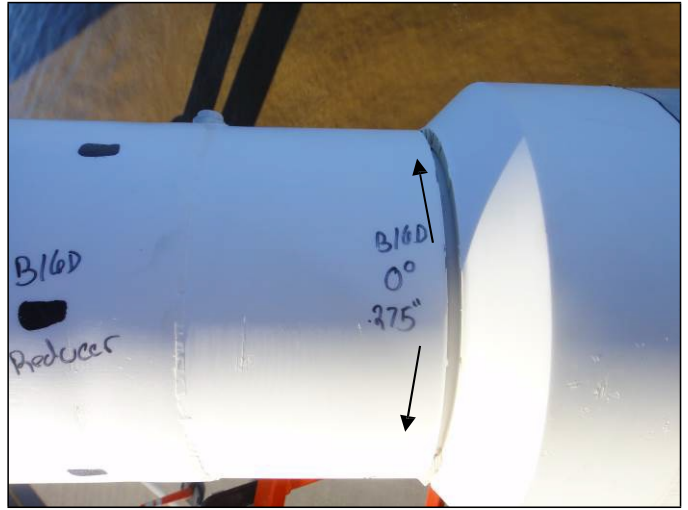
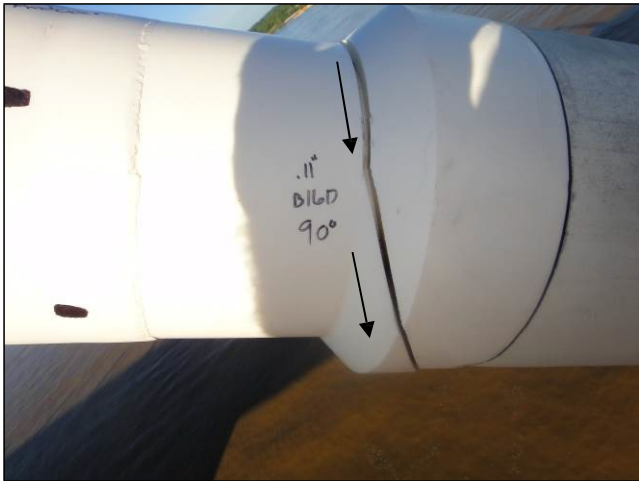
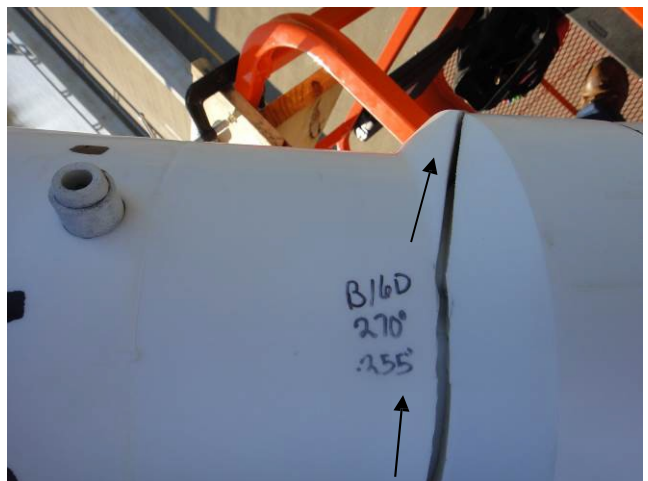
Figure 17: B15D: Reducer Crack at Notch Located at Diameter Transition

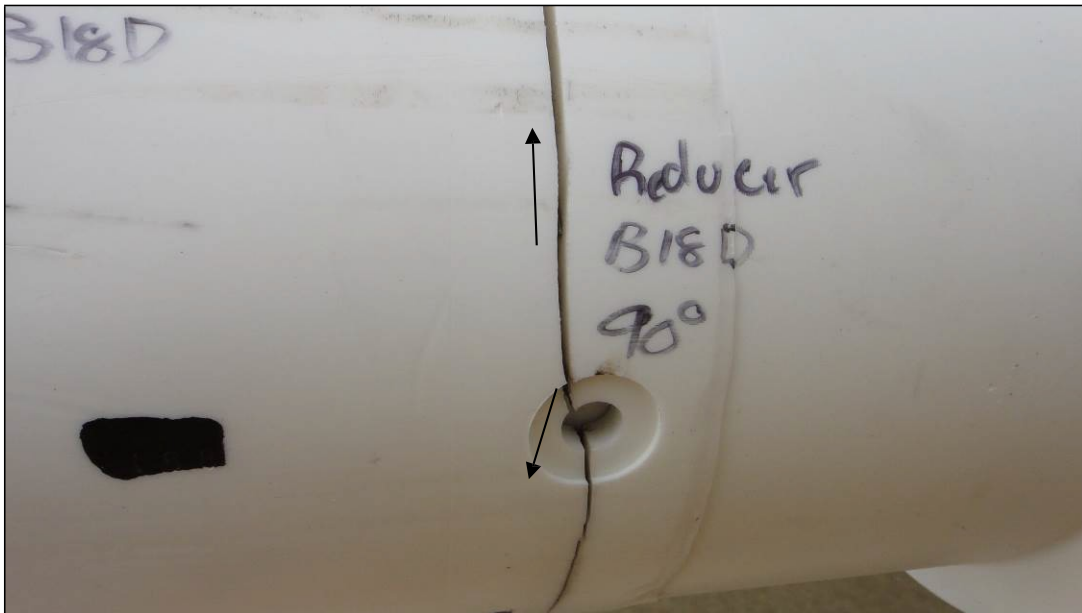
Figure 19: B17D: Reducer Crack at Notch Located at Diameter Transition

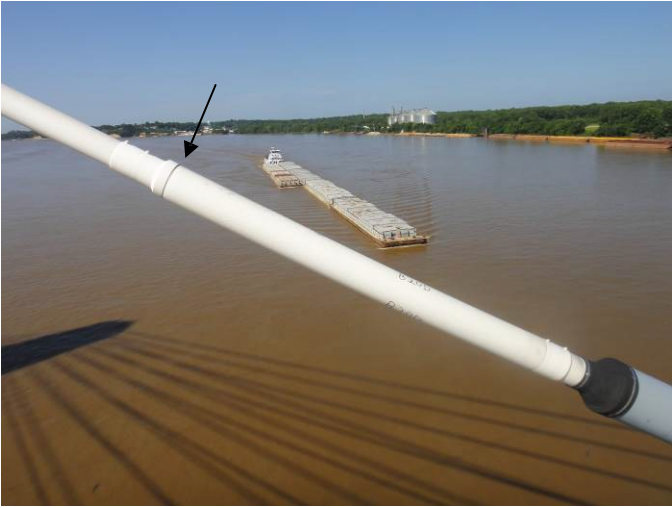
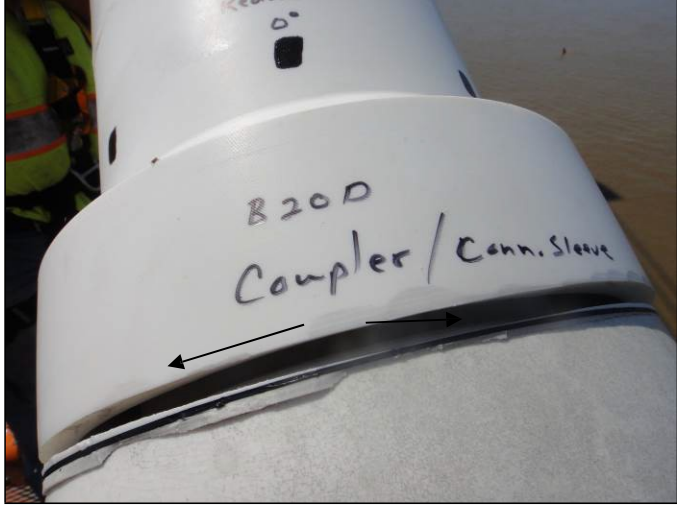
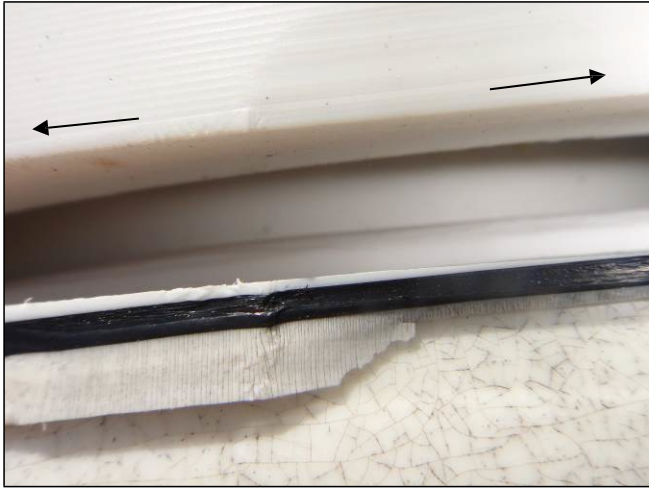
Figure 22: B20D: Reducer Crack at Notch Located at Diameter Transition

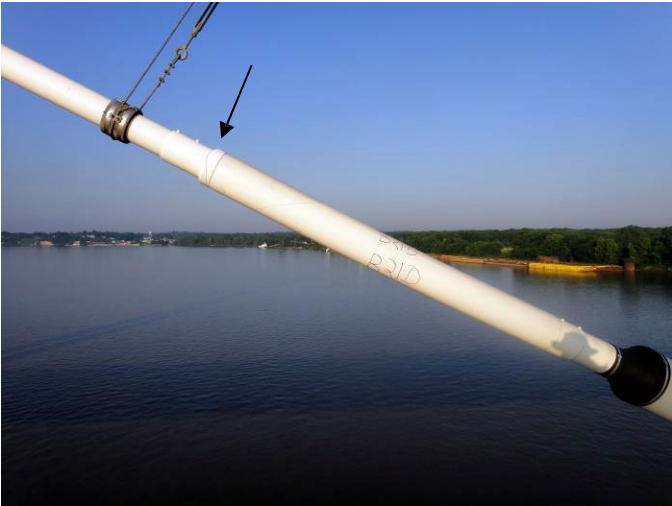
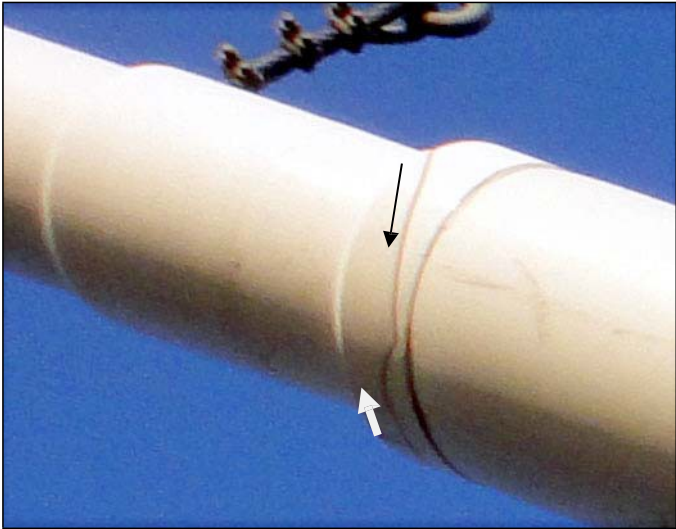
Figure 23: **B21D: Reducer Crack at Notch Located at Diameter Transition**

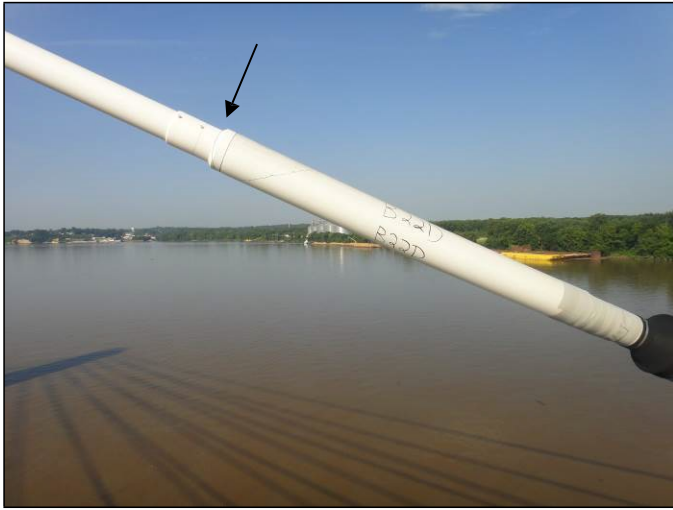
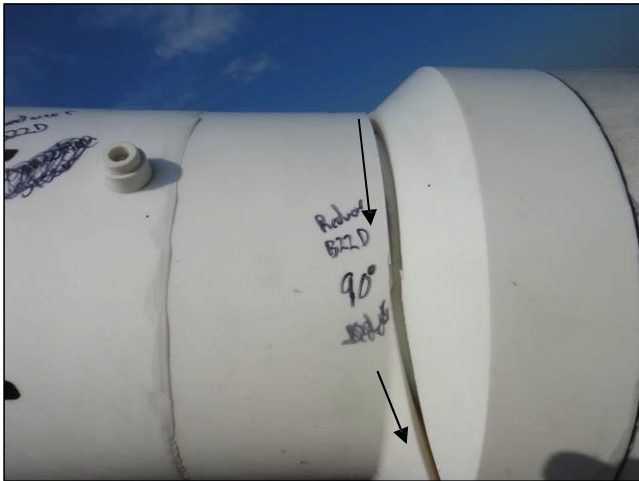
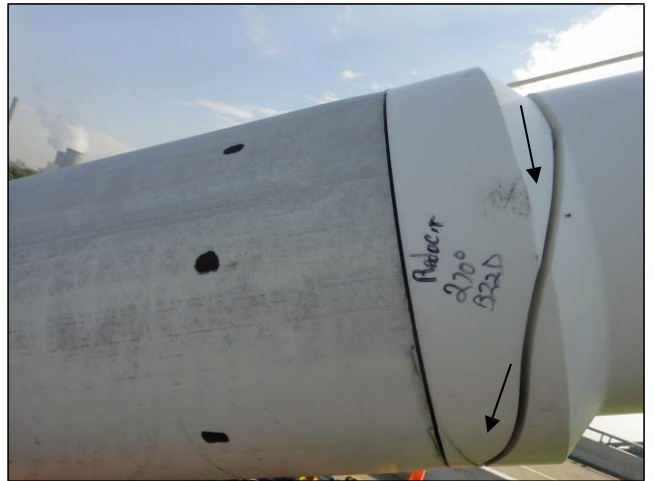
Figure 24: B22D: Reducer Crack at Notch Located at Diameter Transition

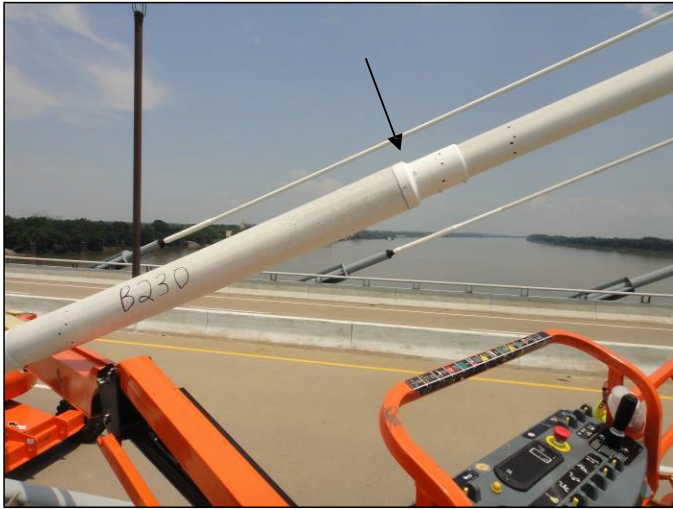
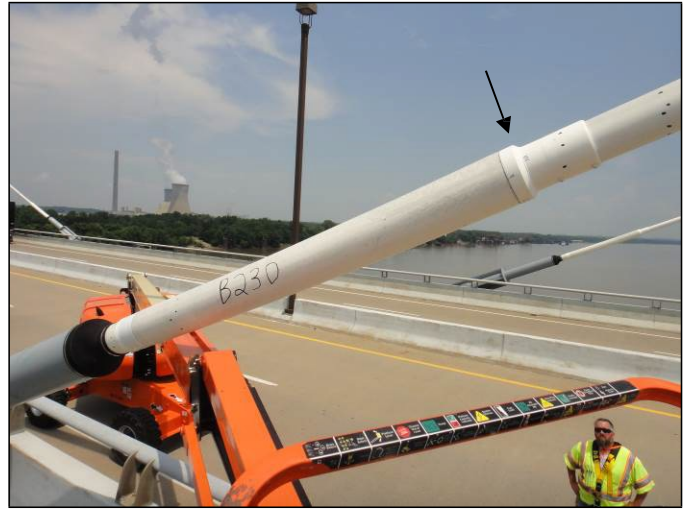
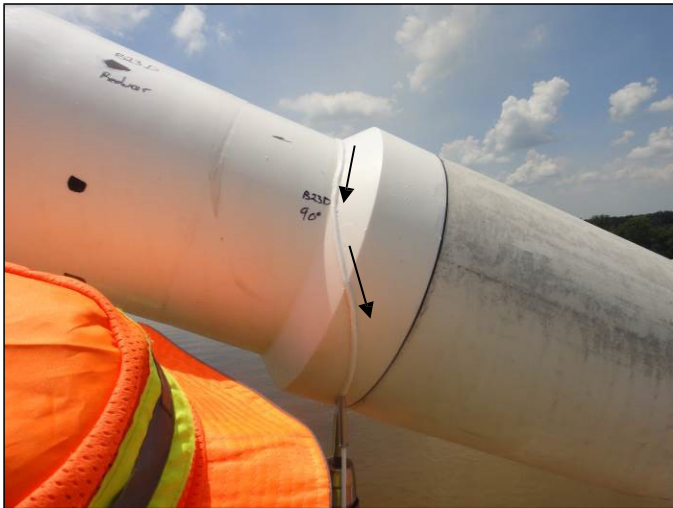
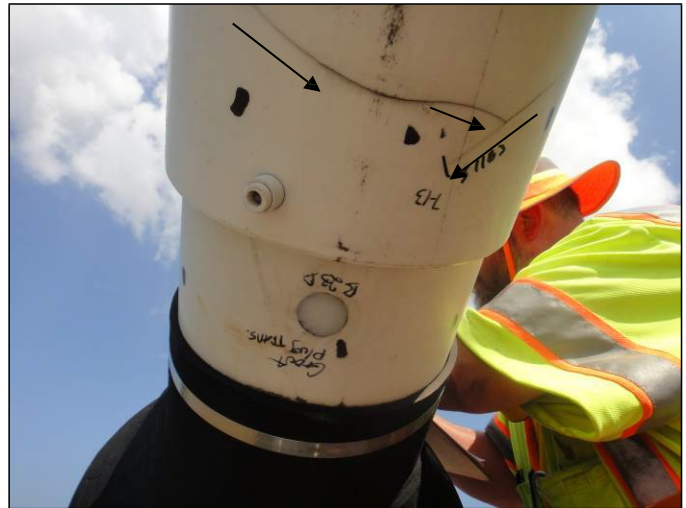
Figure 25: B230D: Reducer Crack at Notch Located at Diameter Transition

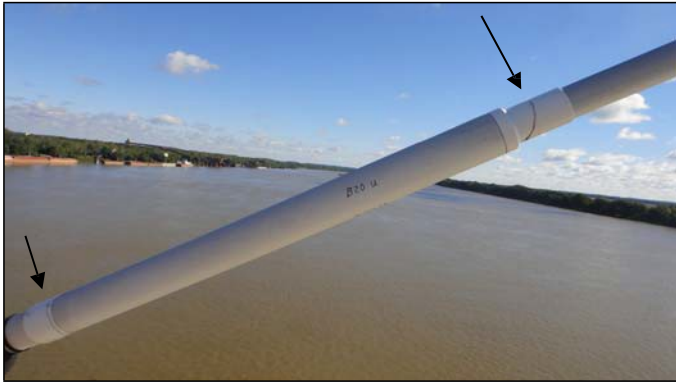
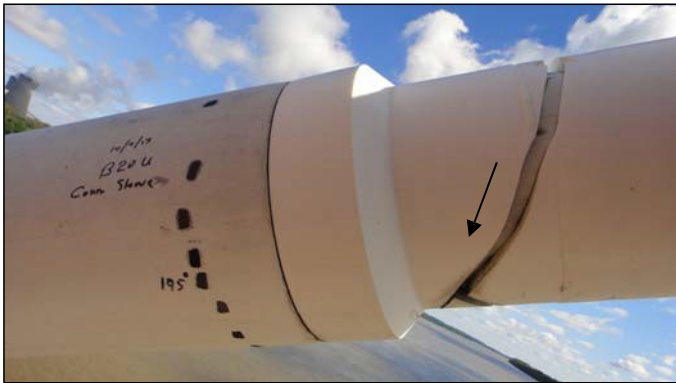
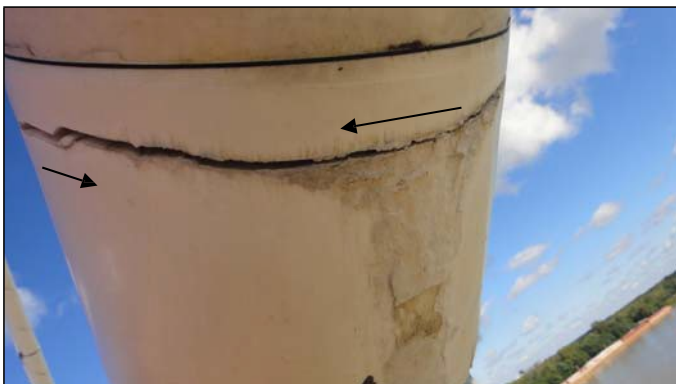
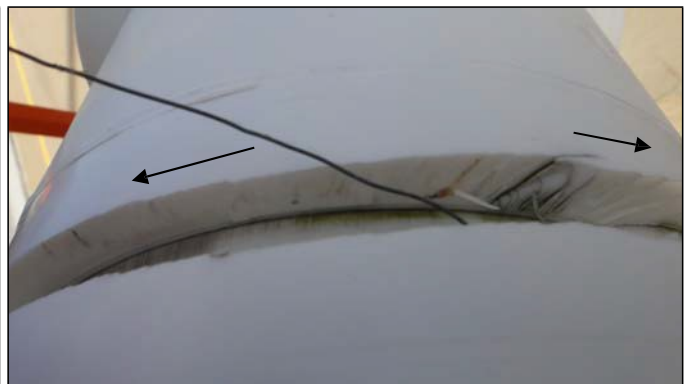
Figure 28: B20U: Top Coupler Crack at Weld Nipple Hole Propagating into and around the Reducer (Top 4 photographs) & Crack at Bottom Coupler (Bottom 2 photographs)

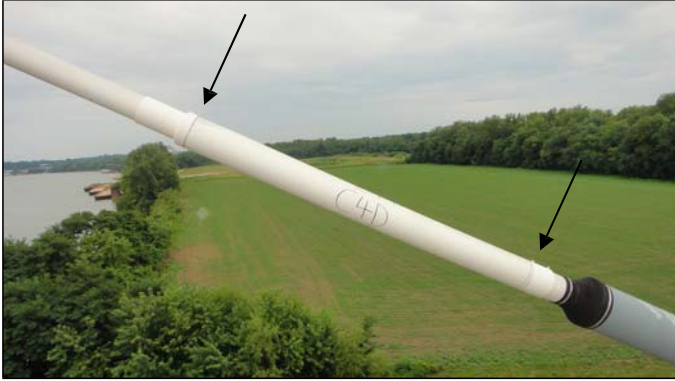
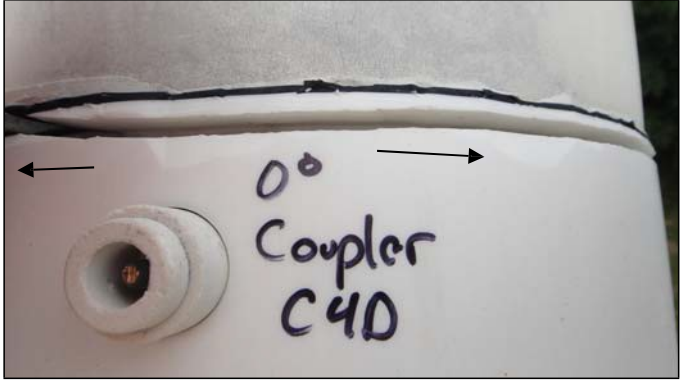
Figure 29: C4D: Bottom Coupler Crack at Butt Weld to Larger Diameter Pipe (4 photographs) & Reducer Crack at Butt Weld to Larger Diameter Pipe (Bottom 2 photographs)

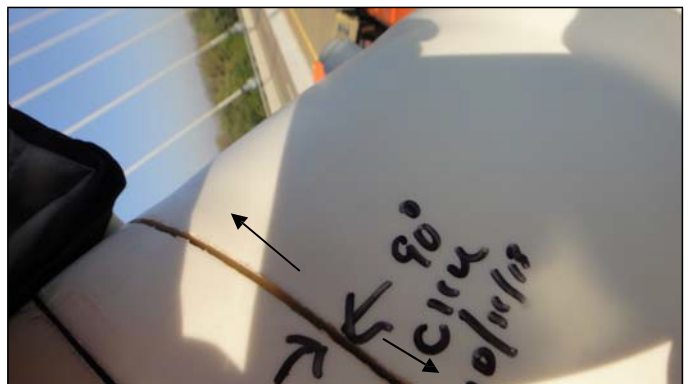
Figure 32: C11U: Bottom Coupler Crack near Butt Weld to the Larger Diameter Pipe Crack Origins at 90° and 270°
