### Cultural site evaluation of Coloma, Montana, 2000

A CULTURAL SITE EVALUATION OF  
COLOMA, MONTANA  
2000

Prepared for Bureau of Land Management  
By Paige Hoskinson

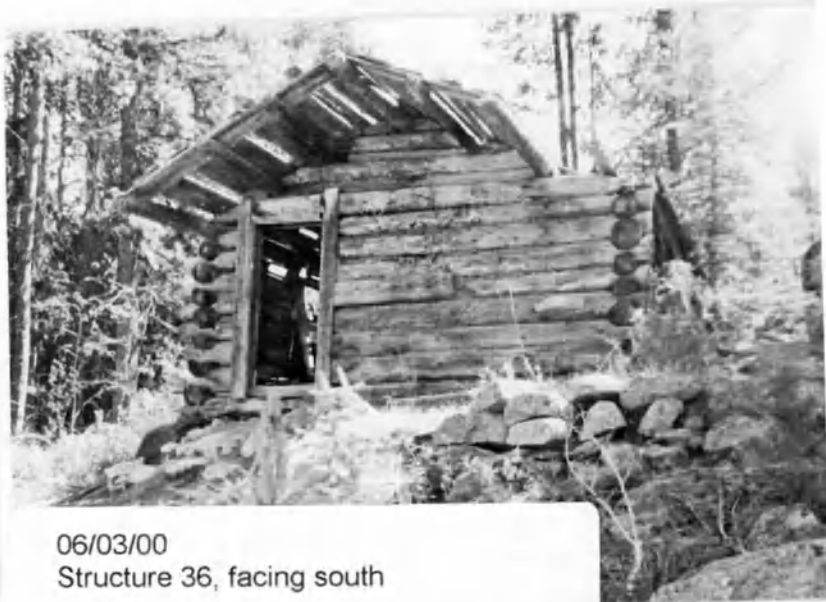
06/03/00  
Structure 36, facing south

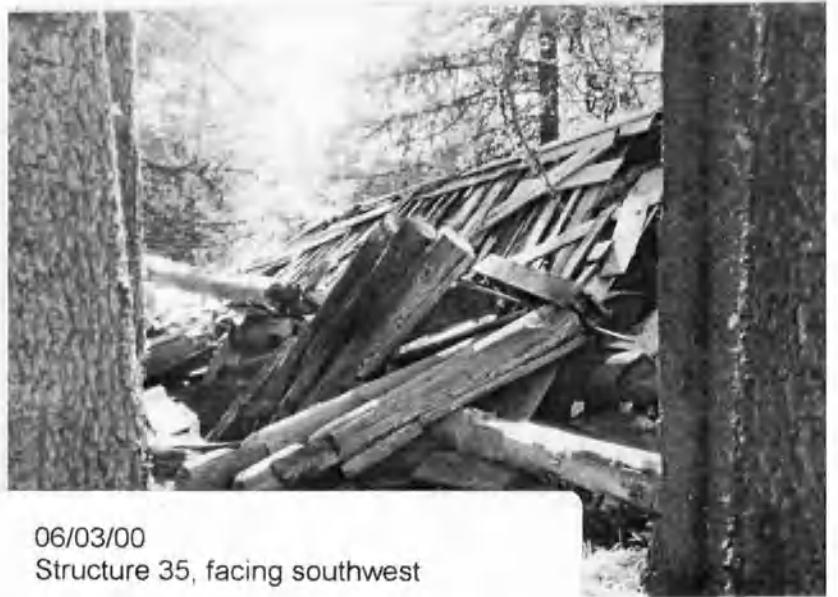
06/03/00  
Structure 35, facing southwest

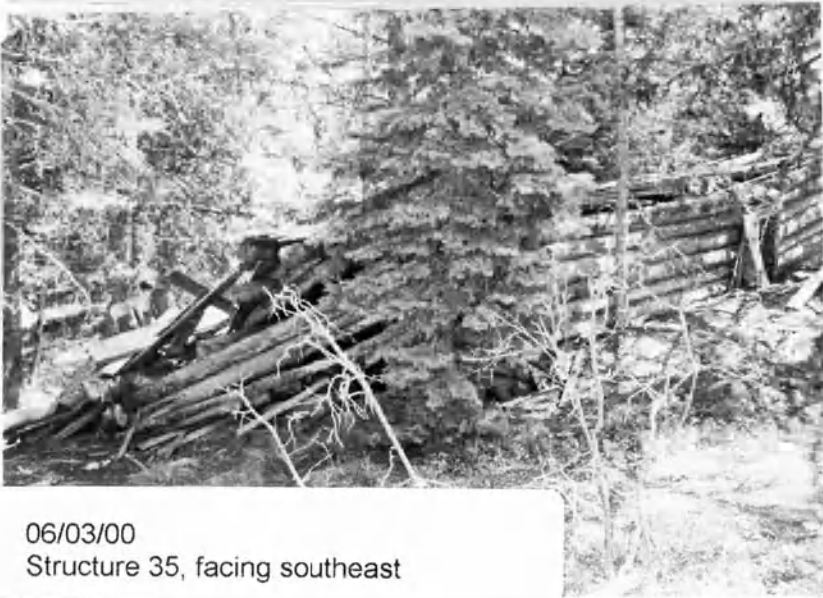
06/03/00  
Structure 35, facing southeast

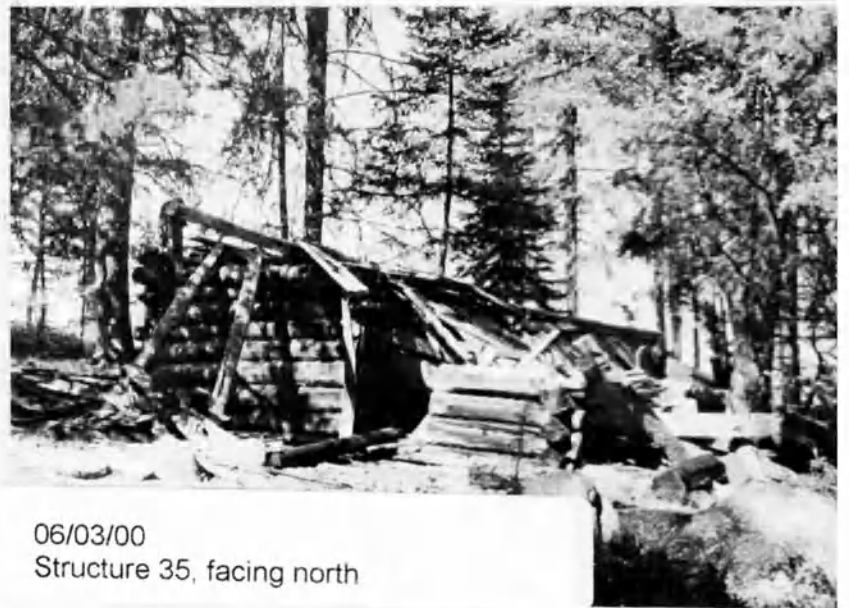
06/03/00  
Structure 35, facing north

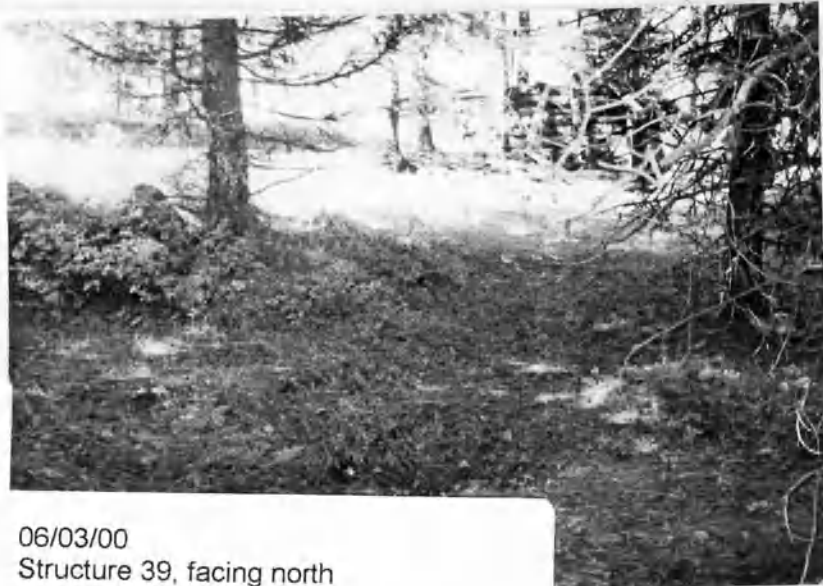
06/03/00  
Structure 39, facing north

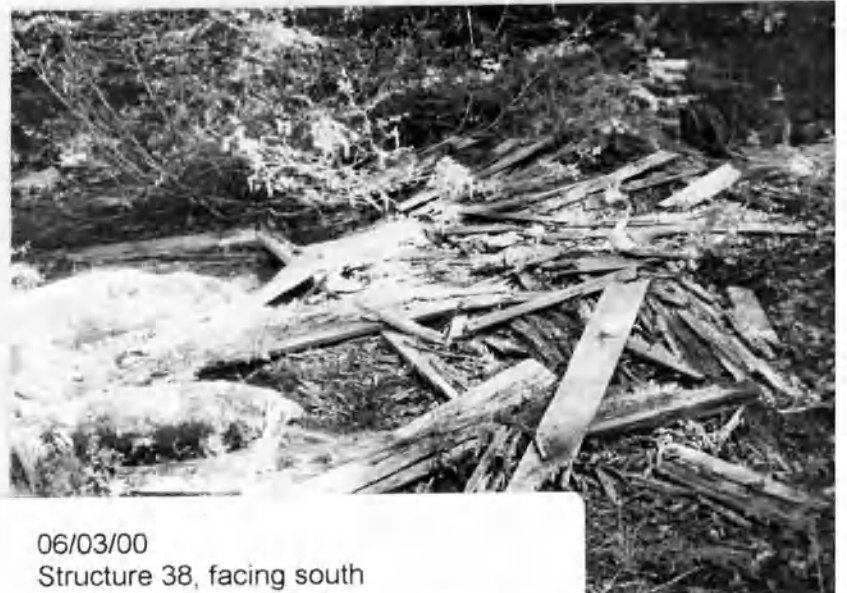
06/03/00  
Structure 38, facing south

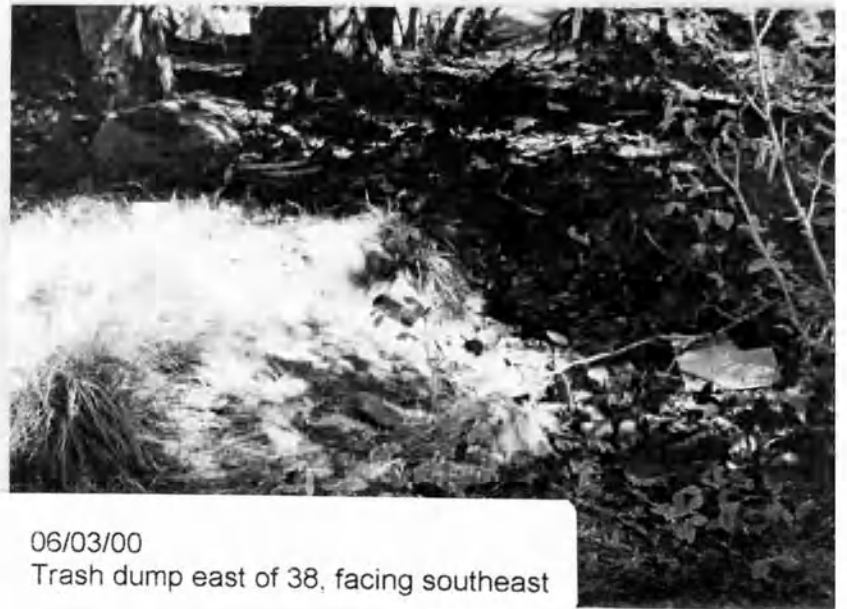
06/03/00  
Trash dump east of 38, facing southeast

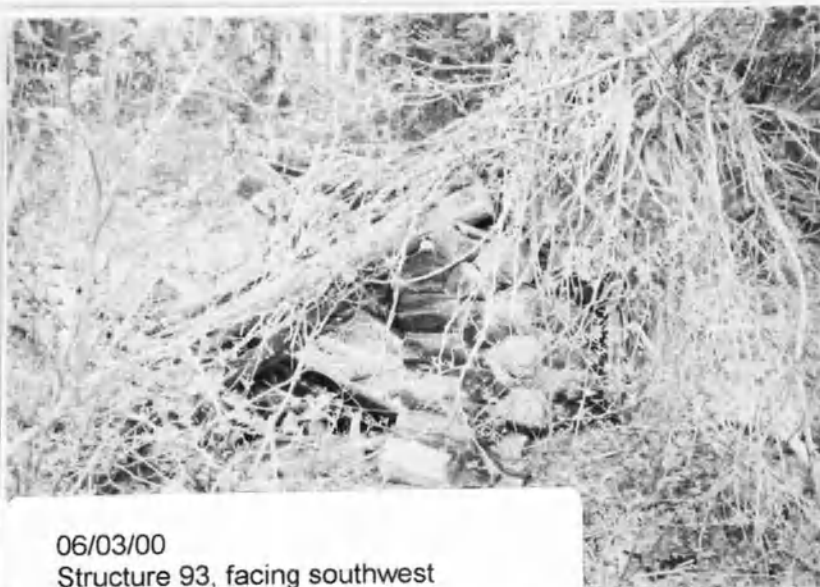
93. Structure 93 is represented by a collapsed log cabin. The stone foundation of the cabin measures approximately 16'x26'. The collapsed gable roof was board on board. The lower portion of the north and east walls indicate an exterior chinking of mortar/mud and quarter pole nailed to log chinking on the interior. The corners are axe and saw cut set in a V-notch. The window and doorway do not appear to be framed. A thin piece of wire is attached to the east wall. Charcoal was found inside the structure as well as numerous round nails.

06/03/00  
Structure 93, facing southwest

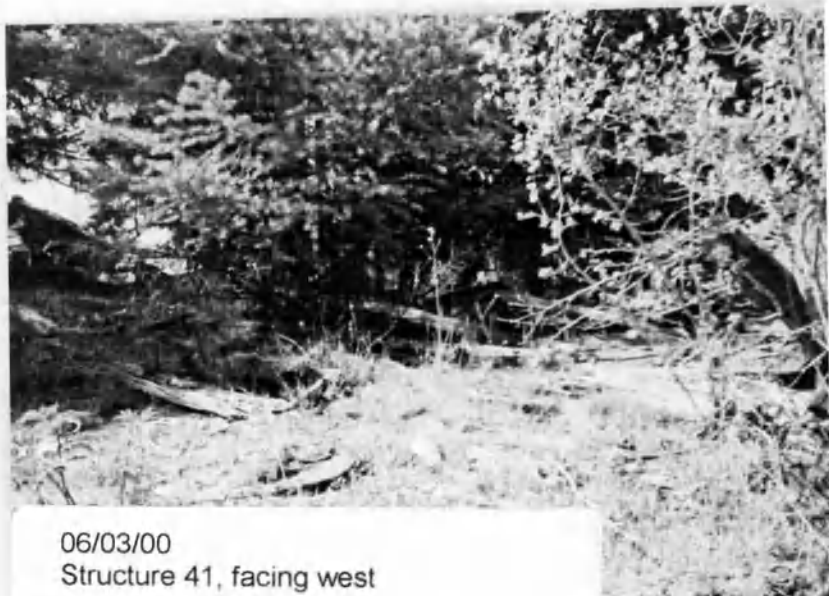
06/03/00  
Structure 41, facing west

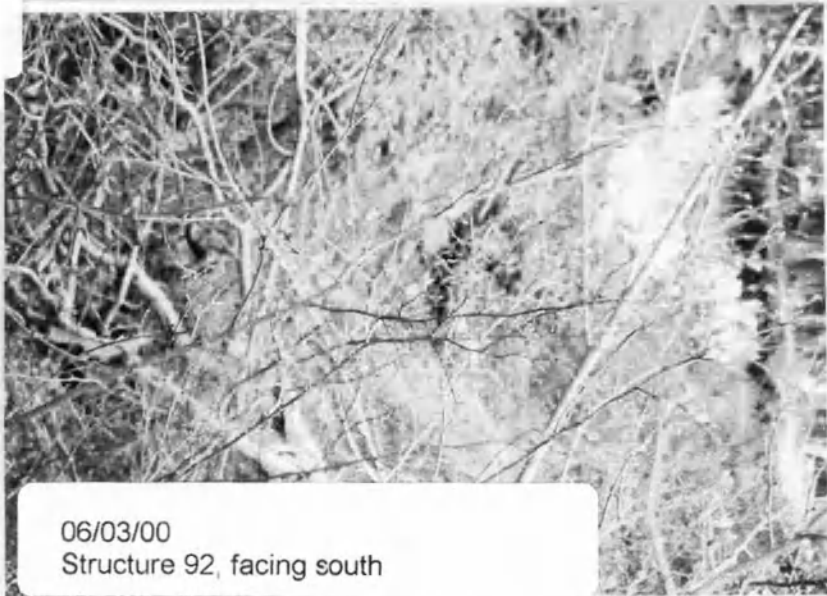
06/03/00  
Structure 92, facing south

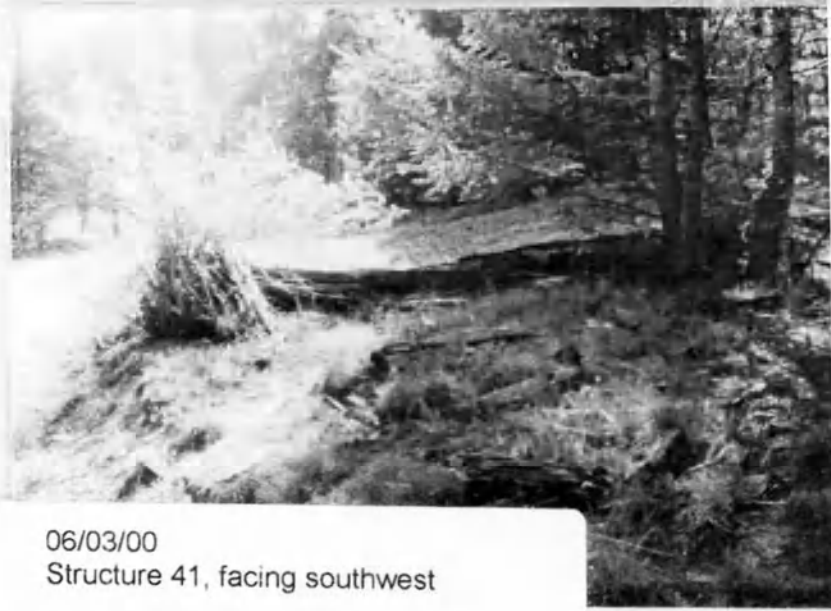
06/03/00  
Structure 41, facing southwest

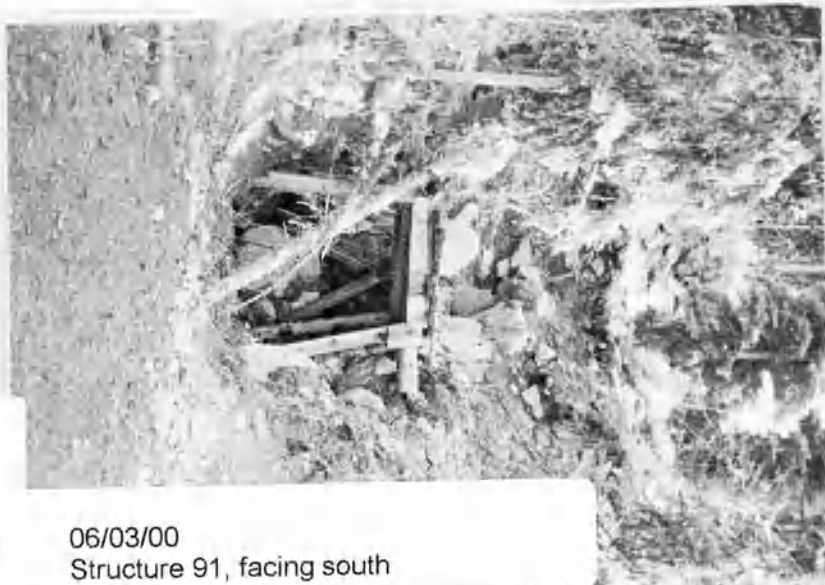
06/03/00  
Structure 91, facing south

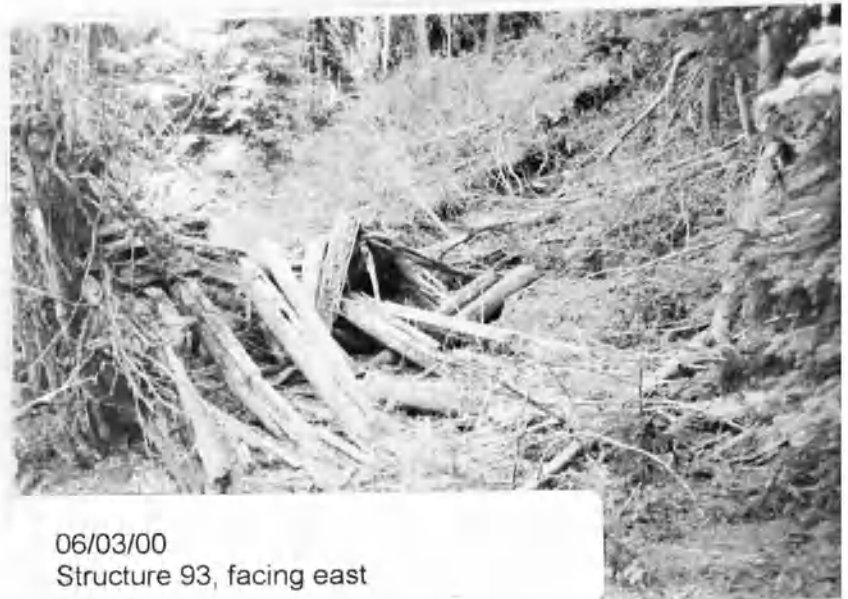
06/03/00  
Structure 93, facing east

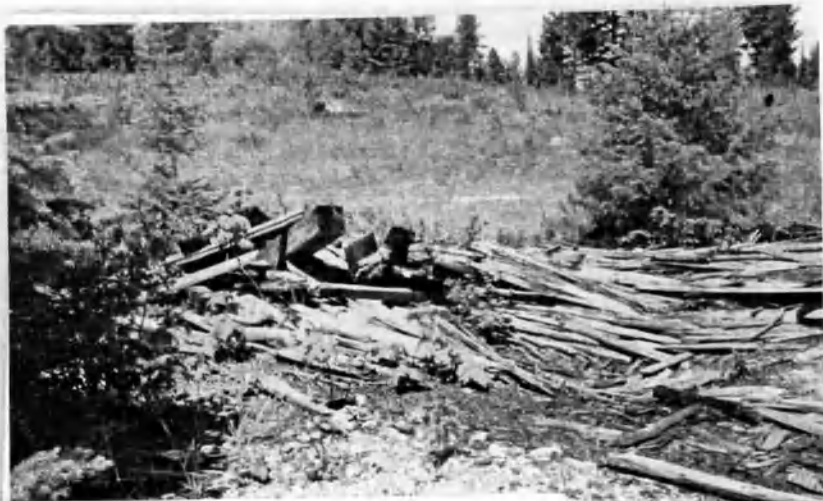
06/24/00  
Structure 28, facing west

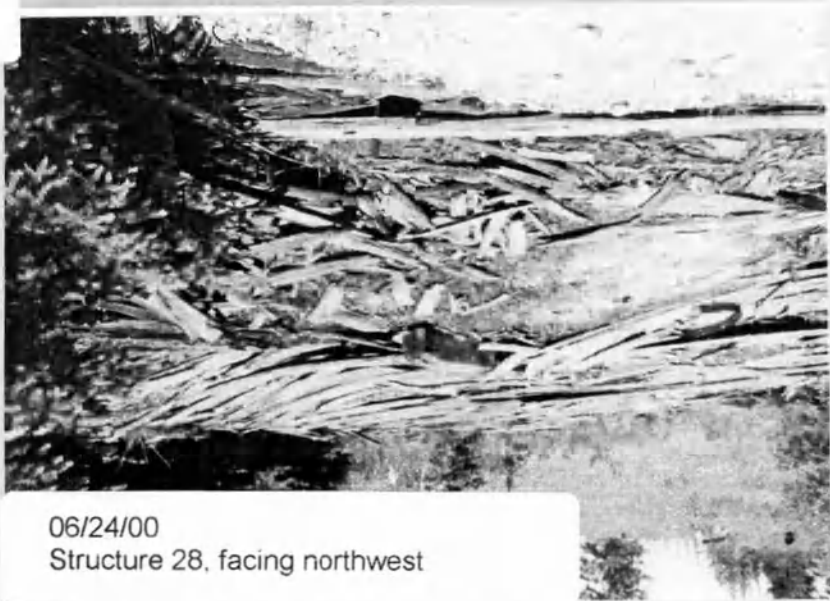
06/24/00  
Structure 28, facing northwest

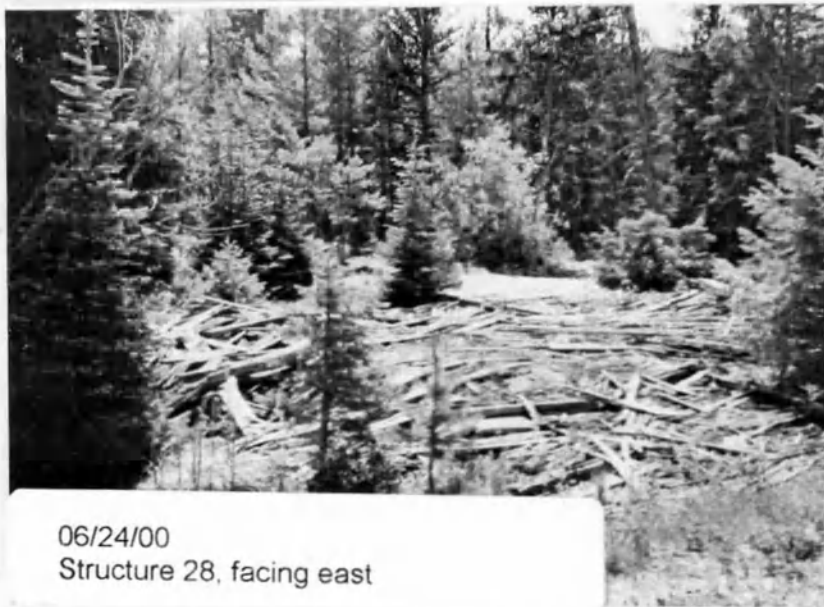
06/24/00  
Structure 28, facing east

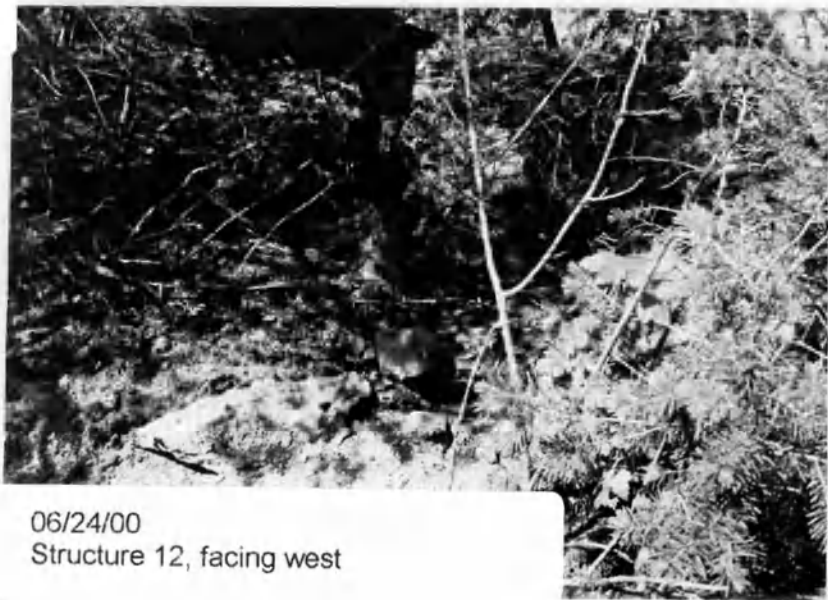
06/24/00  
Structure 12, facing west

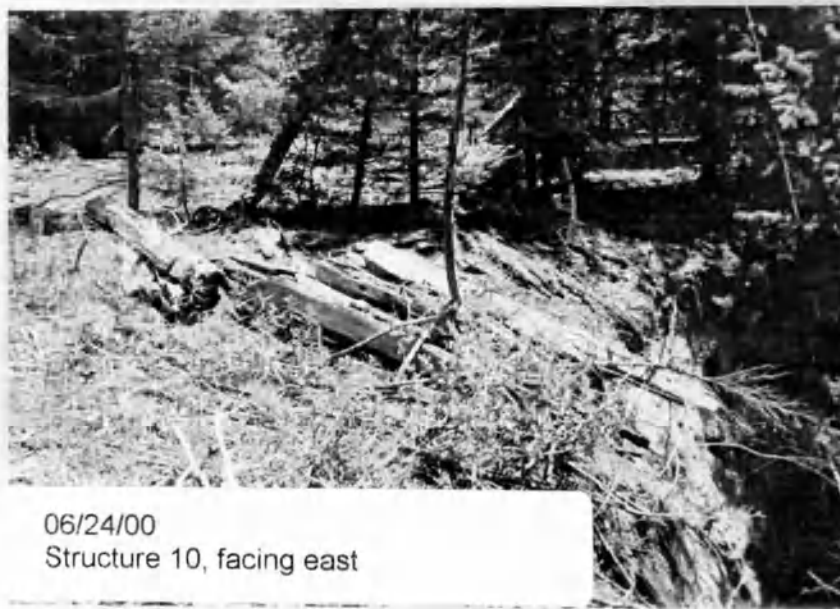
06/24/00  
Structure 10, facing east

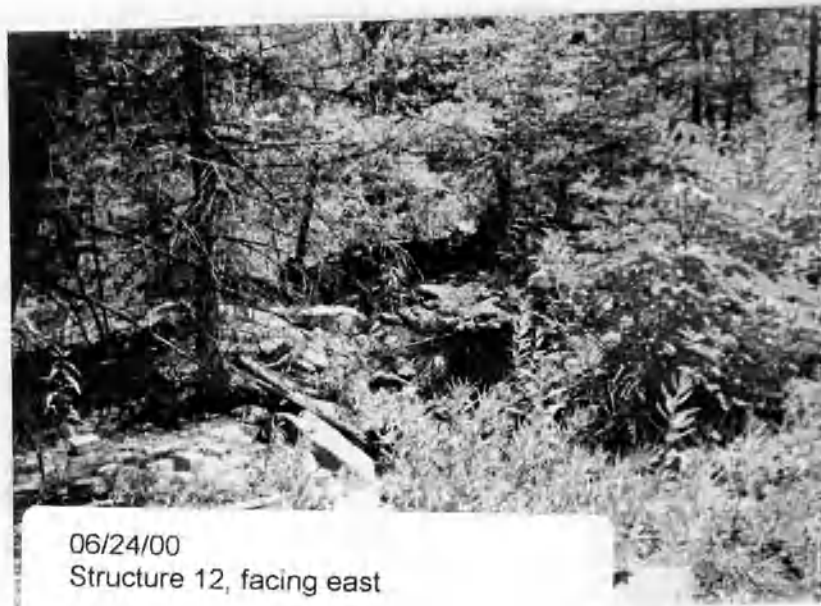
06/24/00  
Structure 12, facing east

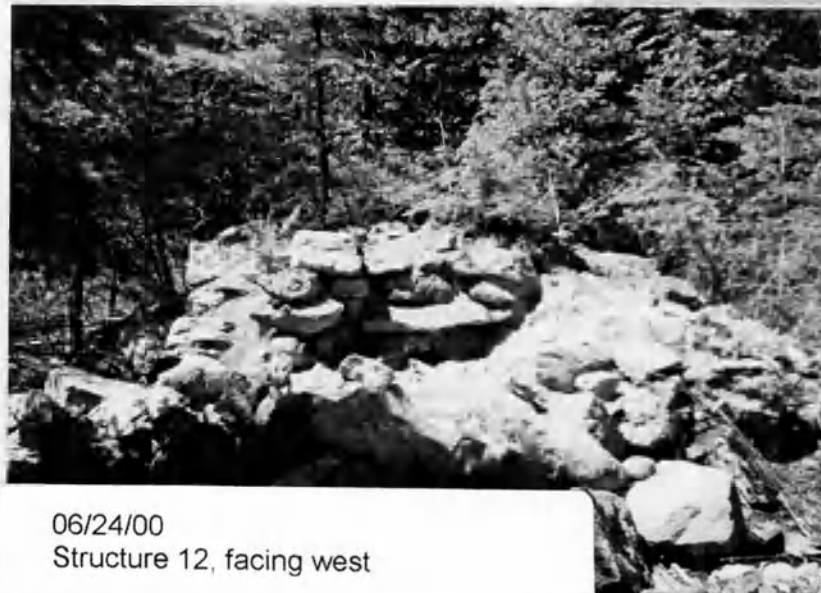
06/24/00  
Structure 12, facing west
