TABLE
BAD RIVER TRIP REPORT
Assessment of Mold and Moisture Conditions

Date:
December 31, 2002

Prepared for:
U.S. Department of Housing & Urban Development
Office of Native American Programs

EXAMINING MOLD AND MOISTURE CONDITIONS OF HOMES ON THE BAD RIVER RESERVATION

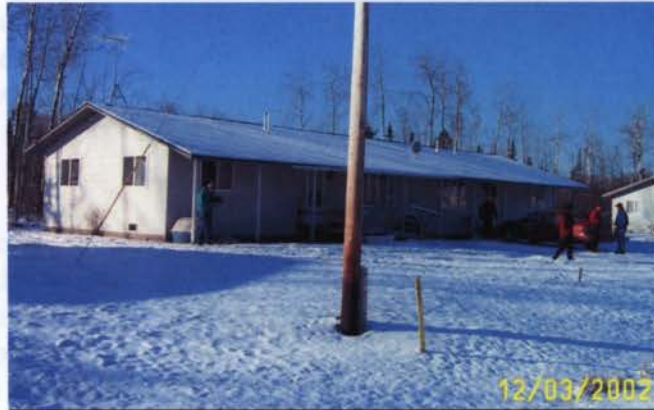
**Figure 1:** 73243 W. Denomie St.**Mold and Moisture Conditions:**

The east apartment in this duplex was suffering from a high moisture load, presumably from an elevated moisture source in the crawl space. Condensation and mold contamination was evident at exterior wall/ceiling junctures and ceilings. Excessive condensation occurred at the windows.

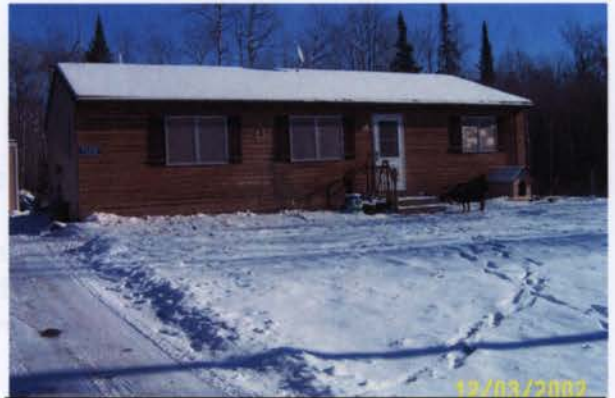
**Figure 1:** 73356 Lemieux Rd.

Mold and Moisture Conditions: There was evidence of water staining at the wall/ceiling junction at exterior walls. The crawl space was very wet, with extensive, mold growth.

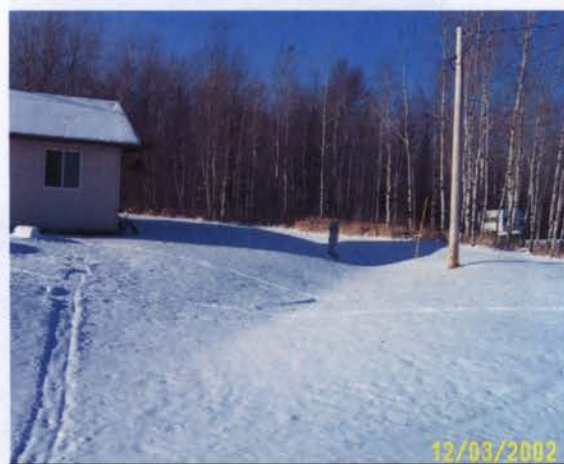
Figure 2: Swale leading to front drainage ditch

1. Install gutters and downspouts. Ideally, downspouts can be placed on the elevation closest to the existing swale and can be discharged into the drain tile that is run to daylight at the swale. Whenever there is an existing grade to move water to daylight away from the foundation, the elimination of leaders at the base of the downspouts removes one of the chronic maintenance problems of roof drainage systems.
2. Ensure that the footing drains are clear and providing the optimum pressure relief from hydraulic pressure at the foundation.
3. Seal cracks between basement slab and concrete block walls.

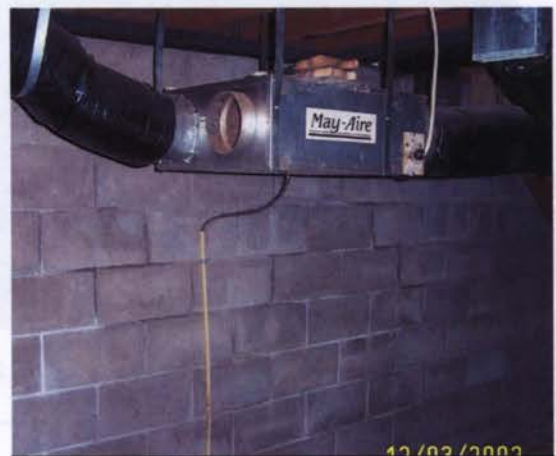
Figure 5: Heat Recovery Ventilation System

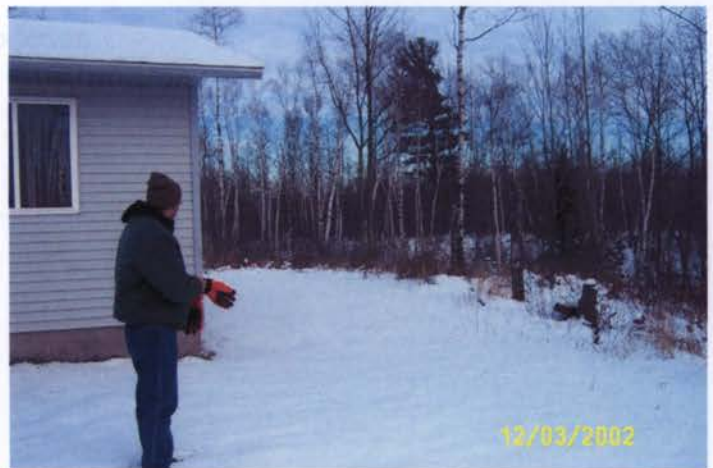
Figure 2: Hillside location, possible outlet for roof drainage system.

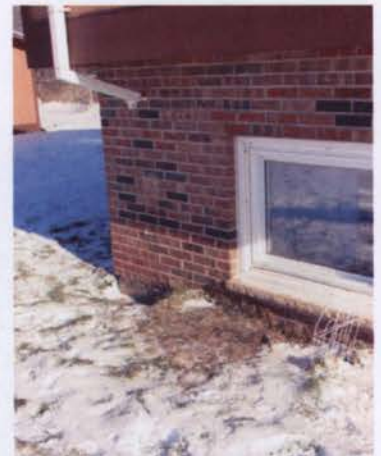
Figure 2 - Compromised Downspout

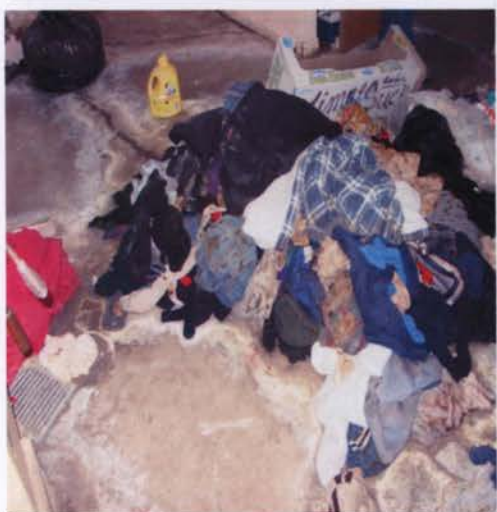
Figure 3- Former resident belongings
