### Humboldt Bay Independent Spent Fuel Storage Installation: Site-Specific License Renewal Application

Humboldt Bay  
Independent Spent Fuel Storage Installation  
**Site-Specific License Renewal Application**

Pacific Gas and Electric Company

Revision 0 July 2018  
NRC Docket No. 72-27

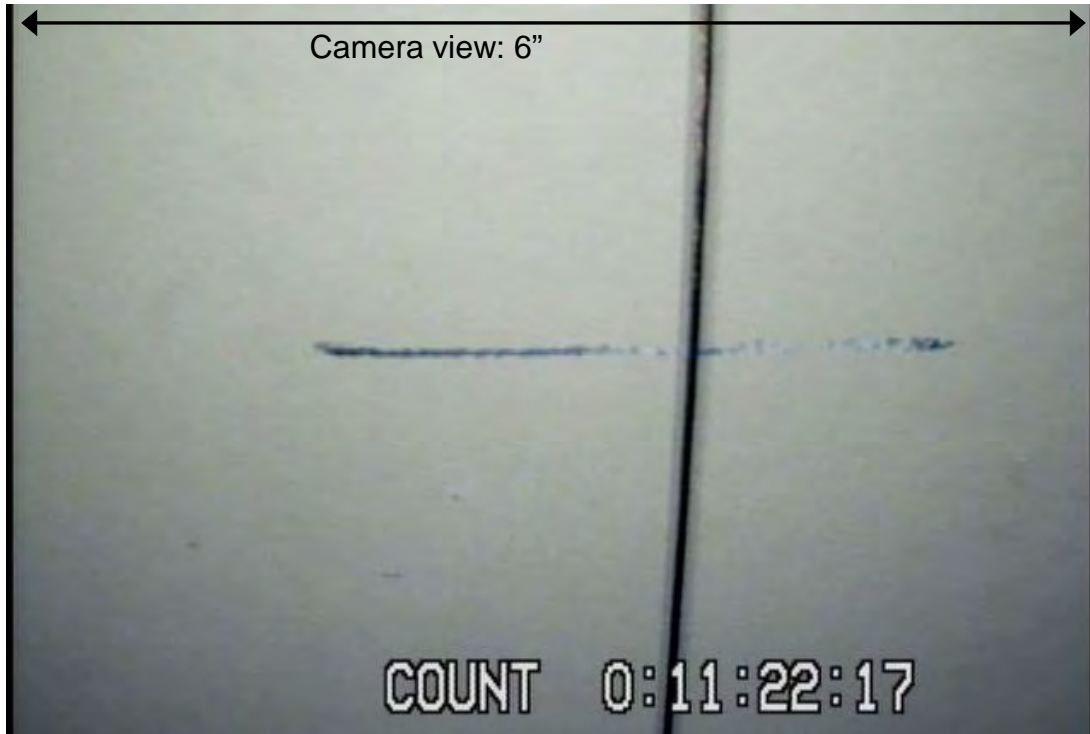
34. Scan 42 coating scrape

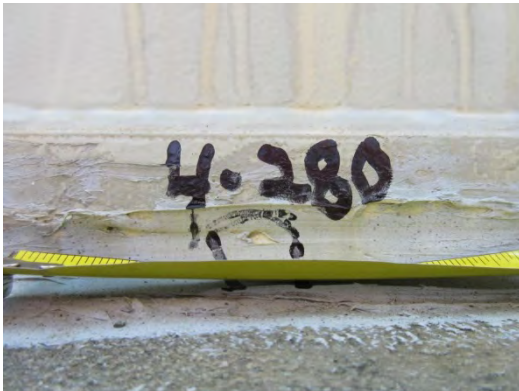
5. Cell 4 Caulking As-Found

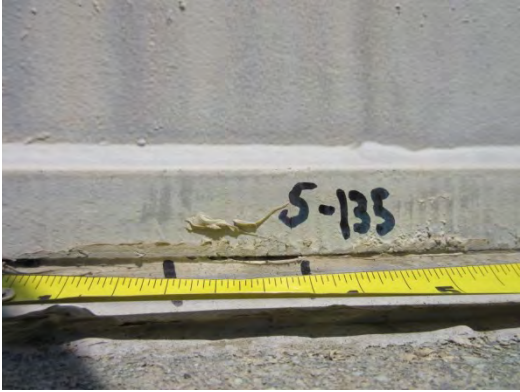
7. Cell 5 Caulking As-Found

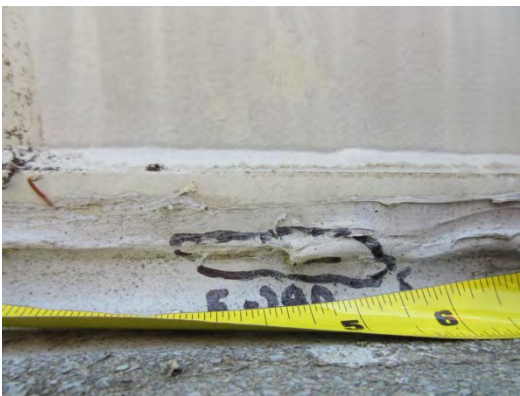
11. Cell 5 Caulking As-Found

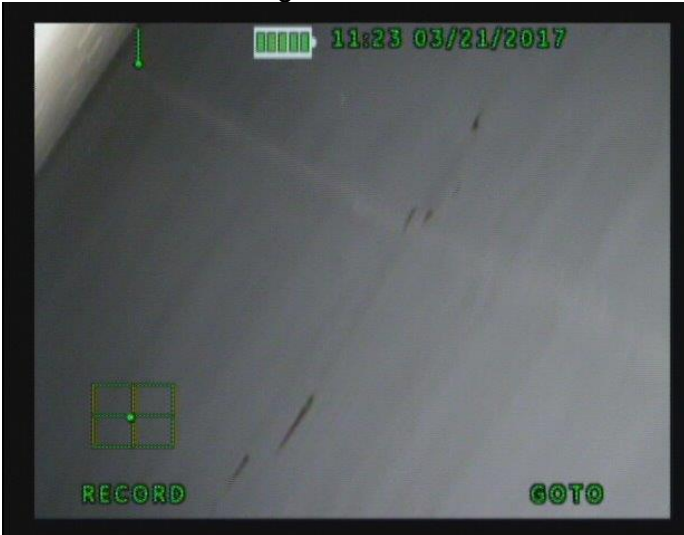
1. As discussed in Sections 3.1 and 3.2, markings were identified on the overpack and vault liner. These markings do not fail acceptance criteria, but will be entered into the CAP as observations (SAPN 1429074, Task 32).

28. Vault liner markings

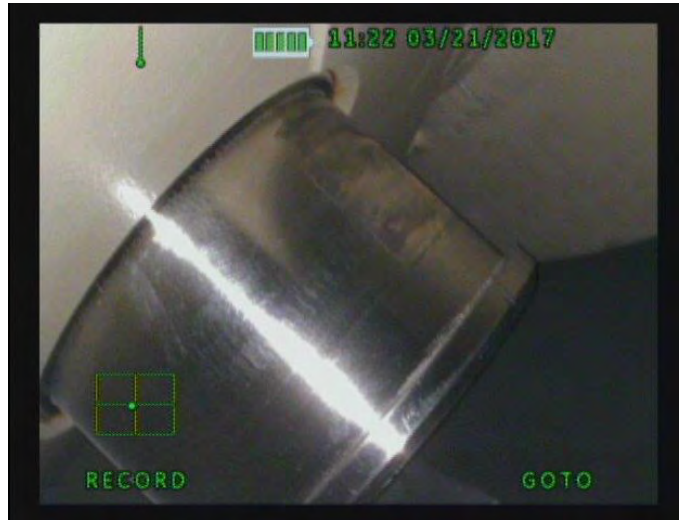
1. As discussed in Section 3.1, orange discoloration was noted at an overpack plug and near the lifting trunnion. Because the discoloration does not meet exam acceptance criteria, this finding was entered into CAP (SAPN 1429074, Task 28) for further evaluation.

29. Lifting trunnion

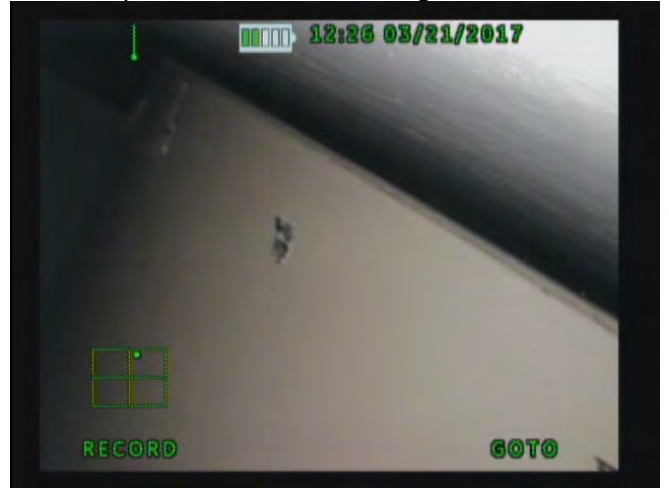
14. Overpack with Scuff Marking

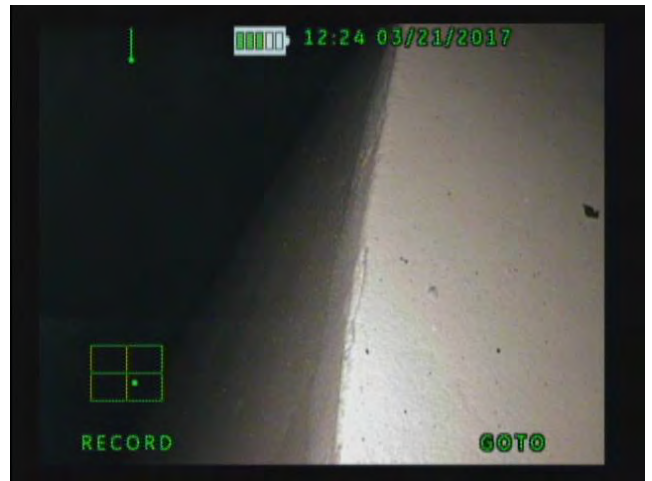
16. Overpack with Debris
