MSE Walls Retrofit

Design and Construction

110th Annual Road School 2024

B-43196 (40 MSE Wall Repair Statewide INDOT) Project Development Process for IDIQ MSE Wall Rehabilitation Projects

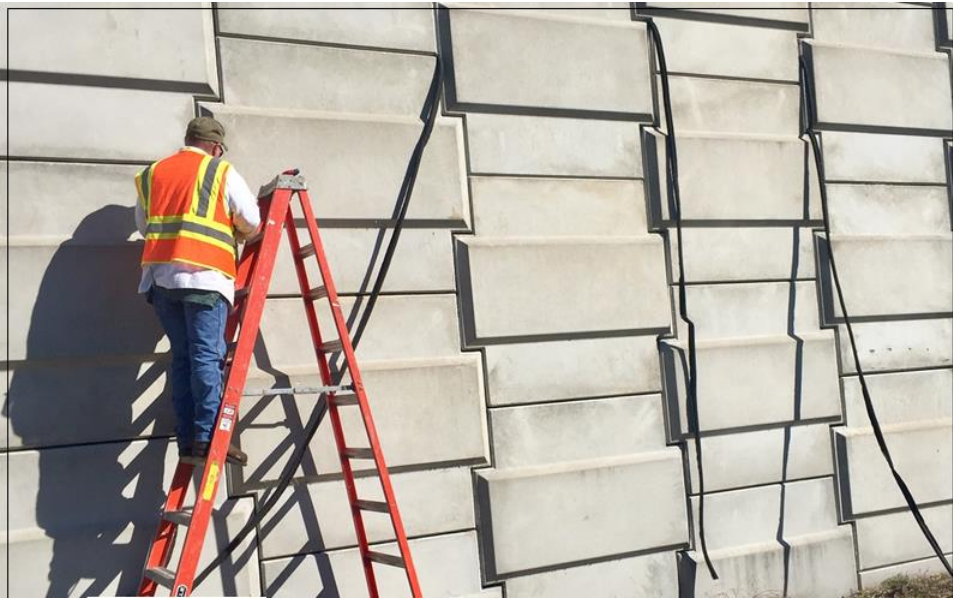
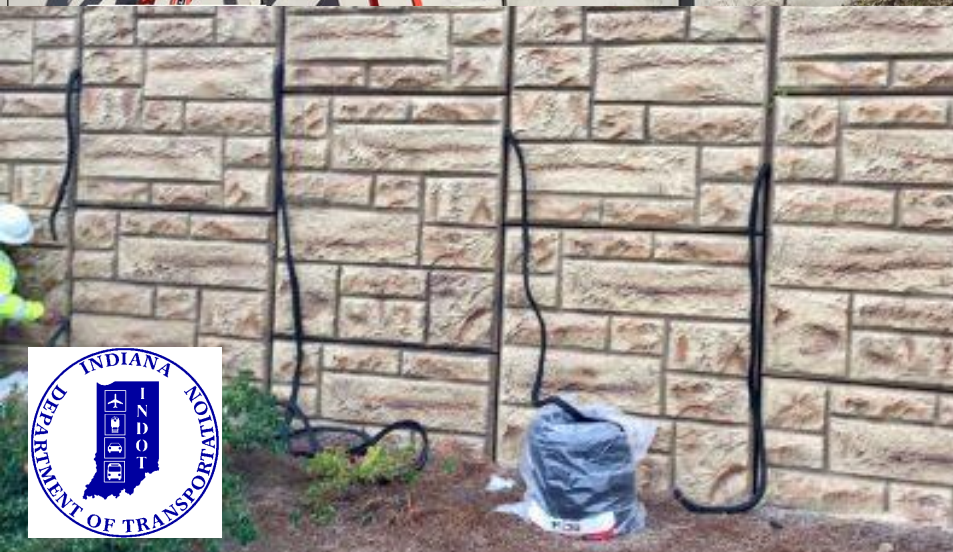
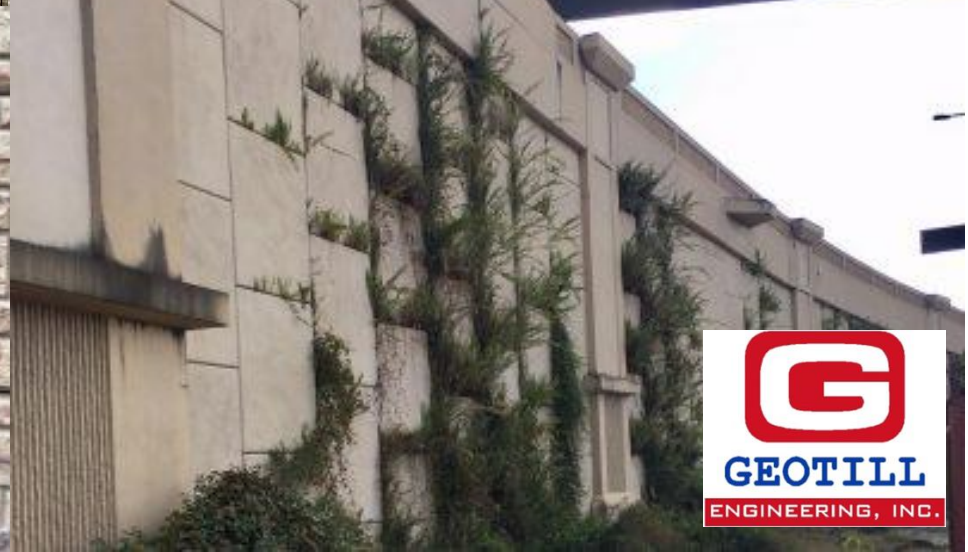
British Columbia, Canada, the MSE wall was 26 ft high and 230 ft long, the backfill is fine dredged river sand

Free Draining Seal (Foam pieces wrapped in a fabric cloth)

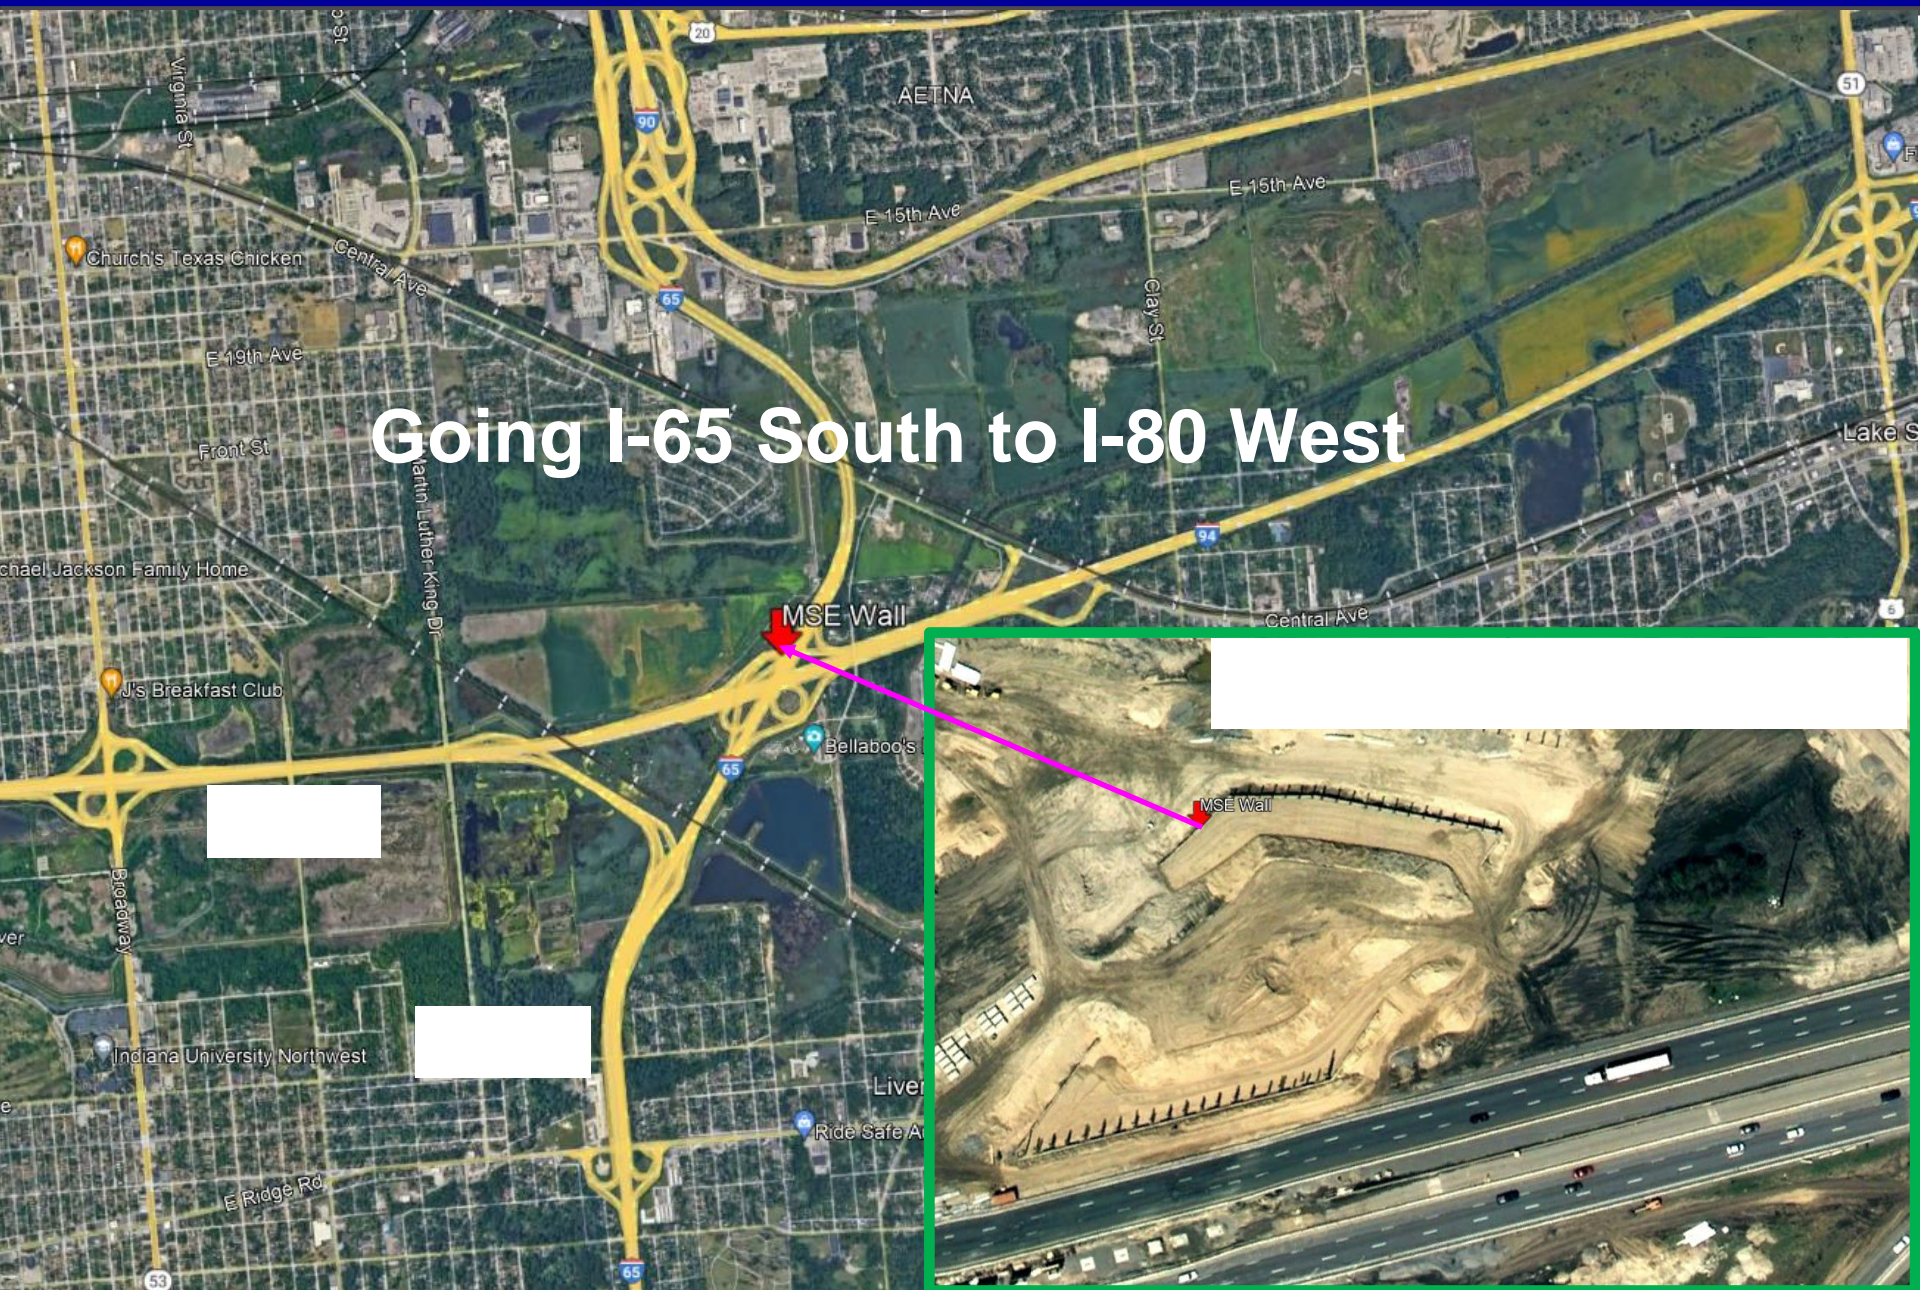
Going I-65 South to I-80 West

MSE Wall

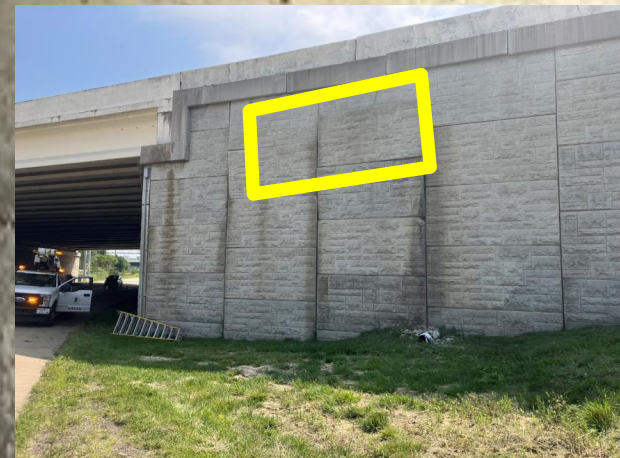
MSE Walls Retrofit - I-65 and I-80-I-94-Wall #41

5 ft High

3.5 Wide

Void
5 ft High

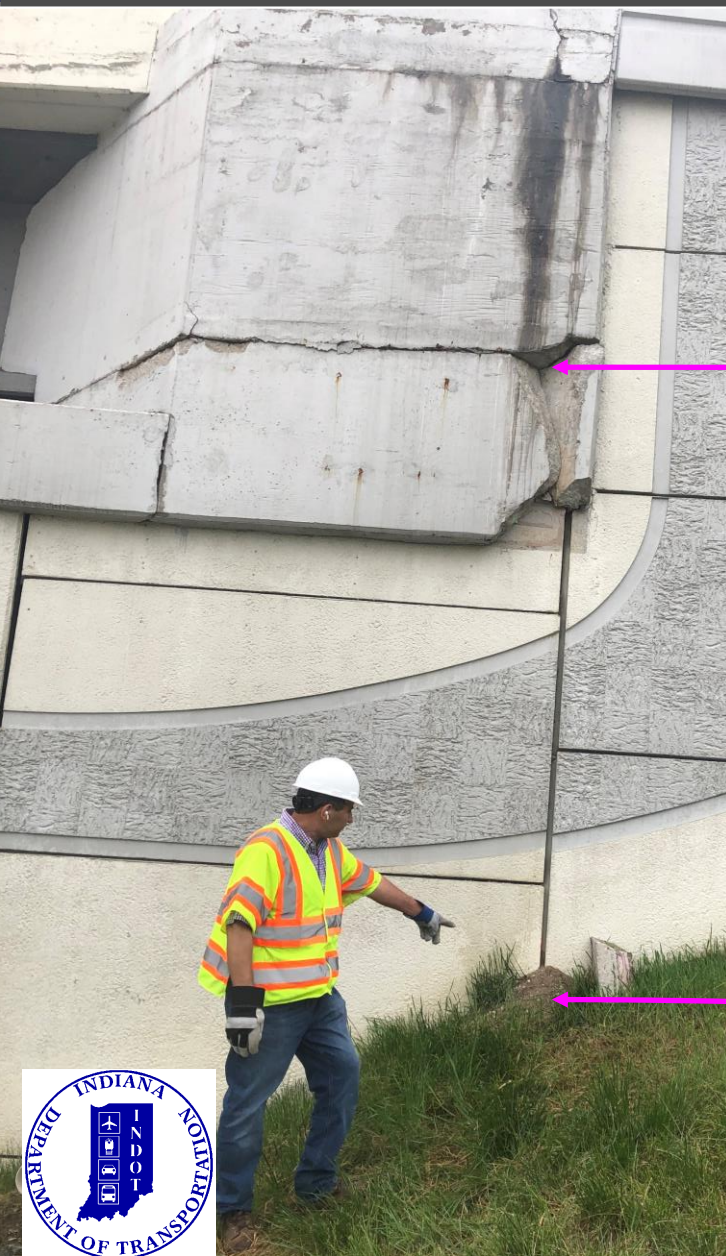
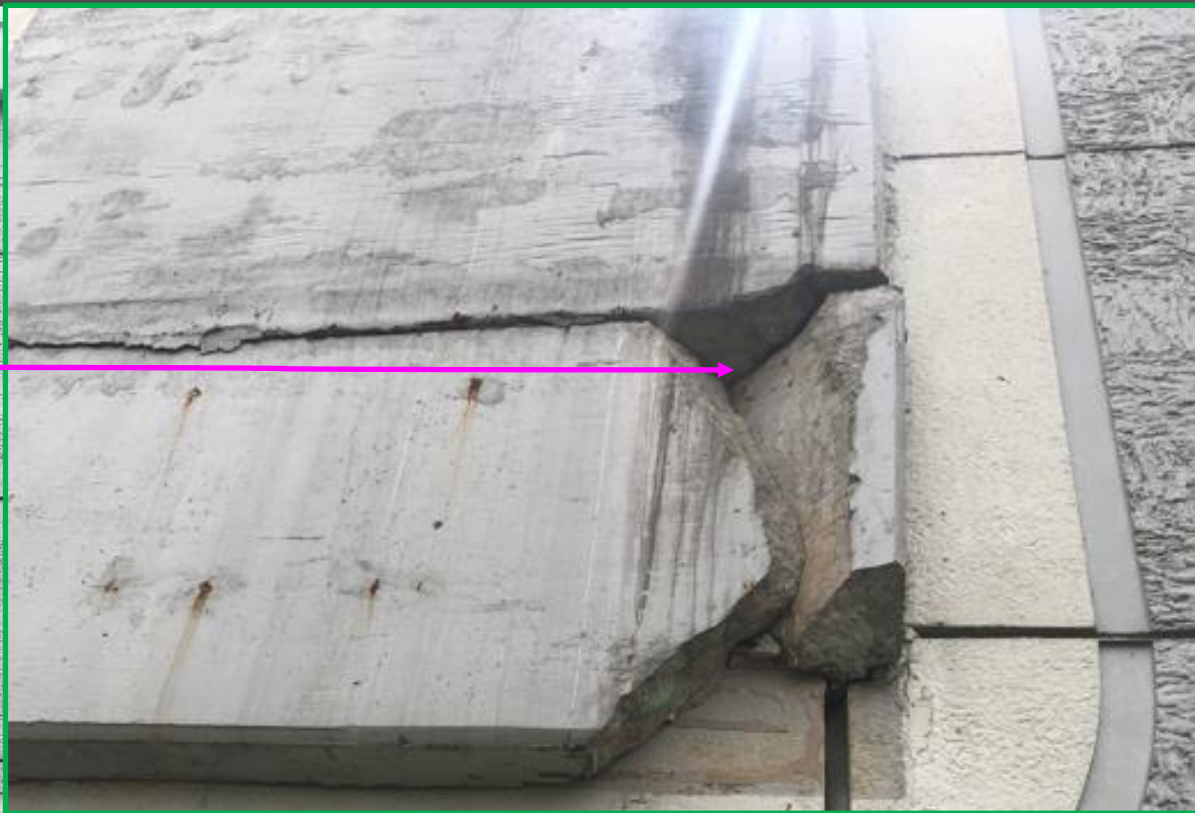
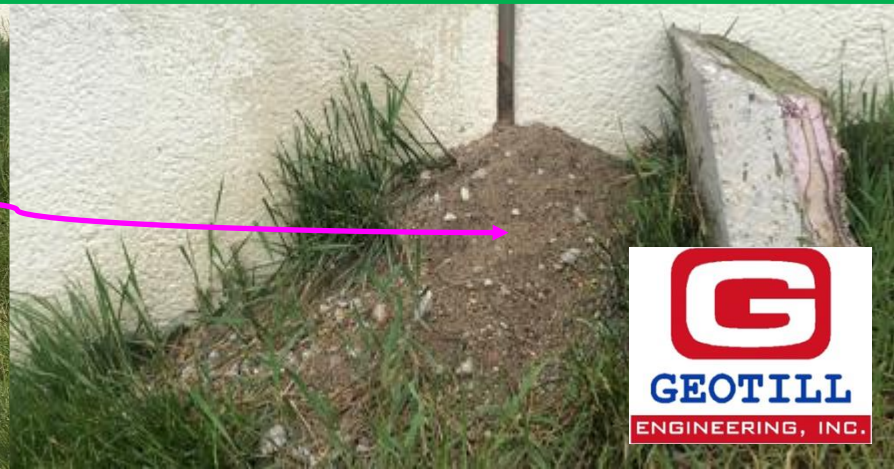
MSE Walls Retrofit – 82nd St Over I-465

- **Backfill leak from Northwest side.**
- **Broken CIP copings.**
- **Some bulging panels.**
- **Pavement issues probably voids.**
- **Widen and tighten panel gaps, possibly because of settlement.**
- **Some blocked underdrain**

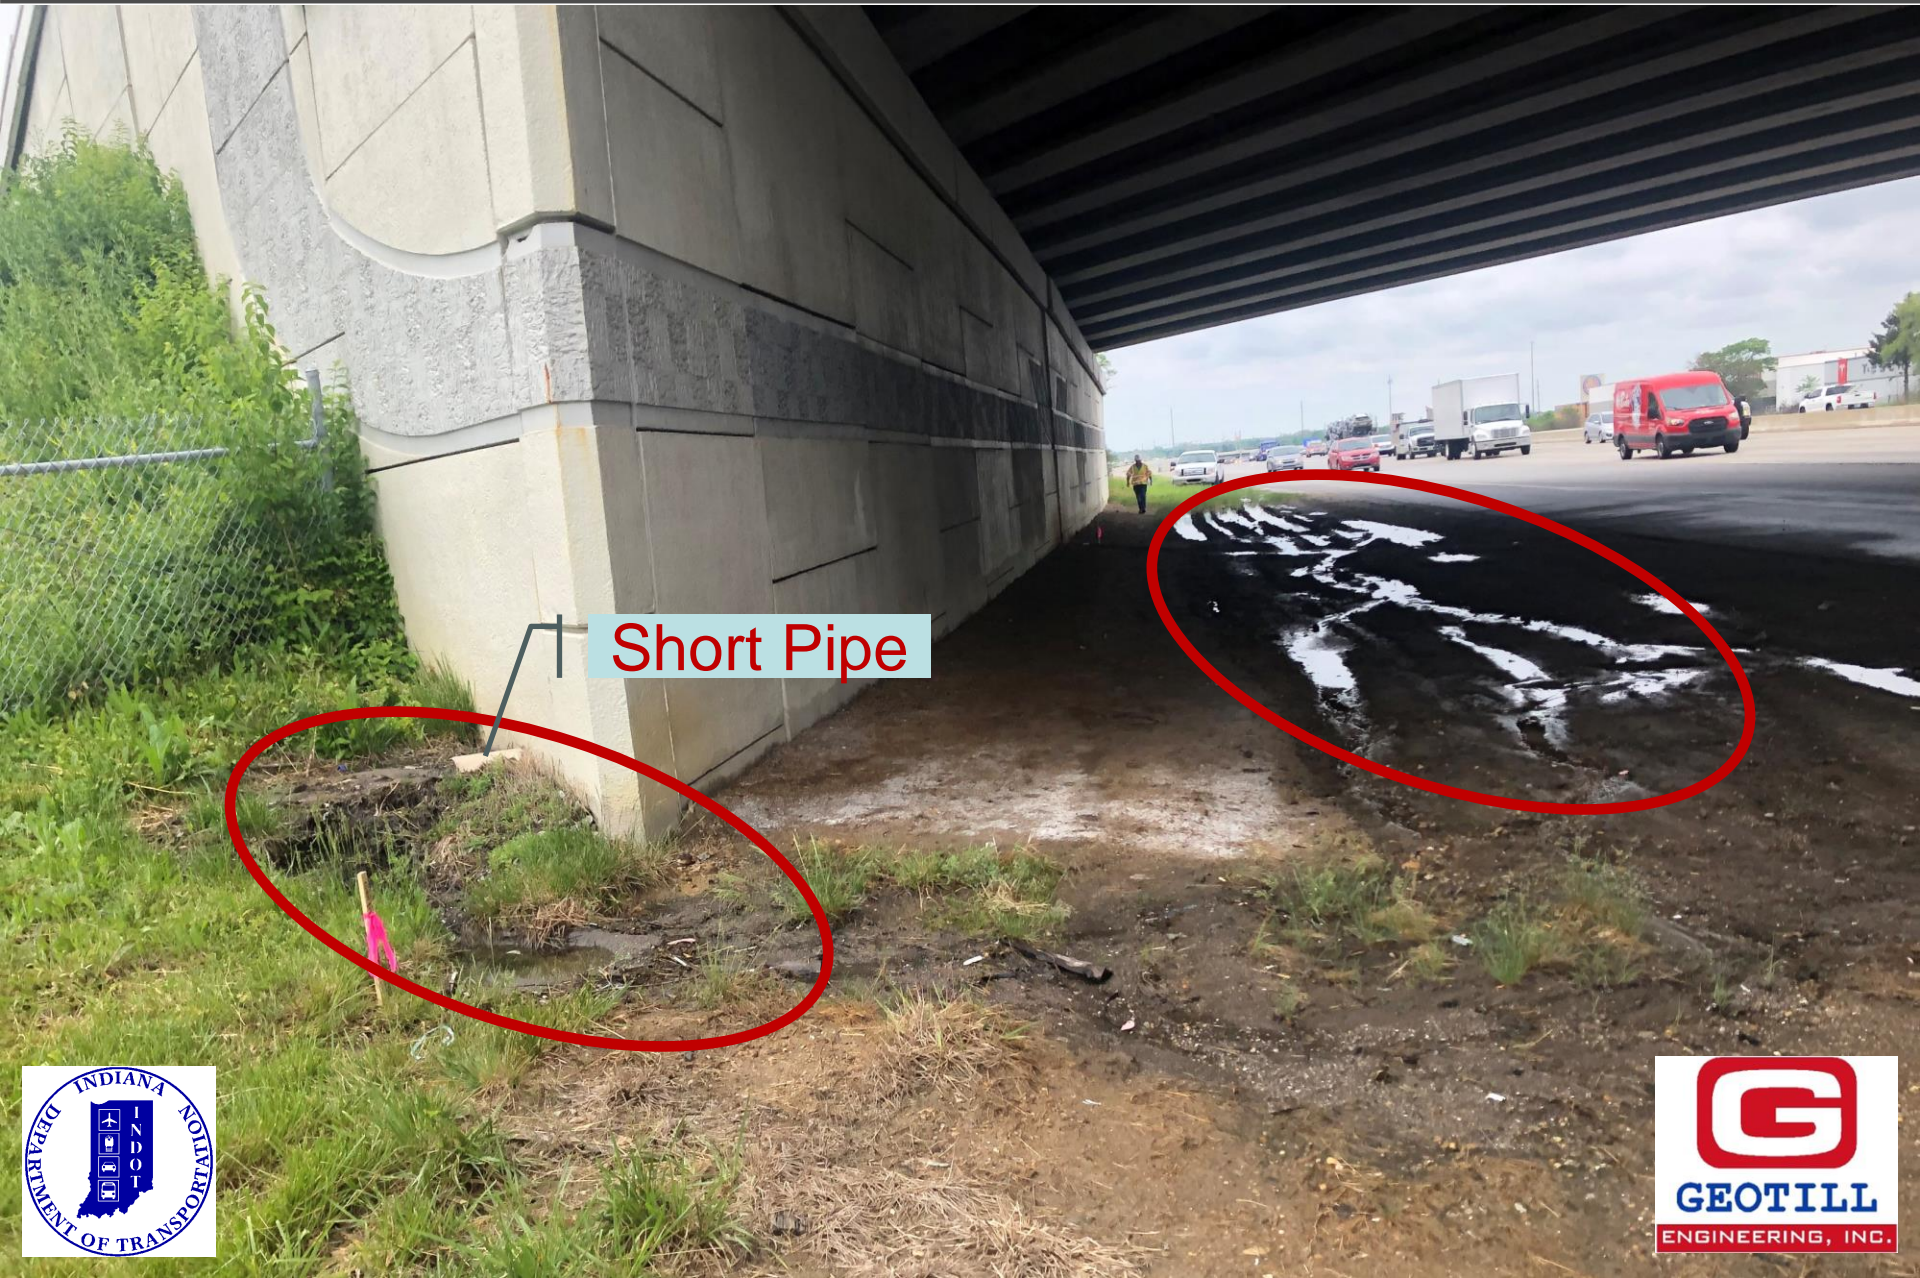
Short Pipe

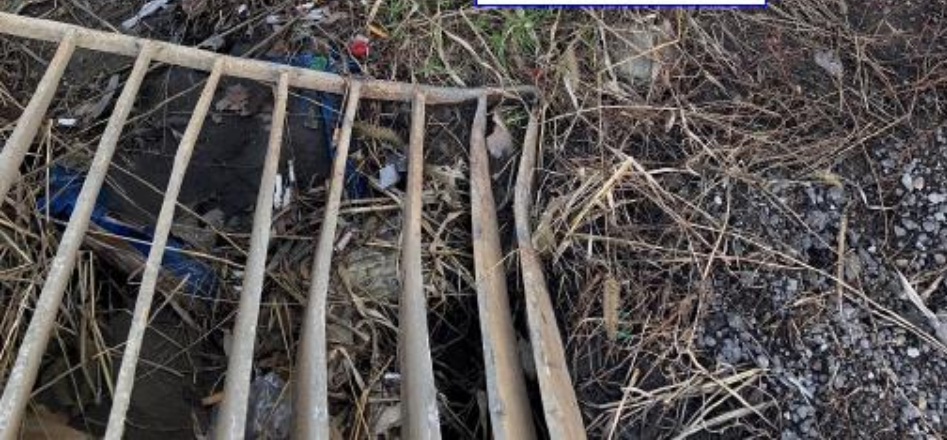
MSE Walls Retrofit – 82nd St Over I-465

The main problem for this location is that the **drainage** system is not able to drain all the water away from the MSE walls. The water seeps through the damaged expansion joints and some manholes and then seep on top of the MSE walls especially at the northwest wall. In addition, to the known **connections** problems that Tricon MSE Wall system has.

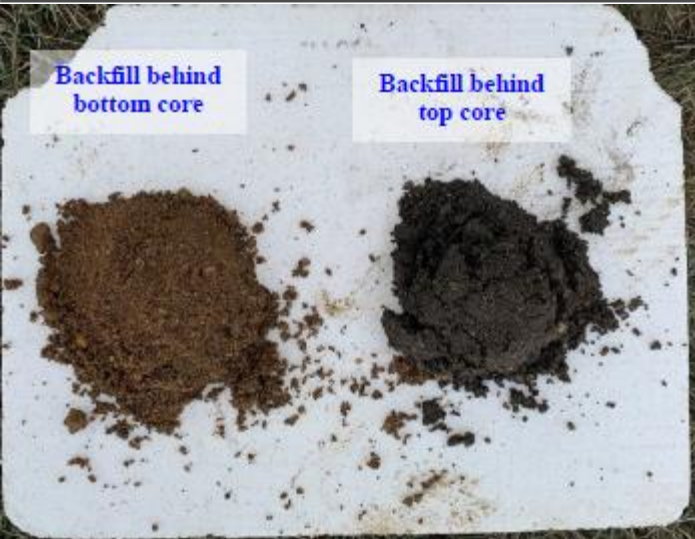
Backfill behind
bottom core

Backfill behind
top core

**Coring for Soil
Nails and
Weep Holes**
