SANDIA REPORT

SAND2005-3429
Unlimited Release
Printed June 2005

Pulse-Echo Ultrasonic Inspection System for In-Situ Nondestructive Inspection of Space Shuttle RCC Heat Shields

Dennis Roach, Phil Walkington, and Kirk Rackow

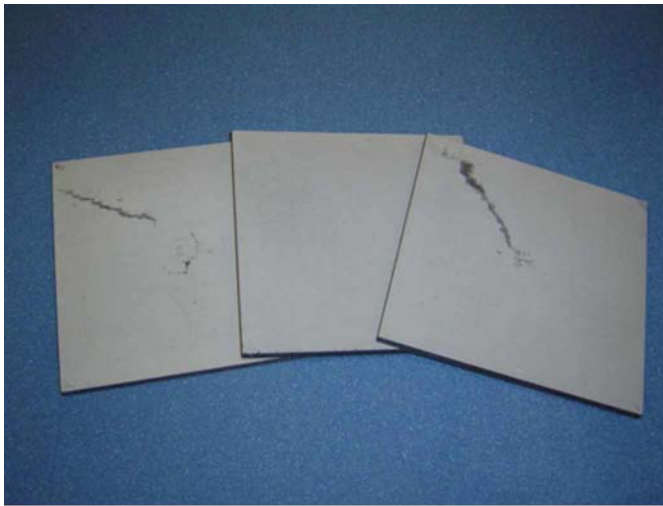
NASA Impact Panel R1-117-14 (R1-47-14)

Lowest impact velocity of 1470 ft/s with no visible impact damage

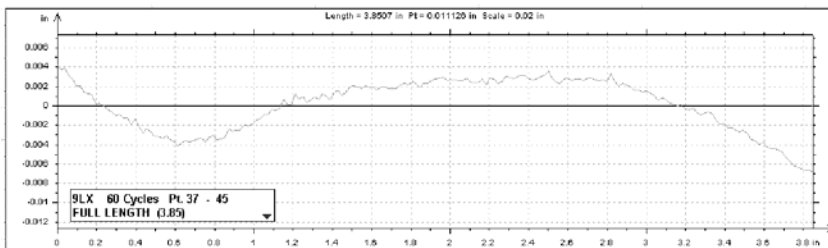
Grid Row 37 - 45

**Contour Plots Across Grid Line 37-45 Before and After UT Scanning –
No Removal of RCC Material Measured**
