Congress Hall Hotel: An Historic Structure Report

Michael Calafati
University of Pennsylvania

CONGRESS HALL HOTEL:

AN HISTORIC STRUCTURE REPORT

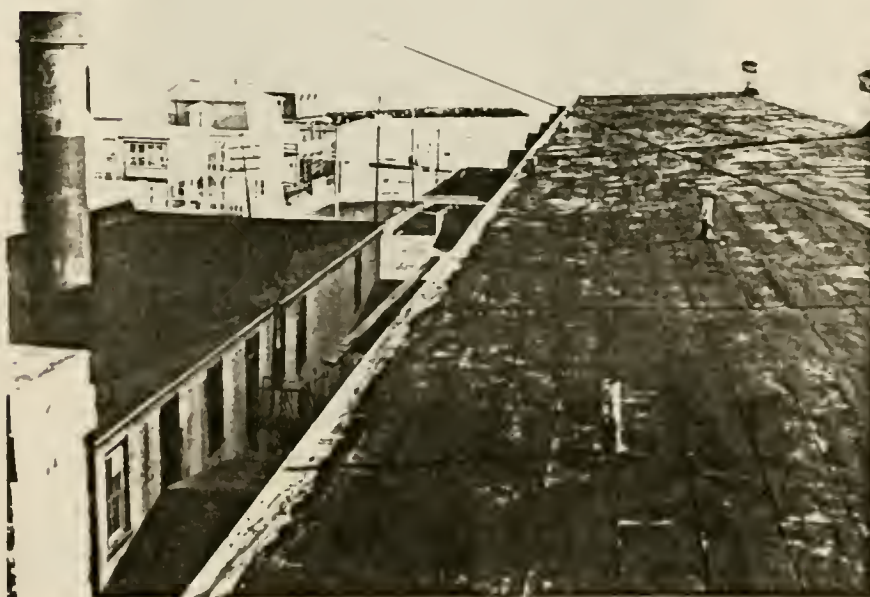
Fig. 26: Transition between asphalt and slate roofing shingles at the west corner of the Congress Place wing.

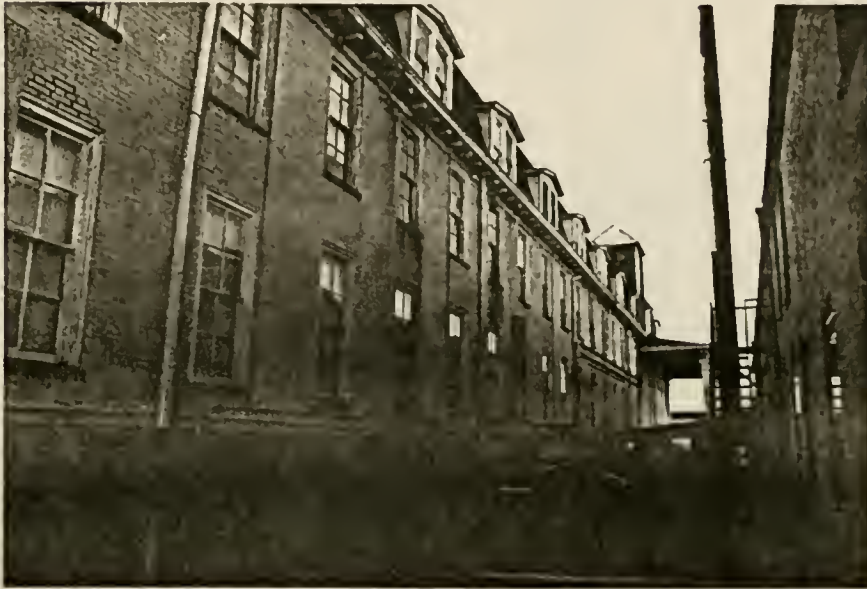
Fig. 33: (Top) Congress Hall's northeast elevation facing the annex looking west.

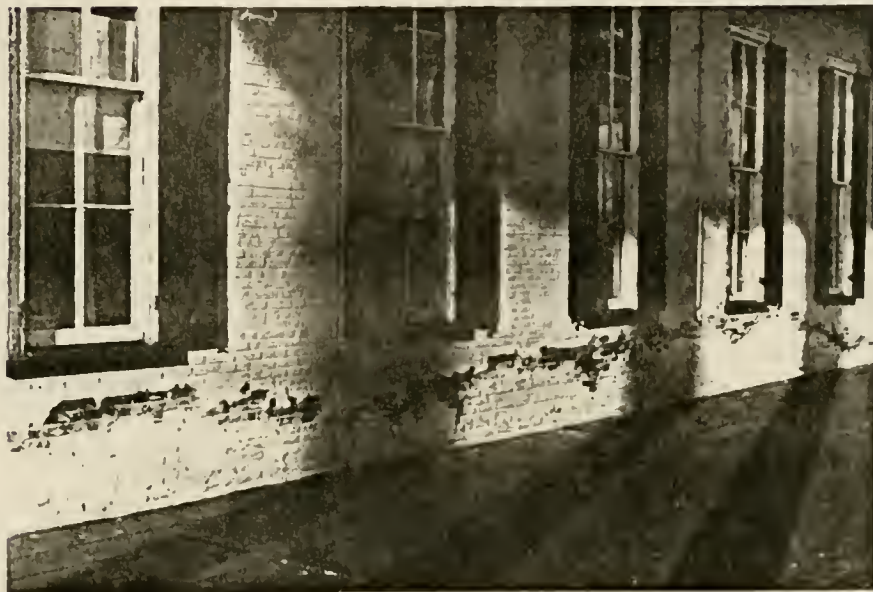
Fig. 36: (Top) Peeling paint due to rising damp at south end of Congress Place wing facing the ocean.

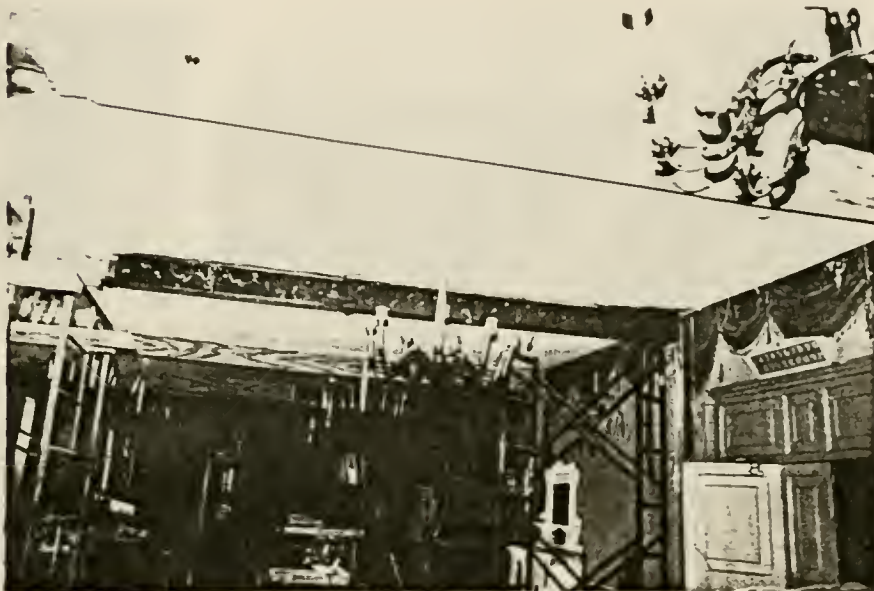
Fig. 47: (Top) General view of truss bottoms as viewed from dining room. Truss T4 is open to view.

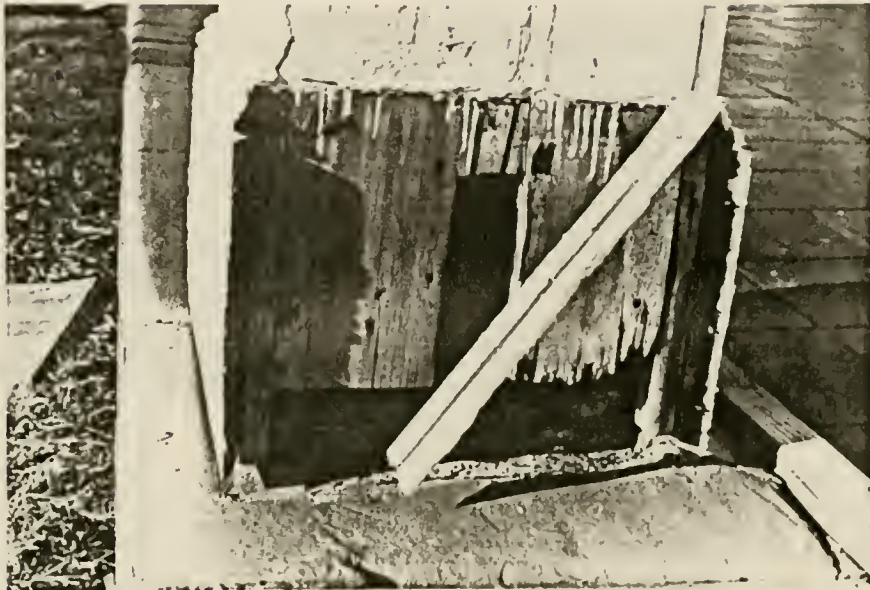
Fig. 49: (Top) Column base detail.

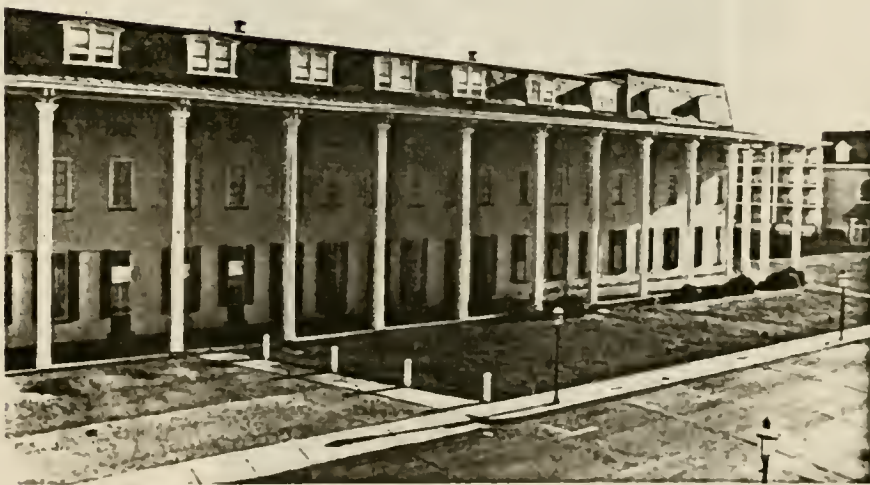
Fig. 52: (Bottom) Overall view of Congress Place wing looking south.
