Evaluation of a Non-Proprietary, High-Tension, Four-Cable Median Barrier on Level Terrain

TESTING CERT # 2937.01

Midwest States Regional Pooled Fund Research Program

EVALUATION OF A NON-PROPRIETARY, HIGH-TENSION, FOUR-CABLE MEDIAN BARRIER ON LEVEL TERRAIN

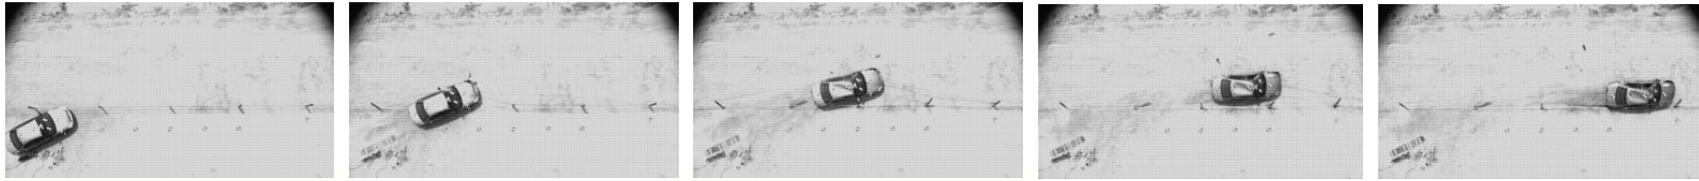
Figure 29. Summary of Test Results and Sequential Photographs, Test No. 4CMBLT-1

The analysis of the test results for test no. 4CMBLT-1 showed that the high-tension, four-cable median barrier placed on level terrain adequately contained and redirected the 1500A vehicle with controlled lateral displacements of the barrier. However, cable no. 2 cut through the windshield and penetrated into the occupant compartment. The test vehicle did not penetrate nor ride over the barrier and remained upright during and after the collision. Vehicle roll, pitch, and yaw angular displacements, as shown in Appendix E, were deemed acceptable because they did not adversely influence occupant risk safety criteria nor cause rollover. After impact, the vehicle did not exit the system and its trajectory stayed within the bounds of the exit box. Therefore, the results for test no. 4CMBLT-1 were determined to be unacceptable according to the MASH safety performance criteria due to windshield and occupant compartment penetration.

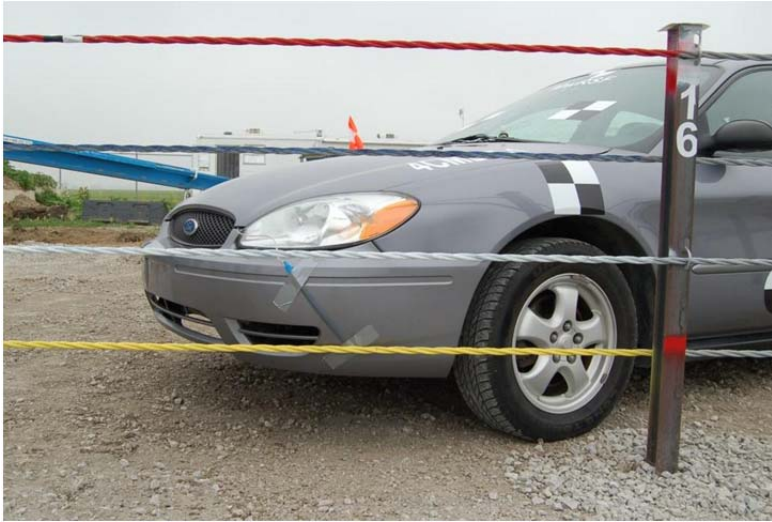
Figure 34. Impact Location, Test No. 4CMBLT-1

Initial vehicle impact was to occur 64 in. (1,626 mm) downstream from post no. 16, as shown in Figure 34, which was selected using an analysis of the vehicle trajectory to maximize the potential for vehicle penetration through the system. A sequential description of the impact events is provided by Table 6. The vehicle came to rest 123 ft (37.5 m) downstream from impact within the system. The vehicle trajectory and final position are shown in Figures 29 and 35.

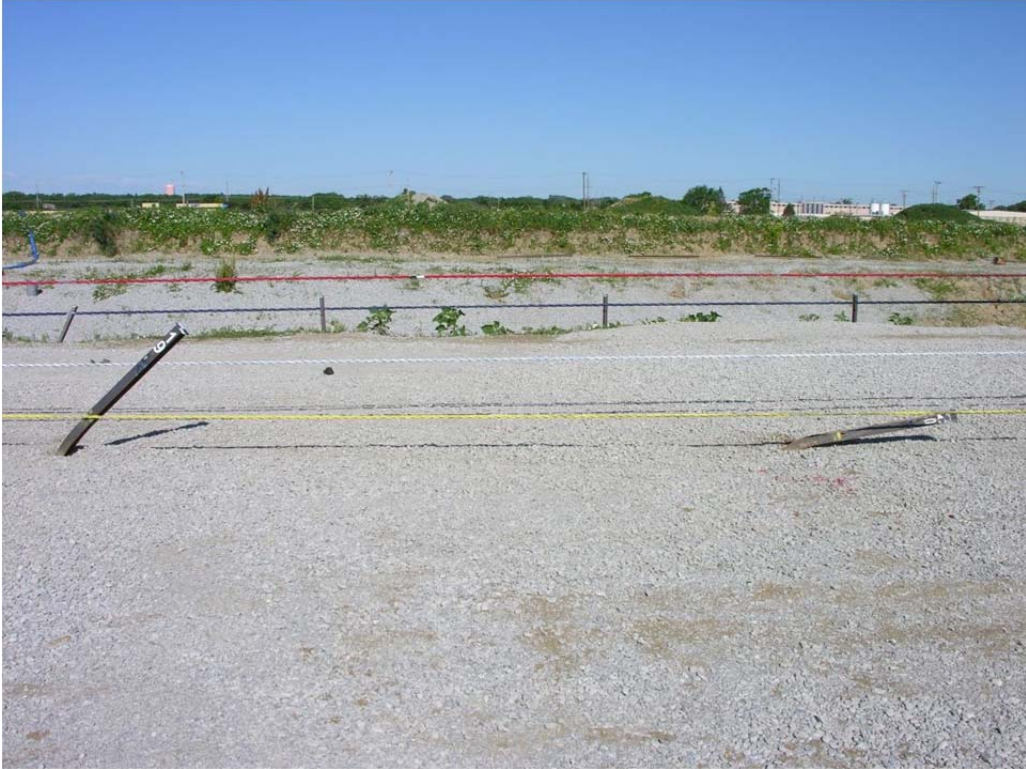
Figure 38. Post Nos. 19 through 22 System Damage, Test No. 4CMBLT-1

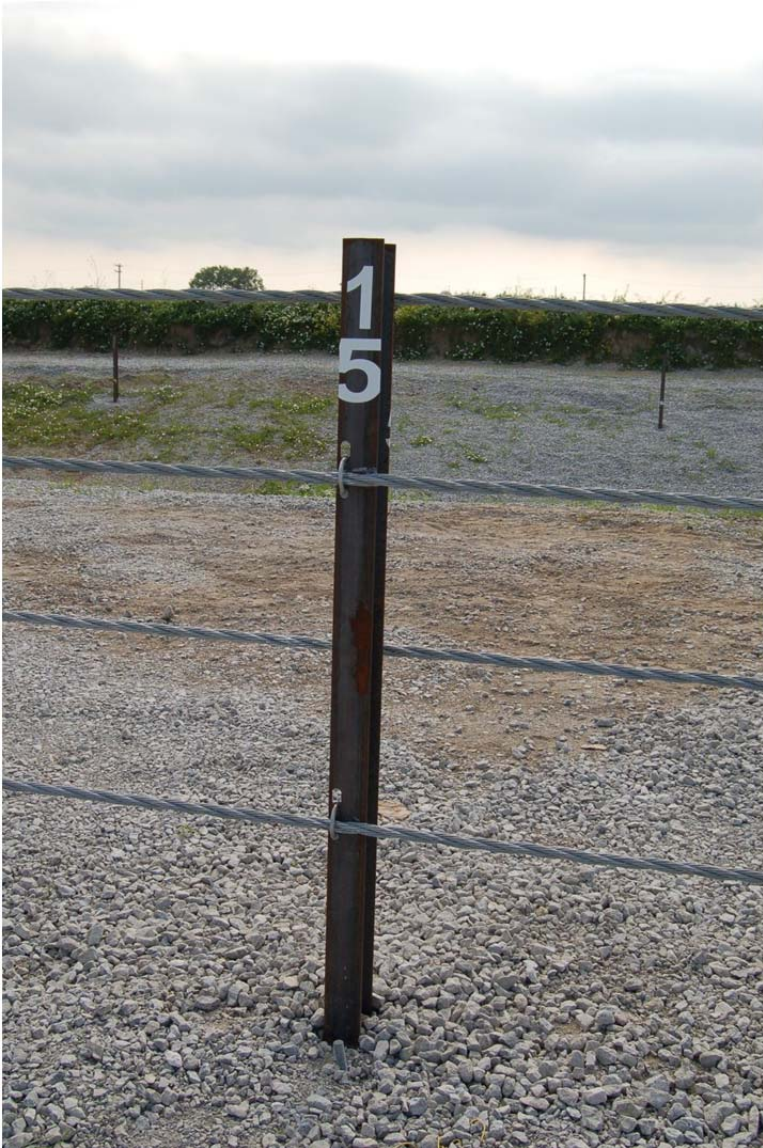
Figure 39. Post No. 15 Damage, Test No. 4CMBLT-1

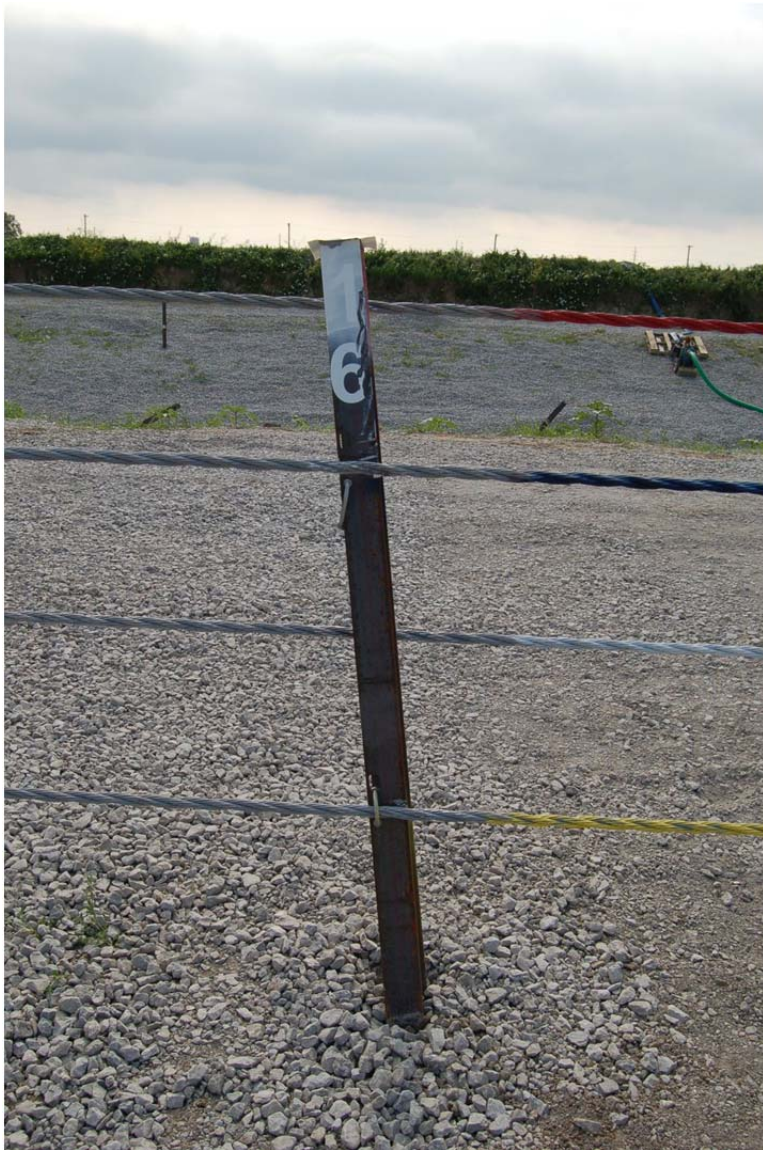
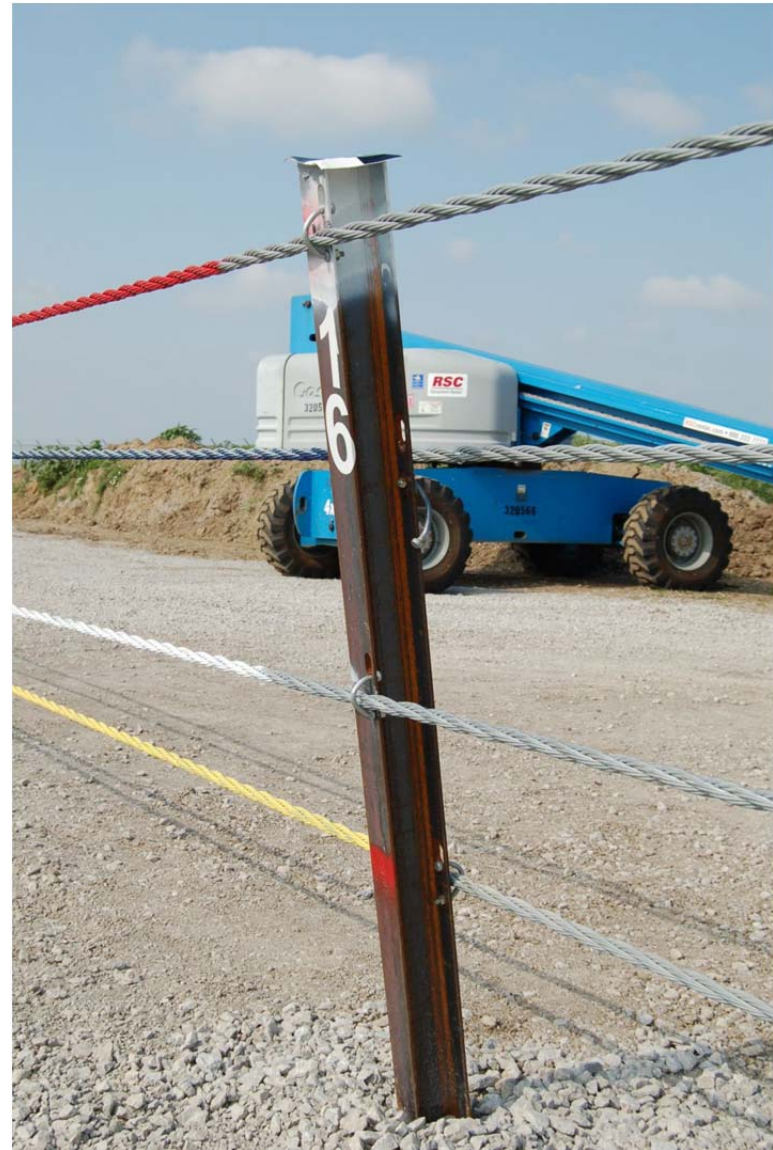
Figure 40. Post No. 16 Damage, Test No. 4CMBLT-1

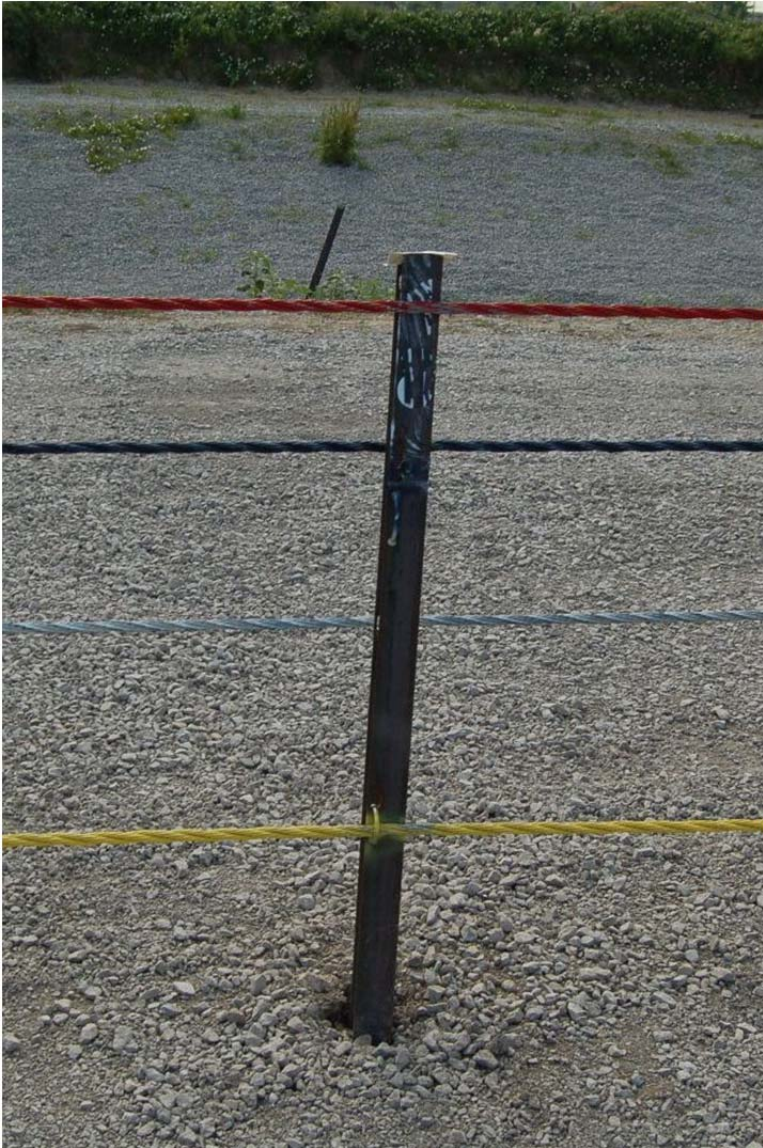
Figure 42. Post No. 18 Damage, Test No. 4CMBLT-1

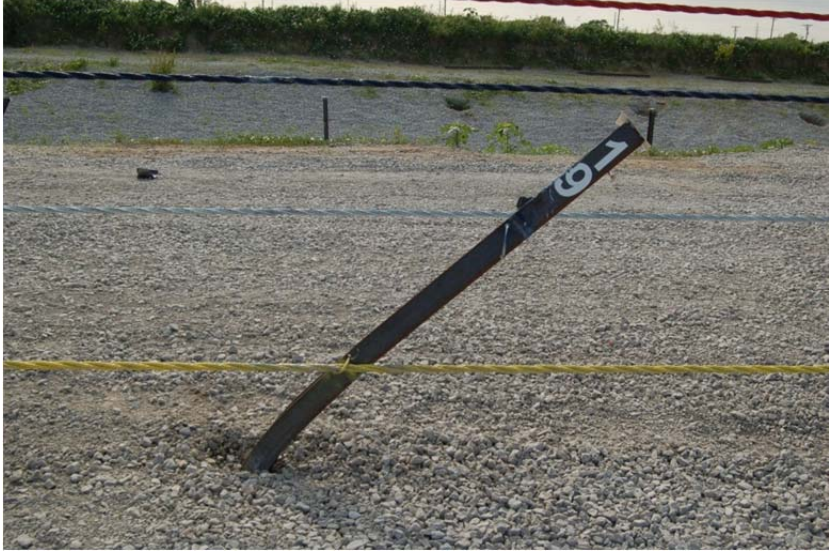
Figure 43. Post No. 19 Damage, Test No. 4CMBLT-1

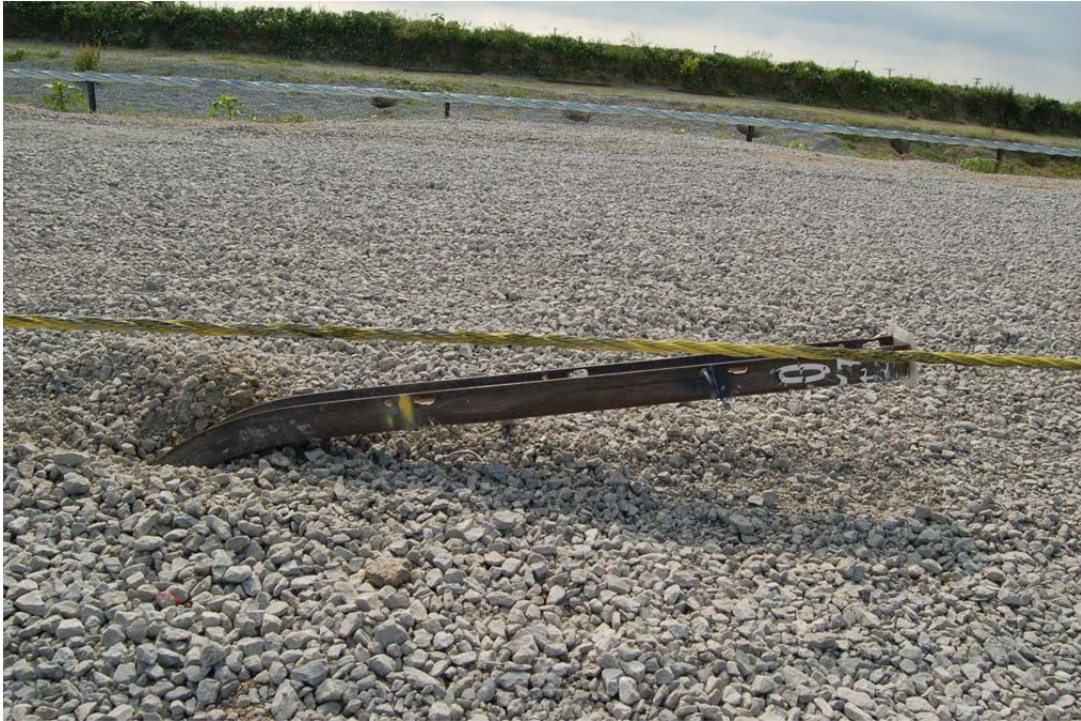
Figure 44. Post No. 20 Damage, Test No. 4CMBLT-1

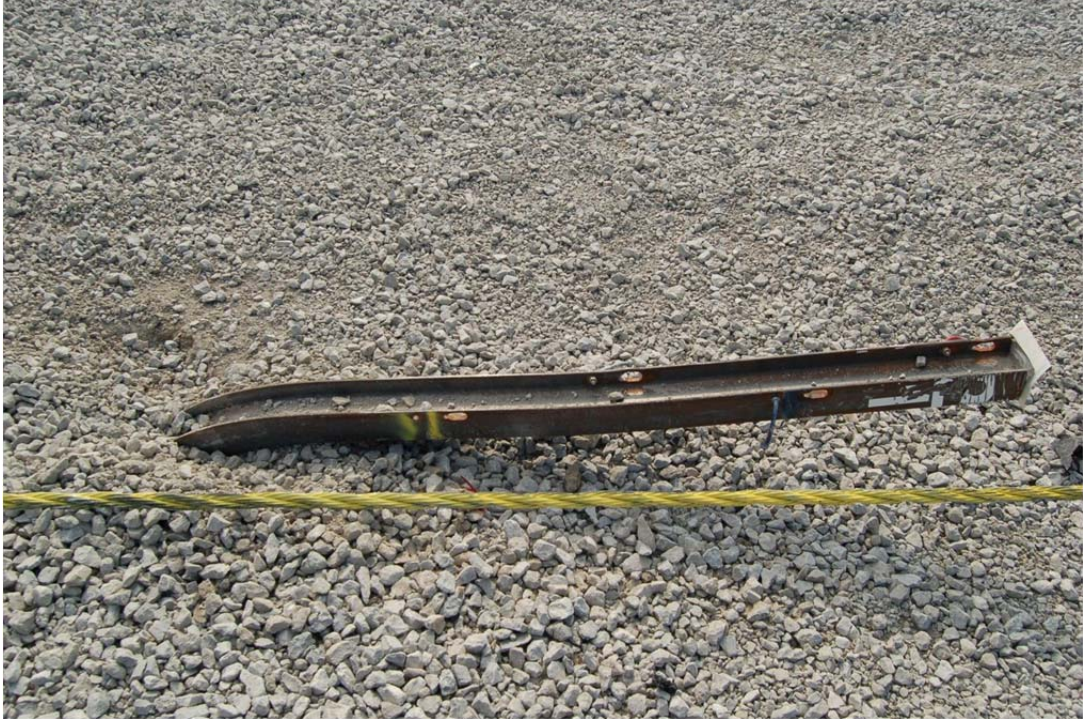
Figure 45. Post No. 21 Damage, Test No. 4CMBLT-1

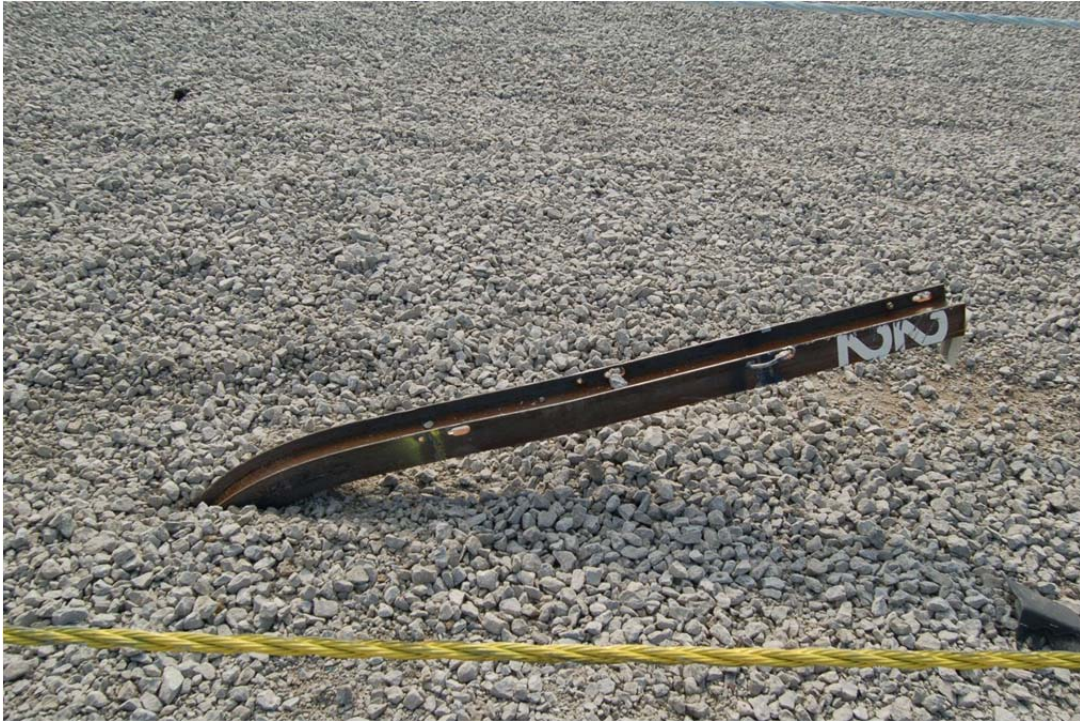
Figure 46. Post No. 22 Damage, Test No. 4CMBLT-1

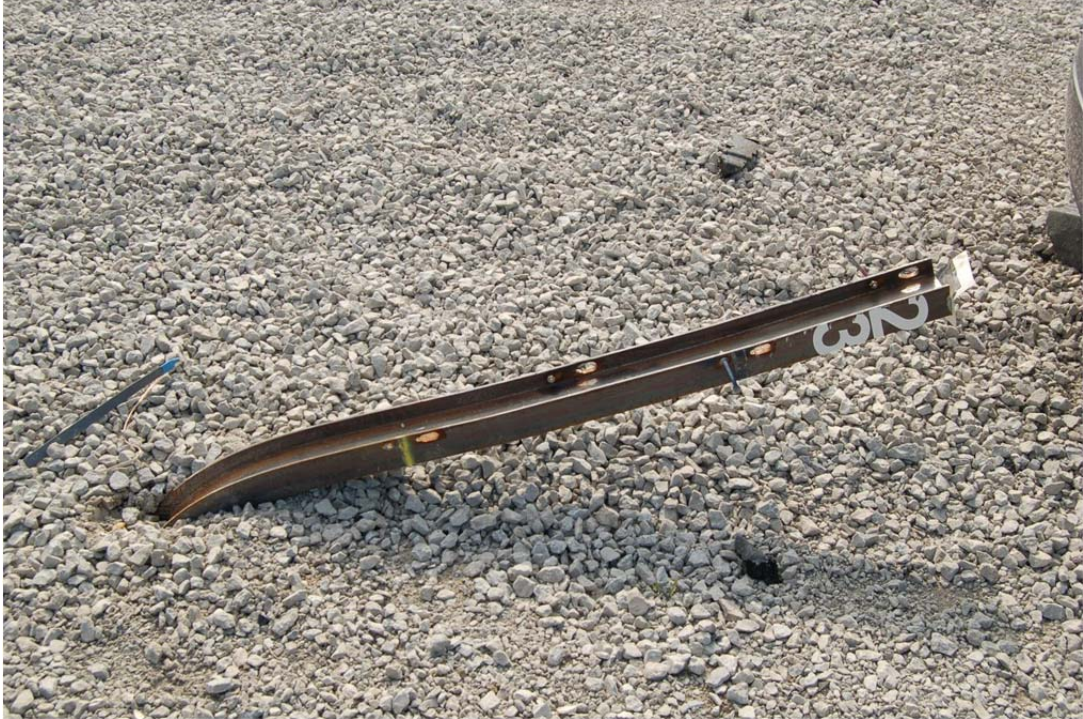
Figure 47. Post No. 23 Damage, Test No. 4CMBLT-1

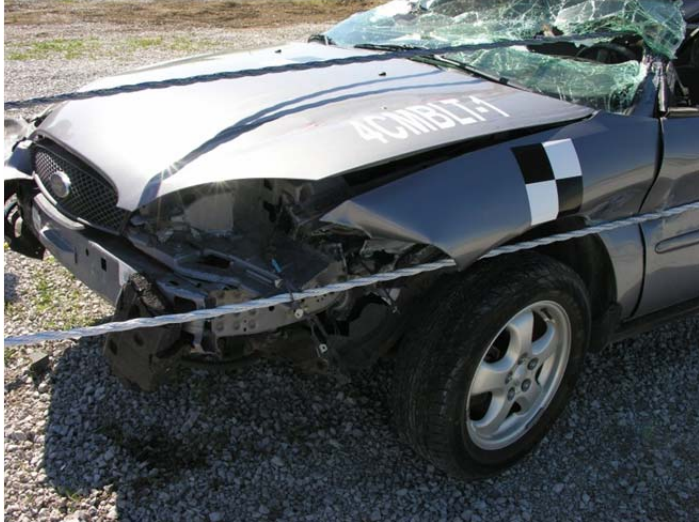
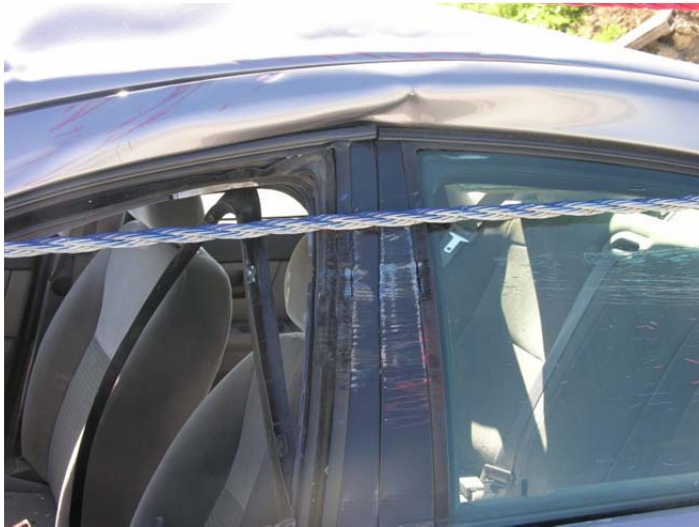
Figure 51. Vehicle Damage, Test No. 4CMBLT-1

After reviewing the high-speed video of test no. 4CMBLT-1, it was determined that the excessive damage to the roof, windshield, and A-pillar was caused by cable no. 2. While the vehicle was redirecting, this cable was in contact with the A-pillar and did not slide up and over the top of the vehicle as anticipated. The cable also did not release away from post no. 18 (the second post downstream from initial impact) as early as predicted. These two phenomena

resulted in a high lateral load being imparted to the vehicle's A-pillar, which eventually caused it to crush along with the windshield and roof.
