# The Space Shuttle Columbia: A Materials Forensic Analysis

## MICROSCOPY 2007

Steve McDanel  
Failure Analysis and Materials Evaluation Branch  
NASA  
Kennedy Space Center, Florida

# Shuttle Columbia: STS-107

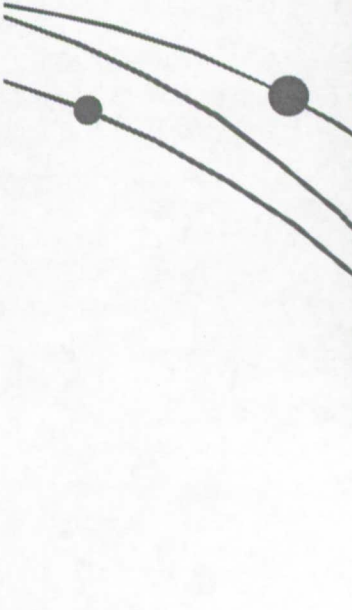
# 3D Reconstruction: Panels 8, 9, 10

- Wing failure initiated in the panel 8 area
  - ◆ Most likely at the panel 8 area near 8-9 joint
  - ◆ Condition existed before or shortly after entry interface
