Image Analysis Overview

Multilateral Imagery Working Group Technical Interchange Meeting

NASA Johnson Space Center
Image Science and Analysis Group (ISAG) (XI4)

May 2018

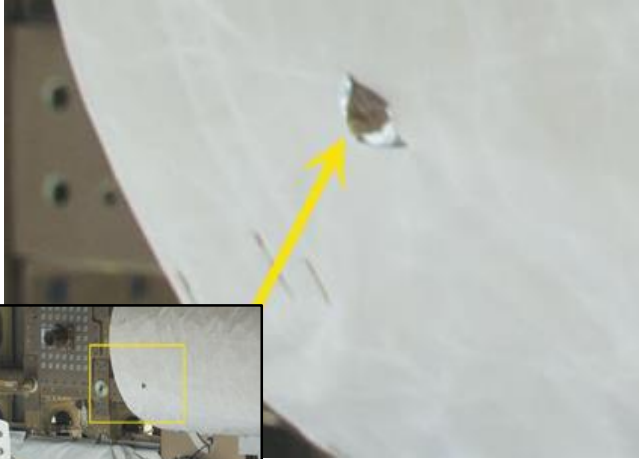
S1 CETA Light Stanchion

Possible MMOD Strikes

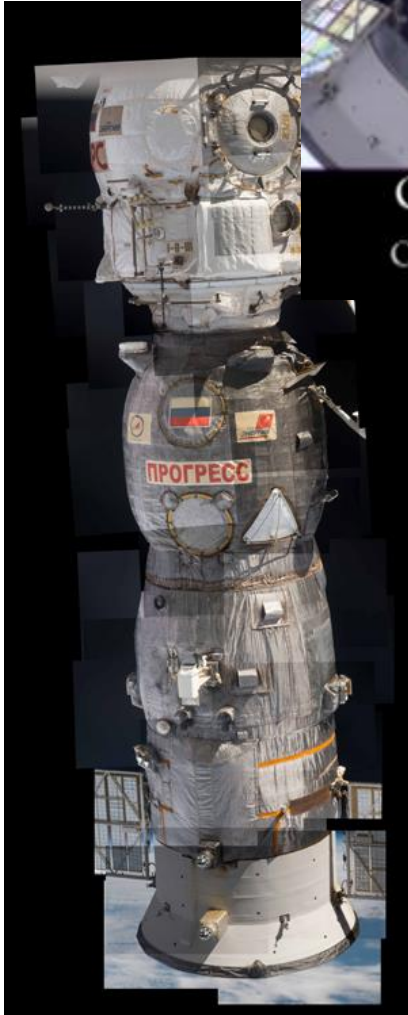
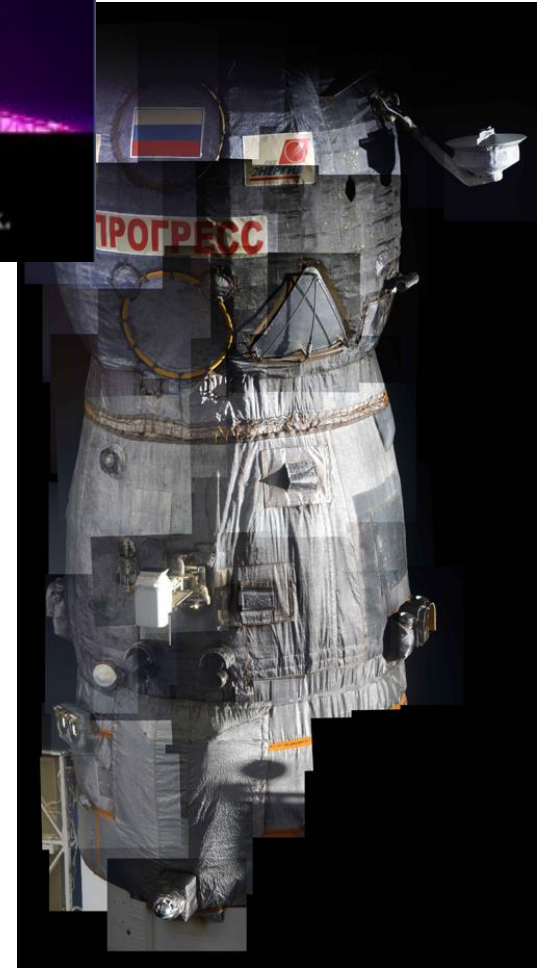
EVA 40 - RBVM Leak

Leak Source Investigation

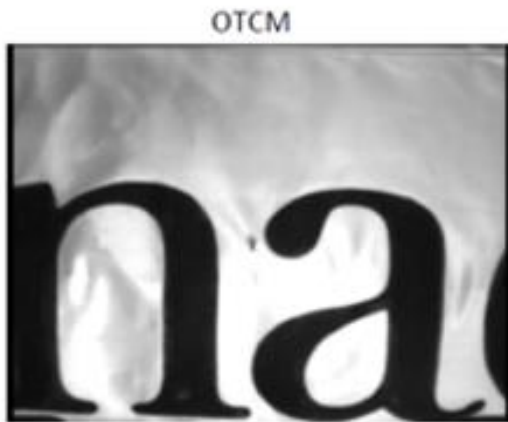
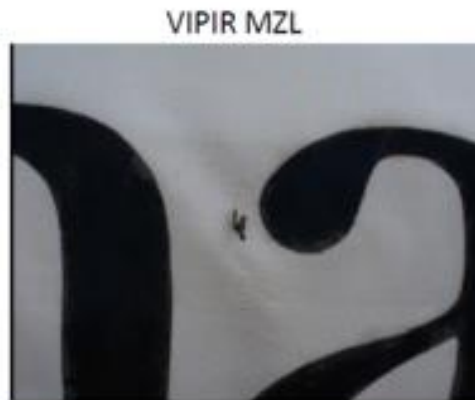
Wide Angle

- CSA had a desire to image an old potential MMOD strike on the SSRMS
- ISAG developed a plan to use the SPDM arm OTCM camera and DTO VIPIR camera.
- Video of the area of interest was acquired from several different arm positions and wrist rotations to allow creation of stereo imagery for analysis.
- Provided a valuable test of focused inspection capability using existing and planned ISS cameras (VIPIR2 and “Dextre Deployable Vision System” a.k.a. “Dextre Operated Camera”).

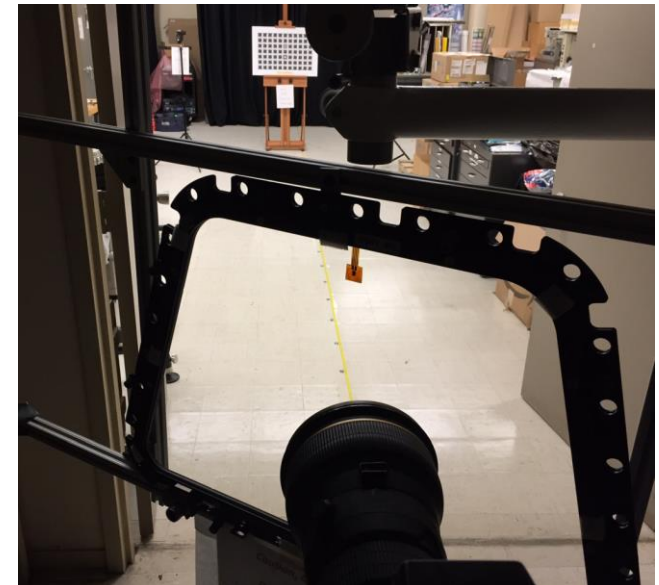
Haze and Nicks on Returned Pane
