AN EVALUATION OF THE FRACTURE OF THE 179 BACK CHANNEL GIRDER

AND THE ELECTROSLAG WELDS IN THE 179 COMPLEX

Report No. 425-1(80)

Project 77-5: Evaluation of Glenfield Bridge Fracture

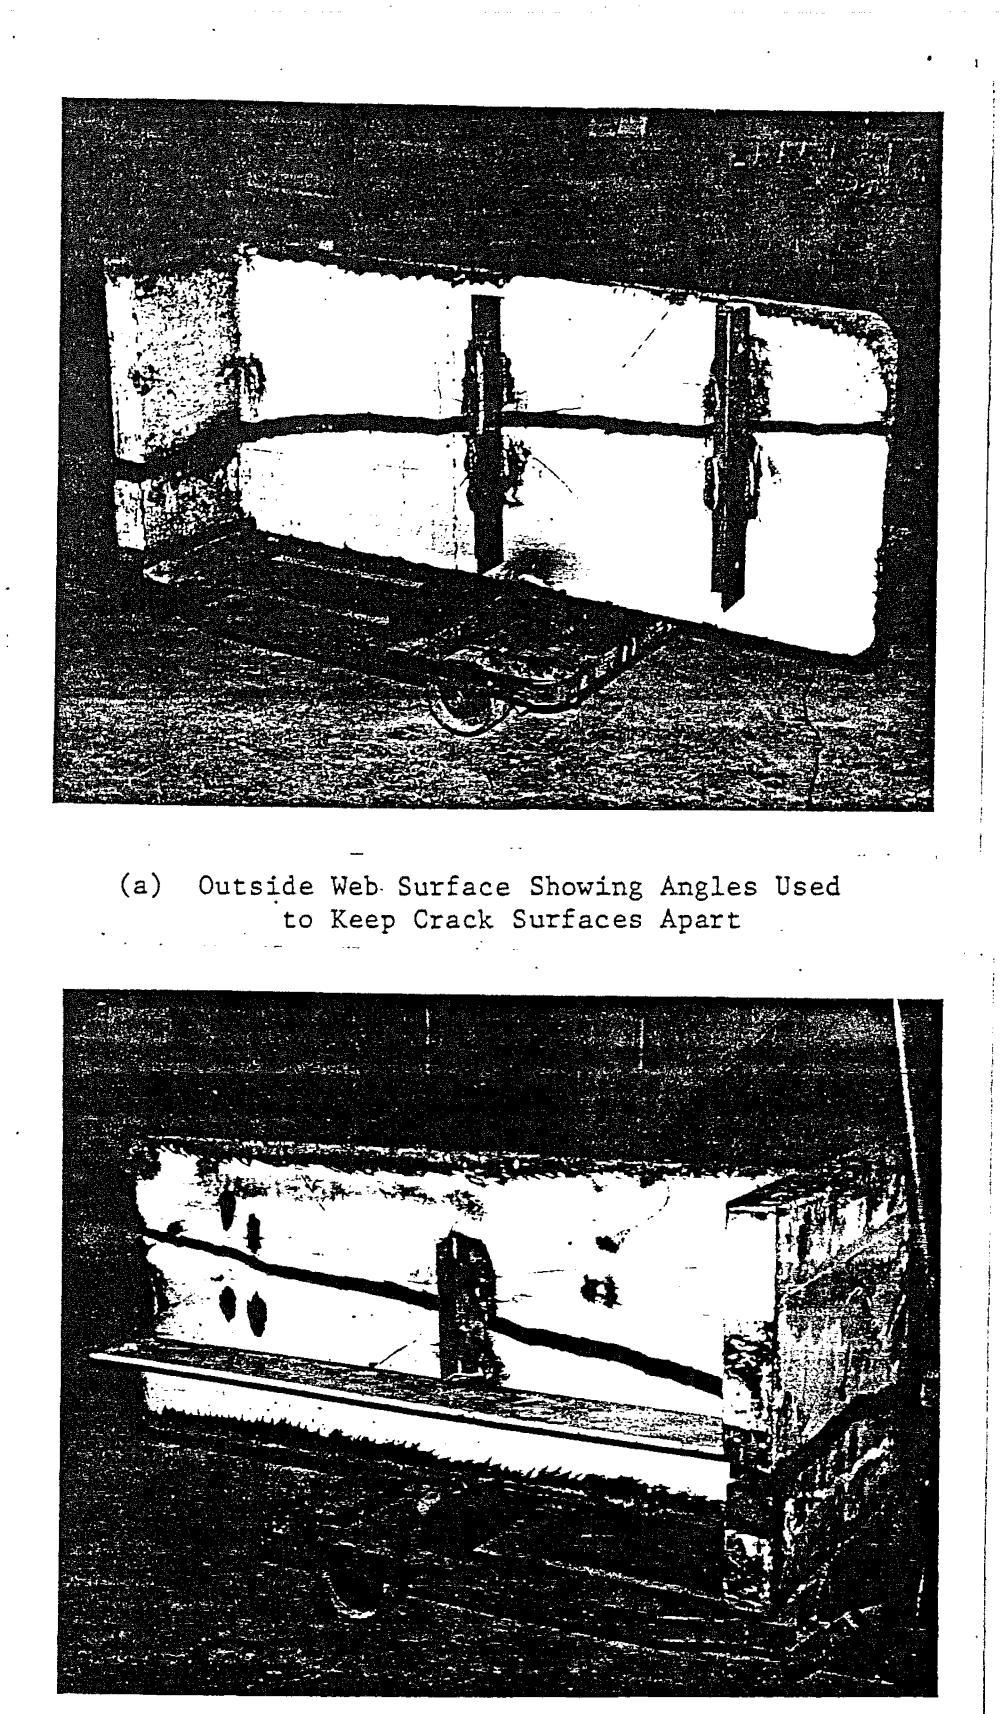
'Fig. 5 Sections of Fractured Girder Removed

The pieces removed from the casualty girder (see Fig. 5) were separated and the fracture surfaces exposed.

(b) Inside Web Surface Showing Transverse Stiffener

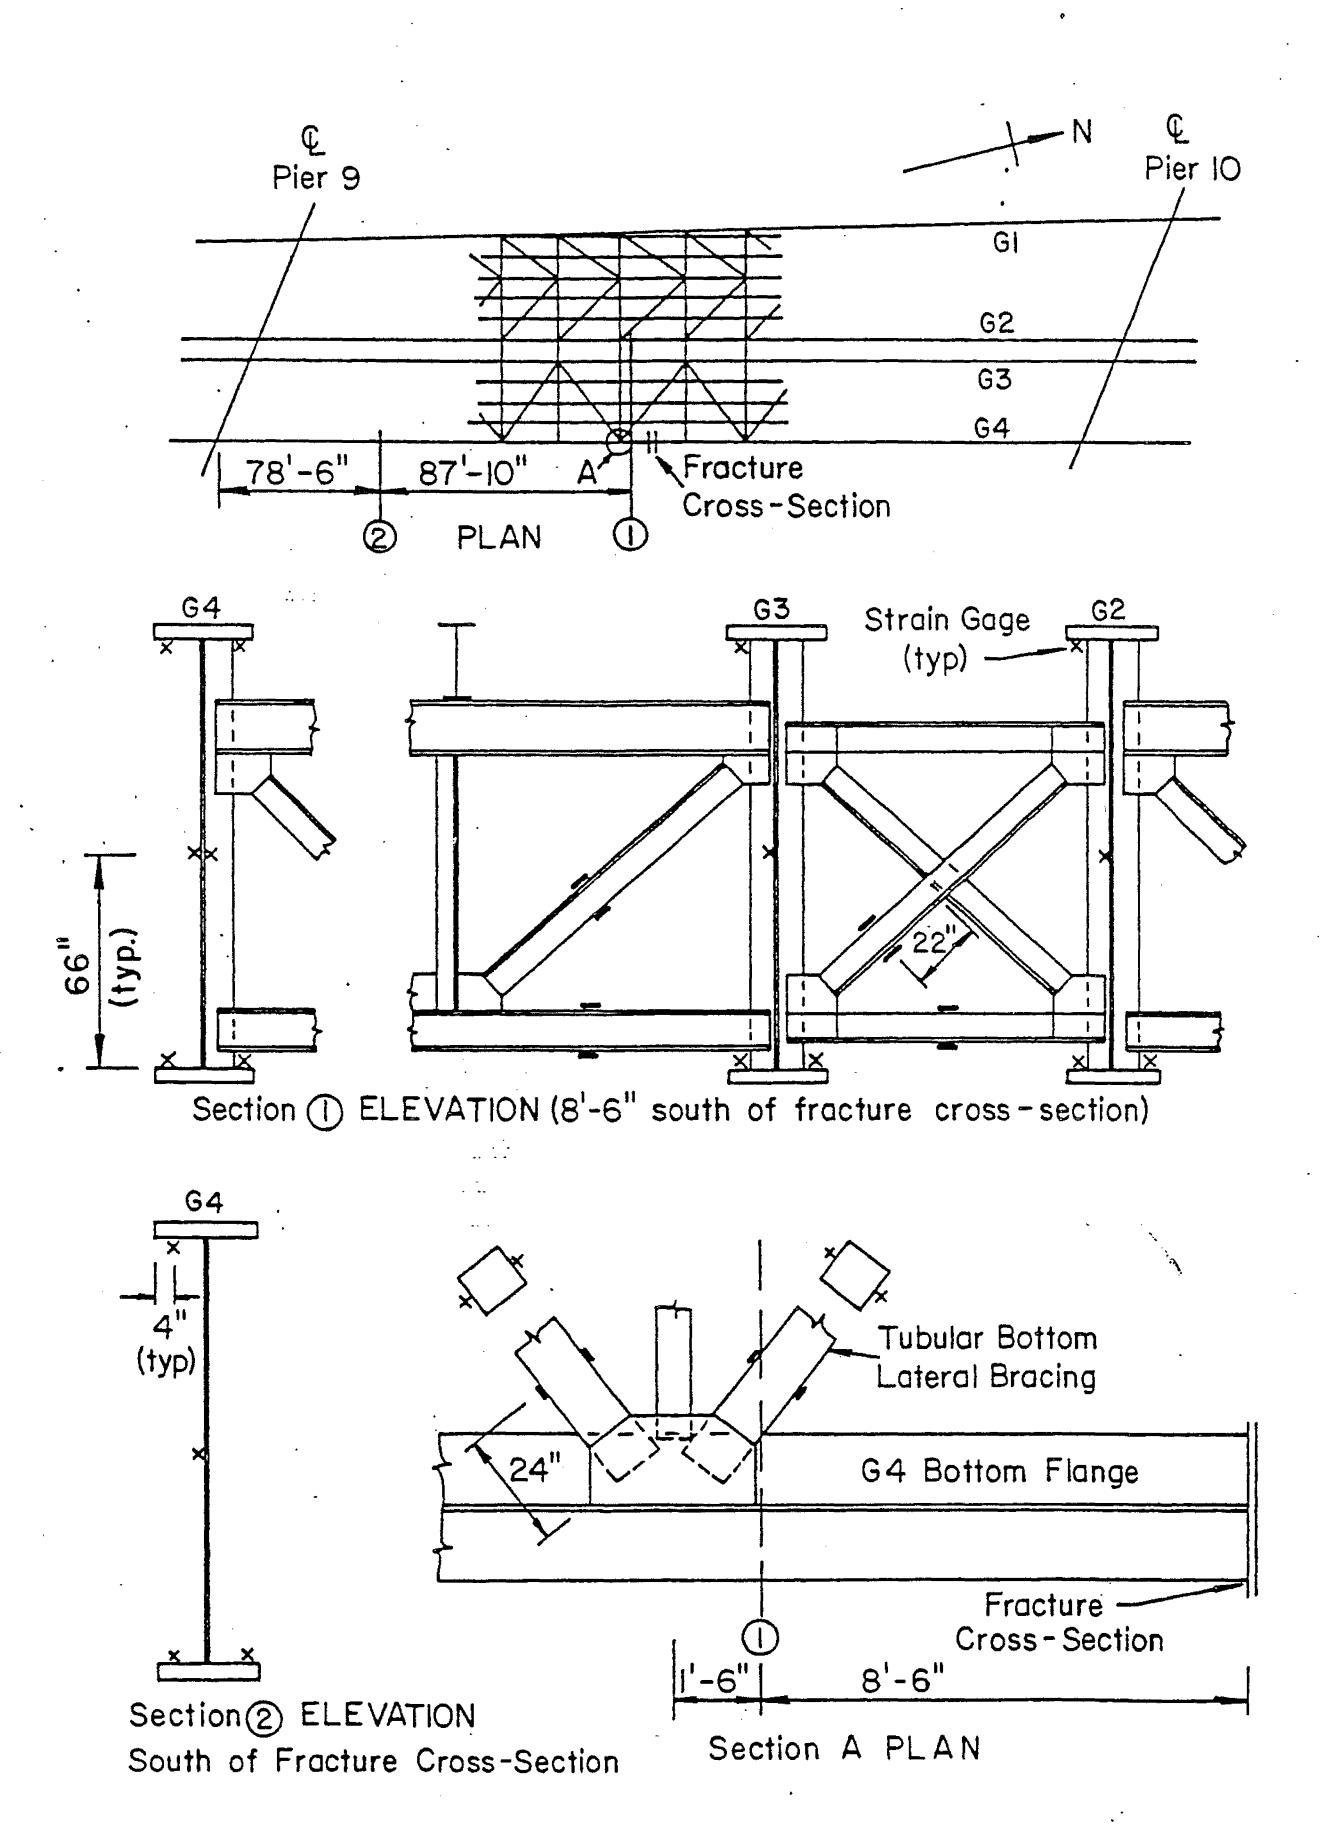
Fig. 8 Instrumentation of Splice Plates

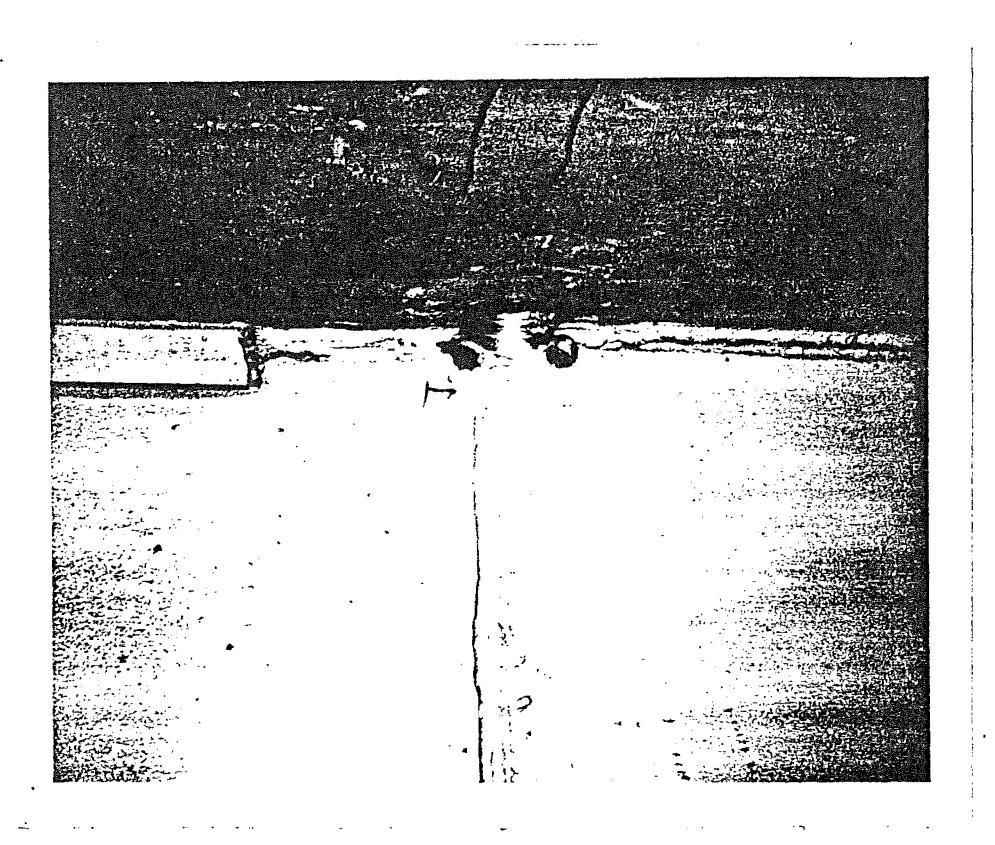
Fig. 14 Inside of Tie Girder Showing Holes in Web and Flange After Removal of Core

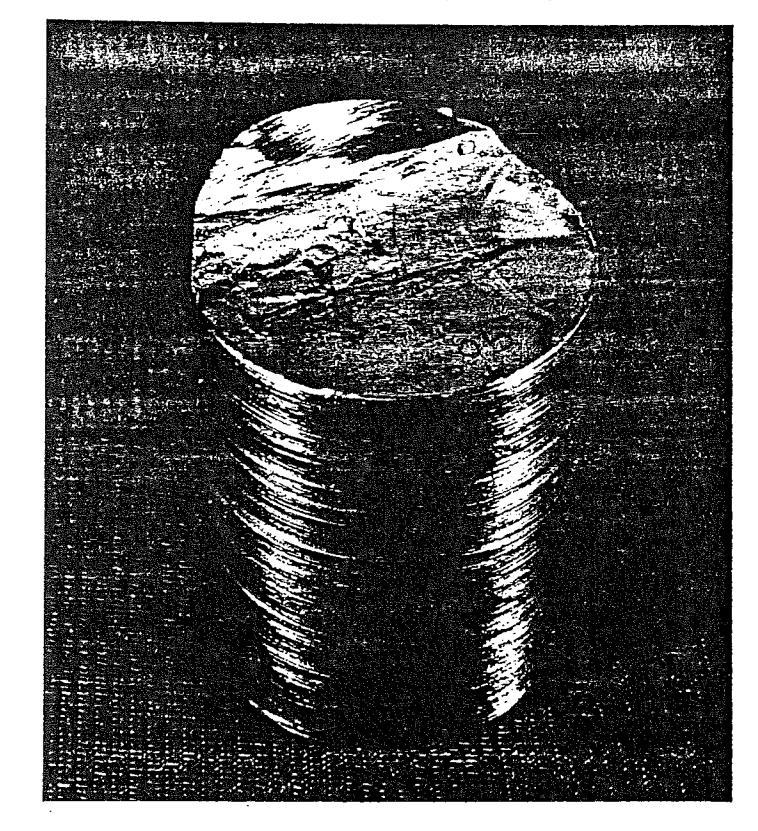
This crack, which extends into the portion of weld that was removed (see Fig. 15b), is the discontinuity detected by the PTL ultrasonic inspection.

Fig. 15b View of Core from Tied Arch Showing Inside Surface and Longitudinal Weld

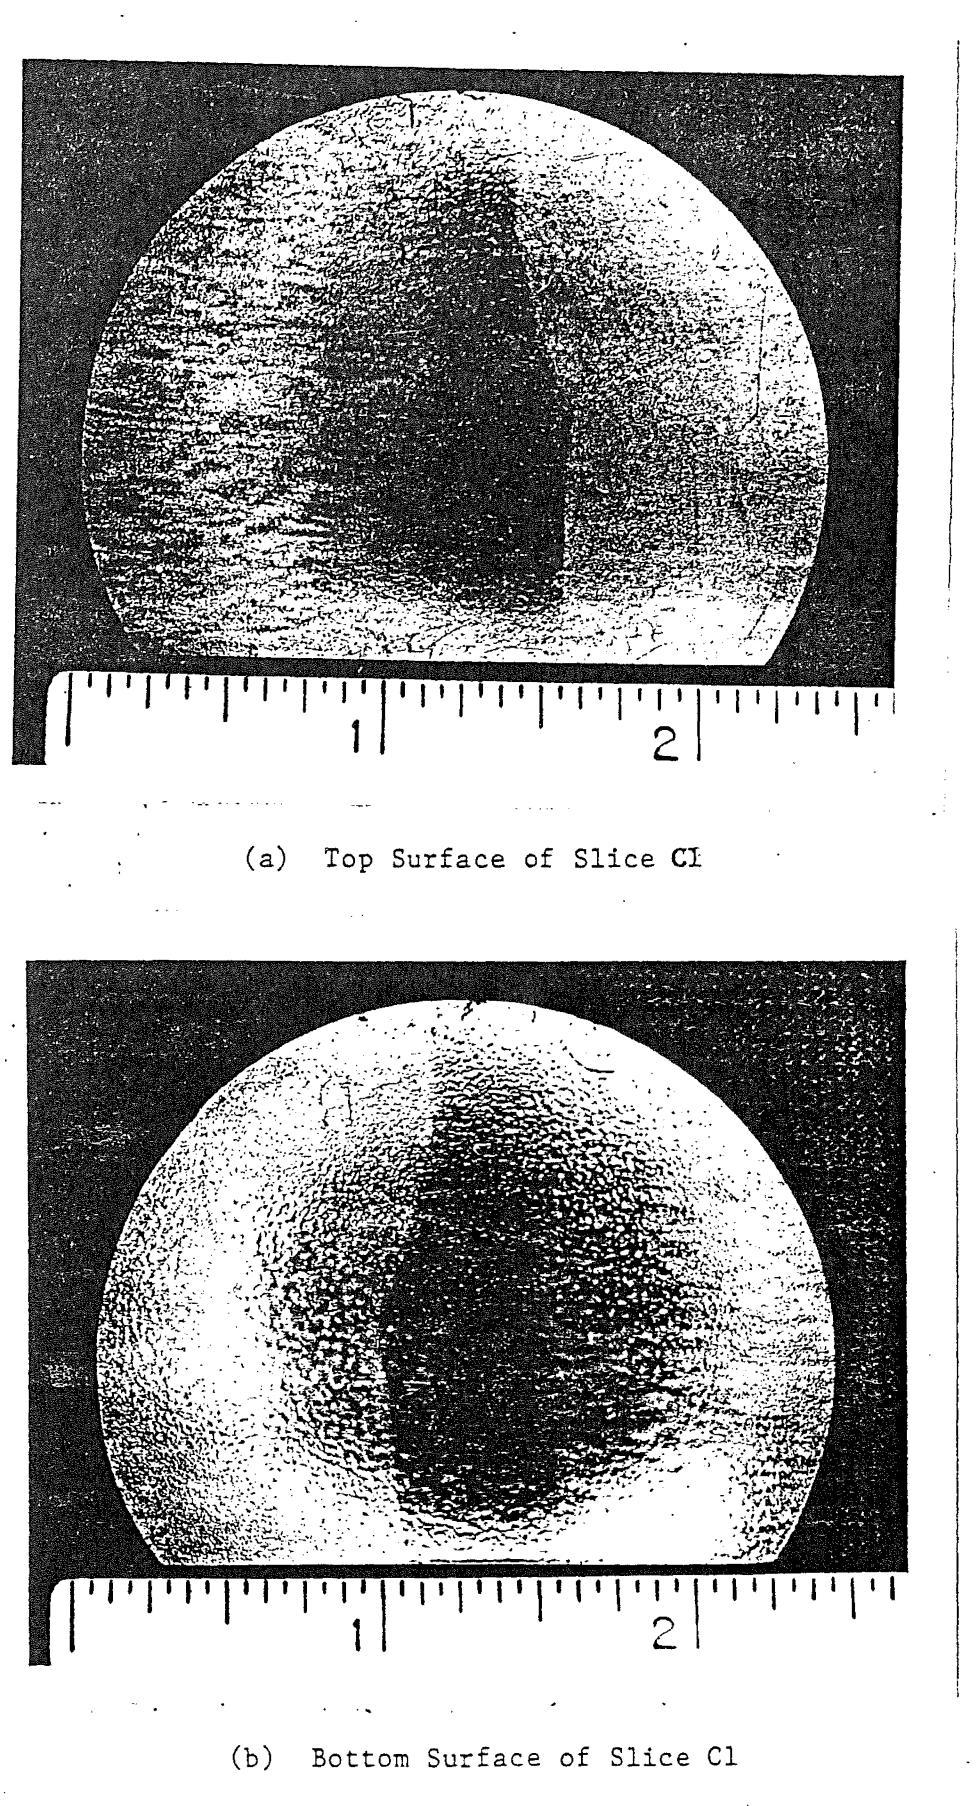
Figures 18, 19 and 20 show the polished and etched surfaces of the three slices used to fabricate Charpy V-notch specimens. No evidence of grain boundary fissures was detected in any of the surface layers. Cracking in the plug removed from the tie girder was confined to the conditions shown in Figs. 38 to 40.

Fig. 18 Polished and Etched Surfaces of Splice C1 Prior to Cutting Into Charpy V-Notch Specimens

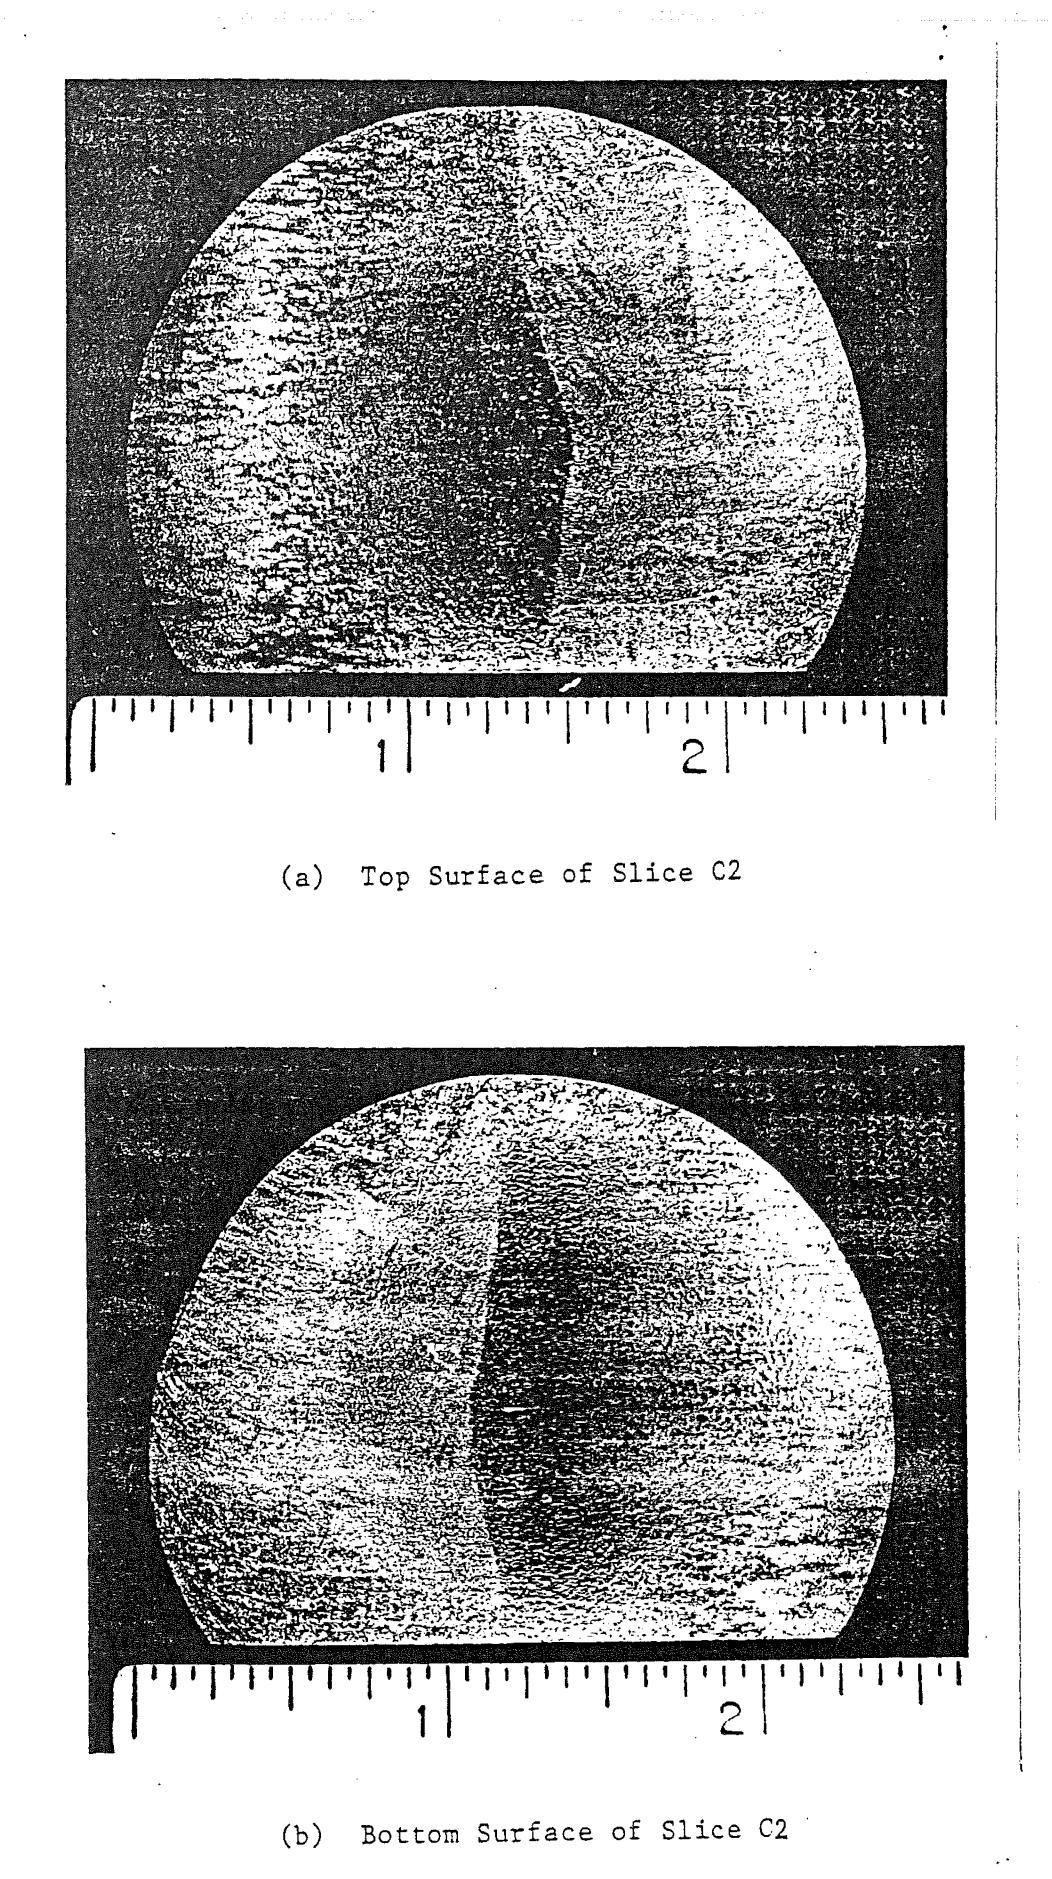
Fig. 19 Polished and Etched Surfaces of Slice C2 Prior to Cutting Into Charpy V-Notch Specimens

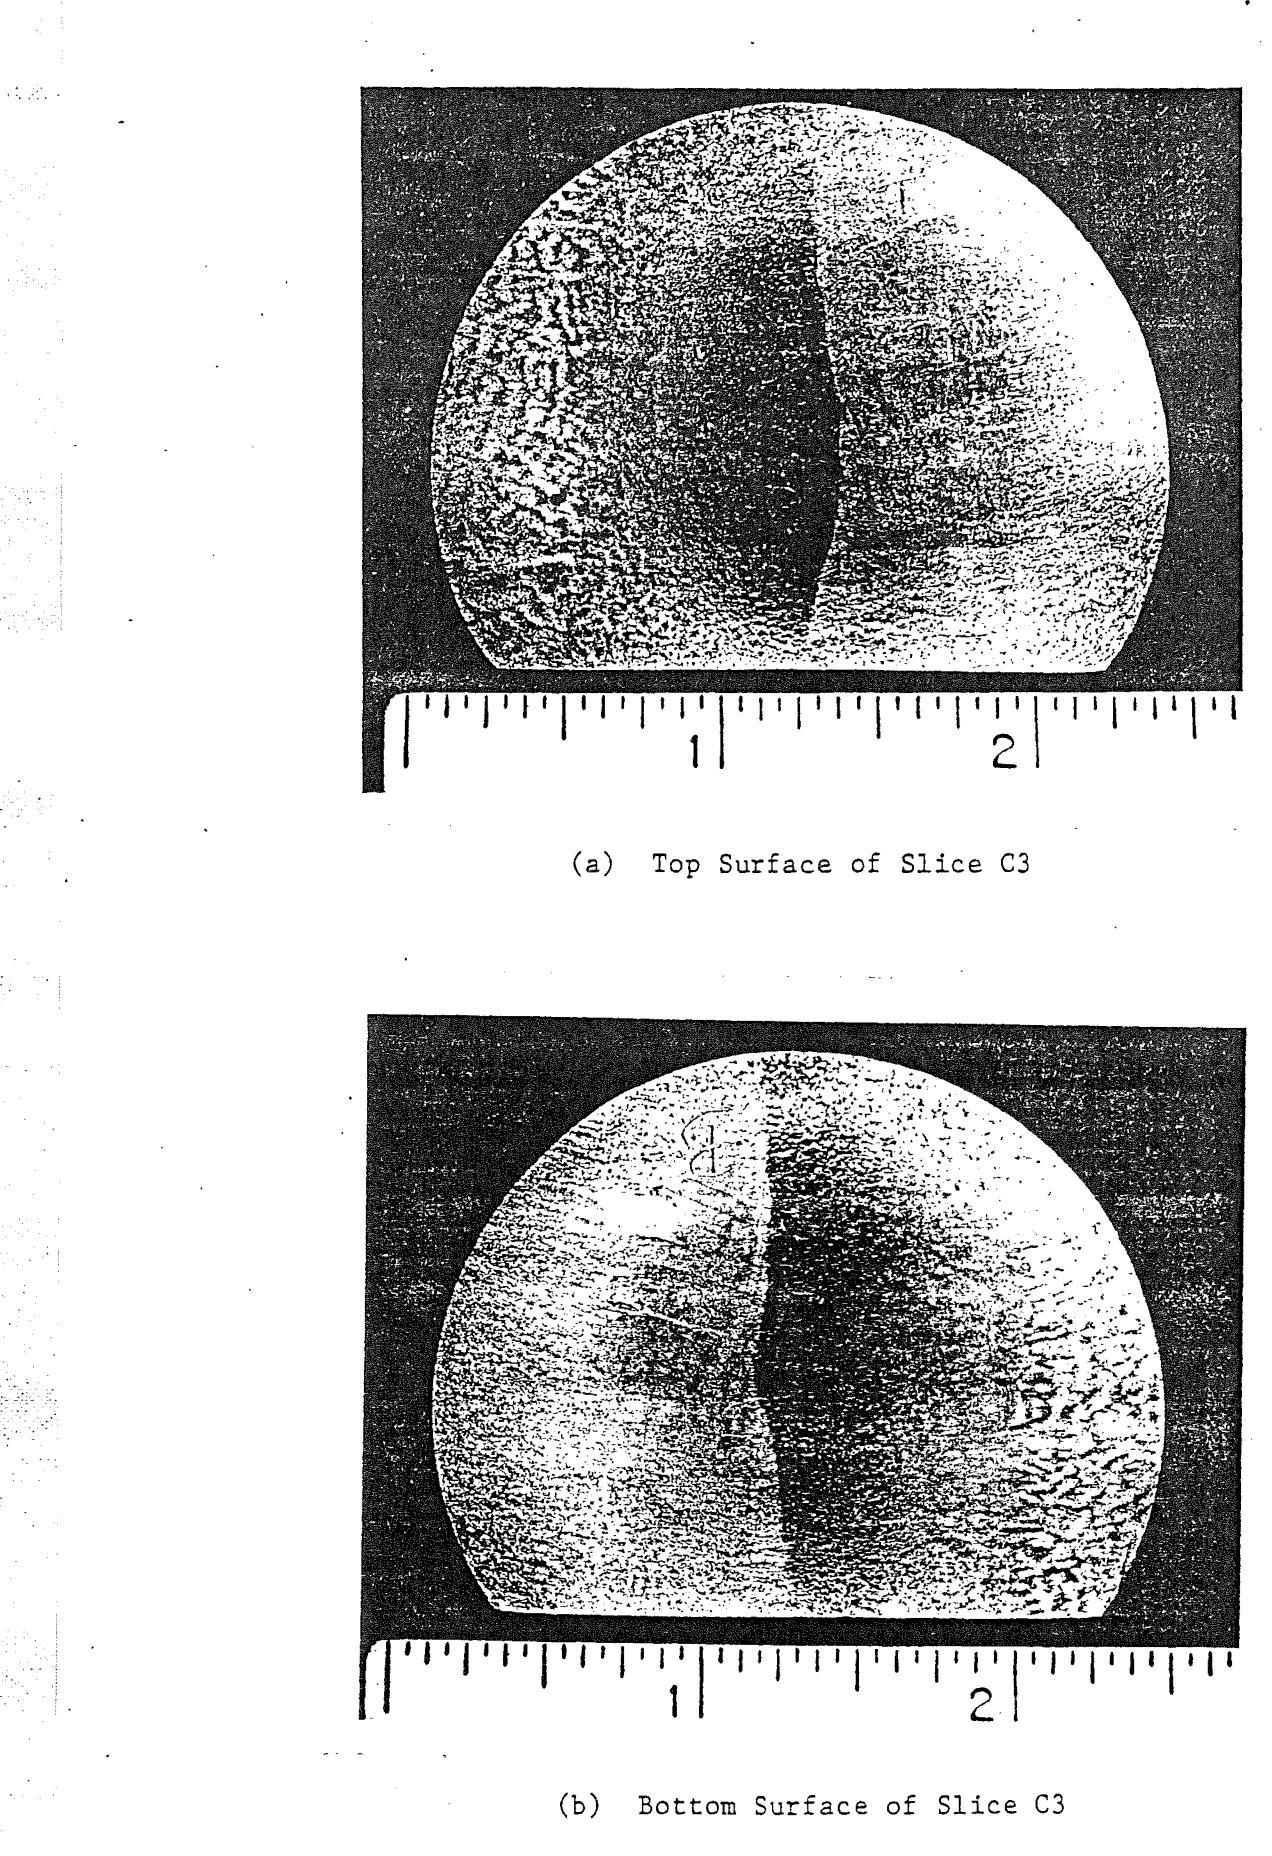
Fig. 20 Polished and Etched Surfaces of Slice C3 Prior to Cutting into Charpy V-Notch Specimens

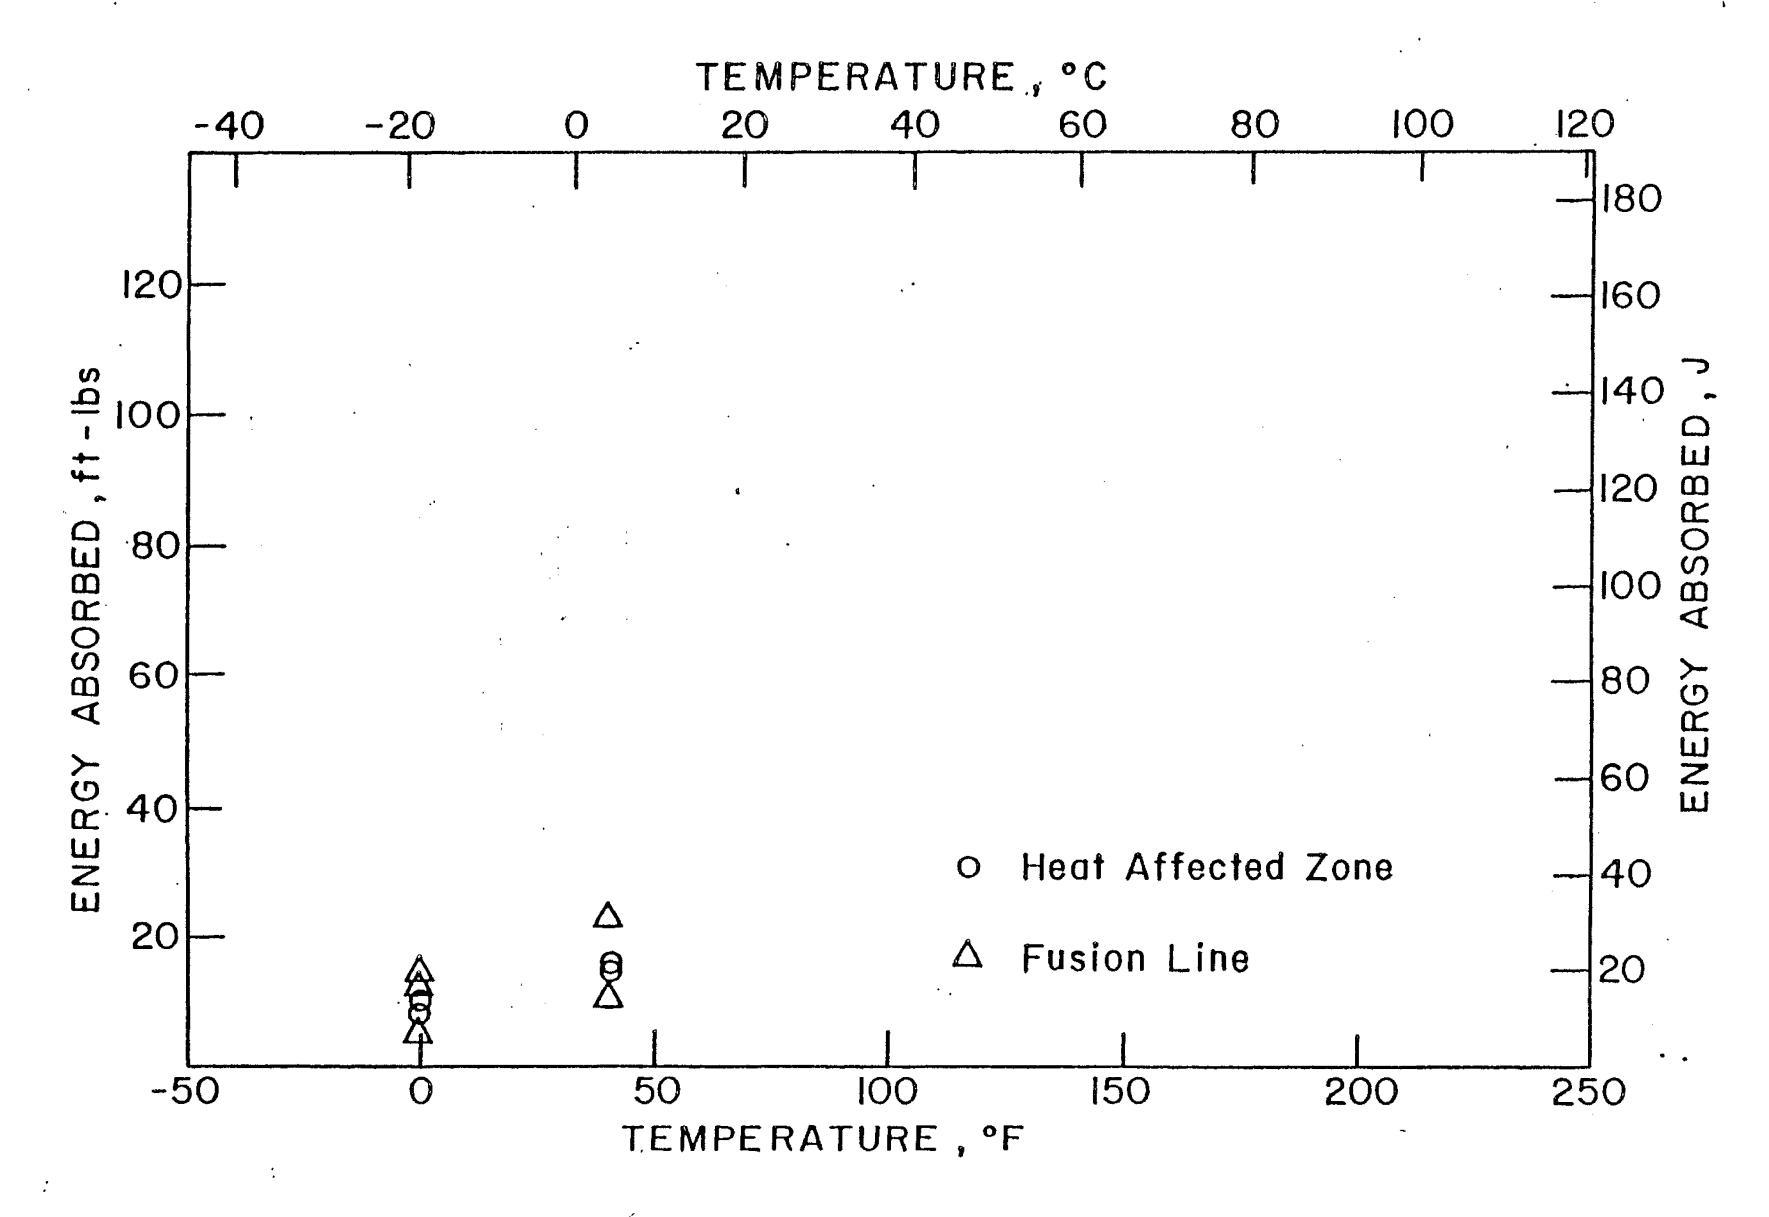
The Charpy V-notch test data obtained at the fusion line and heataffected zone are summarized in Fig. 24. The results suggest that the fracture toughness is comparable to the lower bound provided in Fig. 34 for the fusion line and heat-affected zone of the tie girder weld. Figure 92 shows the estimates of stress intensity and their relationship to the fracture resistance of the tied arch materials. Also shown are the test data for the two three Point bend specimens that were prepared from the top surface layer (see Fig. 17) and tested at -30° F $(-34^{\circ}$ C). The results indicate that the fracture resistance is equaled or exceeded at service temperatures between 0 and -30° F $(-18^{\circ}$ C and to -34° C).

Fig. 24 Summary of Charpy V-Notch Tests from the Tie Girder Core

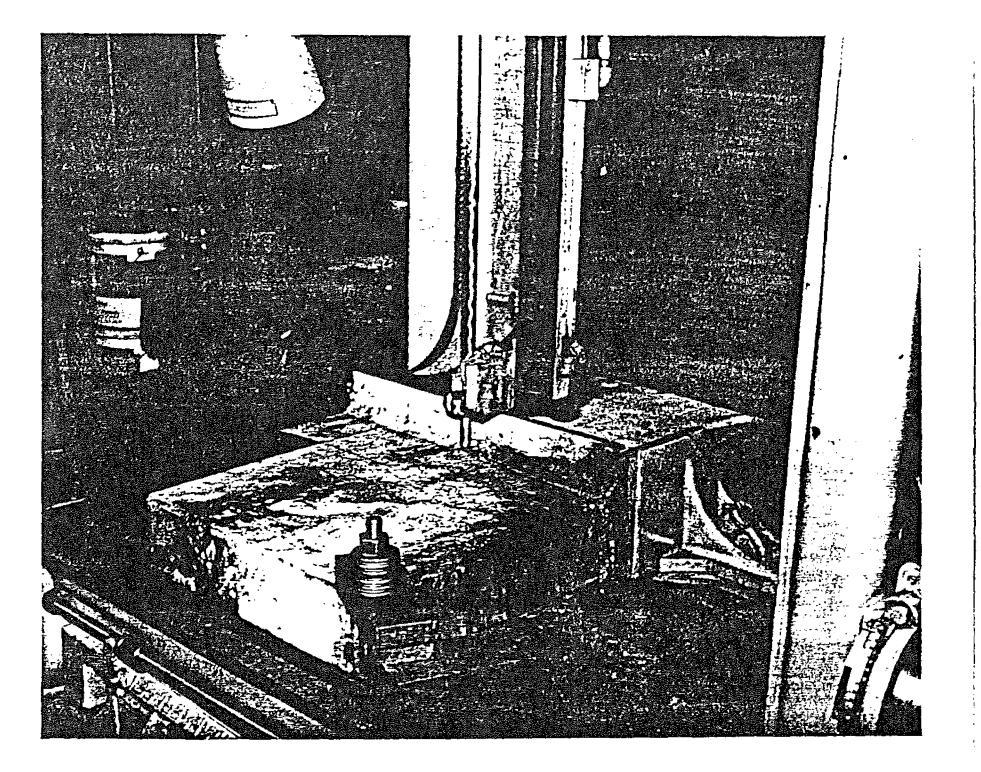
Fig. 26 South Section of Casualty Girder with Web Cut-Off and Segments Being Cut from the Flange

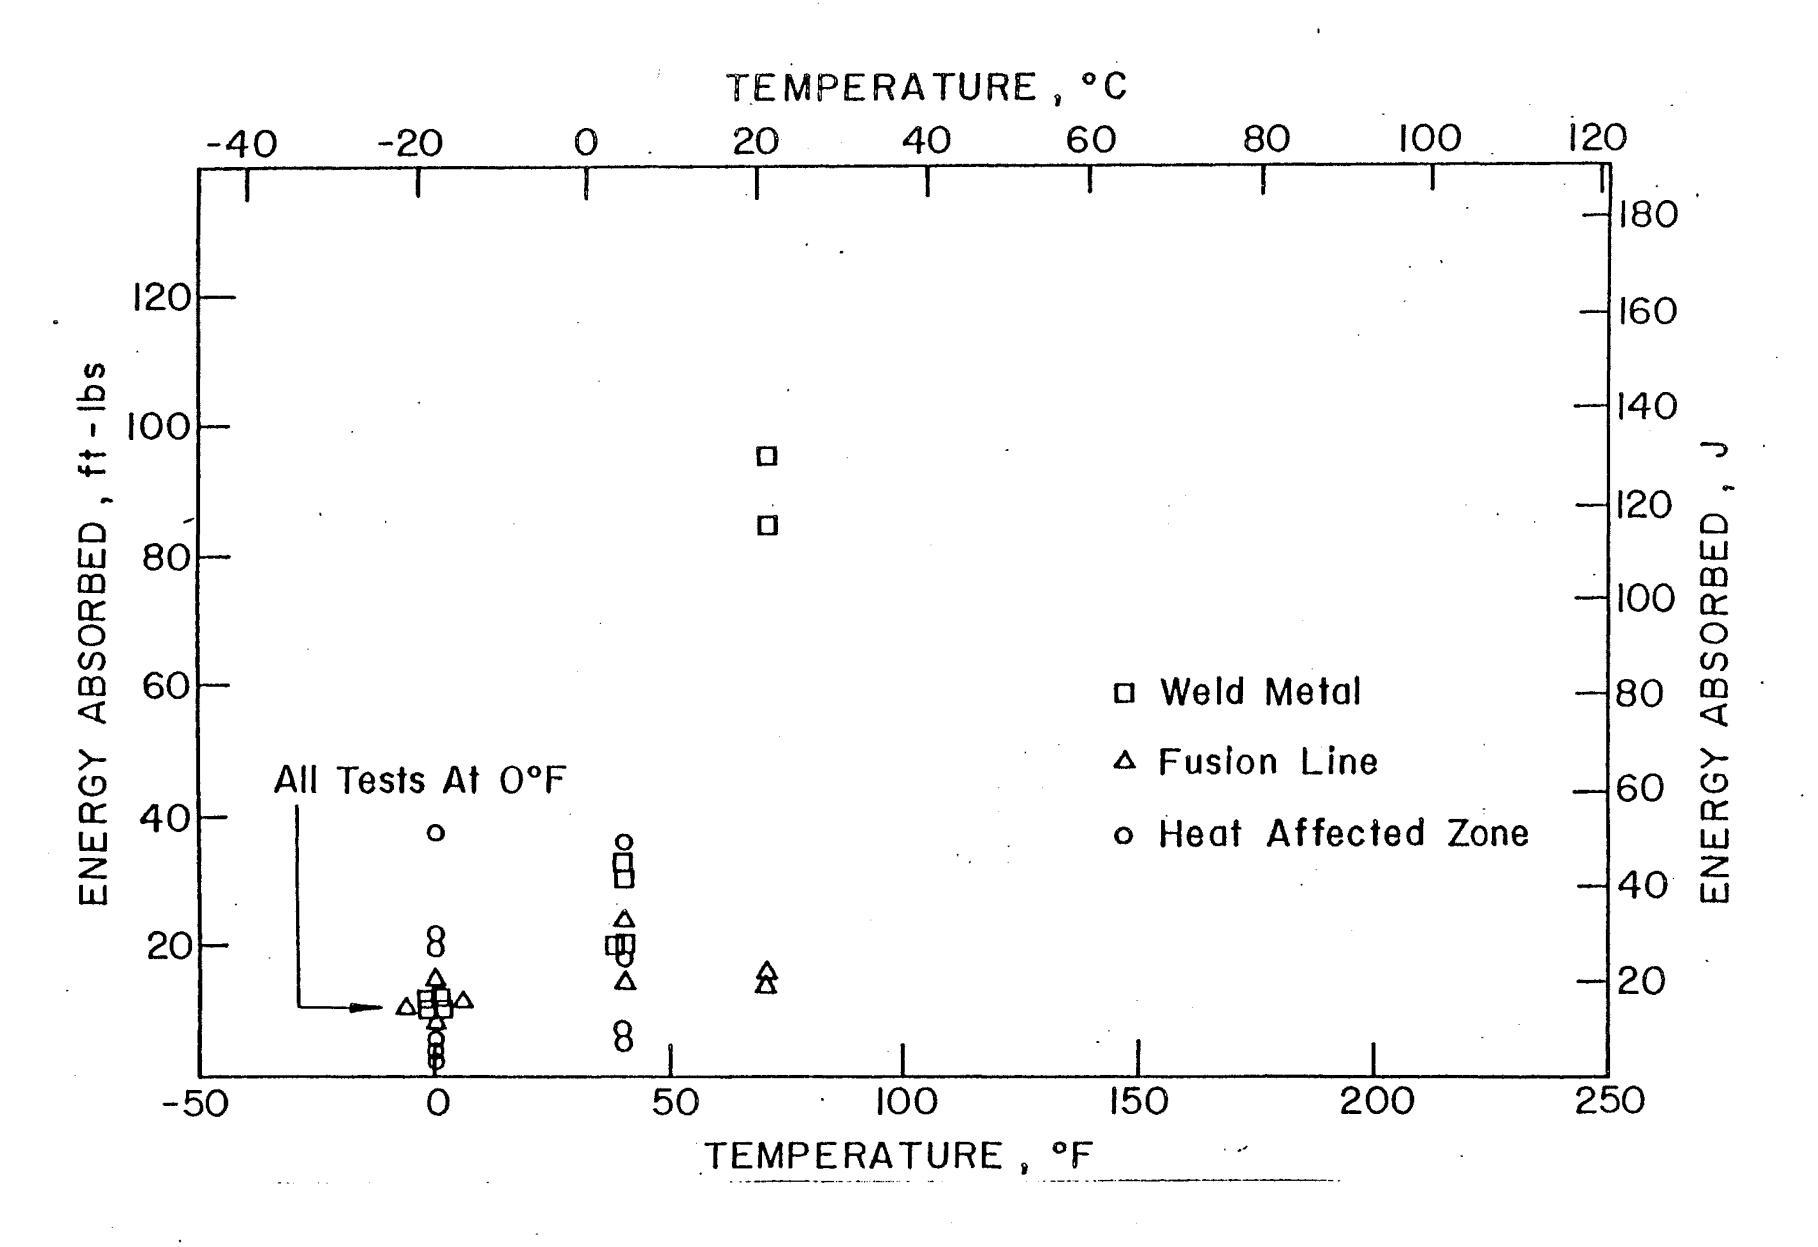
The test results of all Charpy V-notch specimens are tabulated in Table 4 and summarized in Fig. 30. The results suggest that the heataffected zone and fusion line provide a lower bound to the data. The fusion line absorbed energy does not experience a sharp transition as does the weld metal. The weld metal toughness is slightly better than provided by the tied arch weldment.

Fig. 30 Results of Charpy V-Notch Tests from Casualty Girder Weldment

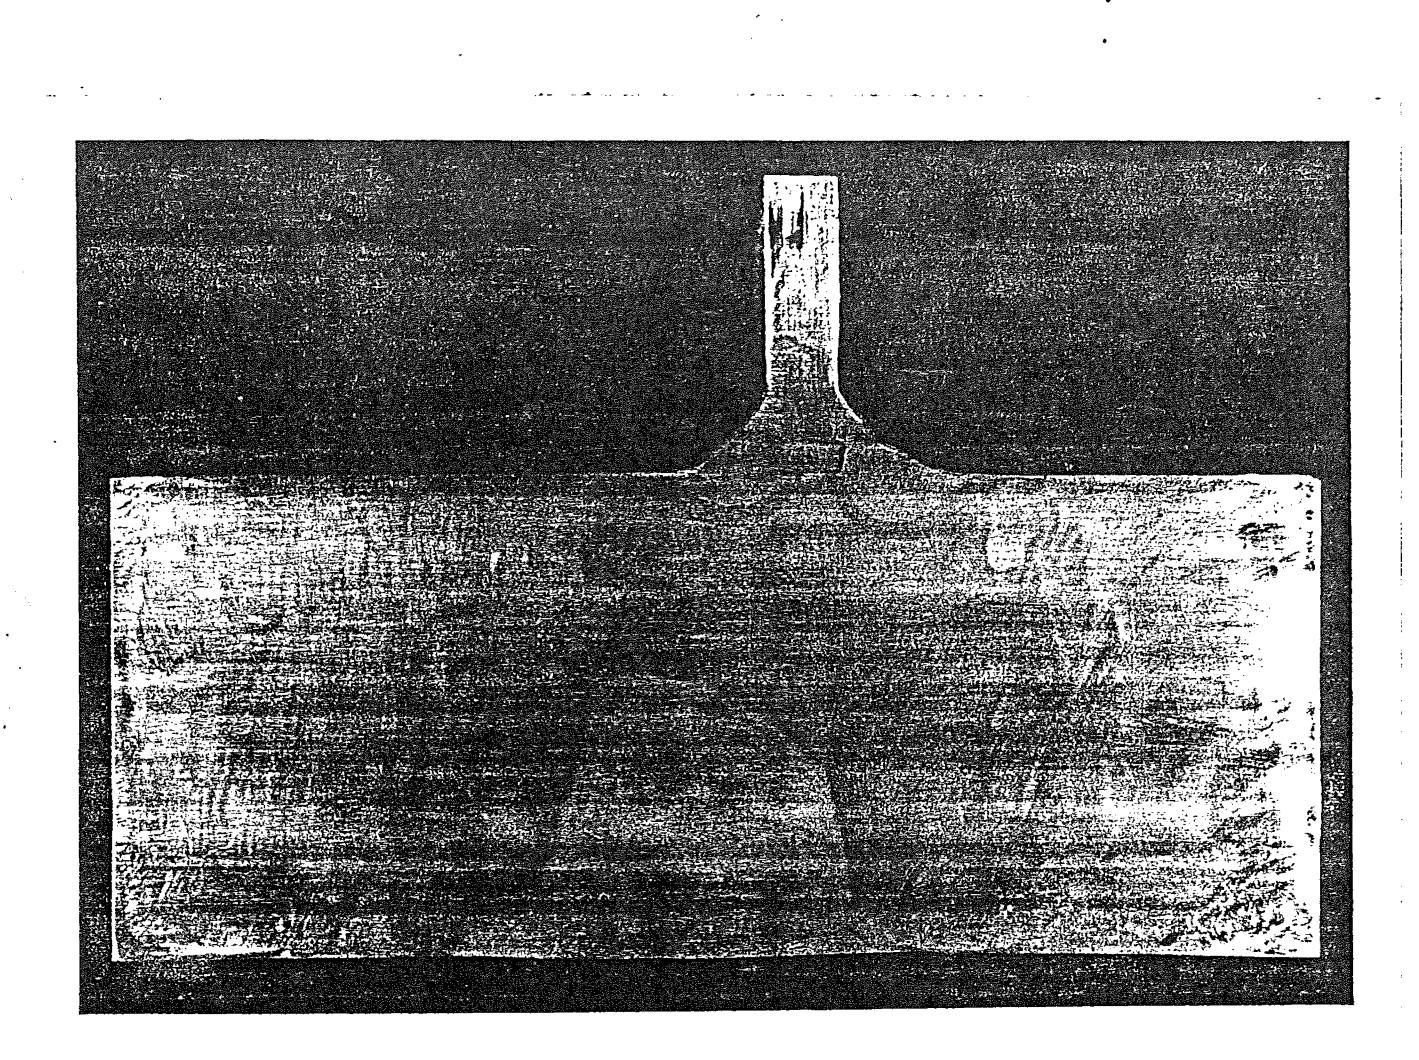
indicated that several fusion line repair passes were made (see Fig. 51a) prior to excavating a major boat-shaped cavity through the weld and into the connected plates in the longitudinal direction (see Fig. 51b). Figure 31a shows the polished and etched top surface of the flange and weld adjacent to the webs. The transverse fusion line weld passes that were made prior to the longitudinal repairs can be seen. The top and bottom surfaces shown in Fig. 31a and b also show the major weld repair that is shown in Fig. 51b. The back surface of Section II shown in Fig. 31c is about 3-1/2 in. (89 mm) from the fracture surface. It indicates that the major repair extends just over halfway through the flange thickness at this location. The longitudinal passes shown in Fig. 31a at the end of the piece are seen to be just cosmetic passes at the end of the section shown in Fig. 31c.

Fig. 31c Etched Surface of Flange about 3 1/2 Inches Behind Crack

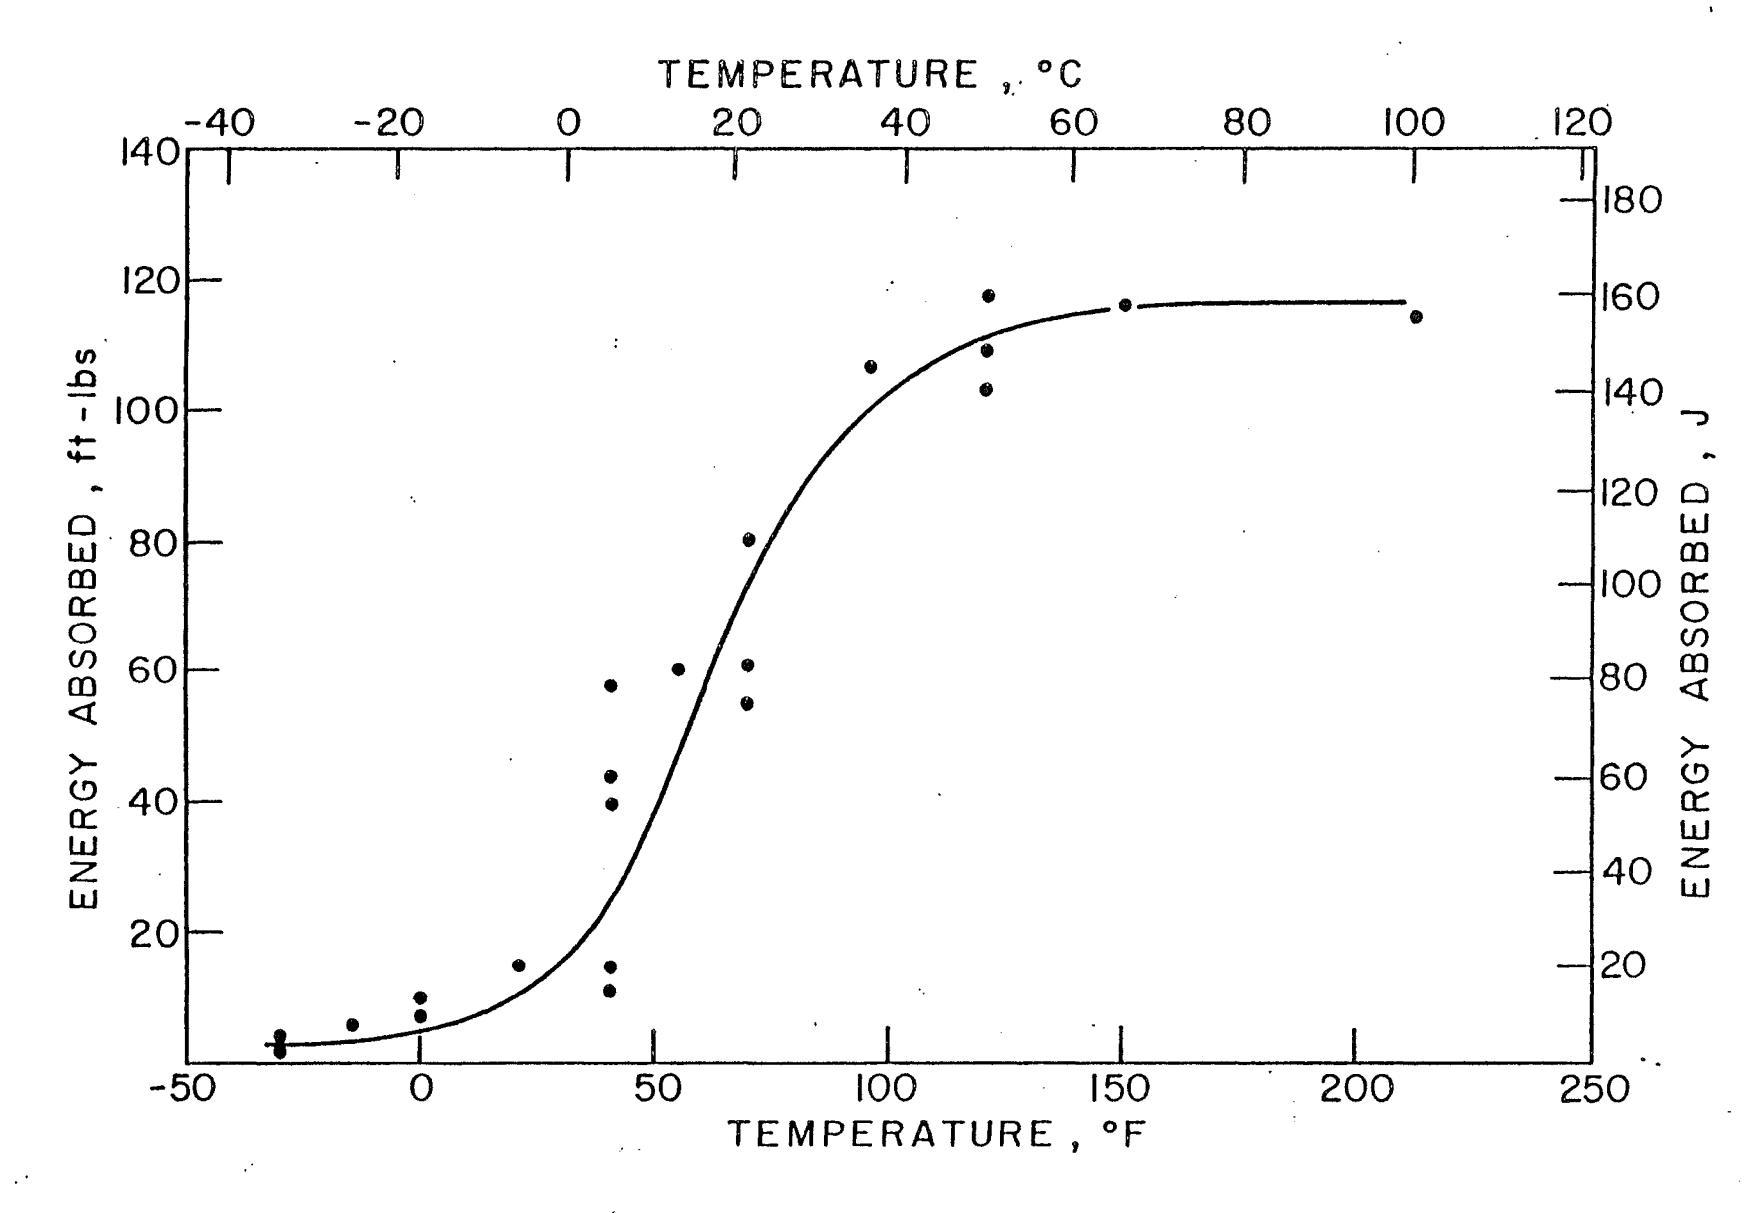
Tests were also carried out on the A588 base metal. The Charpy V-notch tests are tabulated in Table 6 and summarized in Fig. 33. The base metal did satisfy the AASHTO requirements for Zone II. The transition temperature is about 40° F (44° C).

Fig. 33 , Charpy V-Notch Test Results of Flange Base Metal
