AN EVALUATION OF THE FRACTURE OF THE 179 BACK CHANNEL GIRDER

AND THE ELECTROSLAG WELDS IN THE 179 COMPLEX

Report No. 425-1(80)

Project 77-5: Evaluation of Glenfield Bridge Fracture

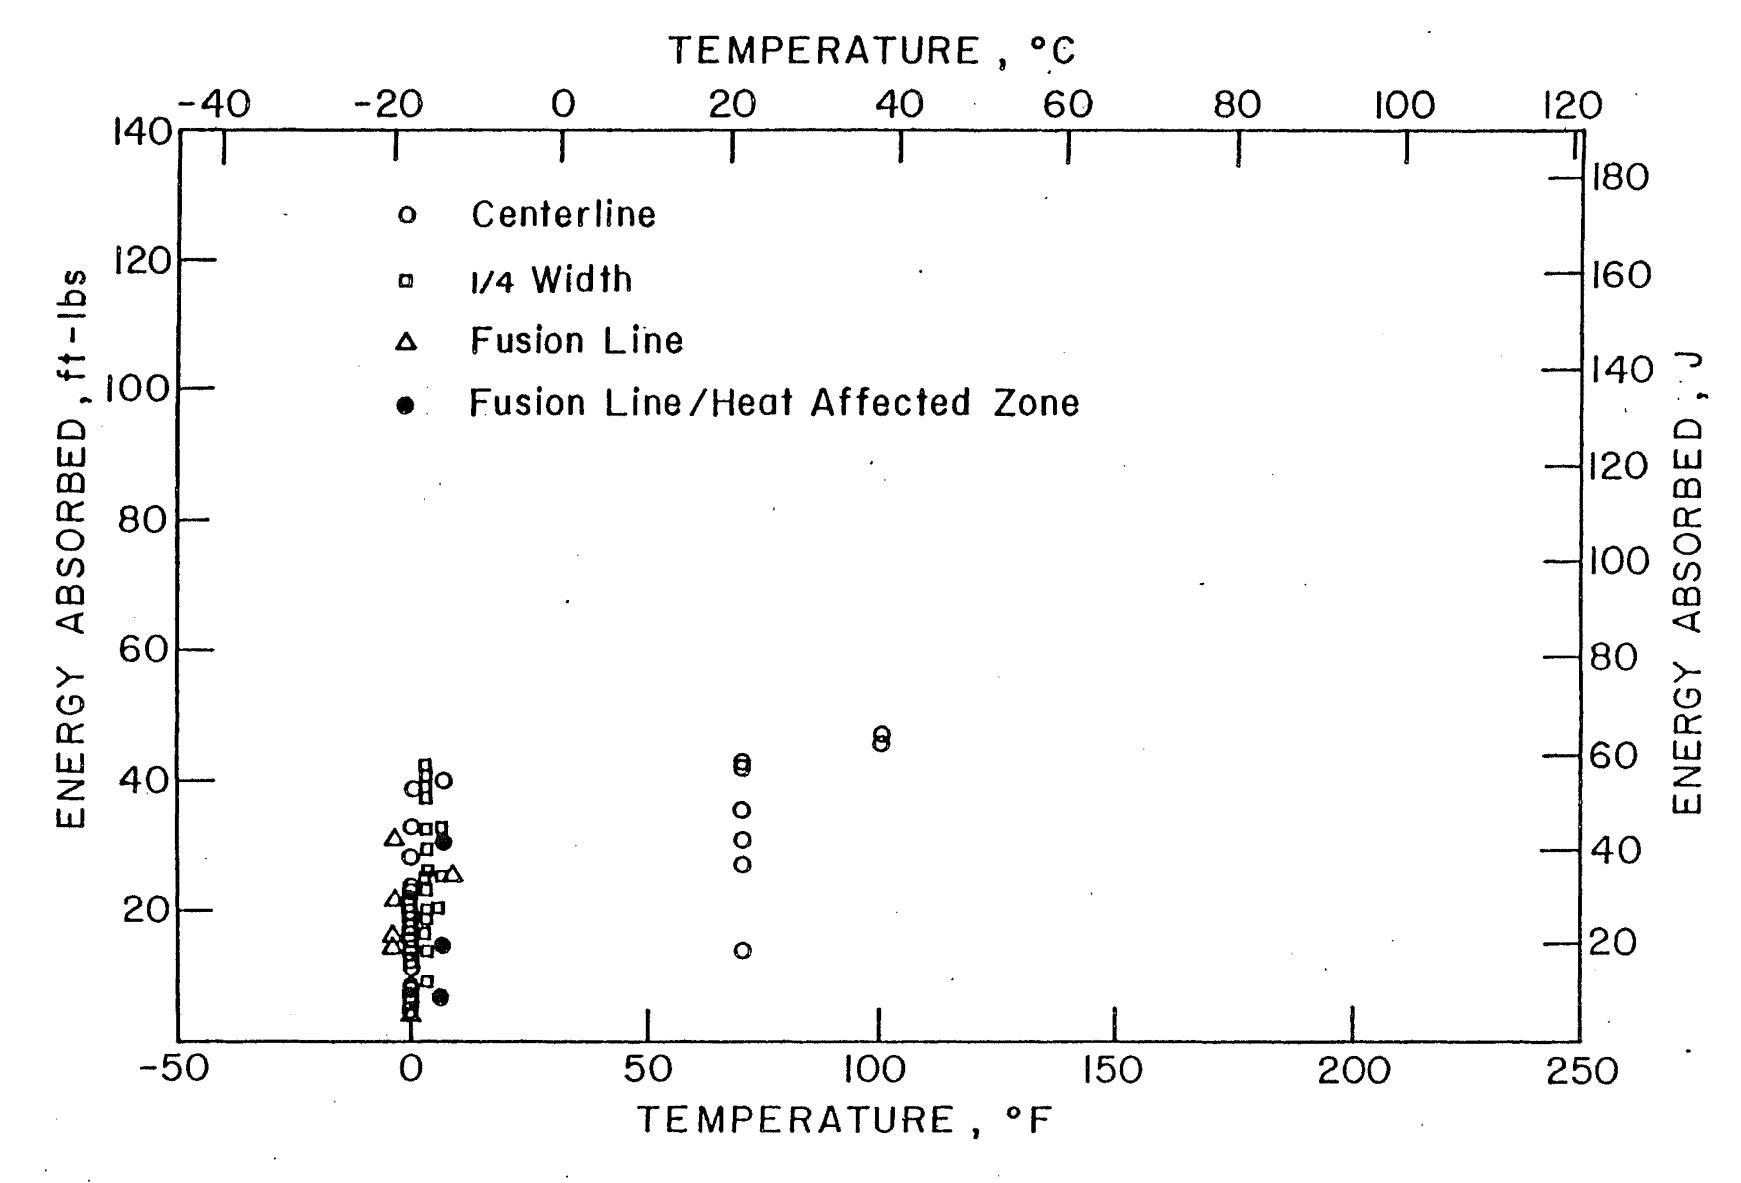
As can be seen in Figs. 36 and 37, the fracture toughness of the back channel structures was not significantly greater than the casualty girder. Hence, the reserve fracture capacity of the ramp D girder was not adequate for a defect located at an electroslag weld. This was particularly true since crack extension was possible under the service loads.

Fig. 36 Results of Charpy V-Notch Tests on Back Channel Cores

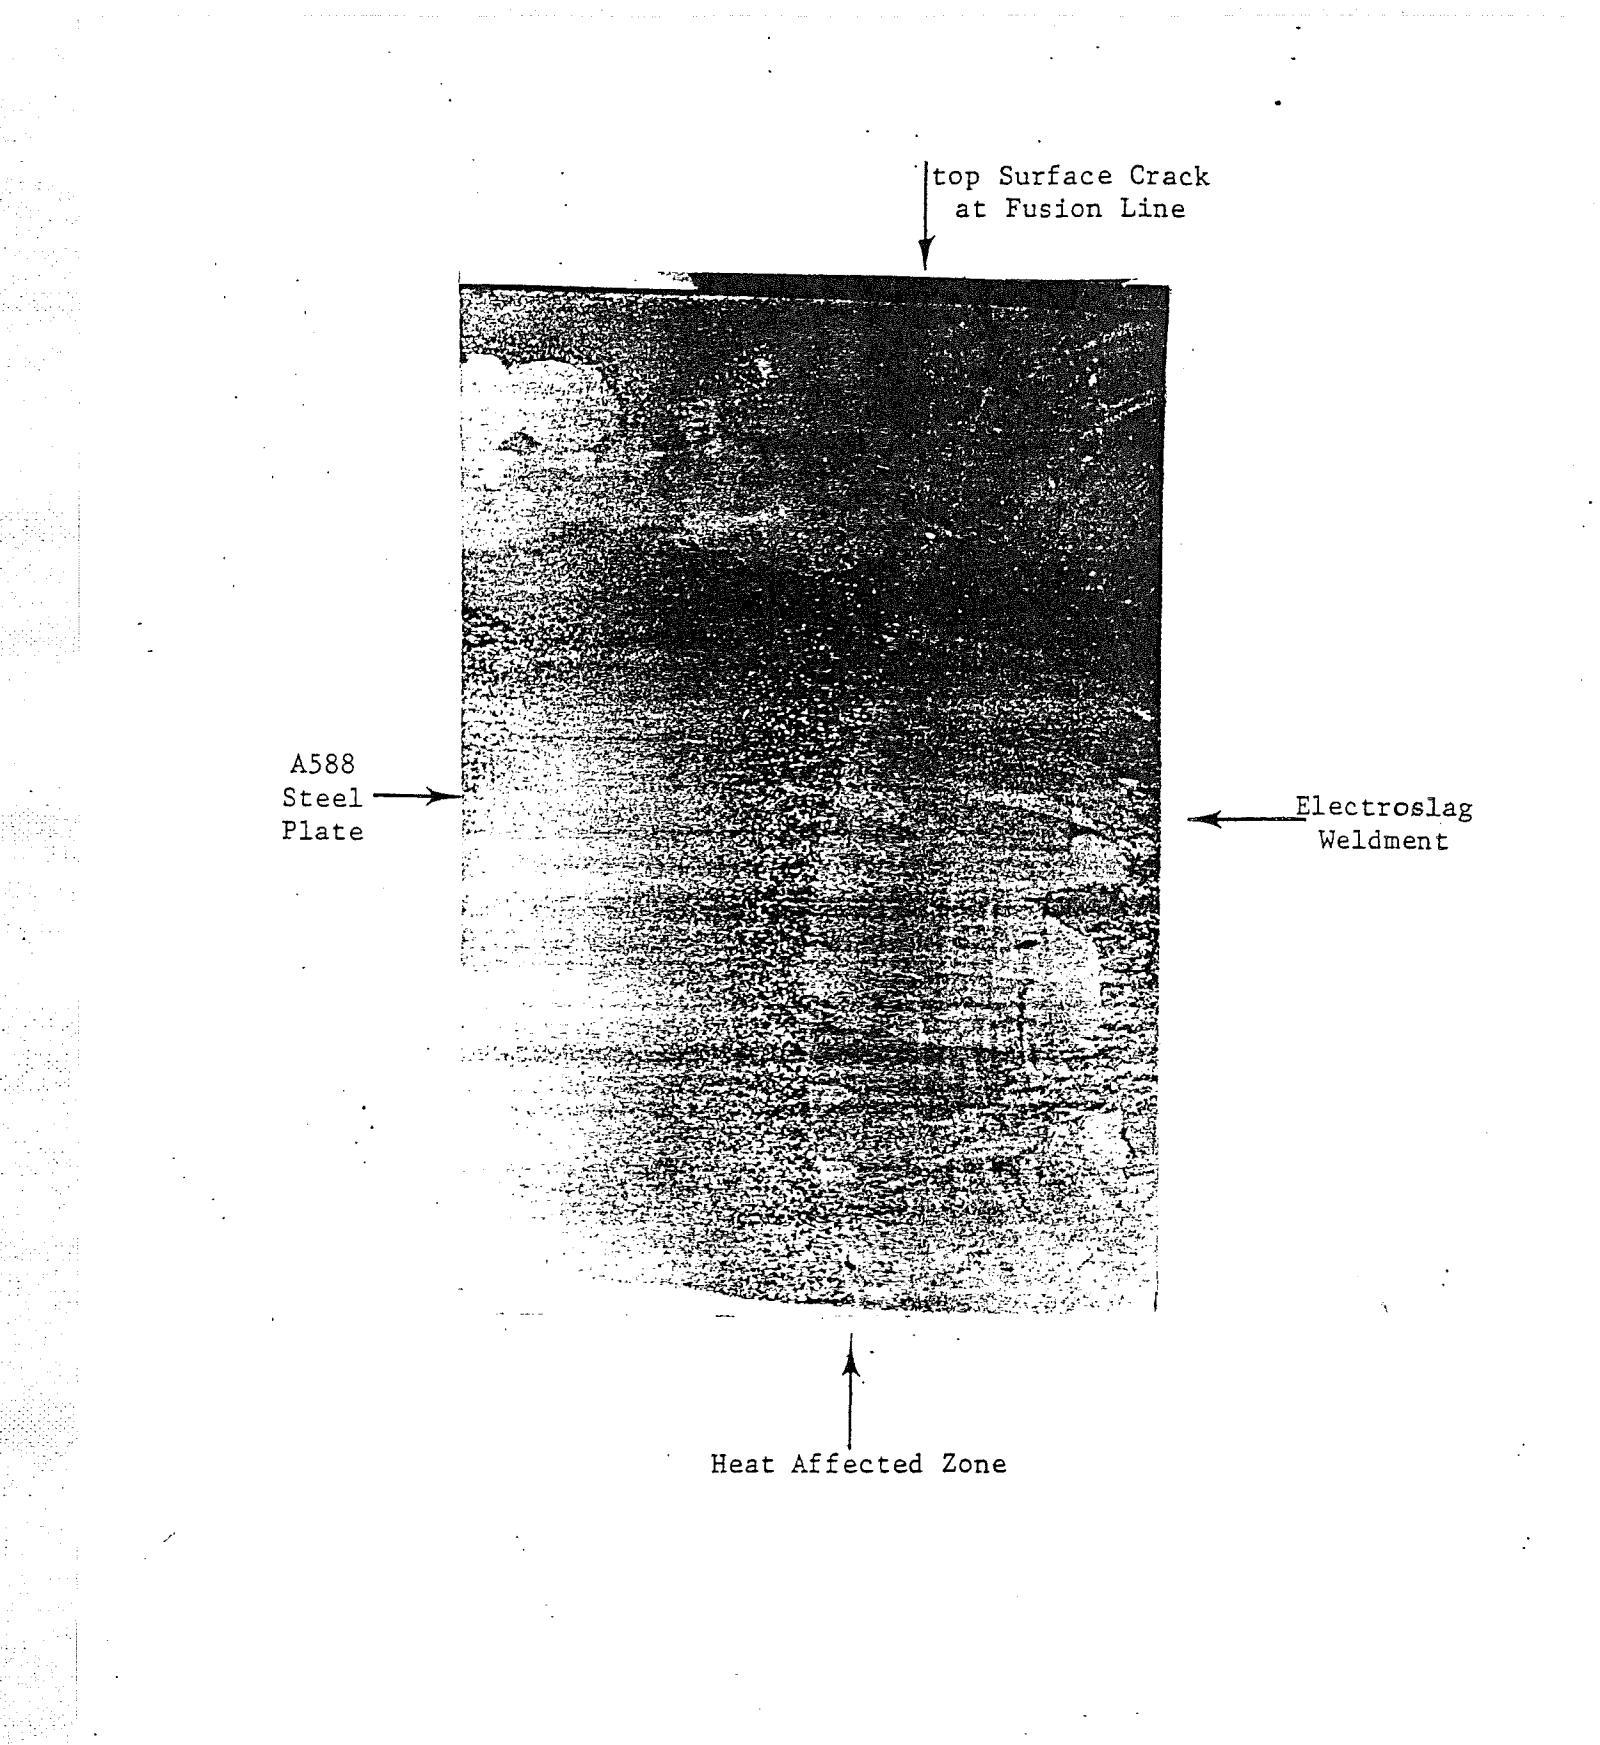
Fig. 40a Polished and Etched Edge of Flange Plate and Electroslag Weldment from the Girder

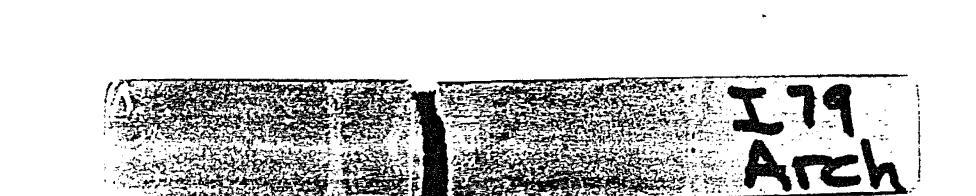
Fig. 41 Small Beam Specimen Fabricated From Tie Girder Slice With Natural Crack

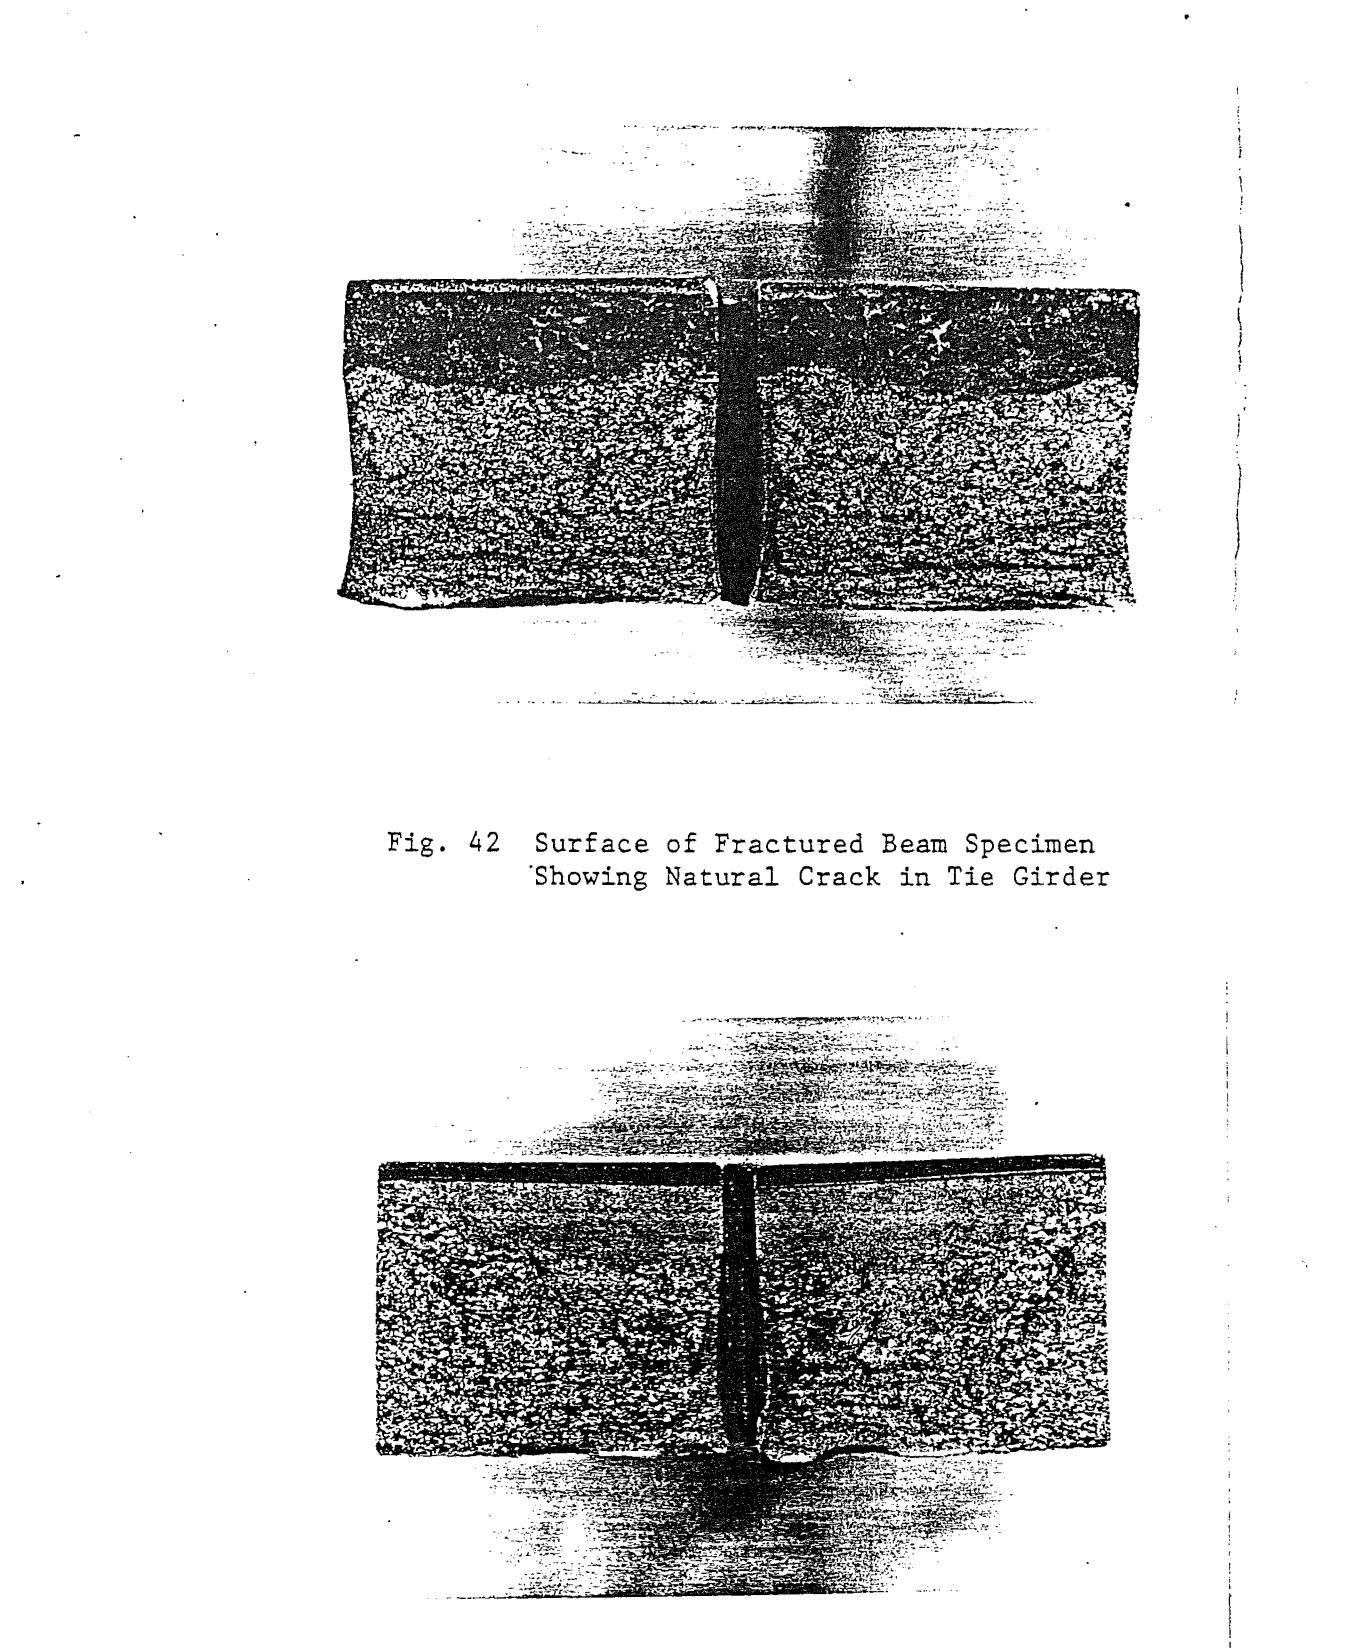
Fig. 43 Surface of Precracked Beam Specimen From Tie Girder Weld

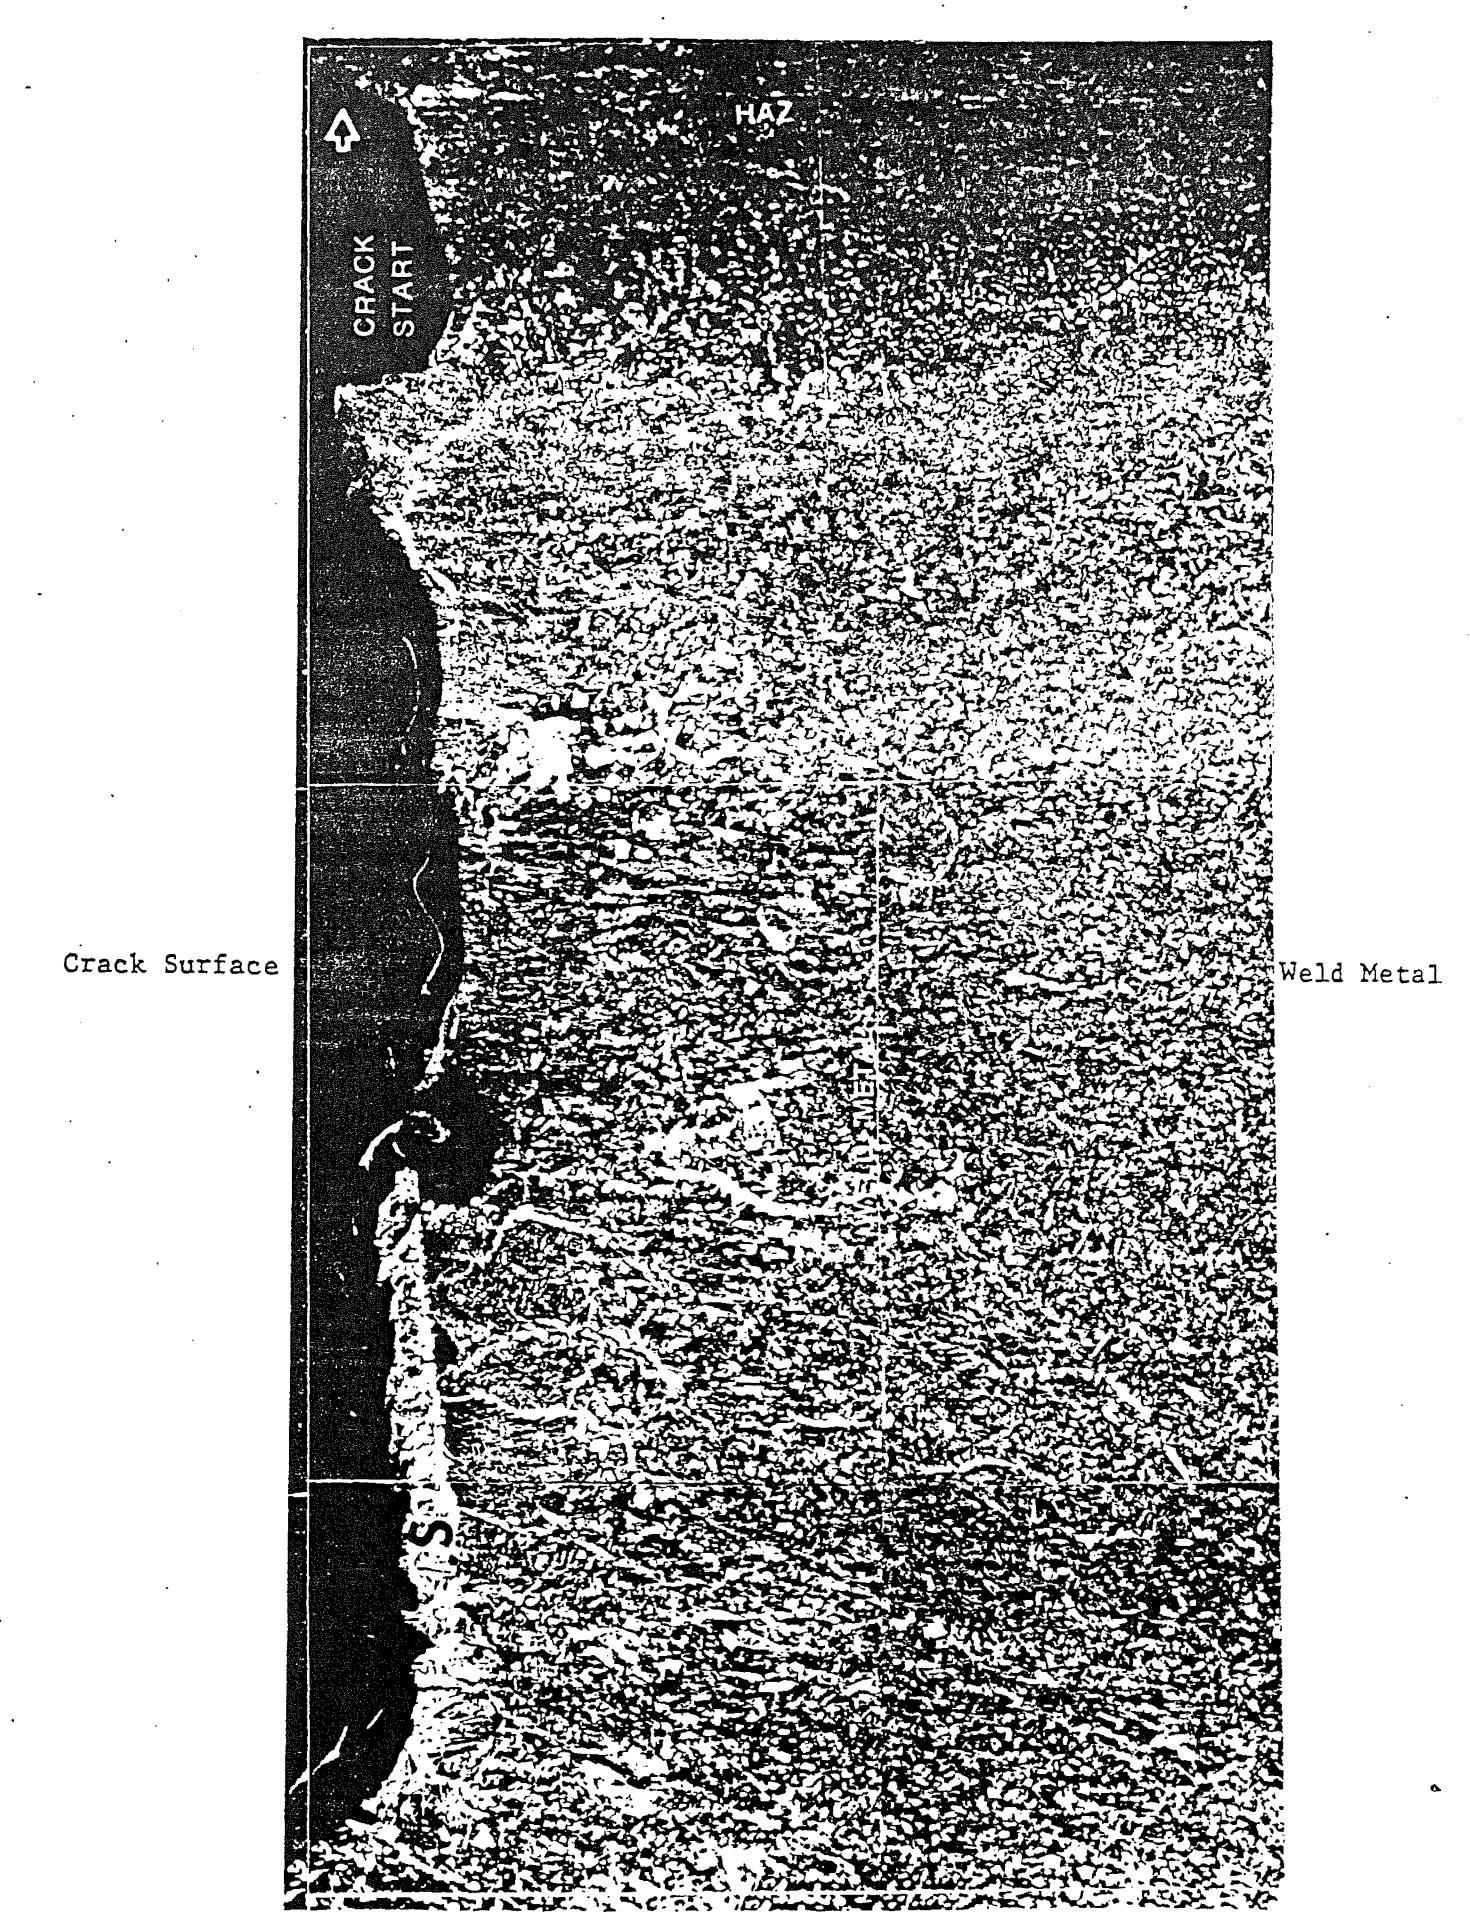
Figure 44a Microstructure Near Crack Surface 100X Nital Etch

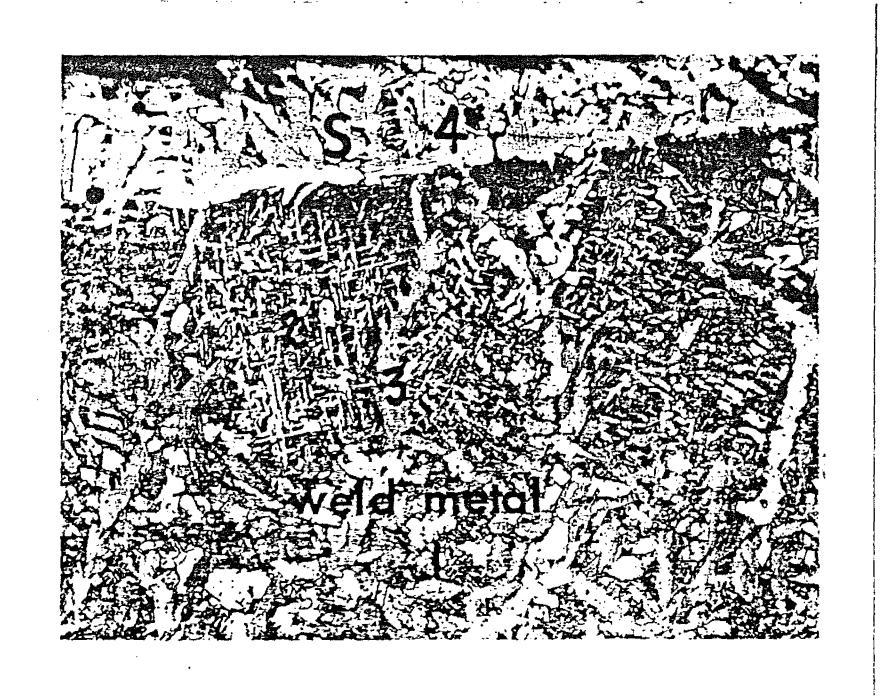
Fig. 44b Microprobe Analysis of weld adjacent to crack

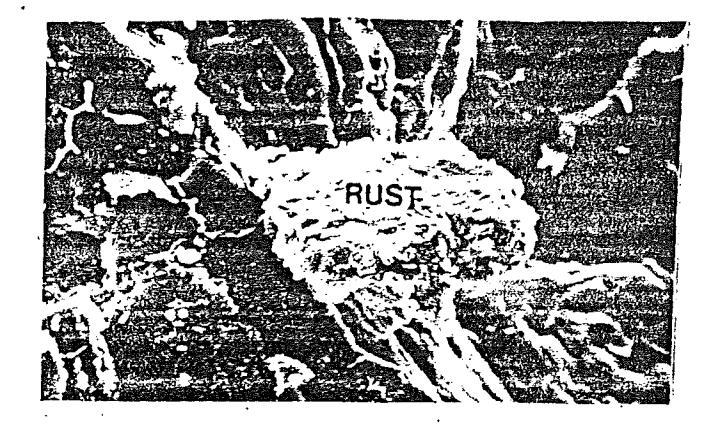
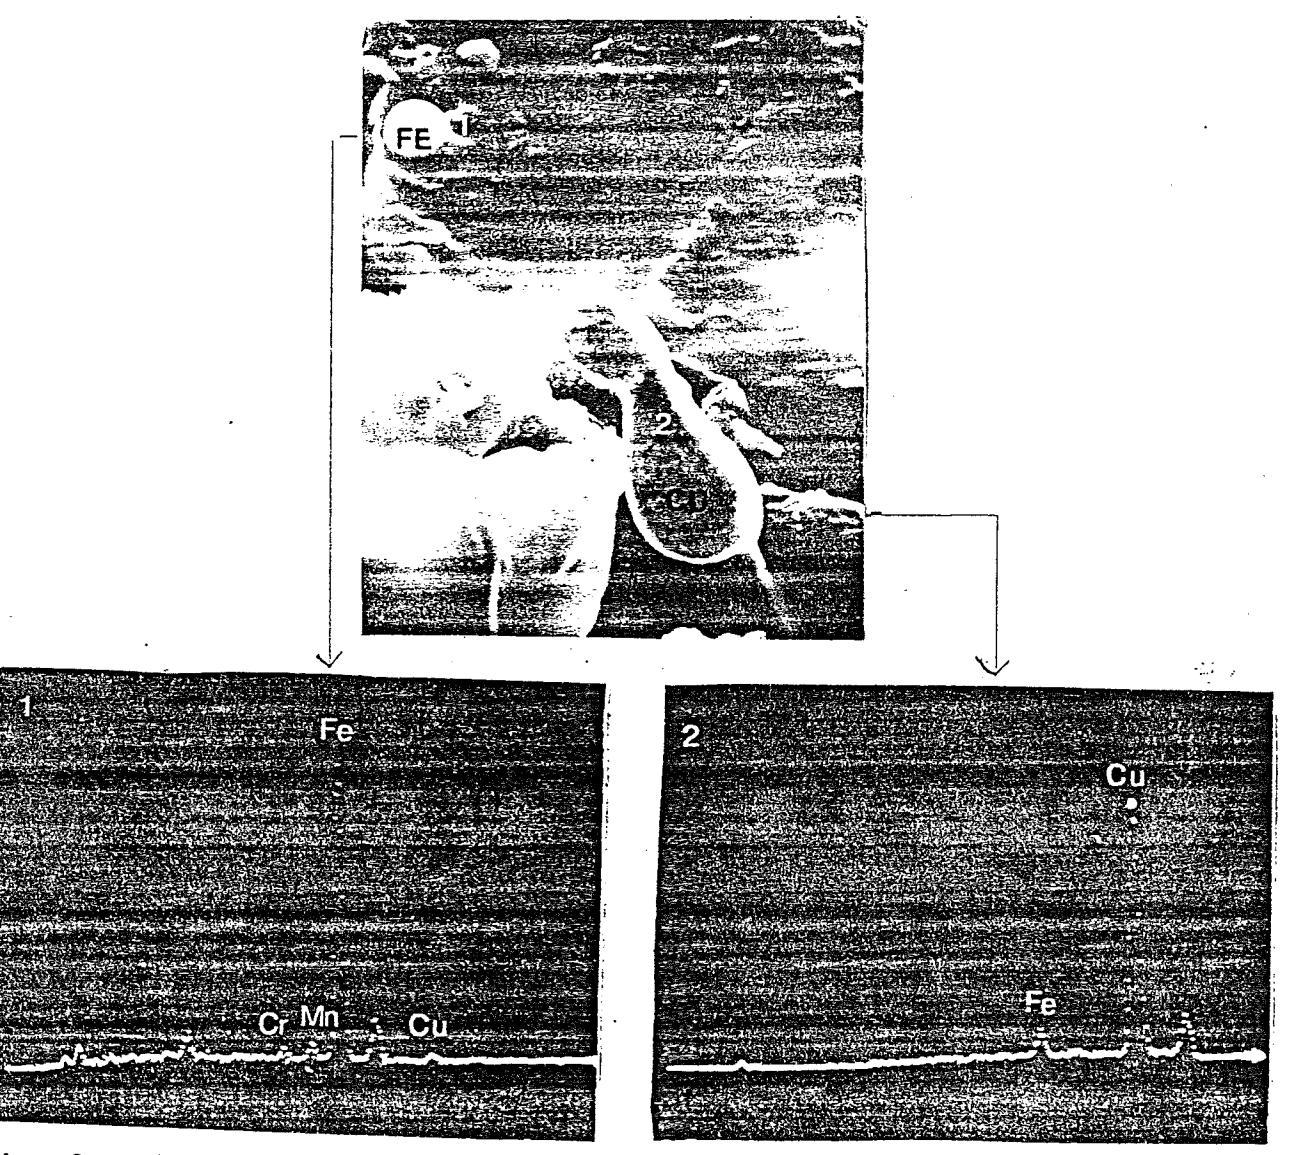
a. Iron Oxide, probably Corrosion Product, on Surface Scanning Electron Microscope Micrograph 600X (

b. Scanning Electron Microscope Micrograph of Iron and Copper Particles (3000X) with Energy Dispersive Spectrometer Trace Showing Composition

Fig. 45 SEM Micrographs of Surface Extension Replica

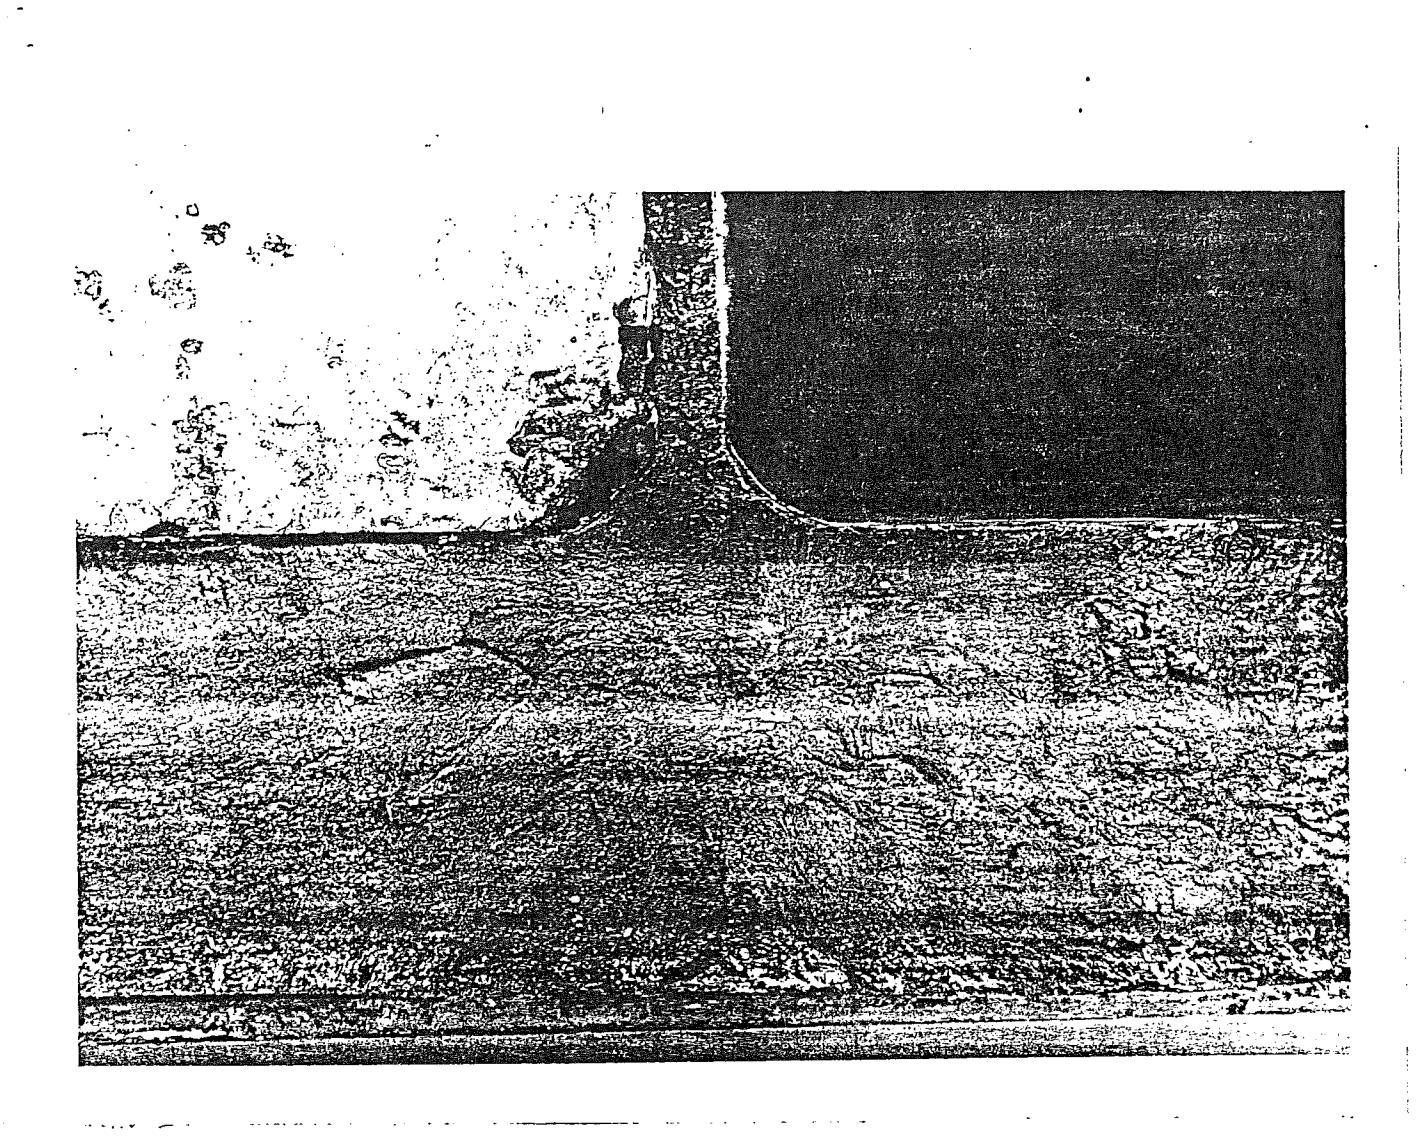
Fig. 48 Close-up of Fracture Surface from North Section

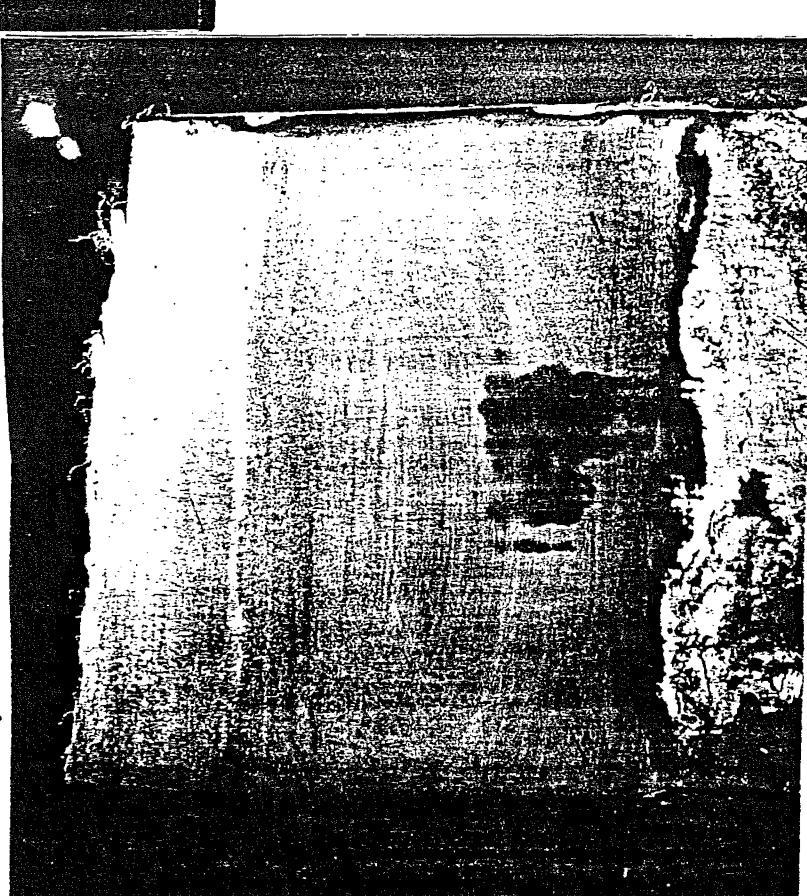
Fig. 49 West Edge of Flange at Fracture

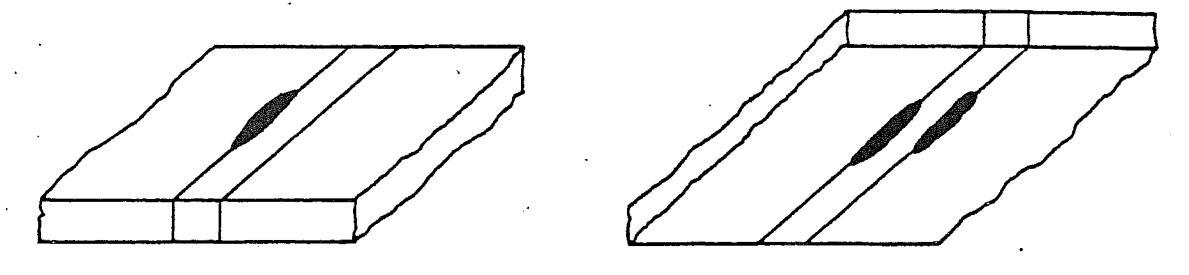
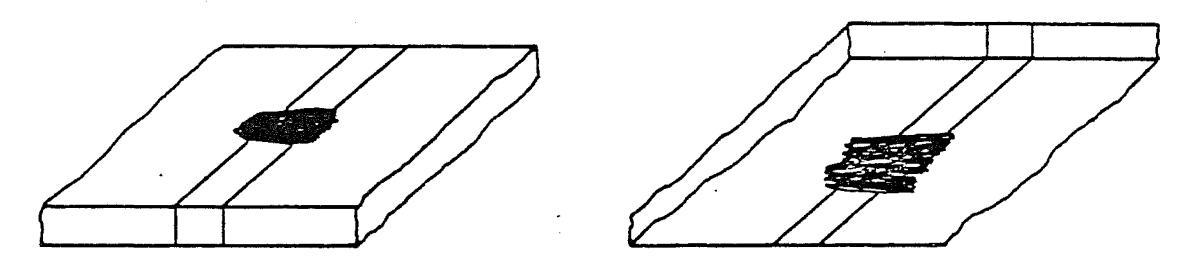
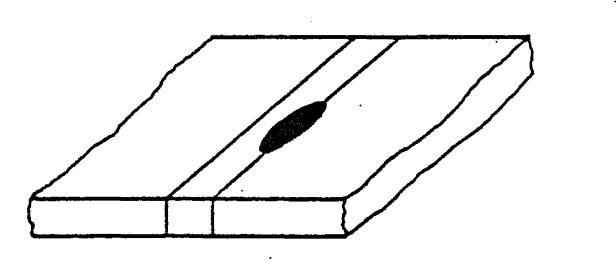
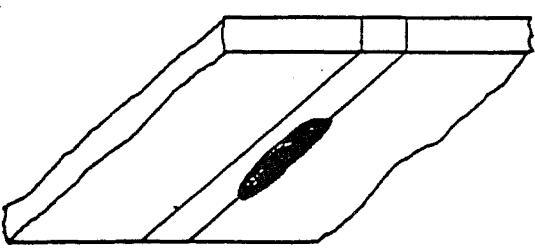
During inspection (radiography) of the original electroslag weld, several flaws were detected which required repair. The repair was made in different stages by air arc gouging and replacing the material with manual welding passes. Different stages of the repair are shown schematically in Fig. 51. The metallographic examination indicated that one repair was made by gouging a boat-shaped cavity through the weld and in the connected plate in longitudinal direction. This excavation was located about 2 in. (51 mm) from the center line of the flange and was made from the bottom flange surface. At the crack plane the repair weld was the full flange thickness (see Fig. 52). A schematic of the repair weld at the crack plane and along the member is shown in Fig. 77. The removing

Fig. 51 Schematic Showing Repair Sequence at the Casualty Section

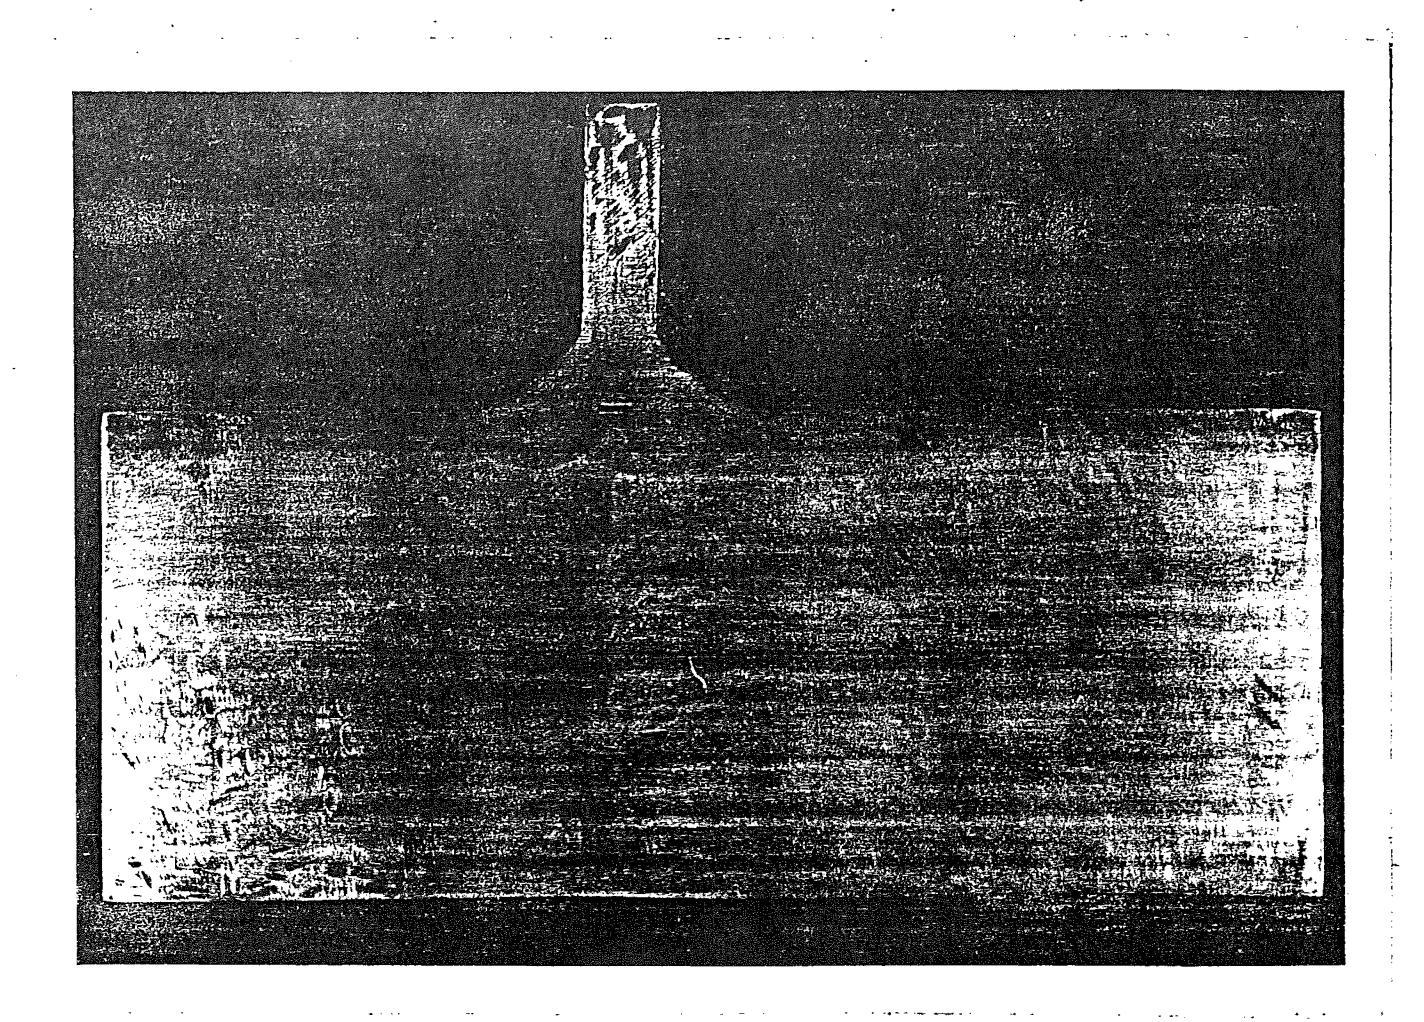
Fig. 52 Polished and Etched Surface of Flange Just Behind the Fracture

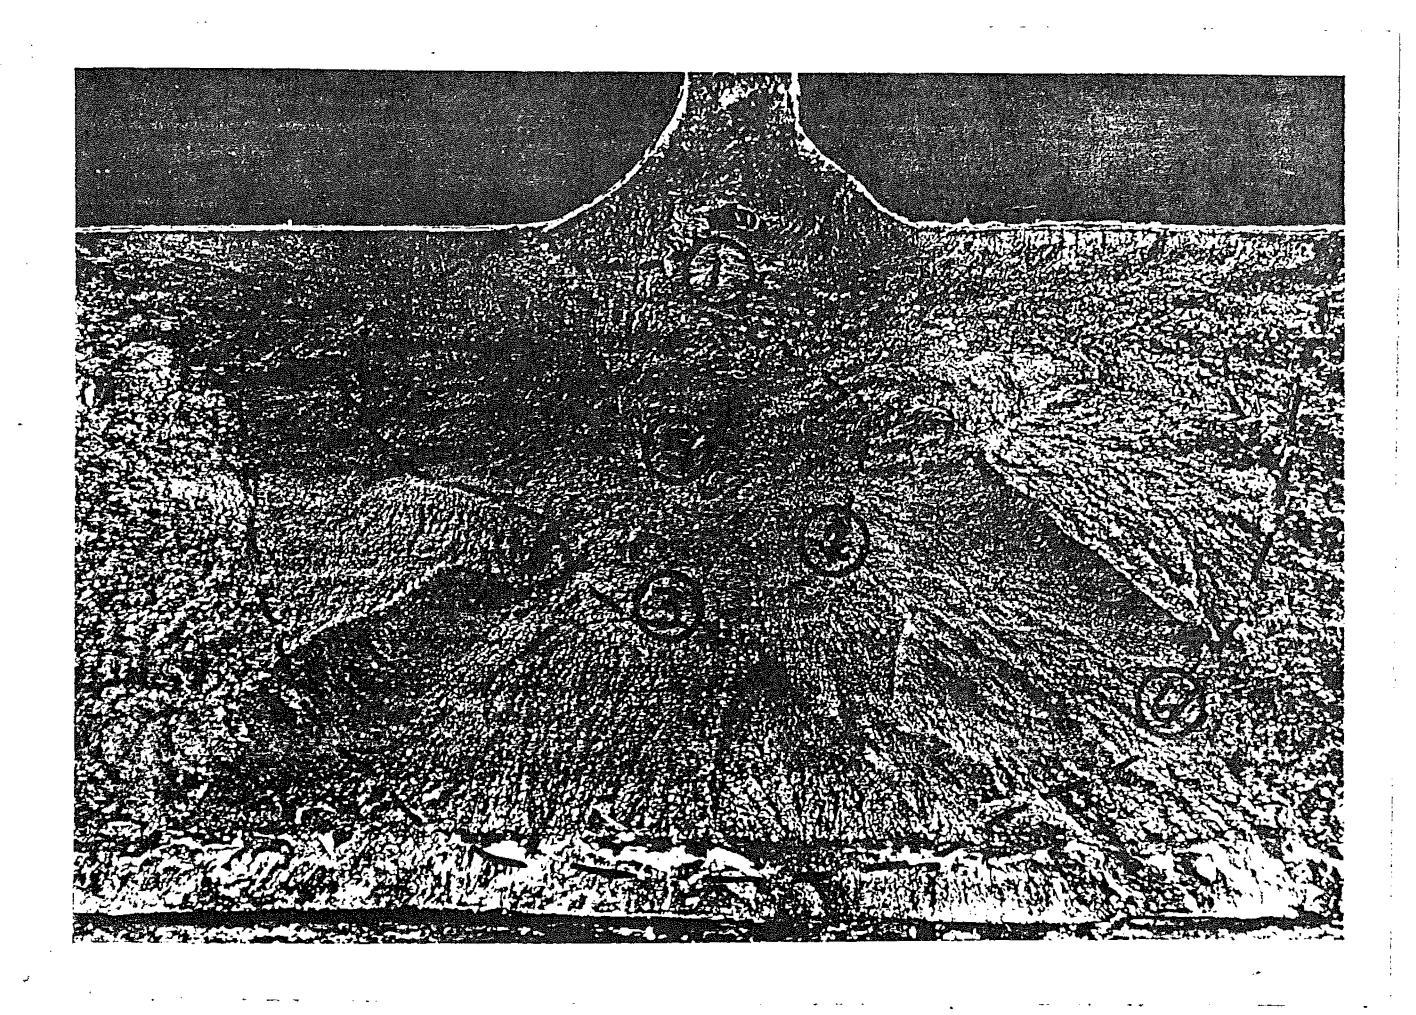
After brittle fracture was arrested, the crack size was increased by fatigue crack growth. Fatigue crack growth was verified by striation markings at crack tip location 6 (Fig. 54). The fatigue crack extension sharpened the crack tip. About 0.04 in. (1 mm) of crack growth was observed.

Fig. 54 Close-up of Crack Surface Showing Locations Where Replicas Were Obtained for Electron Microscope Studies

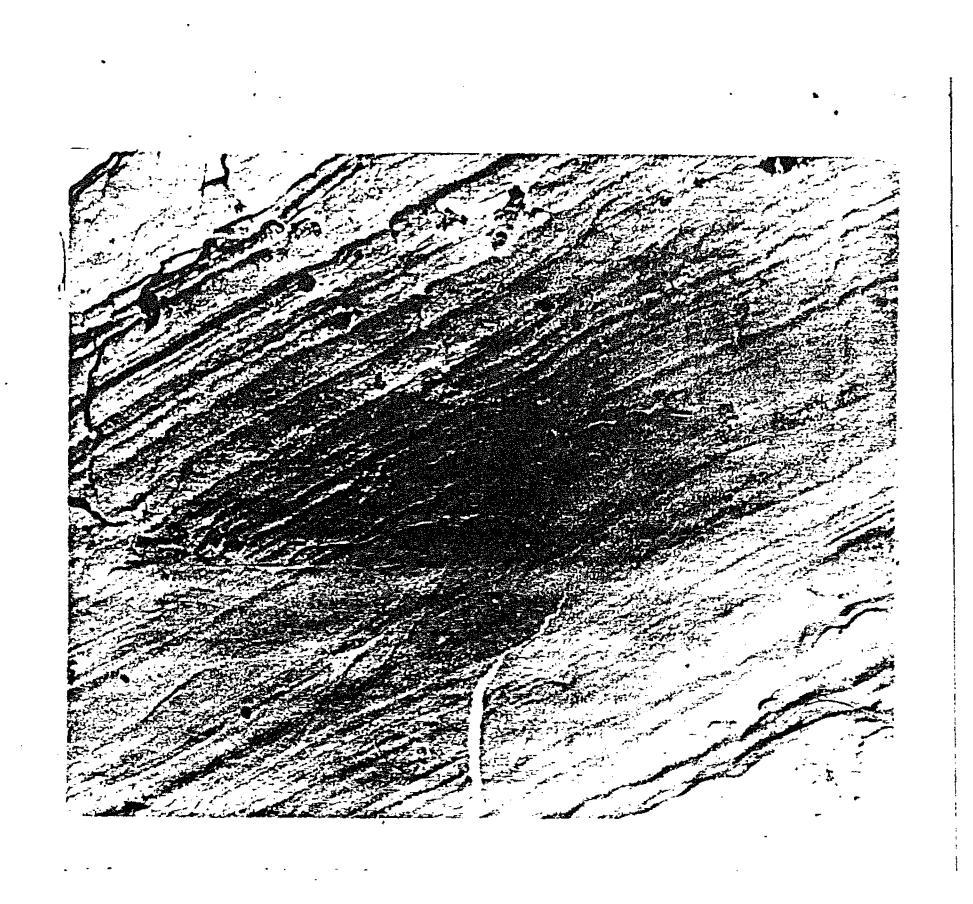
Fig. 59 TEM Photomicrographs of the surface of the Initial Flaw

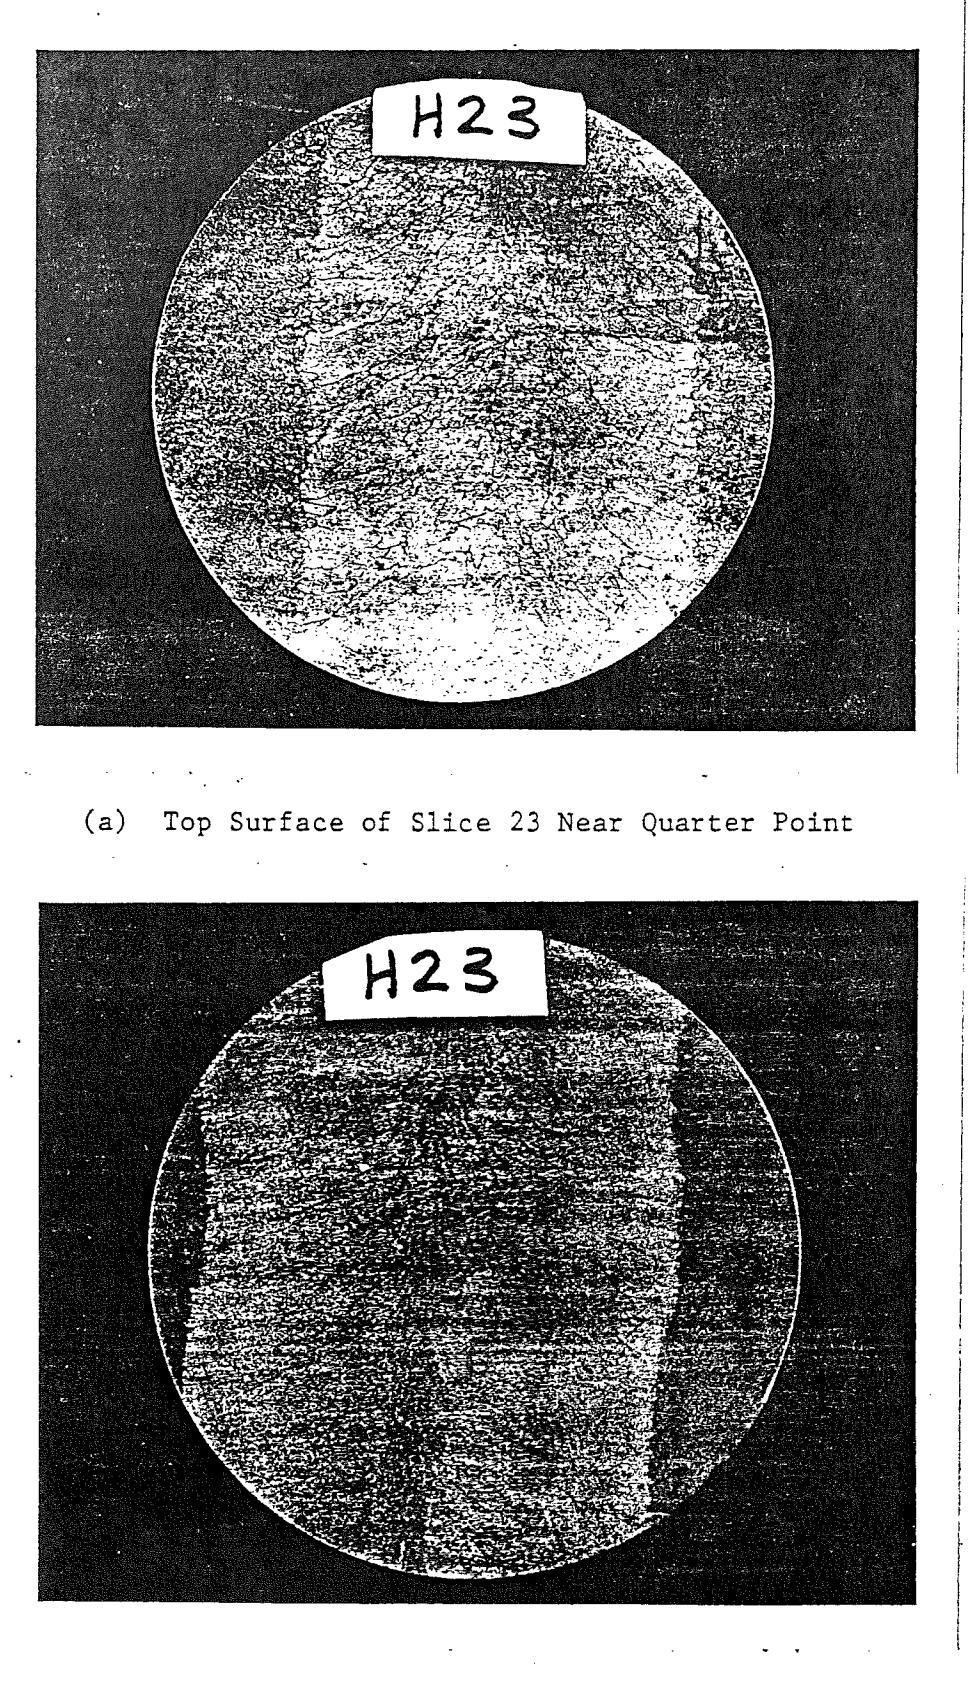
Fig. 60 Polished and Etched Surfaces of Core Removed From Ramp H

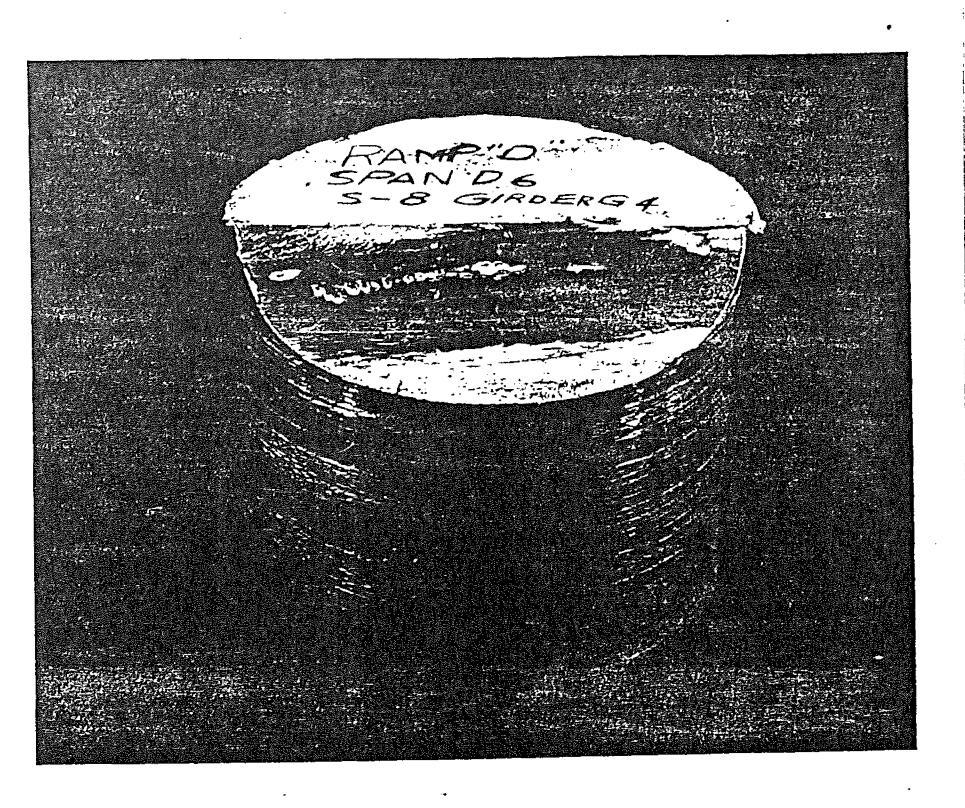
No failures developed in any of the other channel girders that were spliced and cored for further study. The core removed from the ramp D structure was found to have extensive surface discontinuities as shown in Figs. 62 and 64. This sample was removed from weld 4 of girder 27G4C.

Fig. 63 Sample Core Removed from Ramp D
