AN EVALUATION OF THE FRACTURE OF THE 179 BACK CHANNEL GIRDER

AND THE ELECTROSLAG WELDS IN THE 179 COMPLEX

Report No. 425-1(80)

Project 77-5: Evaluation of Glenfield Bridge Fracture

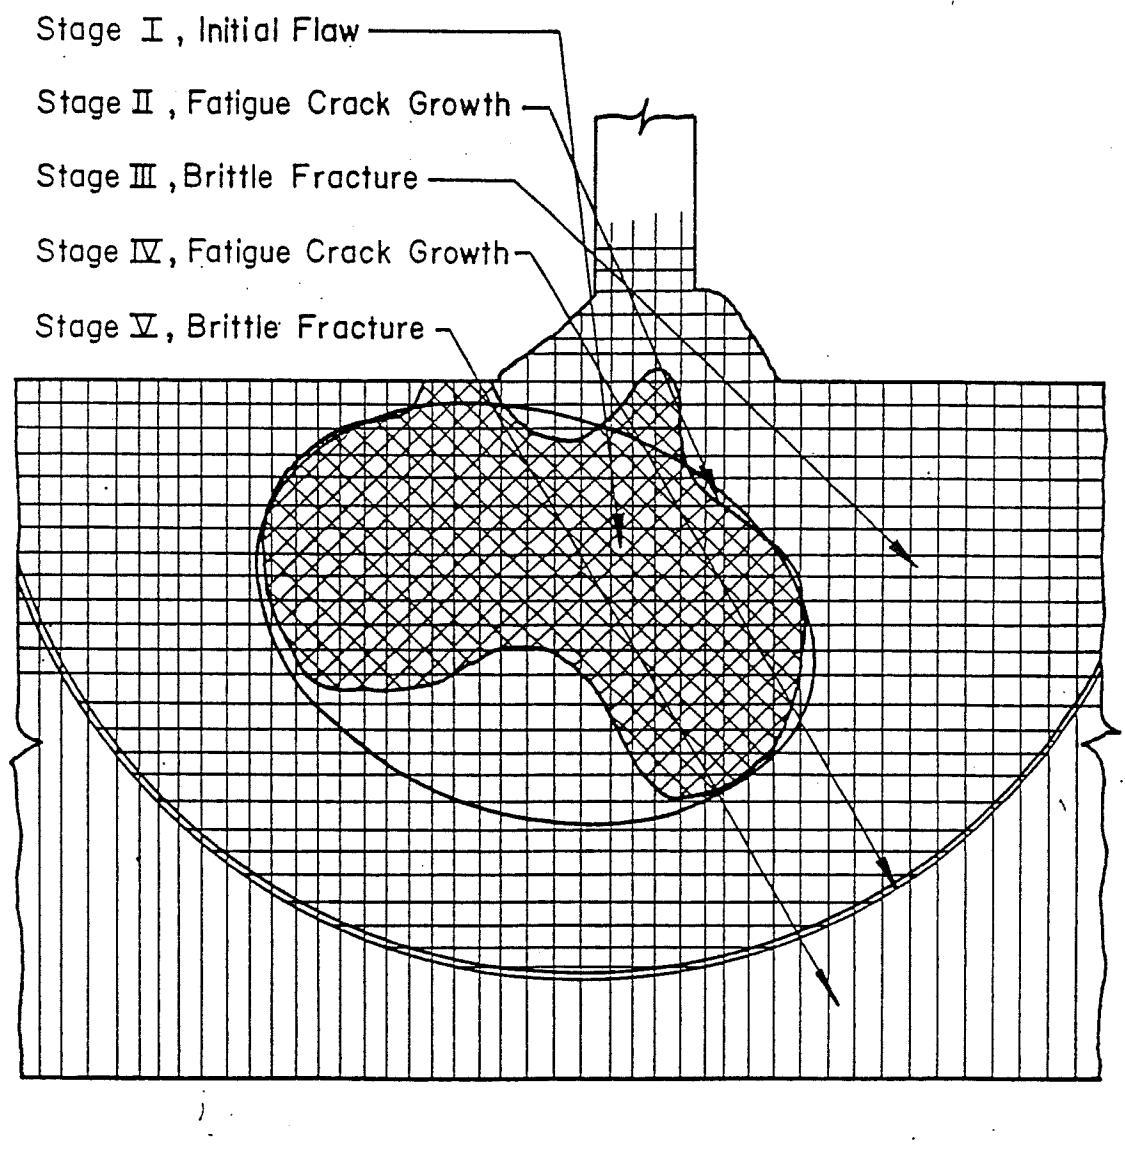
Fig. 80 Idealization of the Various Stages of Cracking at the Casualty Section

which was estimated from Charpy V-notch data. This included electroslag weld and repair weld data. An envelope of the estimated fracture resistance was constructed and shifted to approximate the conditions for an intermediate strain rate. These results were used to bound the material toughness of the material at the crack as a function of temperature. The K_{Tc}-value is indicated as a band in Fig. 85. The estimated maximum K-value of 94.5 ksi $\sqrt{\text{in.}}$ (104 MPa $\sqrt{\text{m}}$) is compared with the experimental results. From the comparison it can be seen that crack instability is possible at temperatures between 20° F and -20° F (-7° C and -29° C). It seems highly probable that crack instability developed from the original defect at temperatures below 0° F (-20° C). It was necessary for the initial flaw to be sharpened by cyclic live load and fatigue crack propagation. This fatigue crack extension of the initial flaw and the decrease in material fracture resistance with the cold temperature in Pittsburgh in early January 1977 resulted in a crack instability and a sudden enlargement of the crack to a penny-shaped crack shown in Figs. 54 and 80.

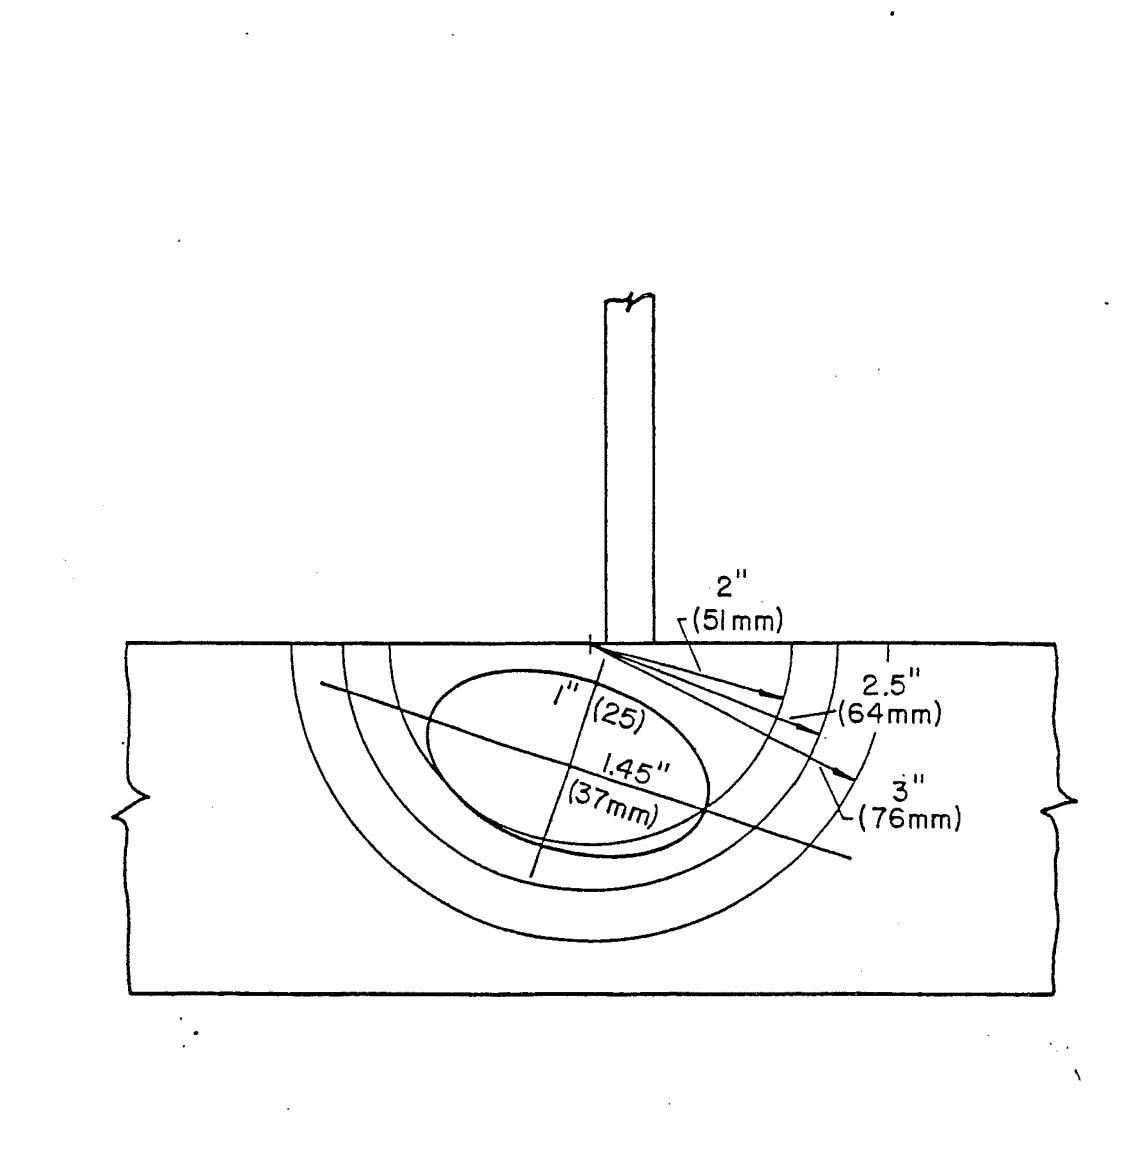
Fig. 81 Idealized Elliptical Shaped Initial Crack and Subsequent Penny-Shaped Crack Fronts

The crack sizes shown in Fig. 81 were evaluated for various stress conditions. Figures 86, 87, and 88 show the resulting distribution of K-values around the crack tip including the effects of the residual stresses due to the electroslag welding, the repair weld, the web-to-flange weld and the stress due to the dead and live load. This shows that the maximum stress intensity factor decreased from its peak value of 94.5 ksi $\sqrt{in.}$ (104 MPa \sqrt{m}) at the start of fracture to about 64 ksi $\sqrt{in.}$ (70 MPa \sqrt{m}).

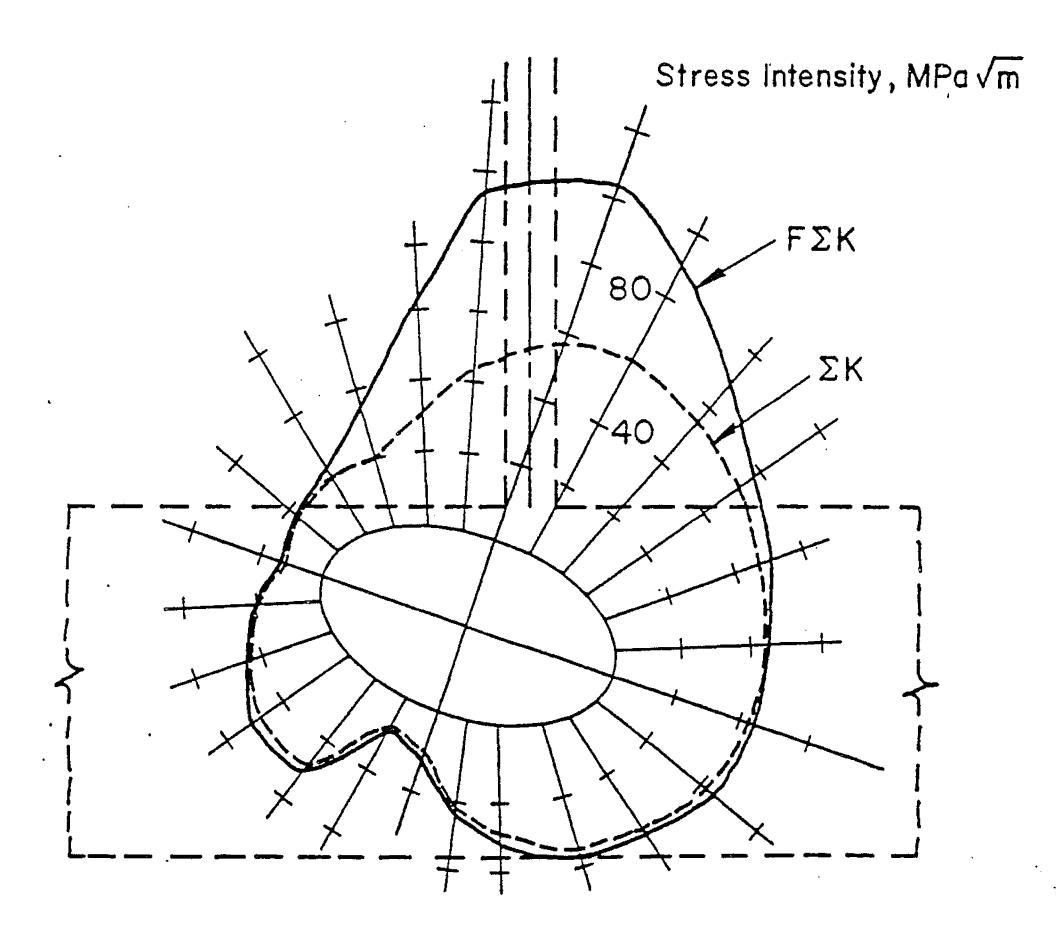
Fig. 84 Predicted Distribution of the Stress Intensity Factor Around the Boundaries of the Initial Flaw

The stress intensity factor along the elliptical crack front due to residual stress and due to stresses from the dead and live load are shown in Fig. 84. The maximum K-value along the crack tip was 94.5 ksi $\sqrt{\text{in.}}$ (104 MPa $\sqrt{\text{m}}$), and occurs directly under the web-flange connection.

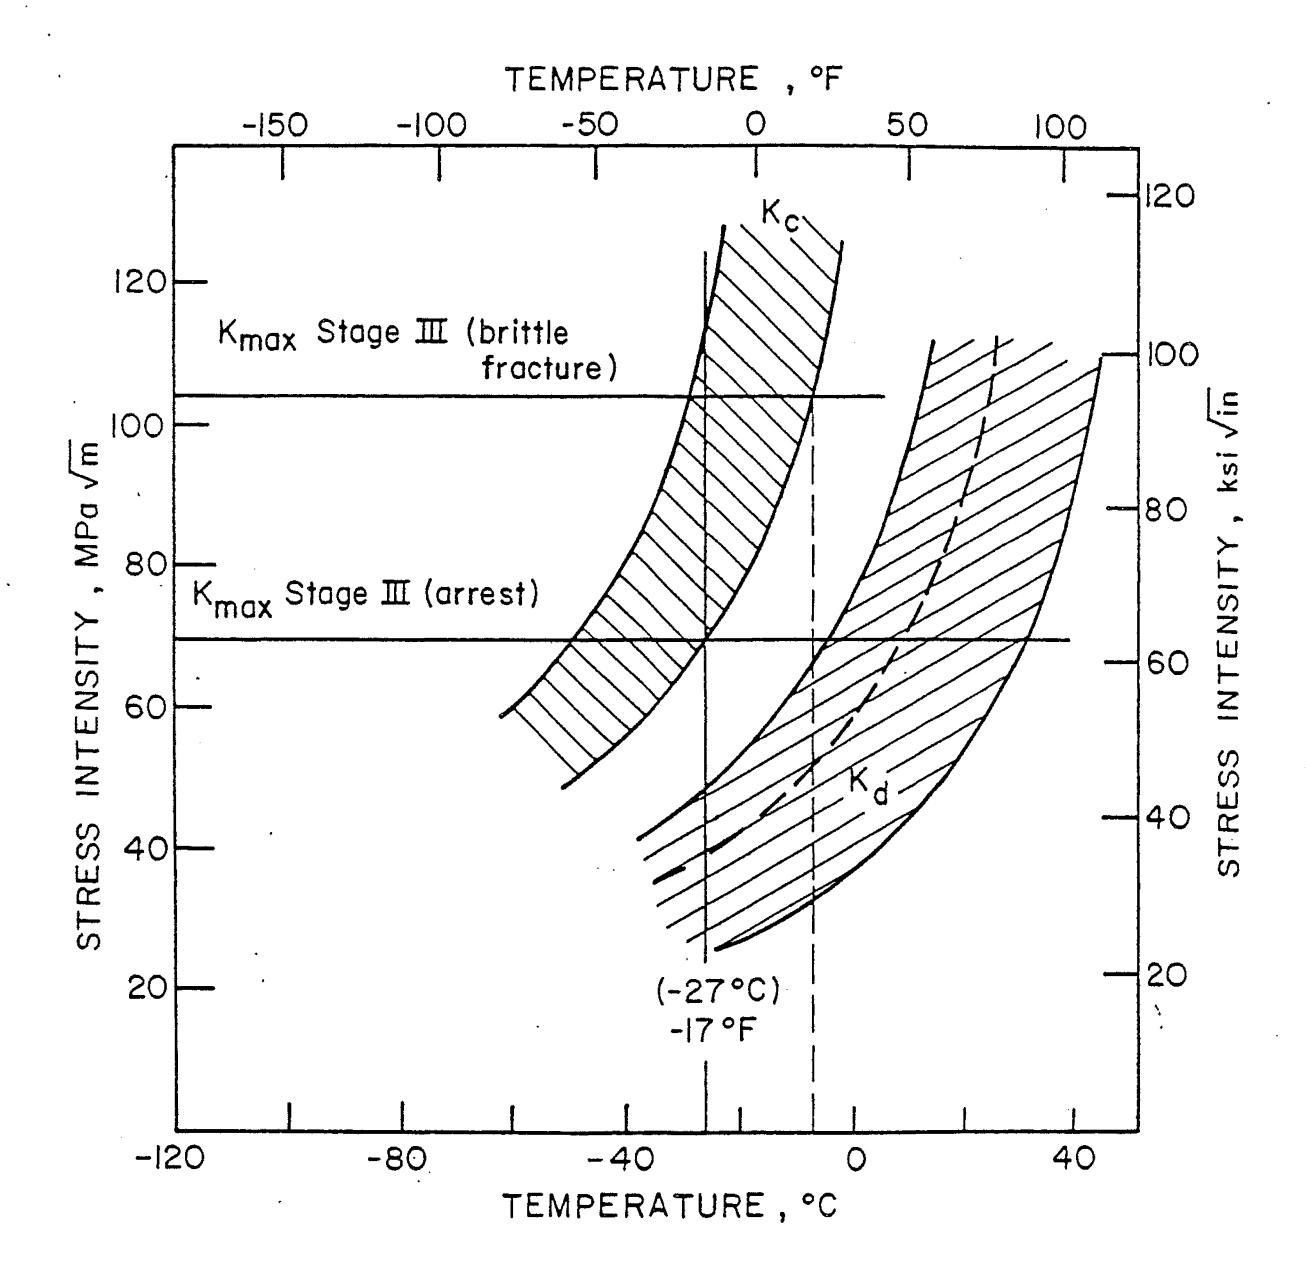
Fig. 85 Comparison of Estimated Stress Intensity Factor for Stage III Crack With Fracture Resistance of Electroslag Weldments

when a temperature shift is considered. The full temperature shift is about 125° F (70° C) for the electroslag weld material. The estimated stress intensity level at crack arrest is plotted in Fig. 85. The comparison of the data with the stress intensity estimate suggests that the initial crack instability developed at about 15° F. It is probable that the irregular crackfront and blunting effects as the crack enlarged provided a higher level of fracture resistance than indicated. The stress intensity for crack sizes less than 3 in. (76 mm) is smaller than $64 \text{ ksi} \sqrt{\text{in.}}$ (70 MPa $\sqrt{\text{m}}$). This assisted in decreasing the velocity at which the crack was moving and helped arrest the crack at the 3 in. (76 mm) radius.

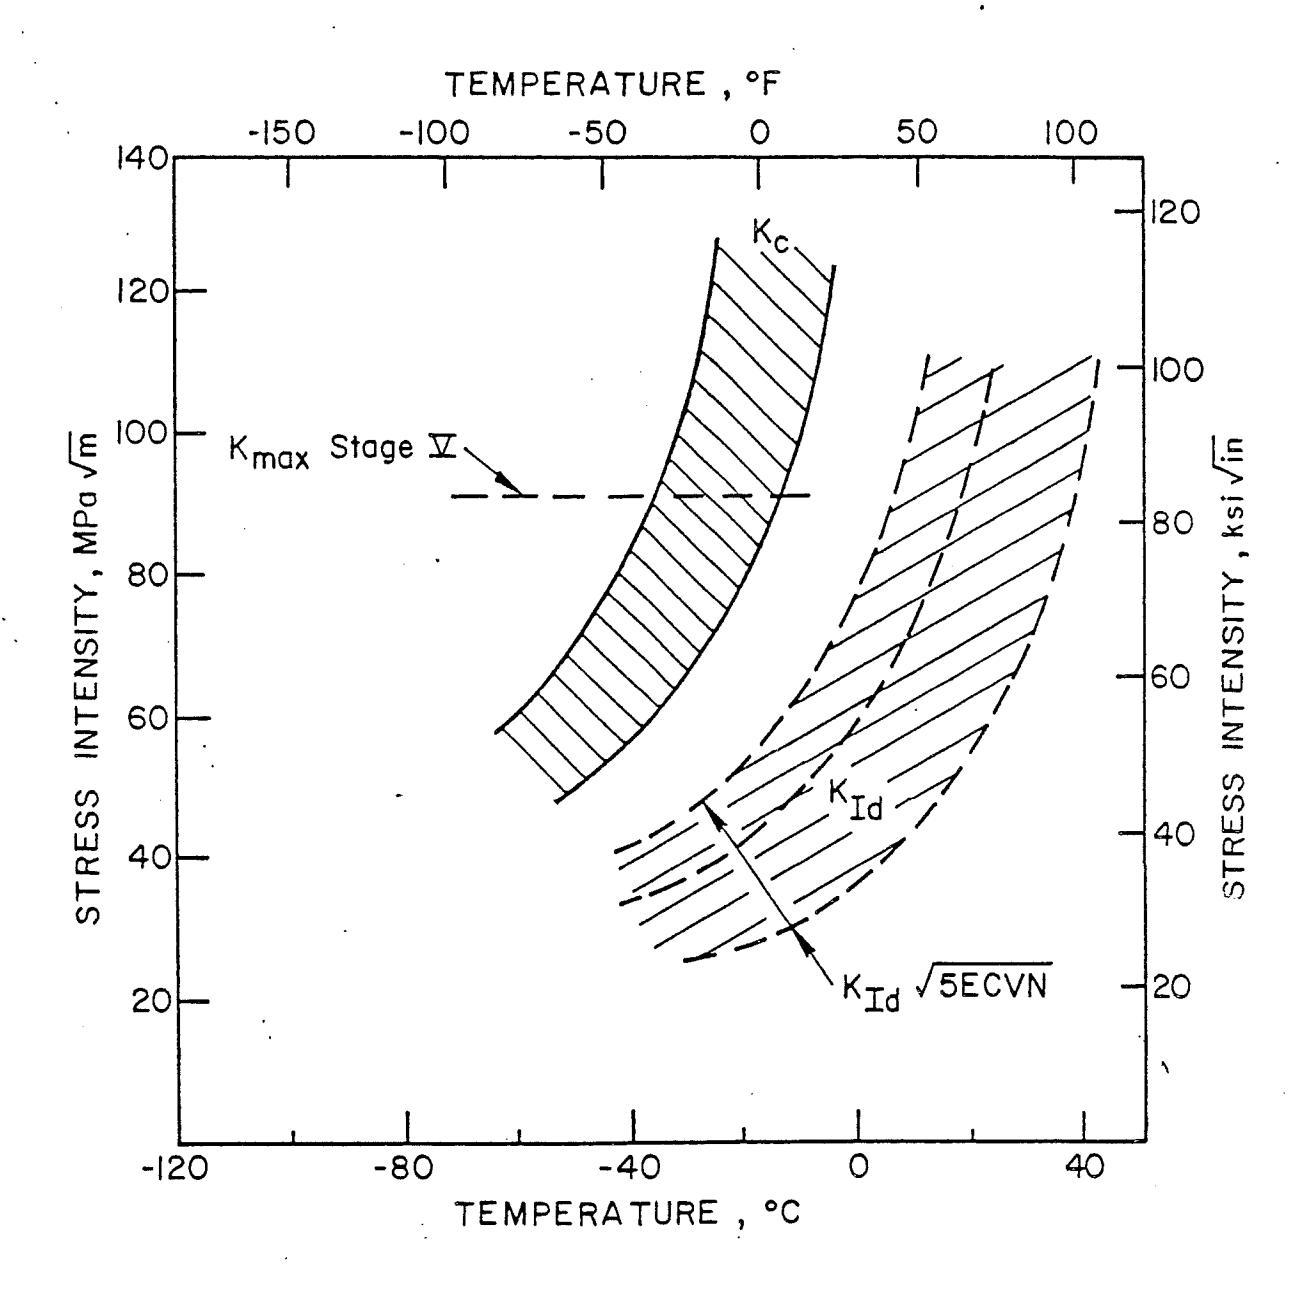
Fig. 89 Comparison of Predicted Stress Intensity Factor for Stage V Crack With Fracture Resistance of Electroslag Weldment

K-value at the time of fracture, considering the residual stress, dead and live load stresses and the thermal stress [assumed to be about 8 ksi (56 MPa)] was 83 ksi $\sqrt{\text{in.}}$ (91.3 MPa $\sqrt{\text{m}}$). The estimated K-value at flange fracture is compared with the material toughness in Fig. 89. The estimated K-value falls within the static fracture resistance band at the temperature believed to exist on January 28, 1977 when the crack was first observed.

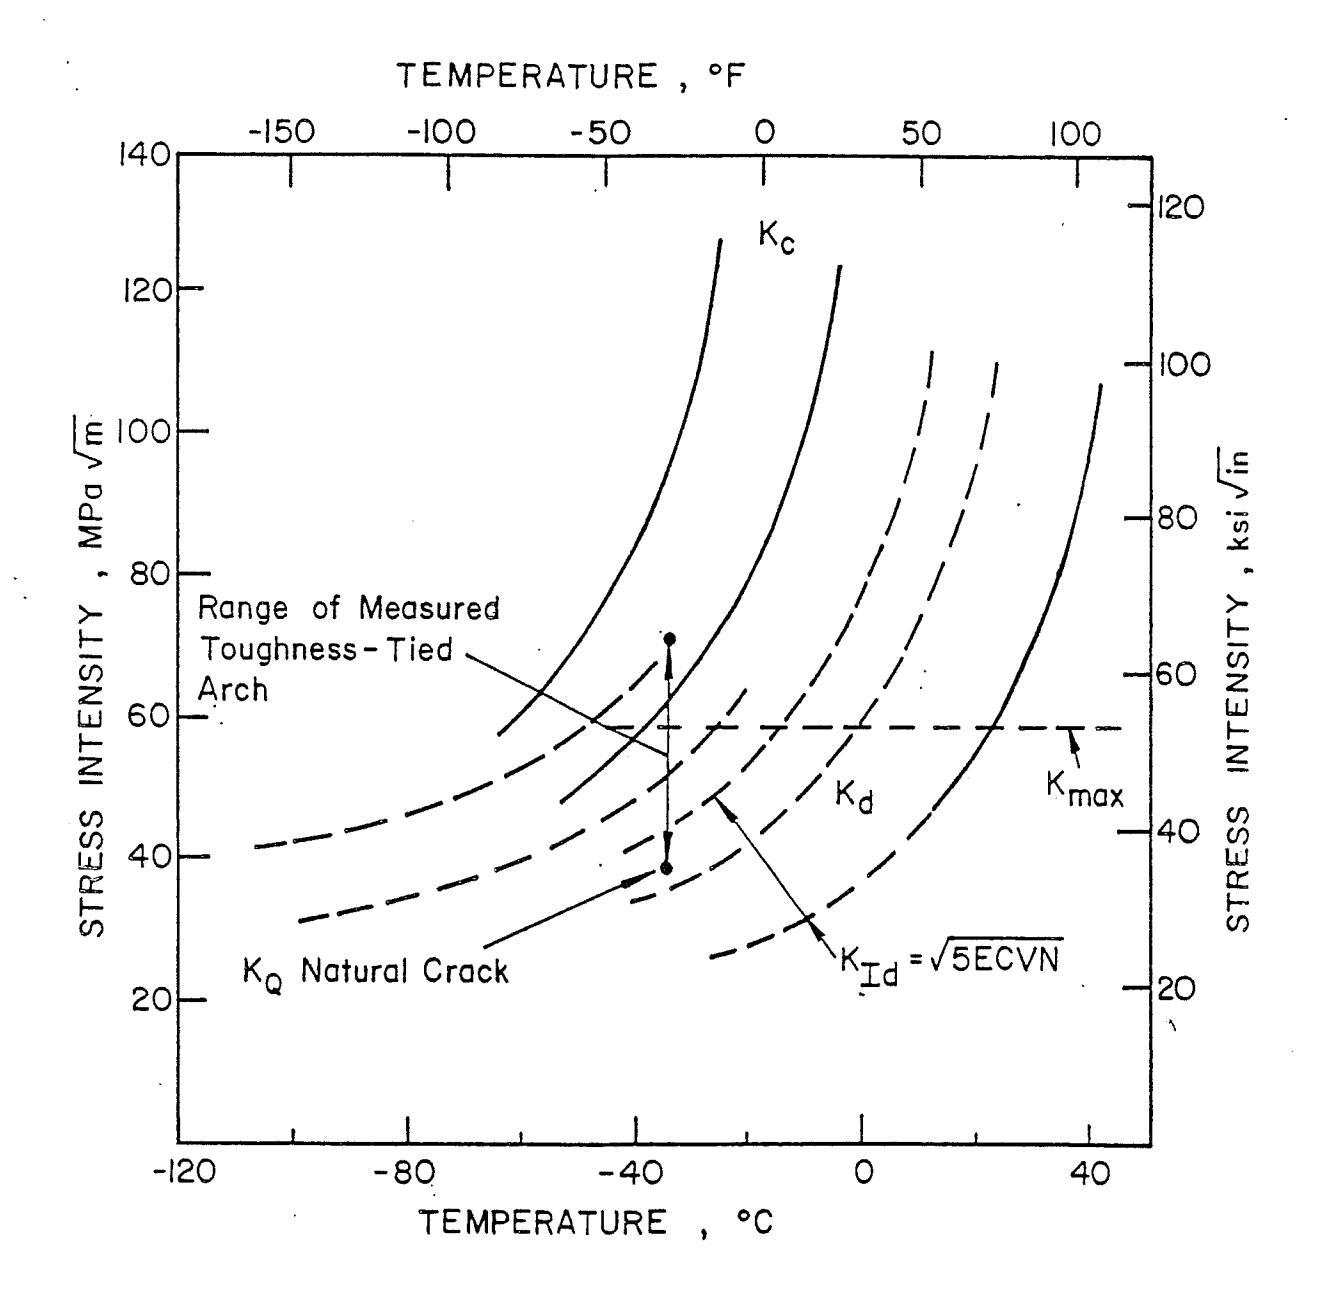
Fig. 92 Comparison of the Estimated Stress Intensity Factor at the Tie Girder Crack with the Estimated Electroslag Fracture Toughness and the two Bend K_Q Tests

The Charpy V-notch test data obtained at the fusion line and heataffected zone are summarized in Fig. 24. The results suggest that the fracture toughness is comparable to the lower bound provided in Fig. 34 for the fusion line and heat-affected zone of the tie girder weld. Figure 92 shows the estimates of stress intensity and their relationship to the fracture resistance of the tied arch materials. Also shown are the test data for the two three Point bend specimens that were prepared from the top surface layer (see Fig. 17) and tested at -30° F $(-34^{\circ}$ C). The results indicate that the fracture resistance is equaled or exceeded at service temperatures between 0 and -30° F $(-18^{\circ}$ C and to -34° C).
