A STUDY OF THE DEFECTS AND ELECTROSLAG WELDS IN THE I-79 BRIDGE AT MEADVILLE

September 1982

Report No. 455-1(82)

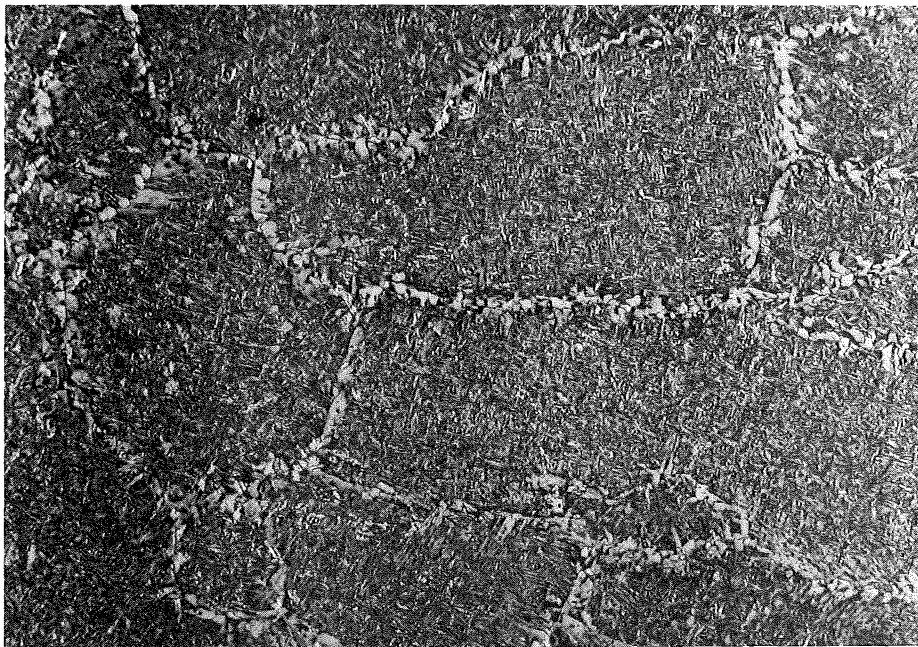
In the microstructure of zone II shown in Fig. 45, the prior austenite grain boundaries are seen as a network of ferrite bands. In

Fig. 45. Coarse columnar grains near the weld center, (Zone II).
