**FINAL REPORT
ON I79 TIED ARCH CRACKING
- NEVILLE ISLAND BRIDGE**

Report No. 494-1(84)

Cracks were detected in the diaphragm to tie girder web welds of the I79 Neville Island Bridge in July 1983. These cracks were observed at the top and bottom ends of the transverse welds between the diaphragm and the outside plate at floor beams. Samples removed from these cracked regions showed that all of these cracks developed from lack of fusion in the welded connections. Cyclic stresses developed in the diaphragms normal to these welds resulted in fatigue crack growth.

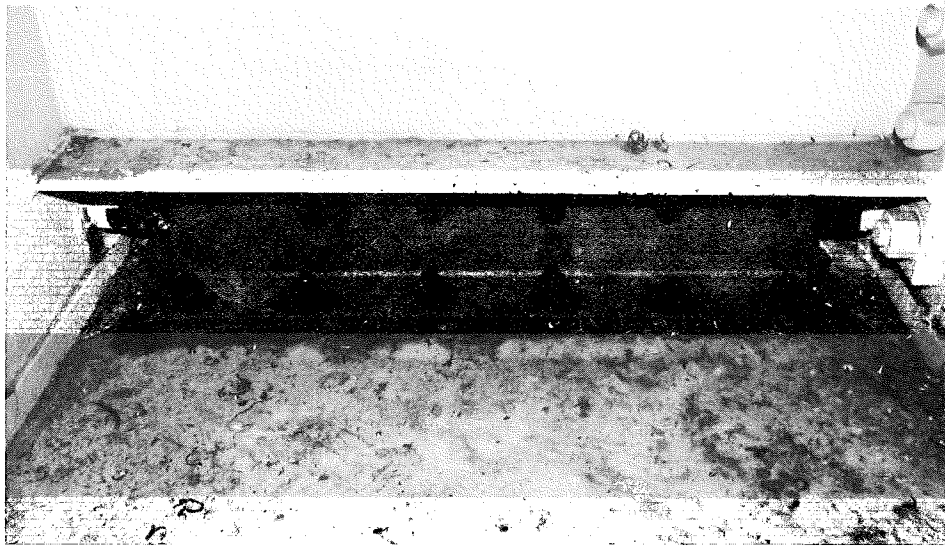
The initial retrofit consisted of pairs of 7 x 4 x 1/2 in. angles connected to the diaphragm and top and bottom flanges, as illustrated in Fig. 21. At several locations the cracked weld had been removed, as illustrated in Fig. 22.

Fig. 21 Initial Retrofit Angles Attached to Diaphragm and Bottom Flange

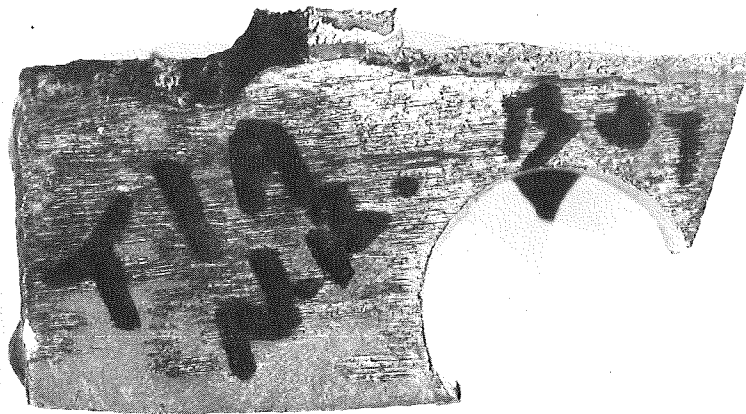
TIA
NB BOTTOM

segments and their crack surfaces. It is readily apparent from most of the crack surfaces that large unfused areas existed in the groove weld that connected the diaphragm to the tie girder web at the top and bottom web gaps. The original flame cut edge is visible on many of these surfaces (see Figs. 33, 35, 37, 39, 42, 48, 50 and 52). Furthermore, many of the weld joints do not appear to be beveled. As a result, very shallow surface welds appeared to exist along the edges of the diaphragm and web, much like small fillet welds.

Fig. 32 View of Sample Removed from Panel Point TIA-NB Bottom

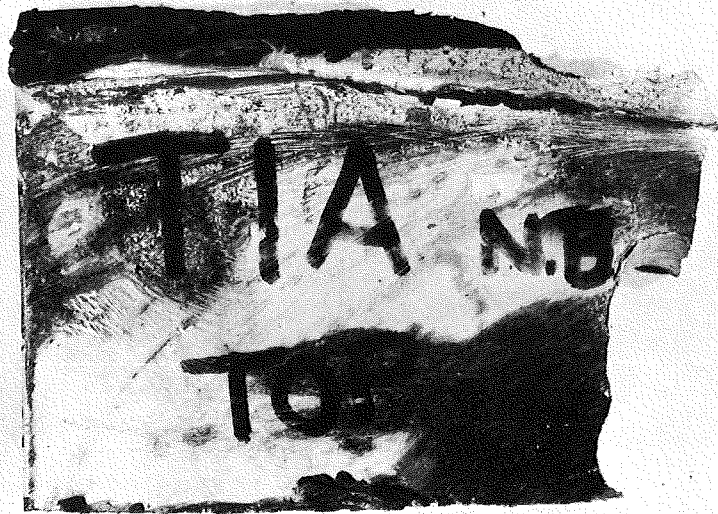
T1A
NB TOP

Fig. 34 View of Sample Removed from Panel Point T1A-NB Top

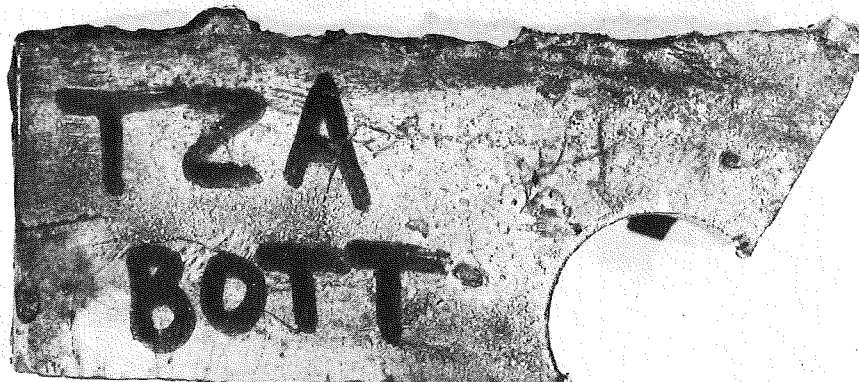
T2A
NB BOTTOM

Fig. 36 View of Sample Removed from Panel Point T2A-NB Bottom

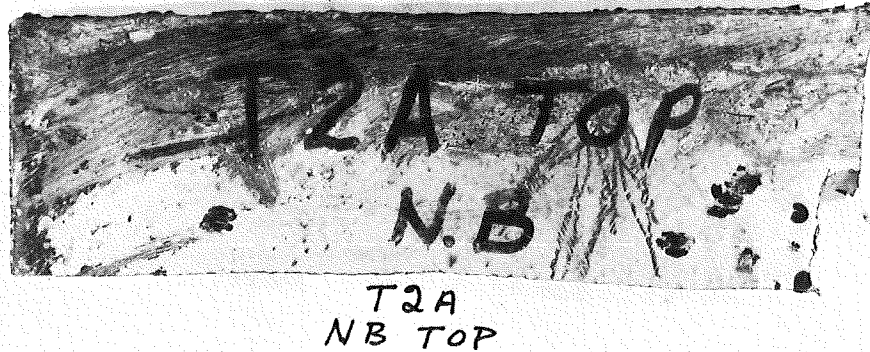
Fig. 38 View of Sample Removed from Panel Point T2A-NB Top

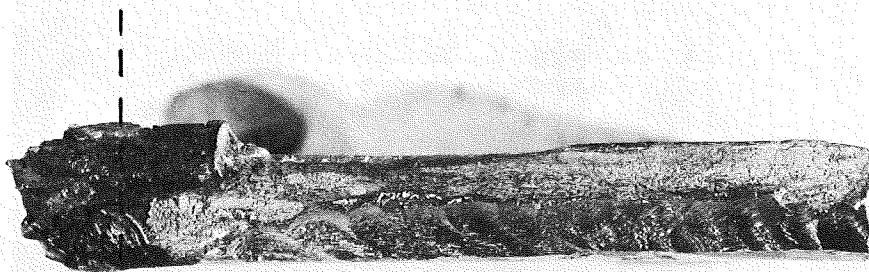
Several of the segments were cut perpendicular to the lack of fusion area, so that the cross-section could be polished and etched. This permitted the groove preparation, lack of fusion and weldments to be examined. The location of the polished section is shown by the dashed lines in Figs. 33, 35, 40, 42, 44 and 50.

In many cases the lack of fusion decreased away from the end of the diaphragm. This is apparent in Figs. 35, 44, 50 and 52. In the case of the samples shown in Figs. 37 and 39, the lack of fusion extended over much longer lengths.

Fig. 44 Crack Surface of T1-NB Top
