# DETERMINE ISS SOYUZ ORBITAL MODULE BALLISTIC LIMITS FOR STEEL PROJECTILES HYPERVELOCITY IMPACT TESTING

Hypervelocity Impact Technology Group (HVIT)  
Astromaterials Research and Exploration Science (ARES) Directorate  
Human Exploration Science Office, KX

July 2013

Prepared for the  
**ISS Systems Engineering and Integration Office**

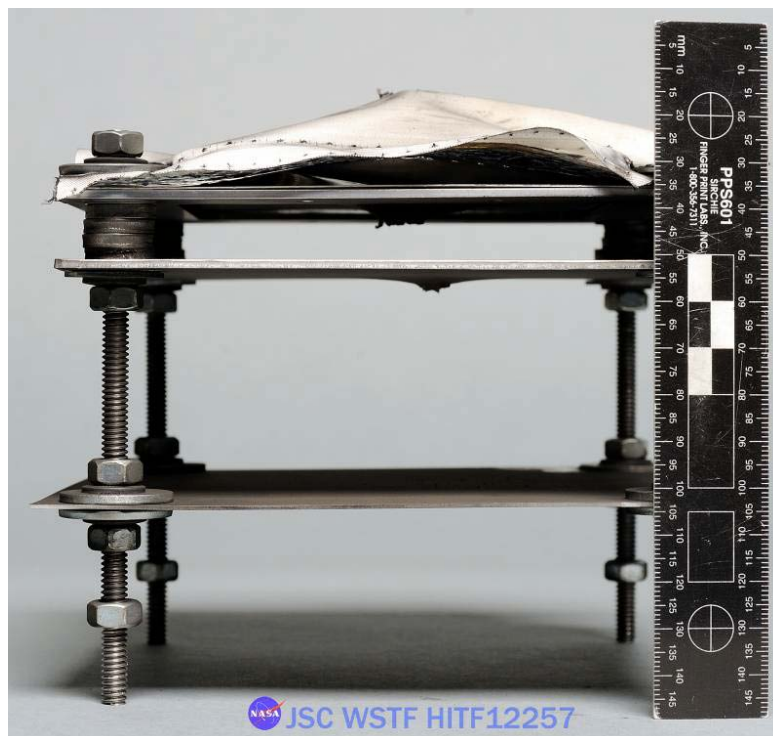
Test #1, HITF12257

Test No.	Actual Projectile Diameter (mm)	Actual Projectile Mass (g)	Actual Impact Velocity (km/s)	Impact Angle (deg)	Results
1 <a href="#">HITF12257</a>	1.79	0.02310	7.18	30	<p><b>Fail</b></p> <p>Beta cloth entry damage = 1.77mm x 1.96mm hole  Mylar Film damage = 45.97mm x 33.08mm hole  Fiberglass entry damage = 10.81mm x 13.44mm hole  Al 6061 Foil damage = 8.64mm x 8.26mm hole  Fiberglass exit damage = 12.89mm x 15.04mm hole  MLI exit damage = 7.71mm x 9.88mm hole  Al 6061-T6 plate damage = 8.14mm x 10.21mm hole  Al 5456-0 RW damage = 3 holes largest is 2.45 x 3.09mm  Al 2024-T3 WP damage = 0.198mm x 0.218mm x 0.051mm  deep crater &amp; many smaller</p>
2 <a href="#">HITF12258</a>	1.59	0.01610	4.99	30	<p><b>Fail</b></p> <p>Beta cloth entry damage = 1.54mm x 1.95mm hole  Mylar Film damage = 13.43mm x 9.34mm hole  Fiberglass damage = 2.87mm x 3.87mm hole  Al 6061 Foil damage = 6.04mm x 5.06mm hole  Fiberglass damage = 8.47mm x 12.48mm hole  MLI exit damage = 7.01mm x 7.80mm hole  Al 6061-T6 plate damage = 4.42mm x 6.33mm hole  Al 5456-0 RW damage = 2 holes largest is 6.57mm x 8.95mm  Al 2024-T3 WP damage = 0.58mm x 0.97mm x 0.275mm  deep crater &amp; many smaller</p>

Figure 17: Side View of ISS Soyuz Orbital Module Test #1

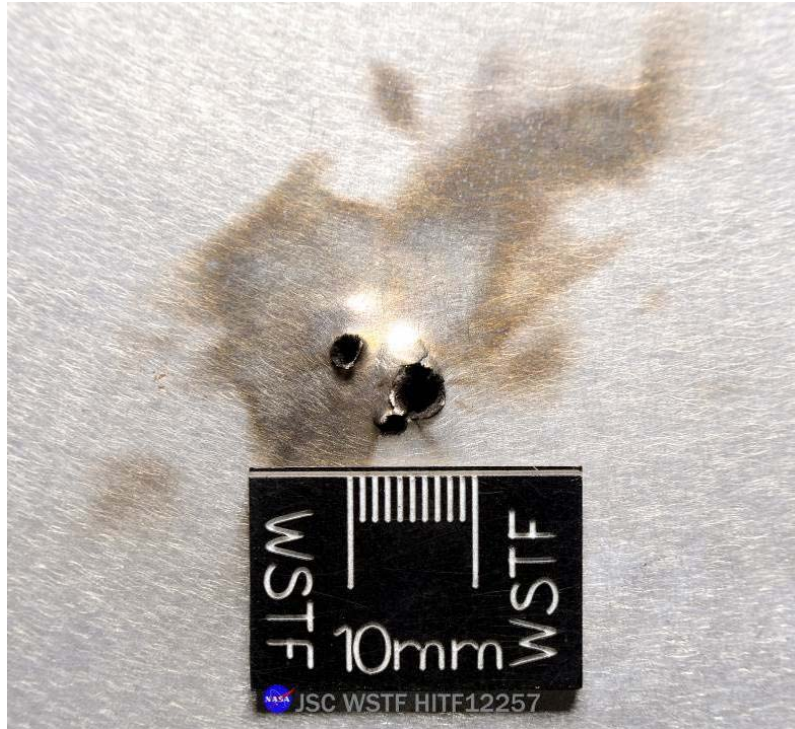
Figure 31: Al 5456-0 Rear Wall (Back) for ISS Soyuz Orbital Module Test #1

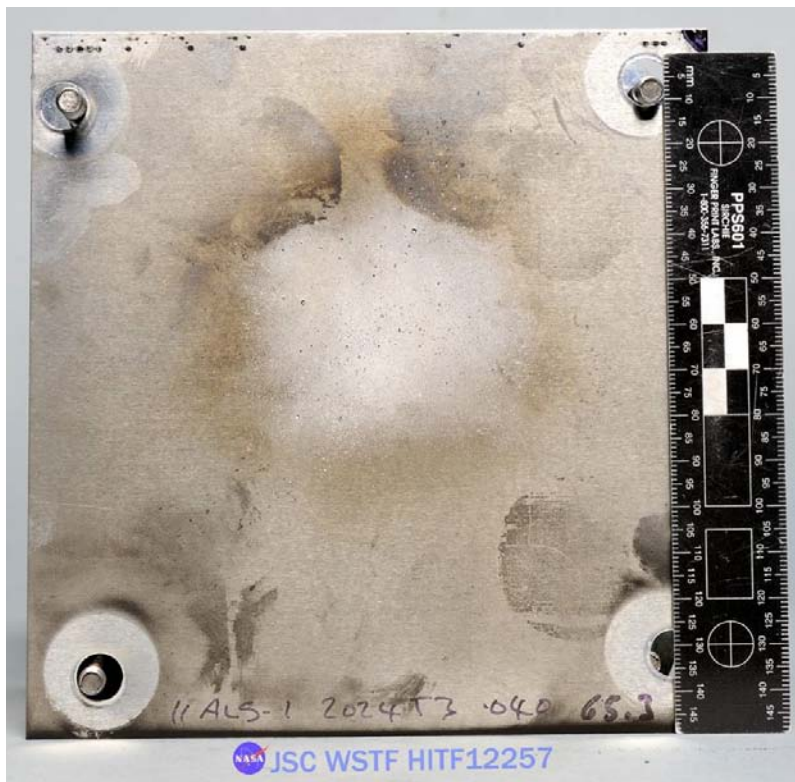
Figure 32: Front Witness Plate View of ISS Soyuz Orbital Module Test #1

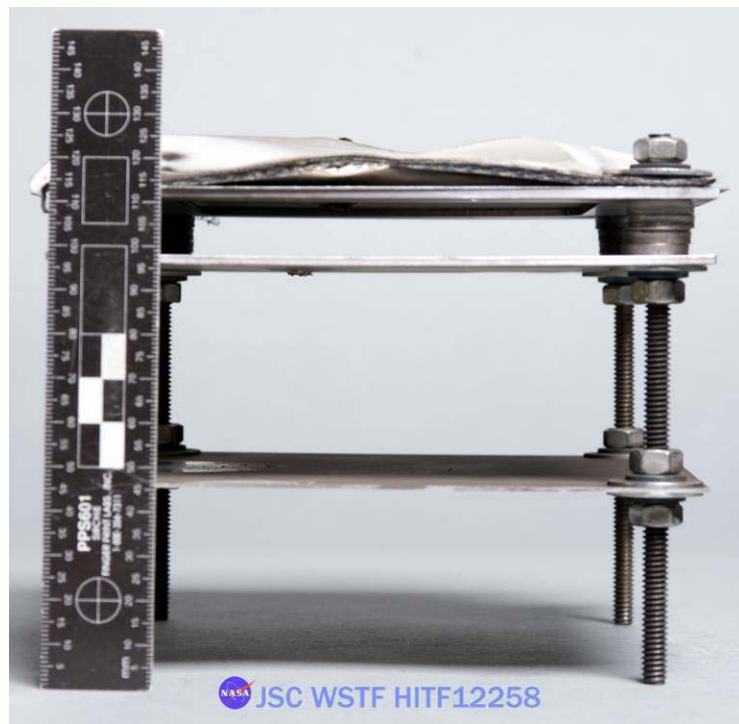
**Figure 34: Side View of ISS Soyuz Orbital Module Test #2**

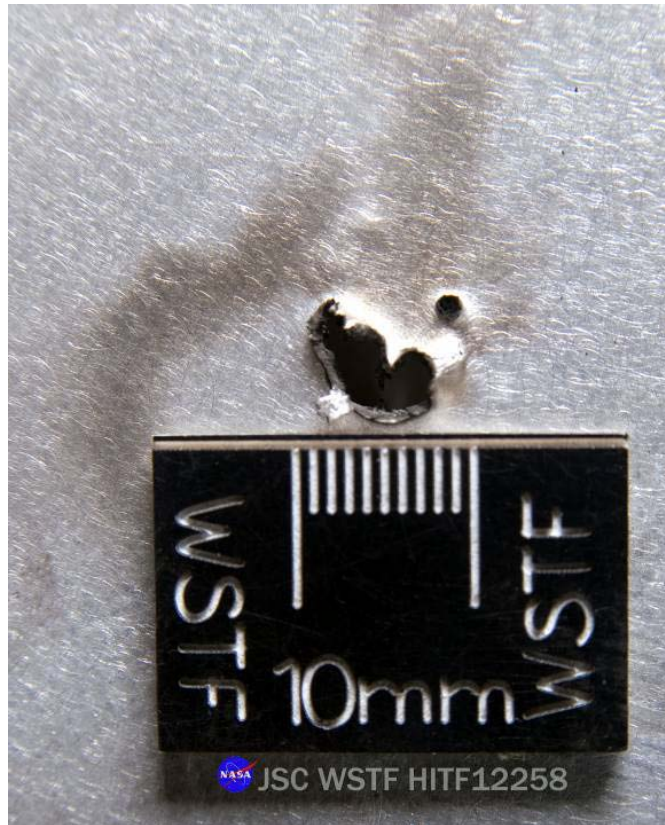
Test #2, HITF12258

Figure 48: Al 5456-0 Rear Wall (Back) for ISS Soyuz Orbital Module Test #2

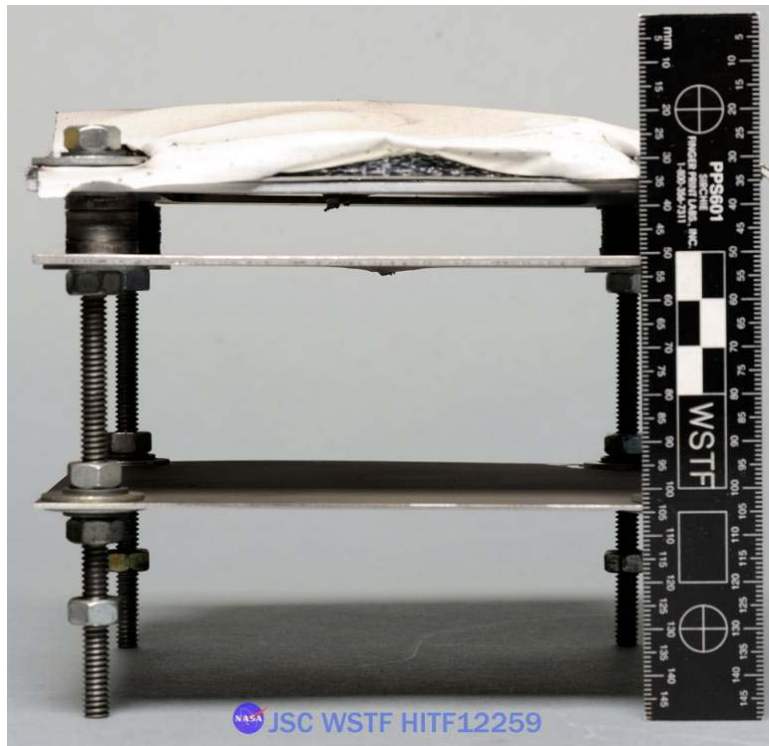
Figure 51: Side View of ISS Soyuz Orbital Module Test #3

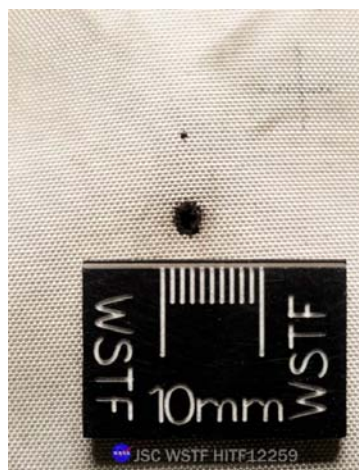
Figure 53: Beta Cloth Bumper of ISS Soyuz Orbital Module Test #3

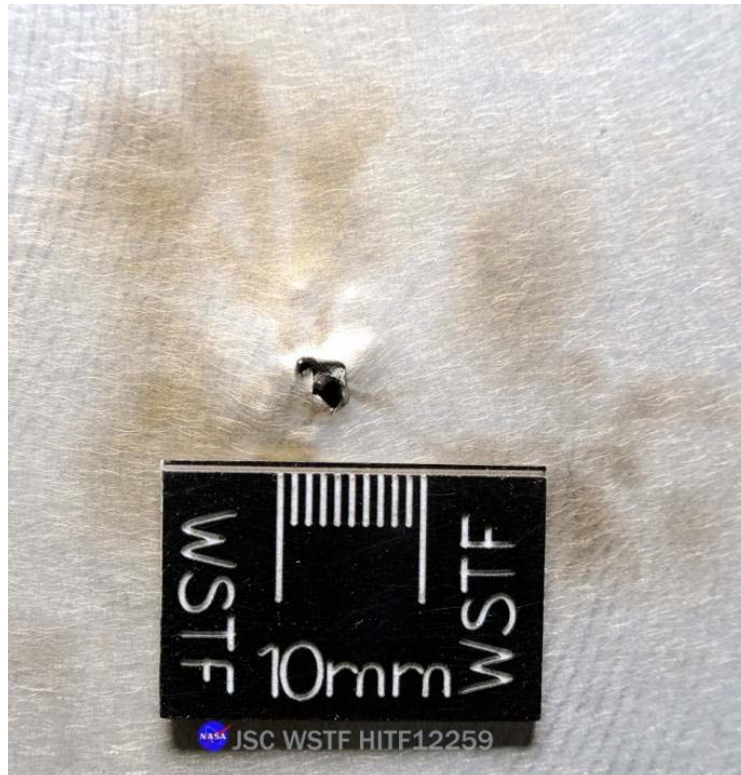
Test #3, HITF12259

Figure 65: Al 5456-0 Rear Wall (Back) for ISS Soyuz Orbital Module Test #3

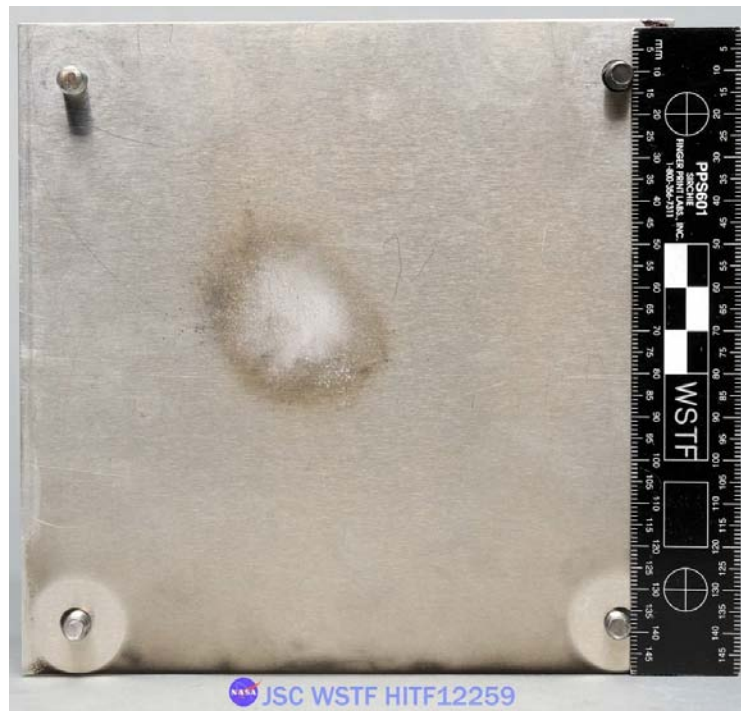
Figure 66: Front Witness Plate View of ISS Soyuz Orbital Module Test #3

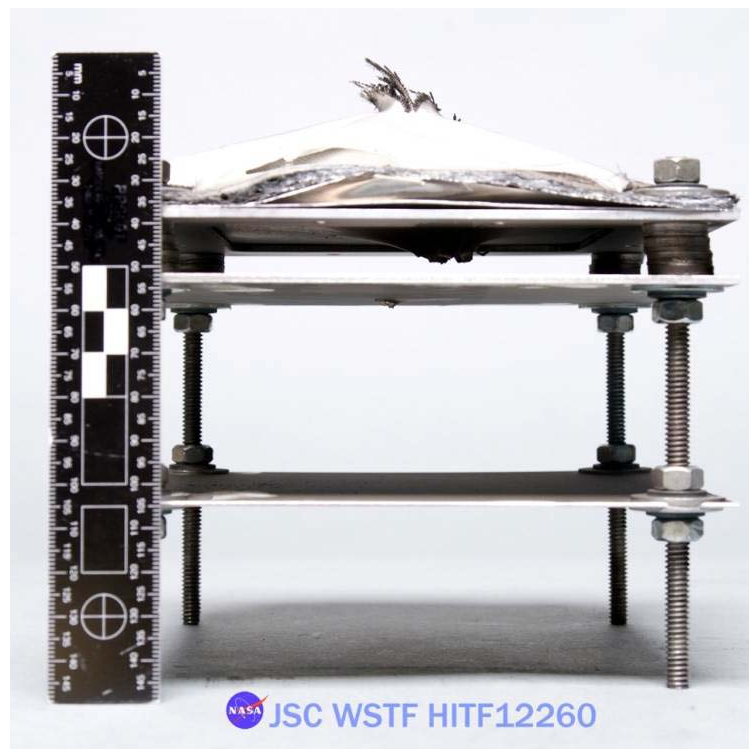
Figure 68: Side View of ISS Soyuz Orbital Module Test #4

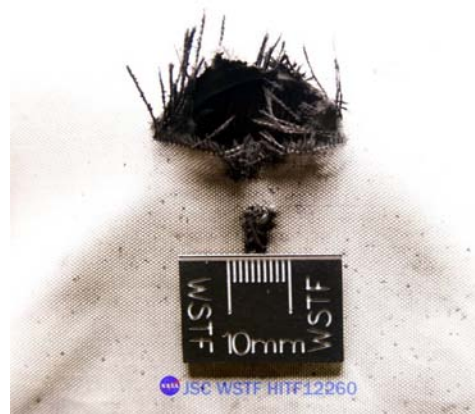
Figure 70: Beta Cloth Bumper of ISS Soyuz Orbital Module Test #4

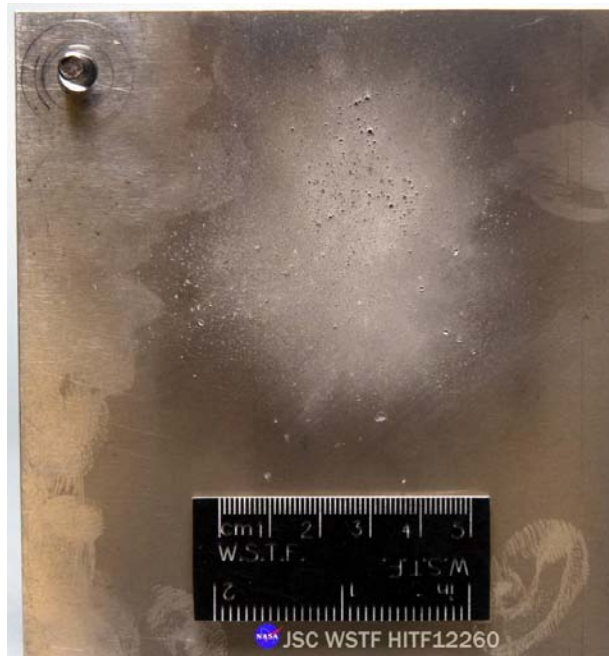
Figure 82: Front Witness Plate View of ISS Soyuz Orbital Module Test #4

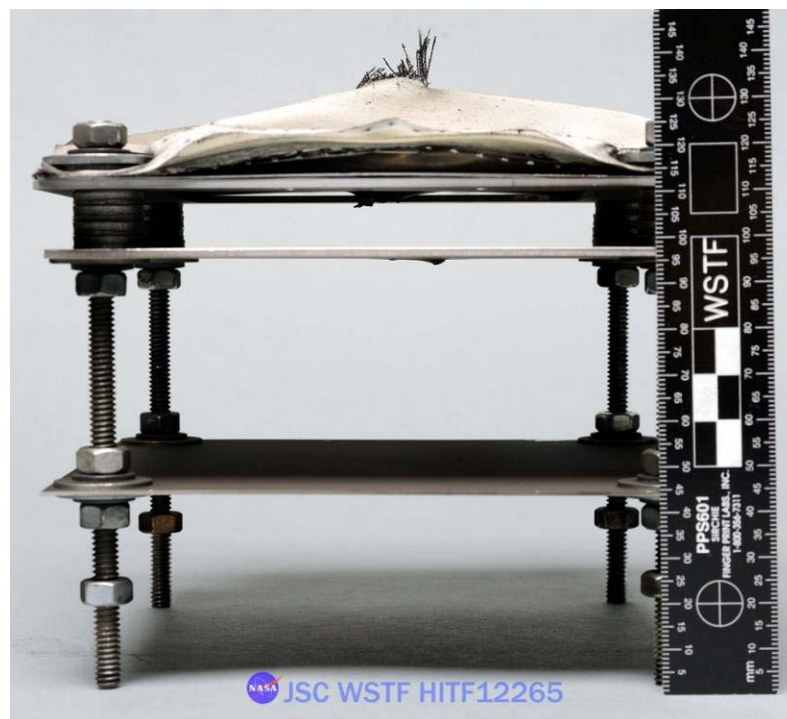
Test #9, HITF12265

9 <a href="#">HITF12265</a>	1.6	0.01615	7.14	45	<p><b>Fail</b></p> <p>Beta cloth entry damage = 5.49mm x 17.51mm hole  Mylar Film damage = 35.16mm x 19.19mm hole  Fiberglass damage = 13.55 x 14.32mm hole  Al 6061 Foil damage = 9.50 x 14.24mm hole  Fiberglass damage = 14.57 x 16.36mm hole  MLI exit damage = 8.51mm x 11.30mm hole  Al 6061-T6 plate damage = 8.93mm x 9.57mm hole  Al 5456-0 RW damage = 1.50 x 2.39mm hole  Al 2024-T3 WP damage = 31mm x 30mm area of aluminum specks</p>
10 <a href="#">HITF12266</a>	1.39	0.01075	3.19	30	<p><b>Fail</b></p> <p>Beta cloth entry damage = 1.56mm x 1.50mm hole  Mylar Film damage = 13.80mm x 15.43mm hole  Fiberglass damage = 2.67 x 2.27mm hole  Al 6061 Foil damage = 2.50 x 2.74mm hole  Fiberglass damage = 2.45 x 2.93mm hole  MLI exit damage = 3.83mm x 4.66mm hole  Al 6061-T6 plate damage = 2.53mm x 2.92mm hole  Al 5456-0 RW damage = 2.84 x 3.09mm hole  Al 2024-T3 WP damage = 1.48mm x 1.93mm x 0.089mm deep crater &amp; many smaller</p>

Figure 147: Post-test of ISS Soyuz Orbital Module Test #9 (HITF12265) article mounted in 0.50-caliber target tank.

Figure 148: Side View of ISS Soyuz Orbital Module Test #9

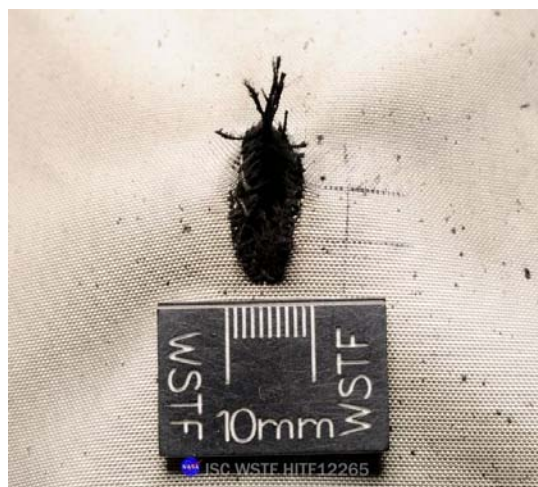
Test #9, HITF12265

Figure 149: Beta Cloth Bumper Layer 1 of ISS Soyuz OM Test #9 (Keyence 3D Microscope Image)

Figure 150: Beta Cloth Bumper of ISS Soyuz Orbital Module Test #9

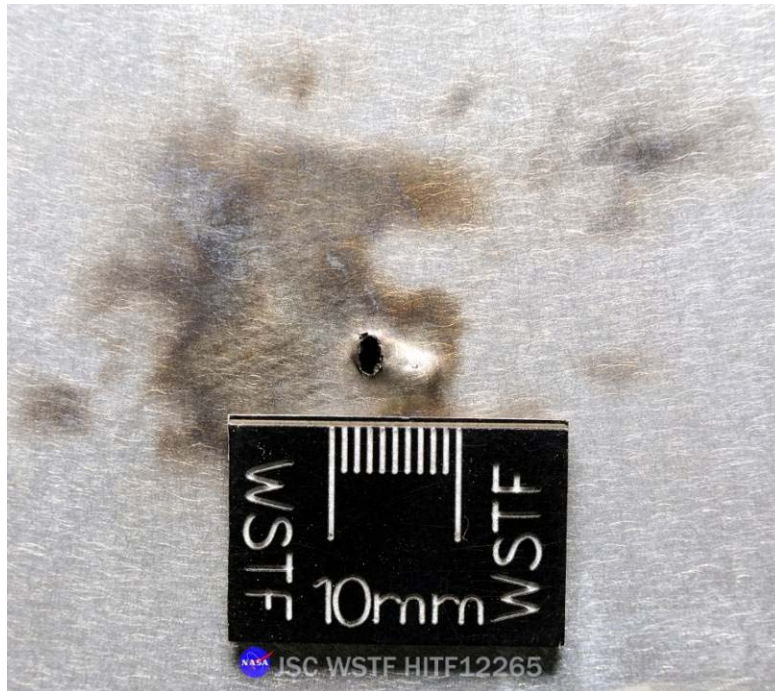
Test #9, HITF12265

Figure 159: Al 5456-0 Rear Wall Layer 8 Back of ISS Soyuz OM Test #9  
(Keyence 3D Microscope Image)

Figure 160: Al 5456-0 Rear Wall (Back) for ISS Soyuz Orbital Module Test #9

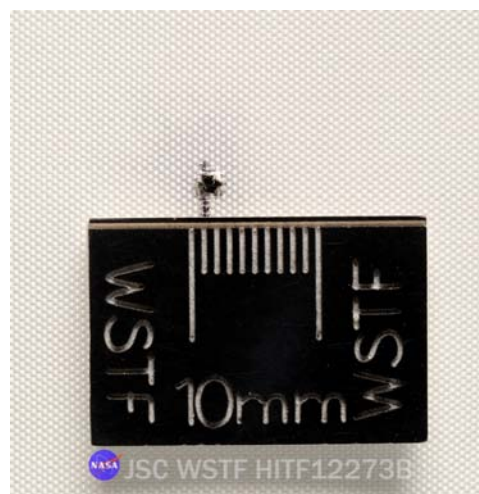
Figure 217: Beta Cloth Bumper of ISS Soyuz Orbital Module Test #13B

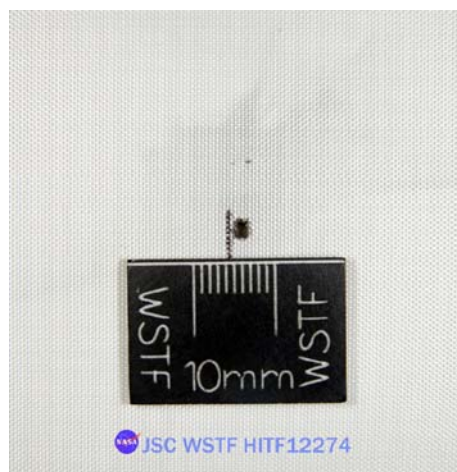
14 <a href="#">HITF12274</a>	1.3	0.00864	4.18	45	<p><b>Fail</b></p> <p>Beta cloth entry damage = 1.43mm x 1.87mm hole  Mylar Film damage 33.26 x 22.20mm hole  Fiberglass damage = 3.10 x 5.92mm hole  Al 6061 Foil damage = 2.95 x 4.06mm hole  Fiberglass damage = 3.46 x 4.32mm hole  MLI exit damage = 5.07mm x 6.72mm hole  Al 6061-T6 plate damage = 3.05mm x 5.04mm hole  Al 5456-0 RW damage = 0.87mm x 0.99mm hole  Al 2024-T3 WP damage = 0.50mm x 0.85mm x 0.056mm deep crater</p>
15C <a href="#">HITF12275</a>	1.0	0.00400	3.93	45	<p><b>Pass</b></p> <p>Beta cloth entry damage = 1.23mm x 1.68mm hole  Mylar Film damage 24.03 x 20.59mm hole  Fiberglass damage = 1.72 x 2.52mm hole  Al 6061 Foil damage = 2.23 x 3.04mm hole  Fiberglass damage = 2.20 x 3.15mm hole  MLI exit damage = 4.10mm x 5.64mm hole  Al 6061-T6 plate damage = 2.70mm x 3.95mm hole  Al 5456-0 RW damage = 1.10mm x 1.21mm hole  Al 2024-T3 WP damage = no damage</p>

Figure 234: Beta Cloth Bumper Layer 1 of ISS Soyuz OM Test #14 (Keyence 3D Microscope Image)

Figure 235: Beta Cloth Bumper of ISS Soyuz Orbital Module Test #14

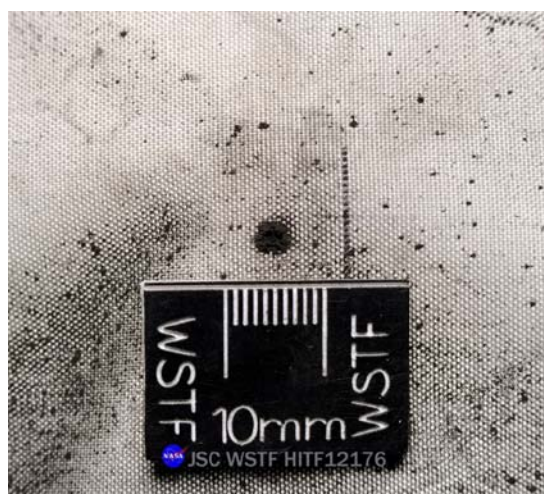
Test No.	Actual Projectile Diameter (mm)	Actual Projectile Mass (g)	Actual Impact Velocity (km/s)	Impact Angle (deg)	Results
16 <a href="#">HITF12276</a>	1.6	0.01610	7.00	30	<p><b>Fail</b></p> <p><b>Beta cloth entry damage</b> = 1.69mm x 1.84mm hole  <b>Mylar Film damage</b> 23.55 x 18.53mm hole  <b>Fiberglass damage</b> 10.23 x 10.29mm hole  <b>Al 6061 Foil damage</b> = 7.72 x 5.93mm hole  <b>Fiberglass damage</b> 11.36 x 12.23mm hole  <b>MLI exit damage</b> = 8.75mm x 9.62mm hole  <b>Al 6061-T6 plate damage</b> = 6.66mm x 7.91mm hole  <b>Al 5456-0 RW damage</b> = 1.77mm x 1.75mm hole  <b>Al 2024-T3 WP damage</b> = 52mm x 63mm area of aluminum specks</p>
17 <a href="#">HITF12277</a>	1.5	0.01331	4.83	30	<p><b>Fail</b></p> <p><b>Beta cloth entry damage</b> = 1.66mm x 1.70mm hole  <b>Mylar Film damage</b> 15.62 x 12.15mm hole  <b>Fiberglass damage</b> = 3.63 x 4.03mm hole  <b>Al 6061 Foil damage</b> = 4.32 x 5.02mm hole  <b>Fiberglass damage</b> = 4.62 x 5.64mm hole  <b>MLI exit damage</b> = 6.47mm x 7.43mm hole  <b>Al 6061-T6 plate damage</b> = 4.63mm x 6.11mm hole  <b>Al 5456-0 RW damage</b> = 2 holes largest is 1.54mm x 2.20mm  <b>Al 2024-T3 WP damage</b> = 0.487mm x 0.536mm x 0.372mm deep crater &amp; many smaller</p>

Figure 266: Beta Cloth Bumper Layer 1 of ISS Soyuz OM Test #16 (Keyence 3D Microscope Image)

Figure 267: Beta Cloth Bumper Close-up of ISS Soyuz Orbital Module Test #16

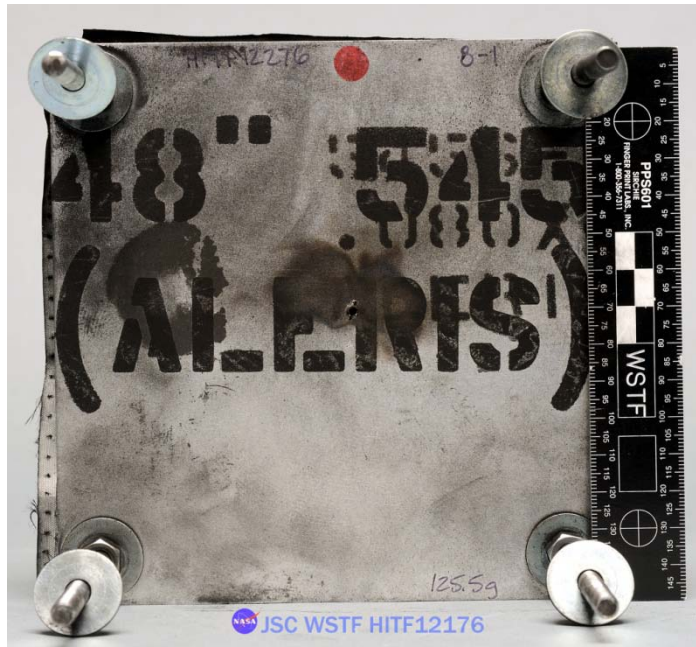
Test #16, HITF12276

Figure 277: Al 5456-0 Rear Wall (Back) for ISS Soyuz Orbital Module Test #16
