NASA Technical Memorandum TM 103820

Debris/Ice/TPS Assessment And Photographic Analysis For Shuttle Mission STS-39

April 28, 1991

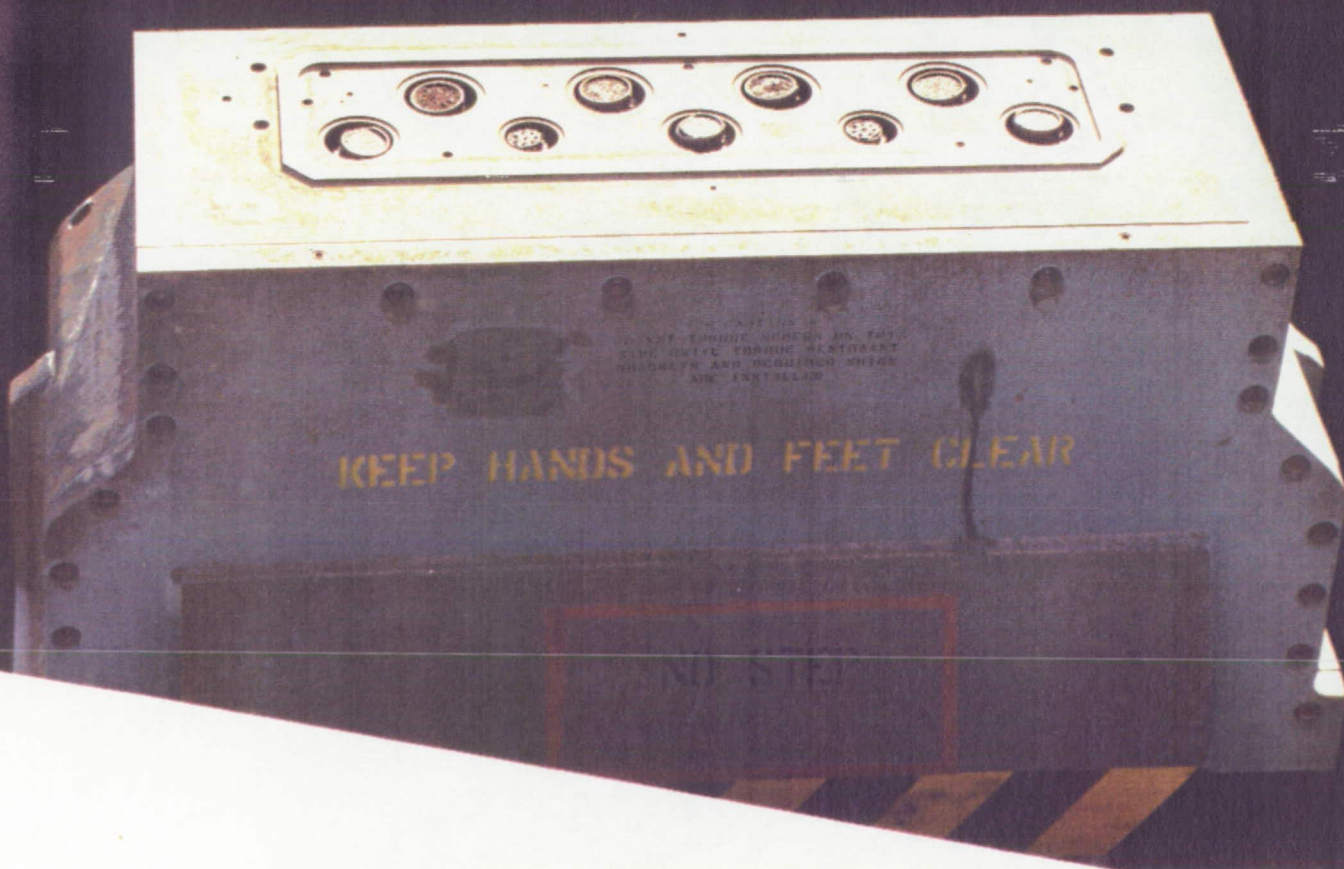
New SRB T-0 umbilical electrical connector savers (sacrificial pieces) were intact

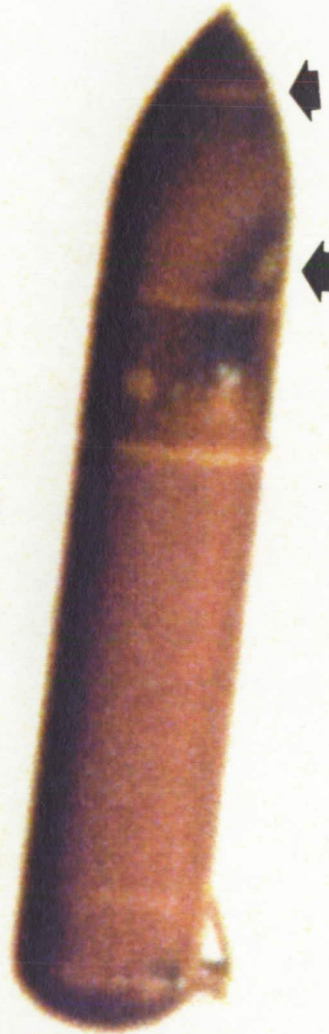
On-orbit view of the External Tank shortly after separation from the Orbiter revealed no major anomalies. BSM burn scar on the LO2 tank is typical. Bright line on the LO2 tank ogive is the SOFI spray interrupt/sanded area - a feature on the tank prior to launch.

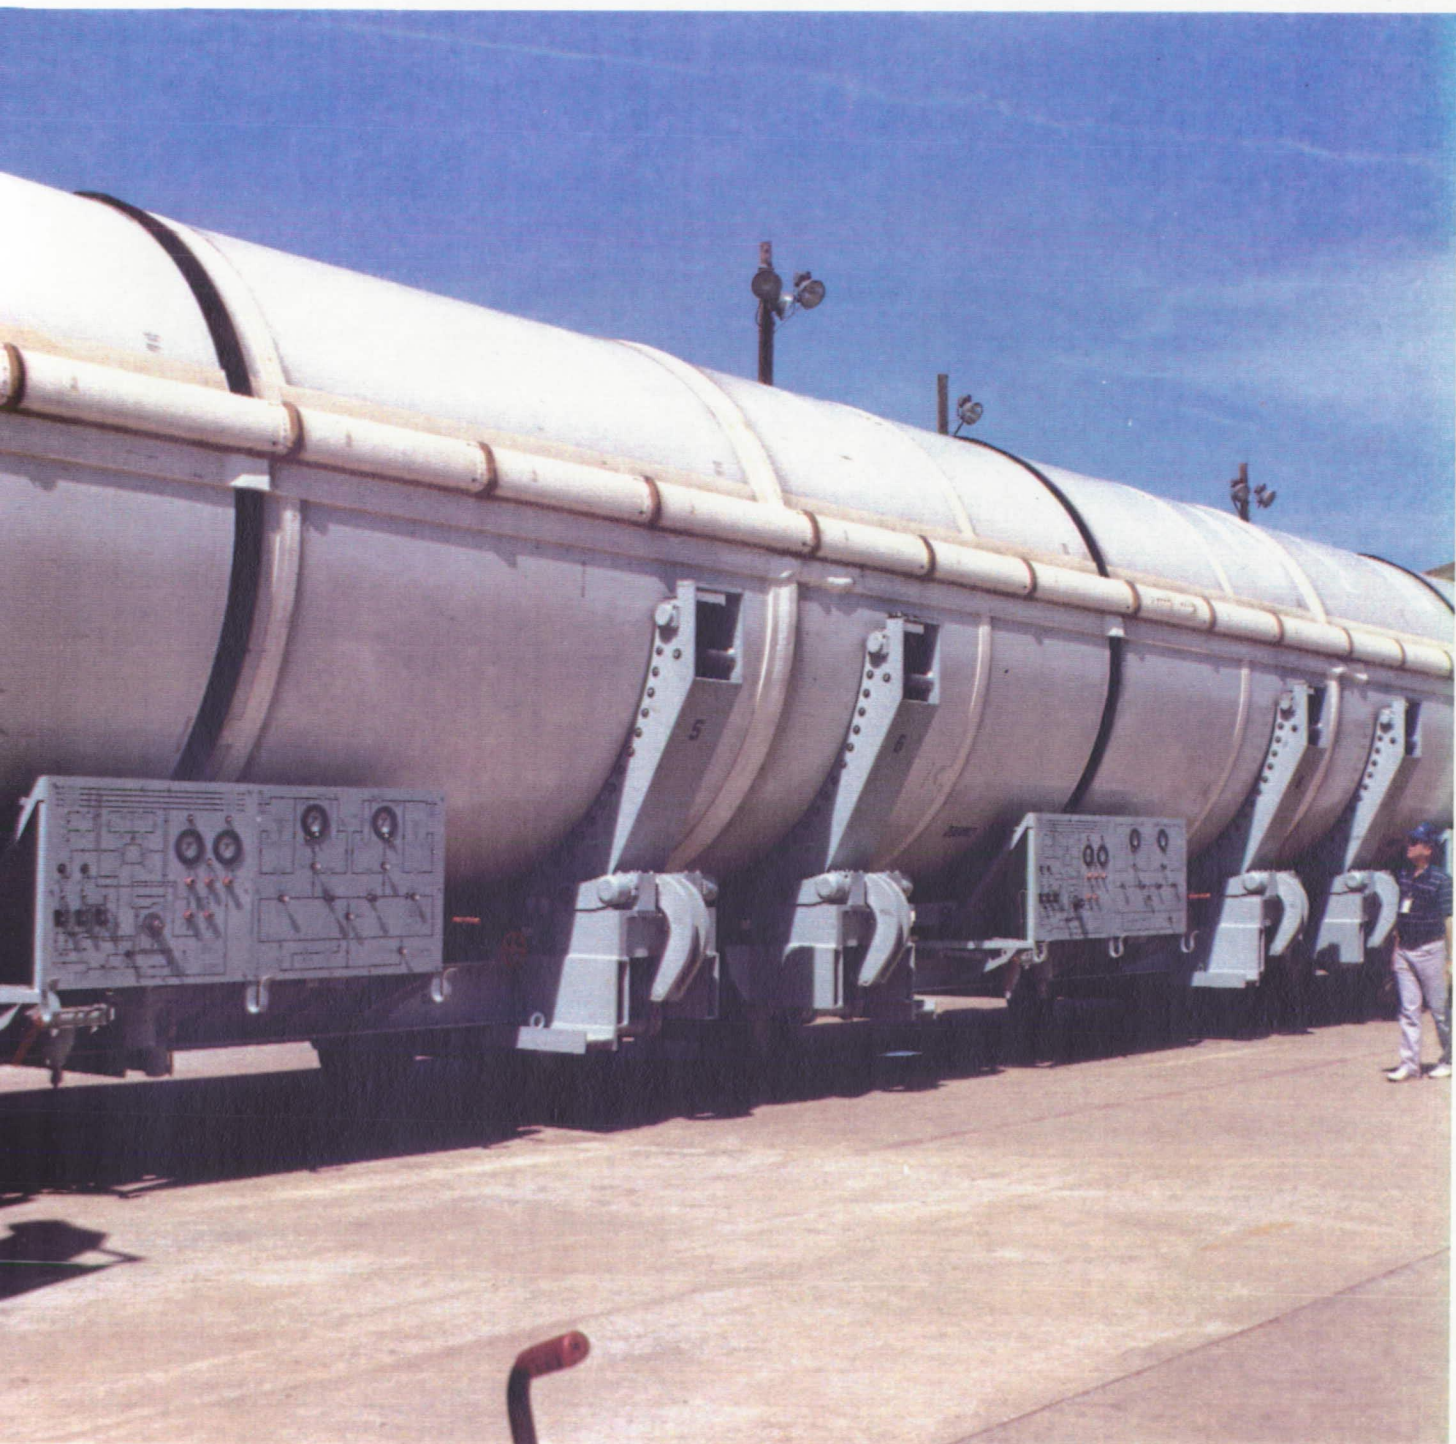
Post flight condition of LH SRM segment cases. The field joint protection system closeouts were generally in good condition.

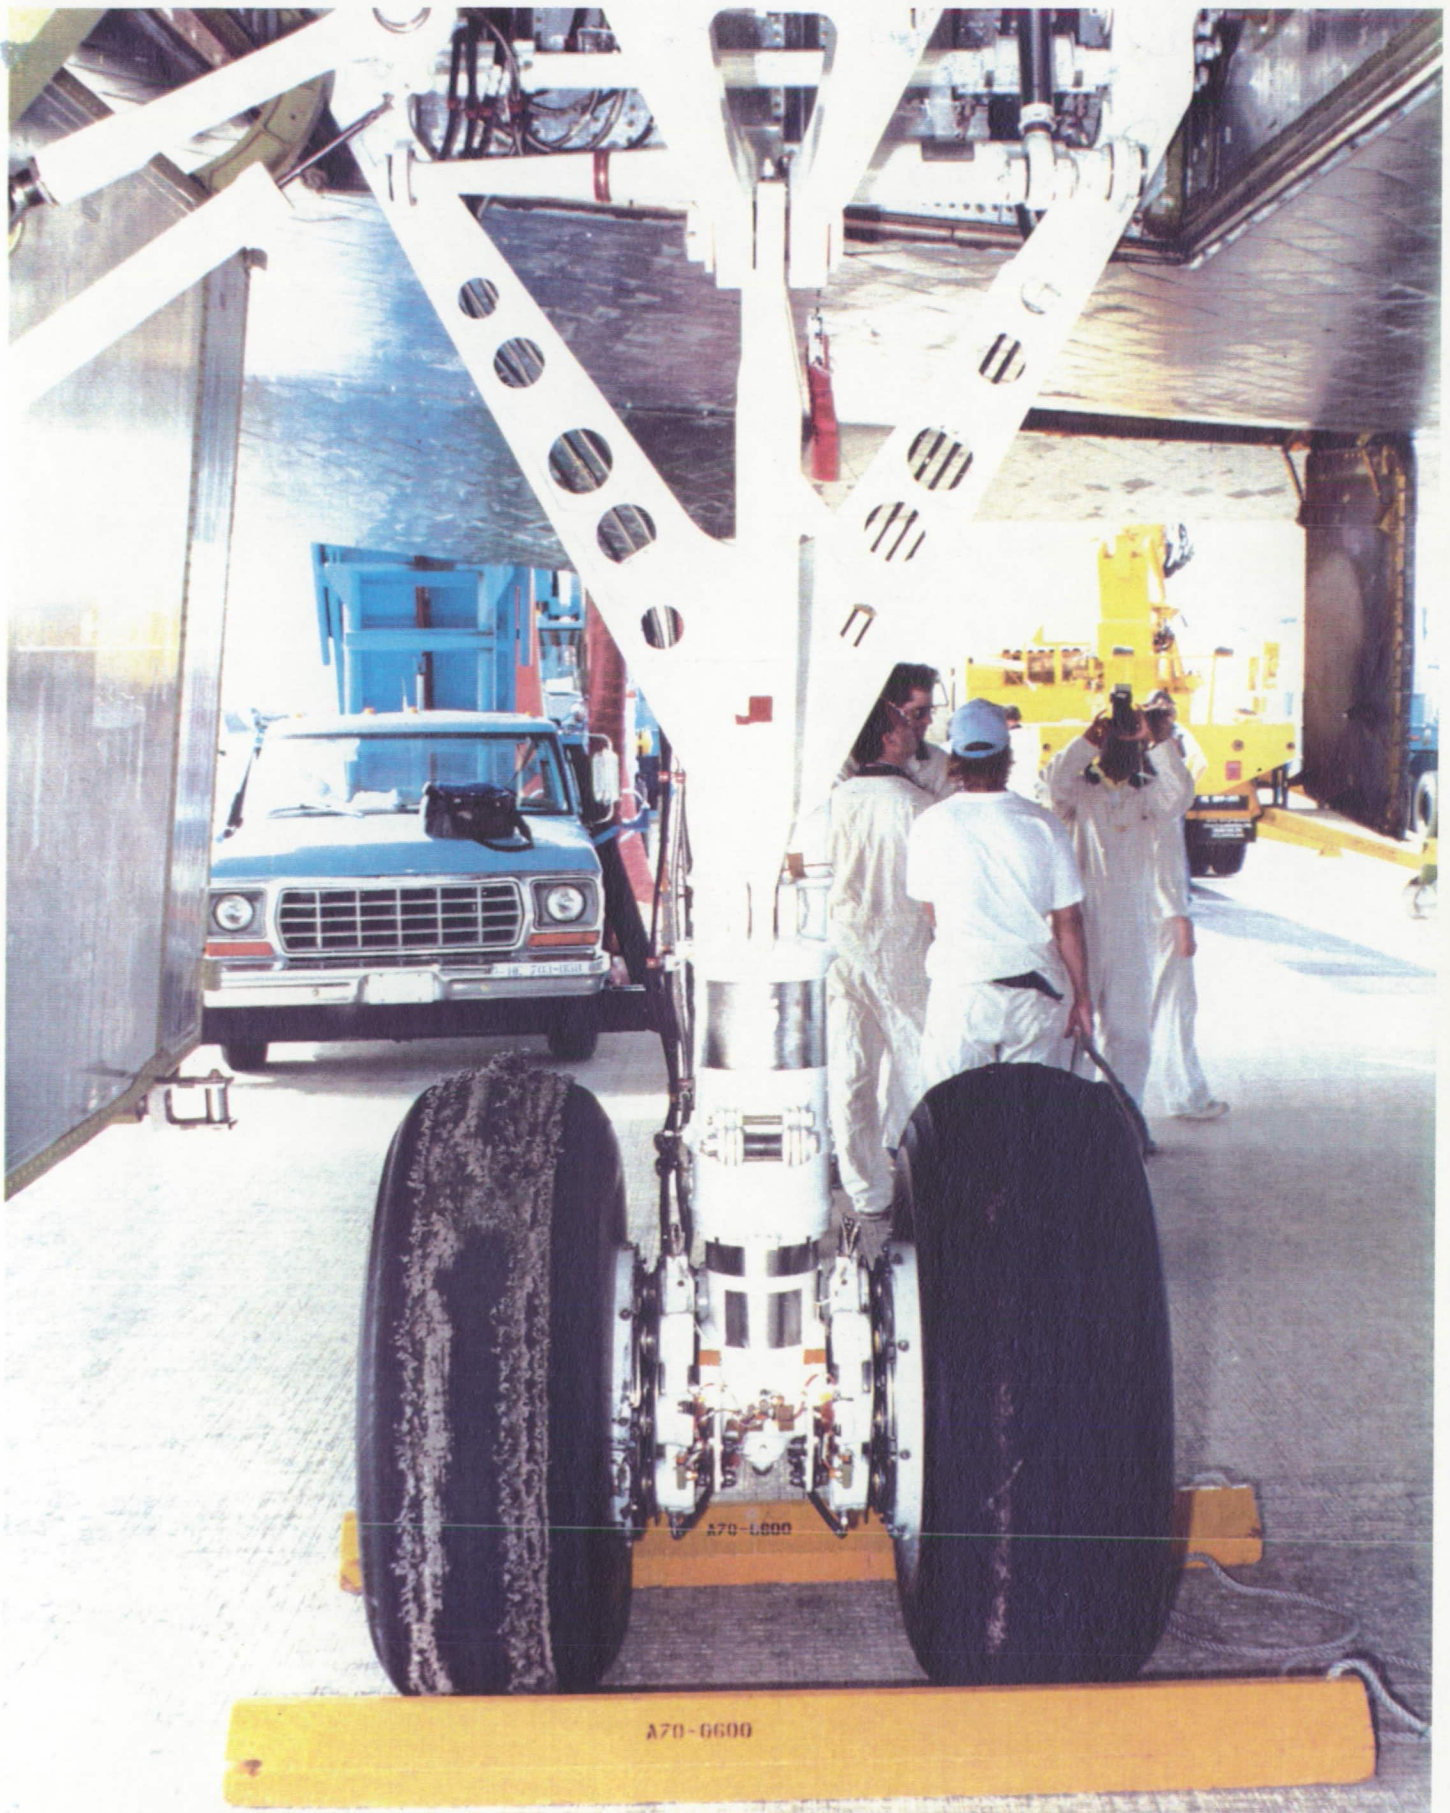
No tile damage was attributed to the loss of tire material from the main landing gear wheels
