NASA Technical Memorandum TM 102790

# Debris/Ice/TPS Assessment And Photographic Analysis For Shuttle Mission STS-31R

Charles G. Stevenson  
NASA/Kennedy Space Center

April 24, 1990

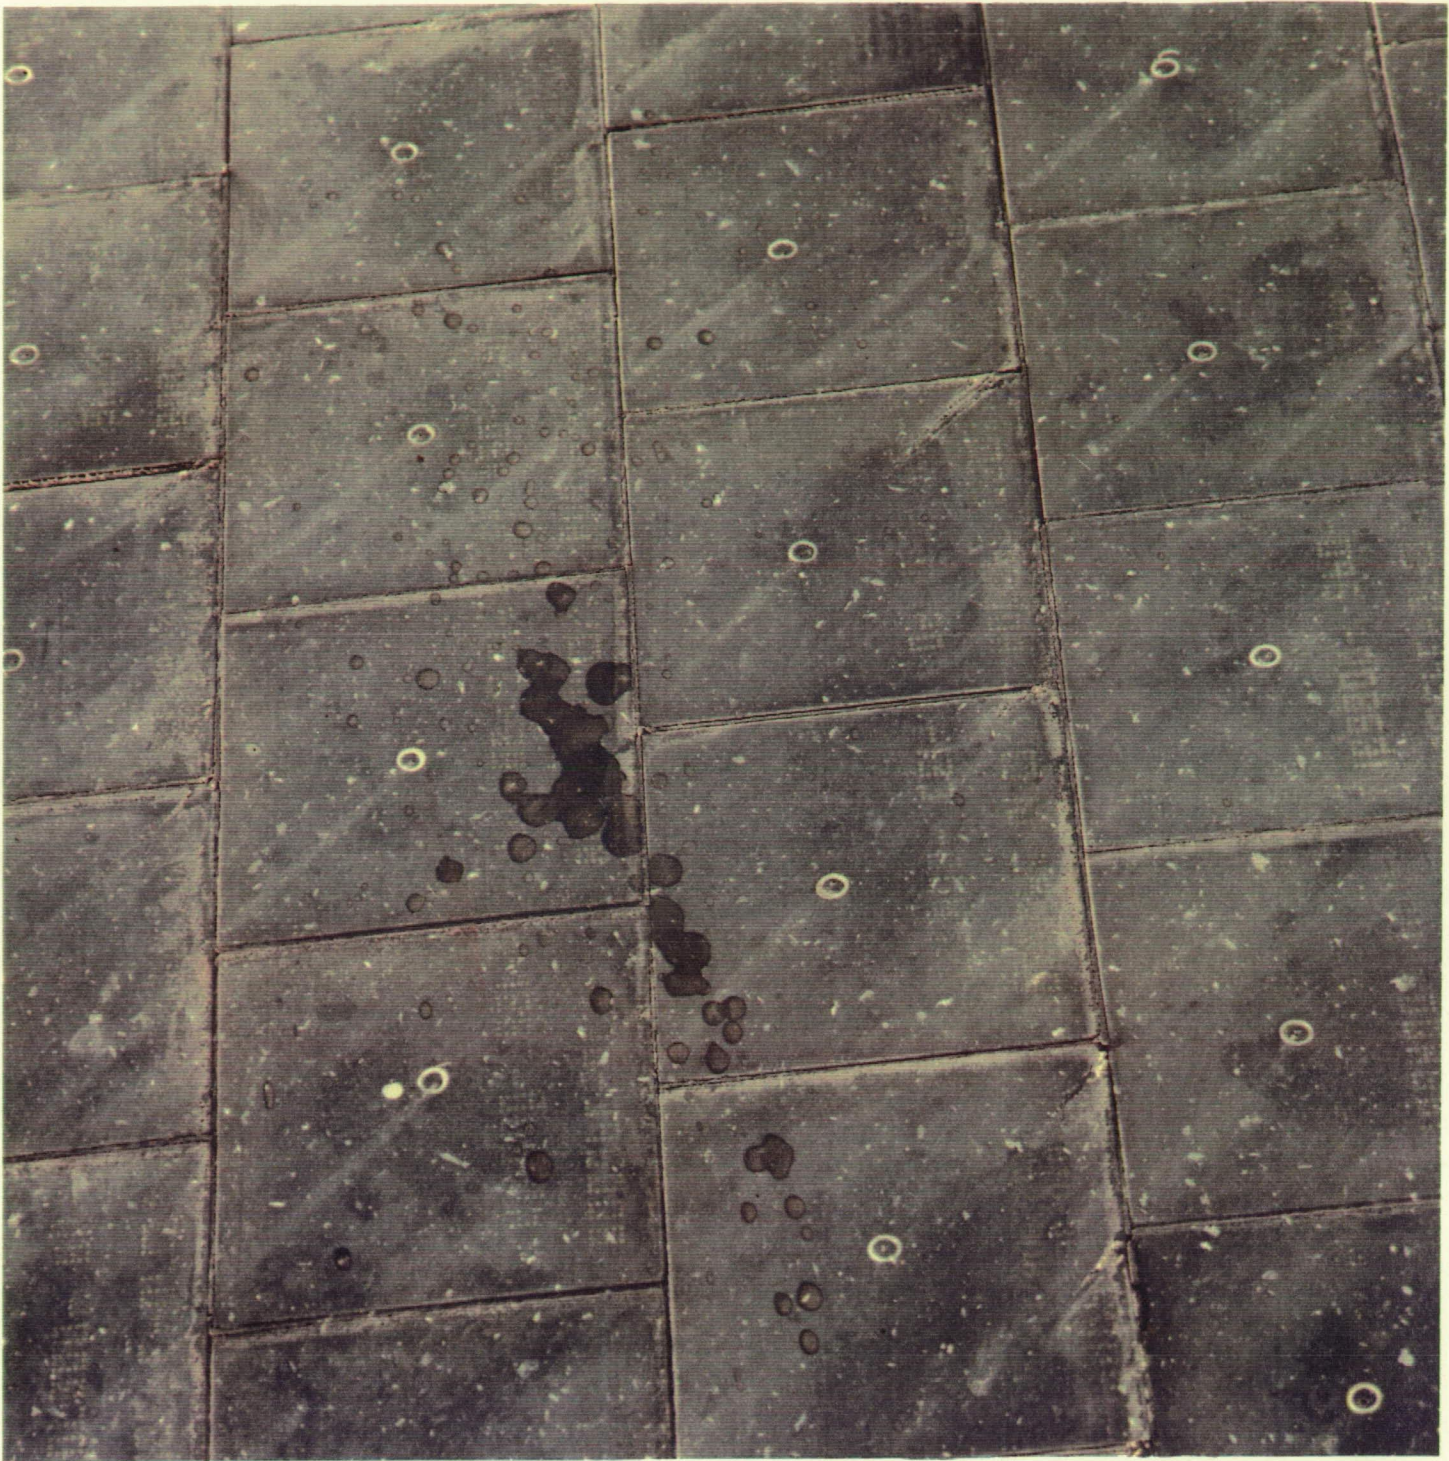
White residue on wing leading edge RCC panels was paint, TPS materials, BSM exhaust residue, and landing site products
