NASA Technical Memorandum TM 102153

Debris/Ice/TPS Assessment And Photographic Analysis For Shuttle Mission STS-34

November 1989

October 18, 1989

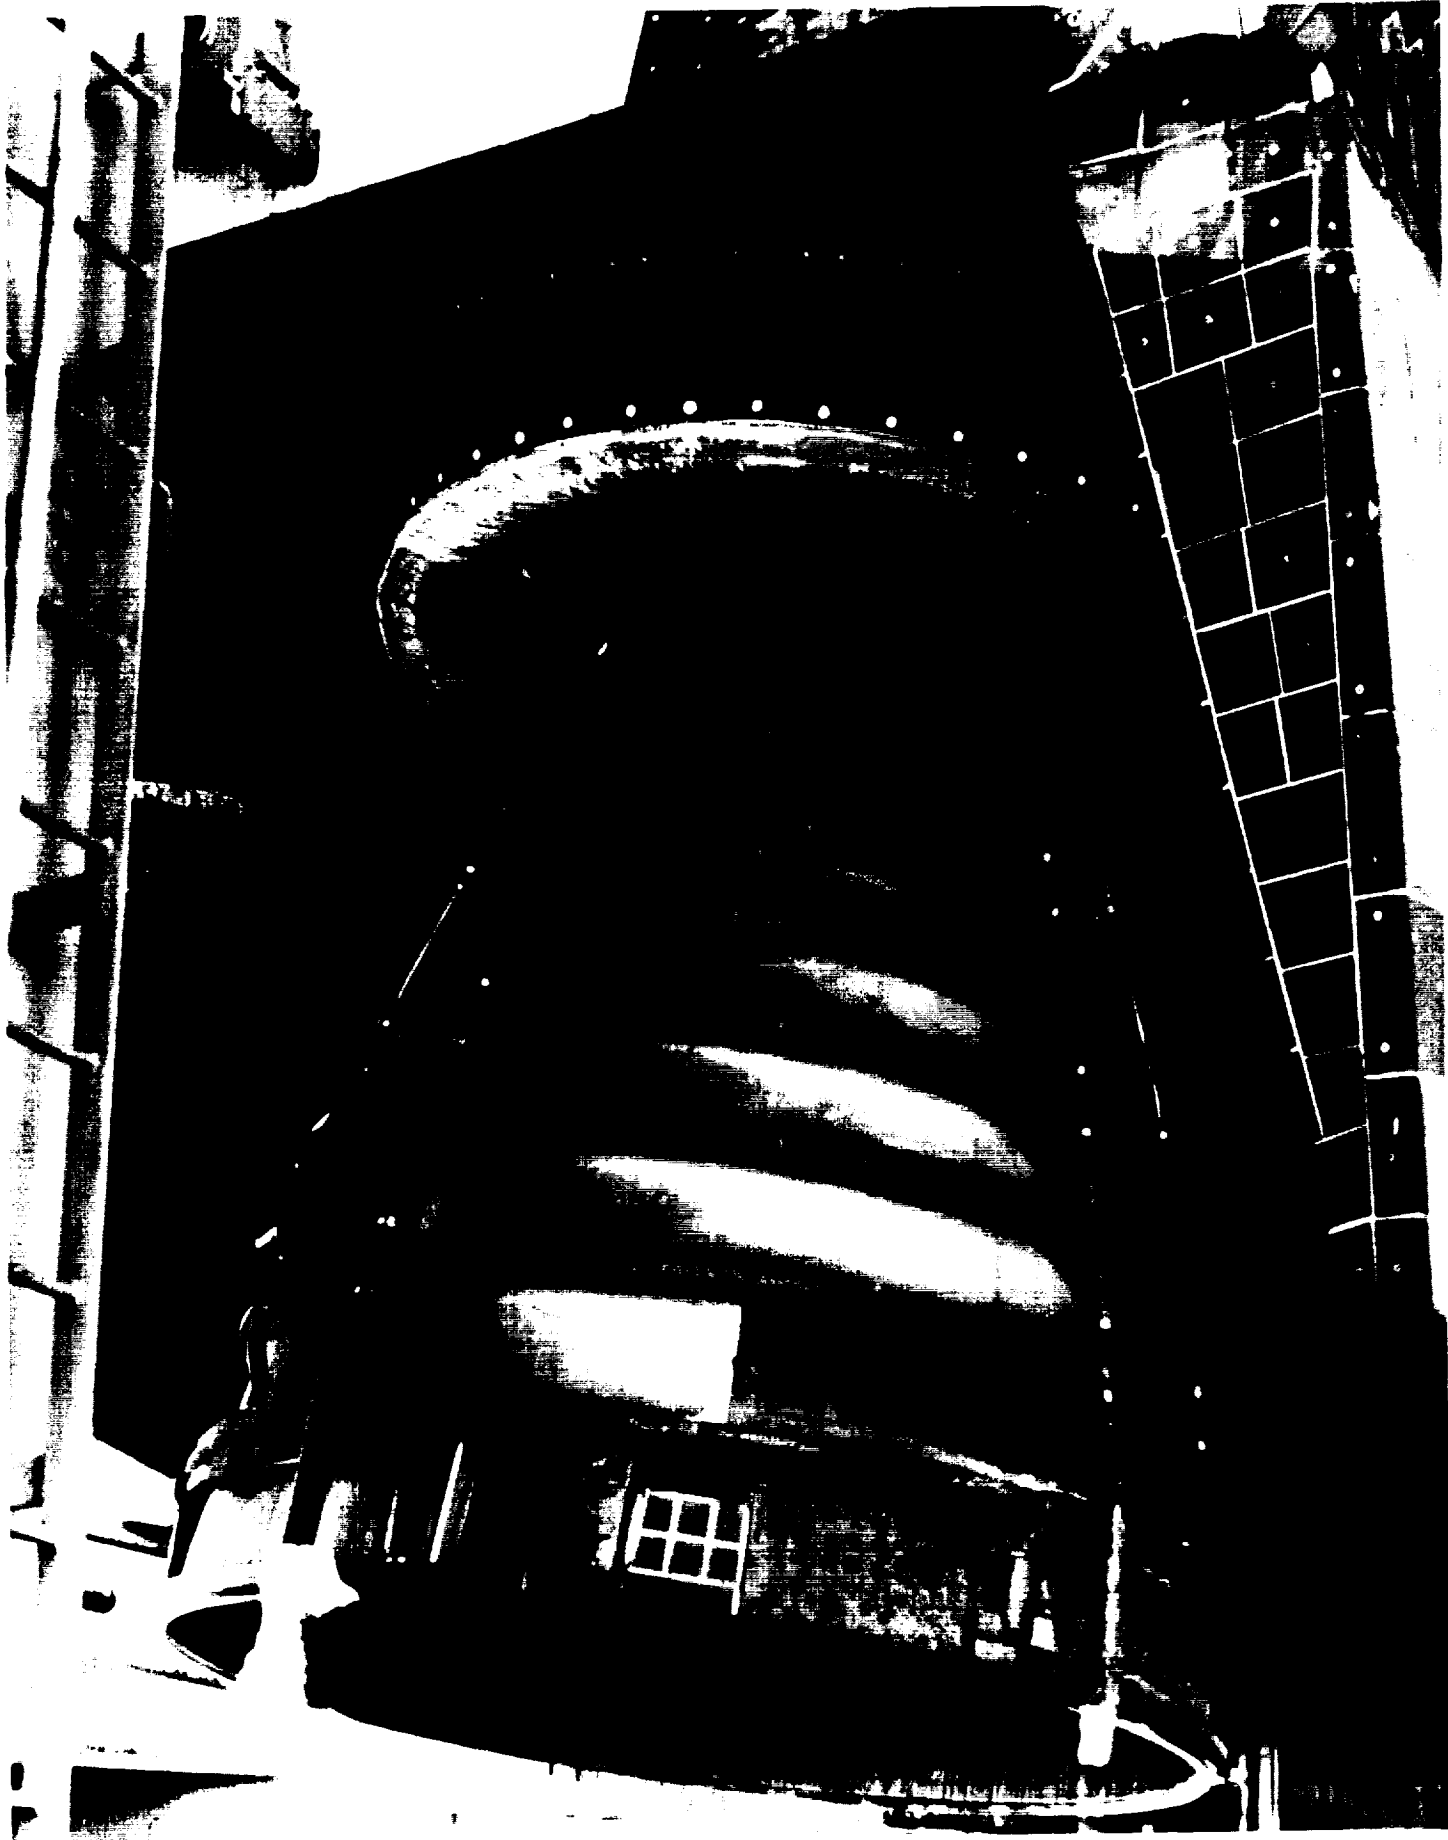
SSME #3 engine mounted heat shield exhibits no condensate/frost

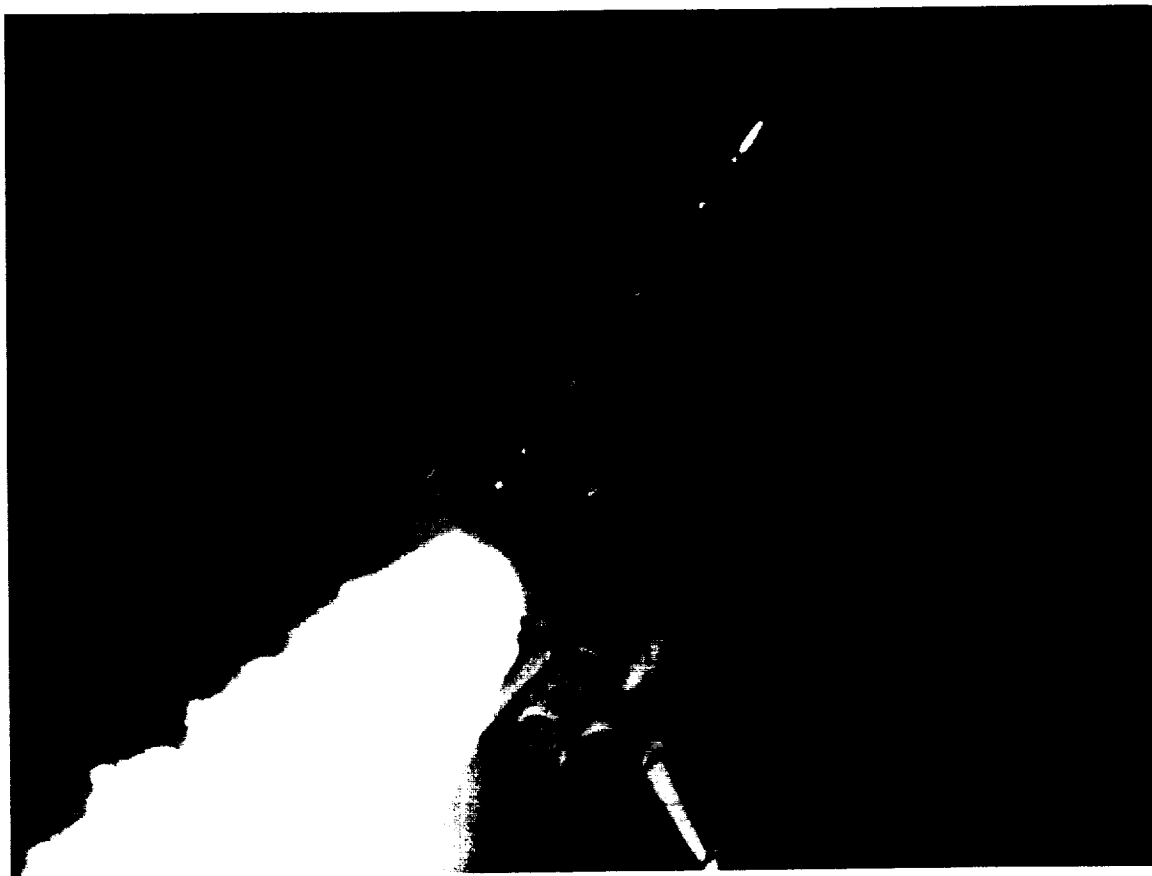
RH RCS thruster paper cover appears at GMT 16:54:33
