CHARACTERIZATION OF METALS MELTING DISCS
SKYLAB EXPERIMENT M551

By Robert E. Monroe
Battelle Columbus Laboratories
Columbus, Ohio 43201

January 1974

NASA-GEORGE C. MARSHALL SPACE FLIGHT CENTER
Marshall Space Flight Center, Alabama 35812

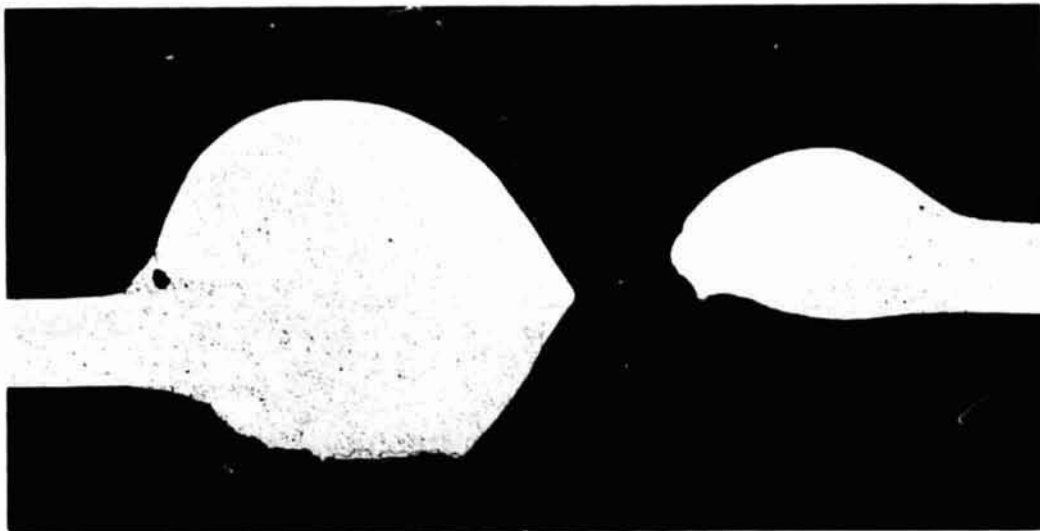
FIGURE A-4. FRONT SURFACE H-1

The radiograph showed longitudinal weld cracks near the weld start (125° to 135°), and near the molybdenum tracer (225° to 235°). Cracks in the dwell crater also were apparent. All of these cracks also were visible on the weld surface. Figure A-4 shows the front surface of Disc H-1. The rectangular cutouts were examined at Battelle. The cross hatch wedge sections were sent to MSFC for examination.

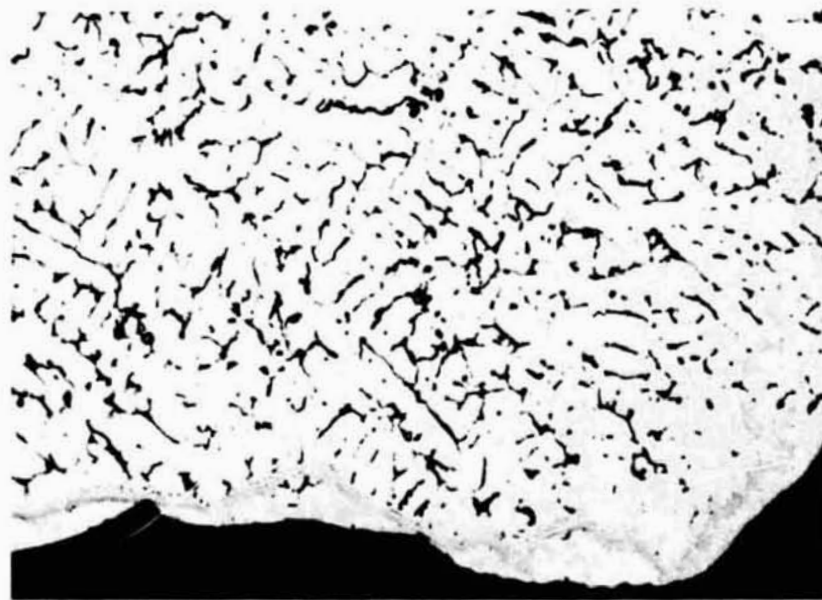
a. Enlarged area of Figure A-6

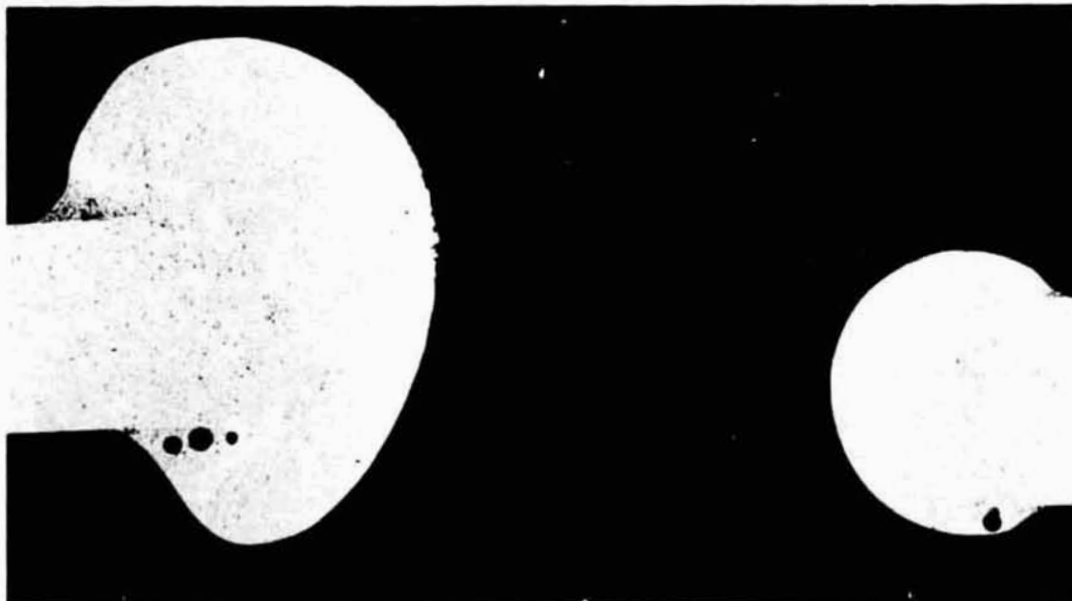
FIGURE A-8. PORE IN SECTION AT BASE METAL INTERFACE
H-1

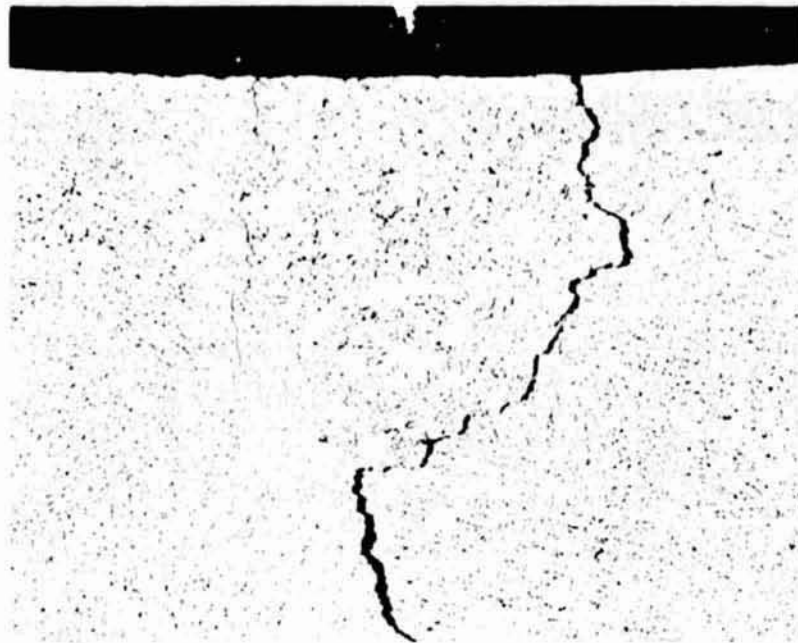
FIGURE A-12. ENLARGEMENT OF LONGITUDINAL CRACK
AT WELD START - H-1

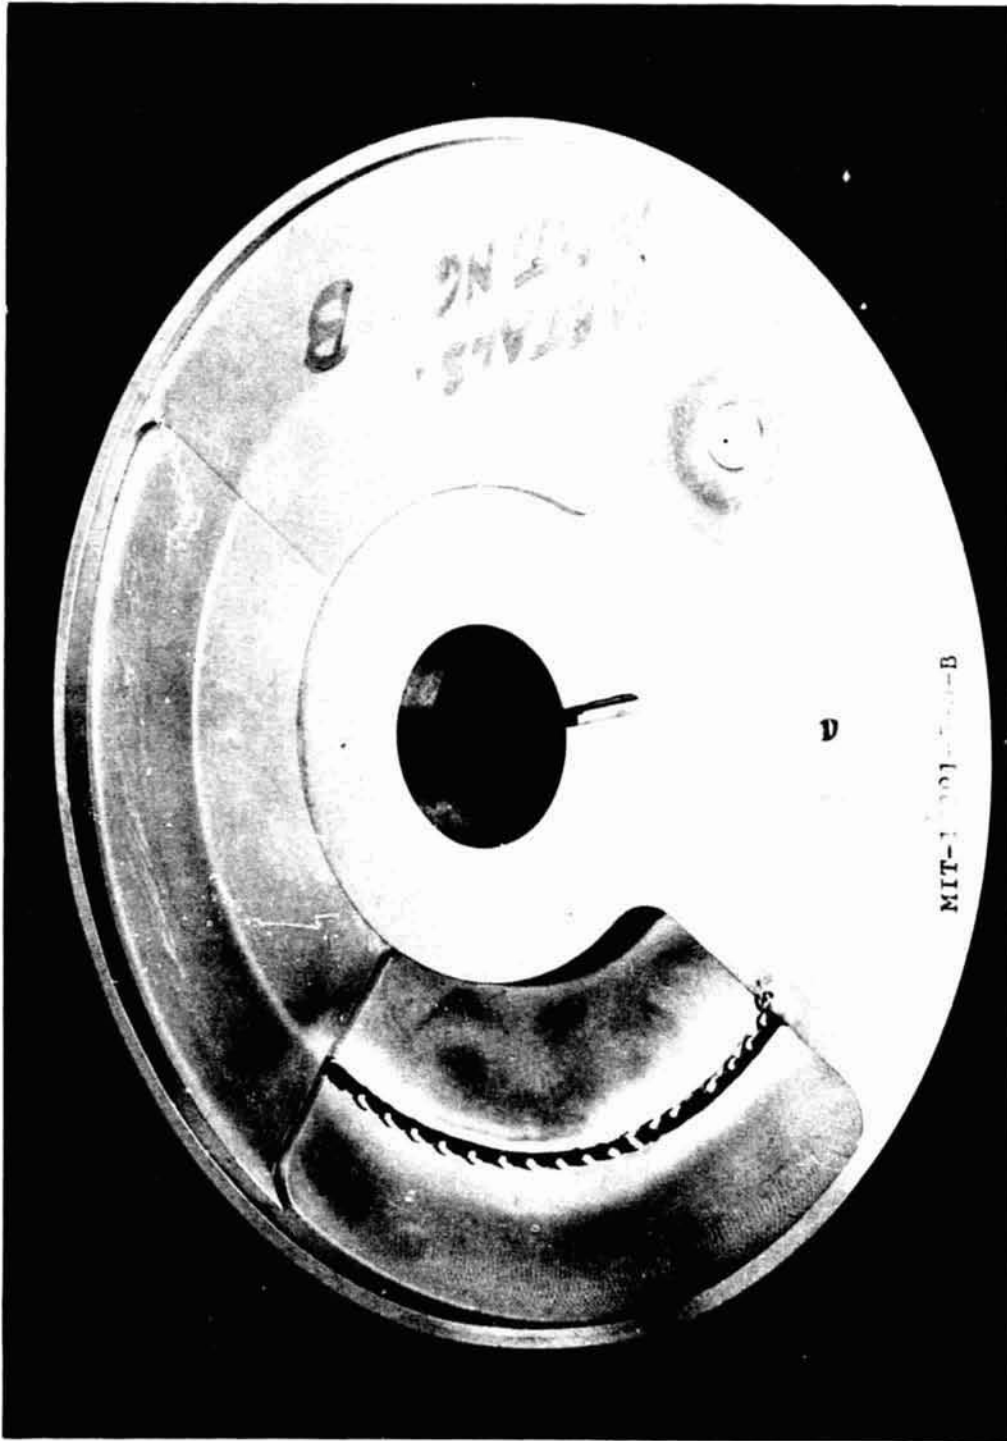
FIGURE A-38. BACK OF DISC B SHOWING QUADRANT DESIGN

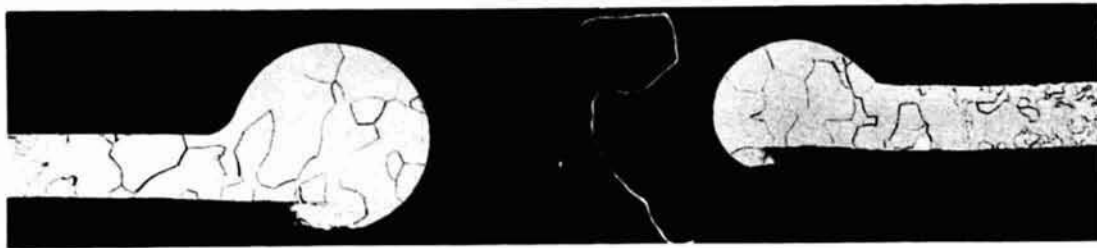
FIGURE A-57. SECTION THROUGH CUT REGION S/N 143

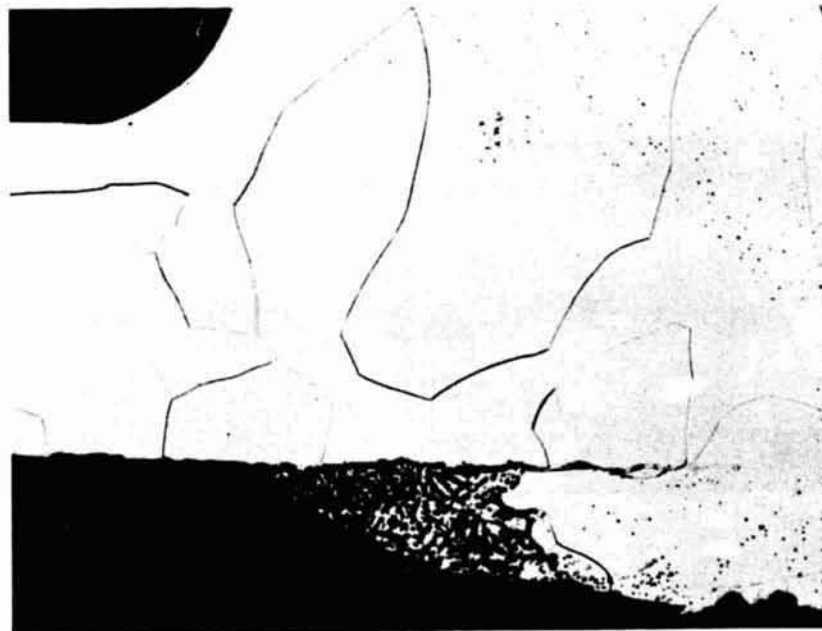
FIGURE A-58. BOTTOM SURFACE OF OUTSIDE CUT EDGE S/N 143

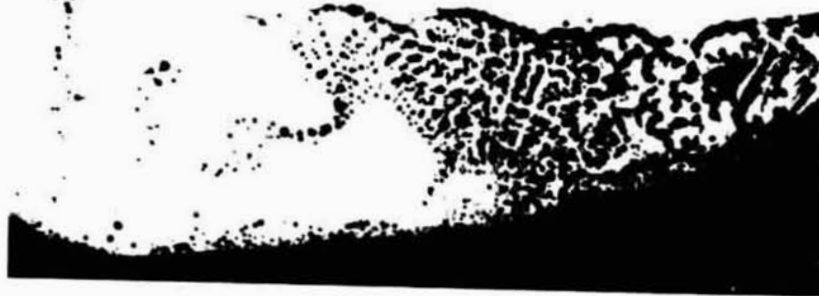
FIGURE A-59. BOTTOM SURFACE OF INSIDE CUT EDGE S/N 143
