PHASE B REPORT

MATERIALS PROCESSING IN SPACE M512

CONTRACT NAS 8-28725

July 15, 1973

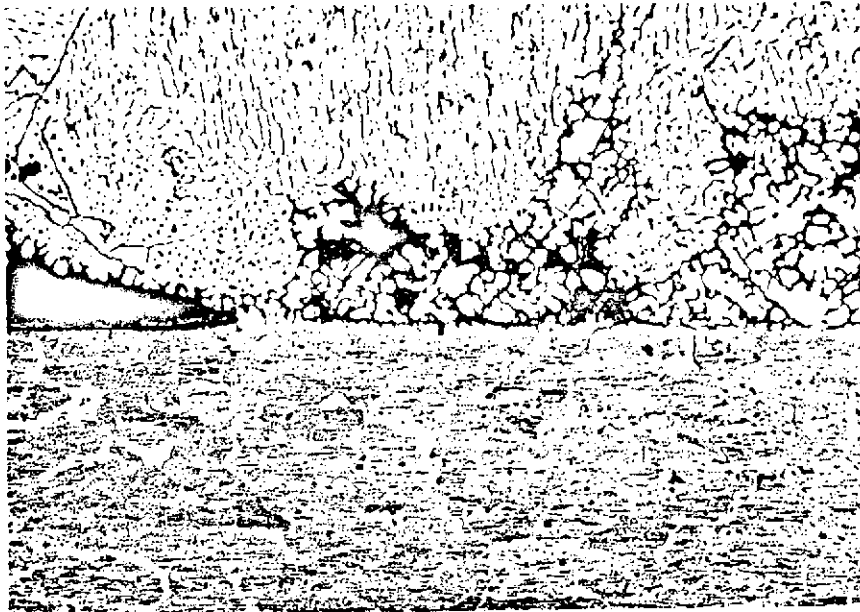
a. Weld metal-base metal interface

b. Internal microstructure

FIGURE A-32. STRUCTURES IN DWELL REGION  
S/N-124

c. Surface microstructure

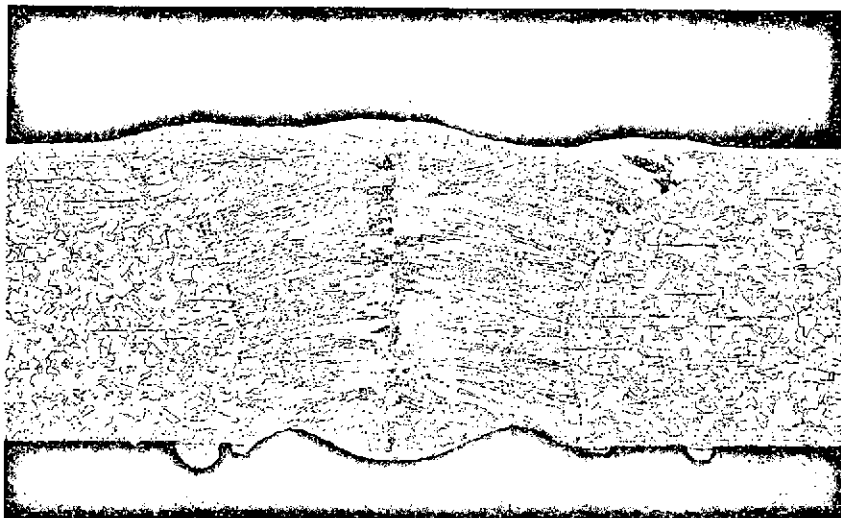
105°(+)

FIGURE A-42. SECTION THROUGH RAMP  
REGION - S/N 104

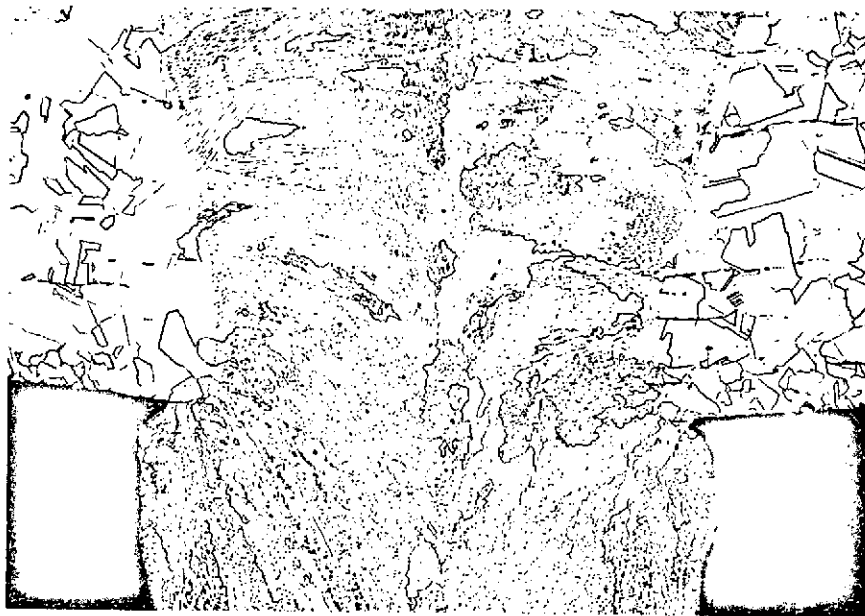
235° (-)

FIGURE A-45. SECTION AT ROOT OF WELD S/N 104

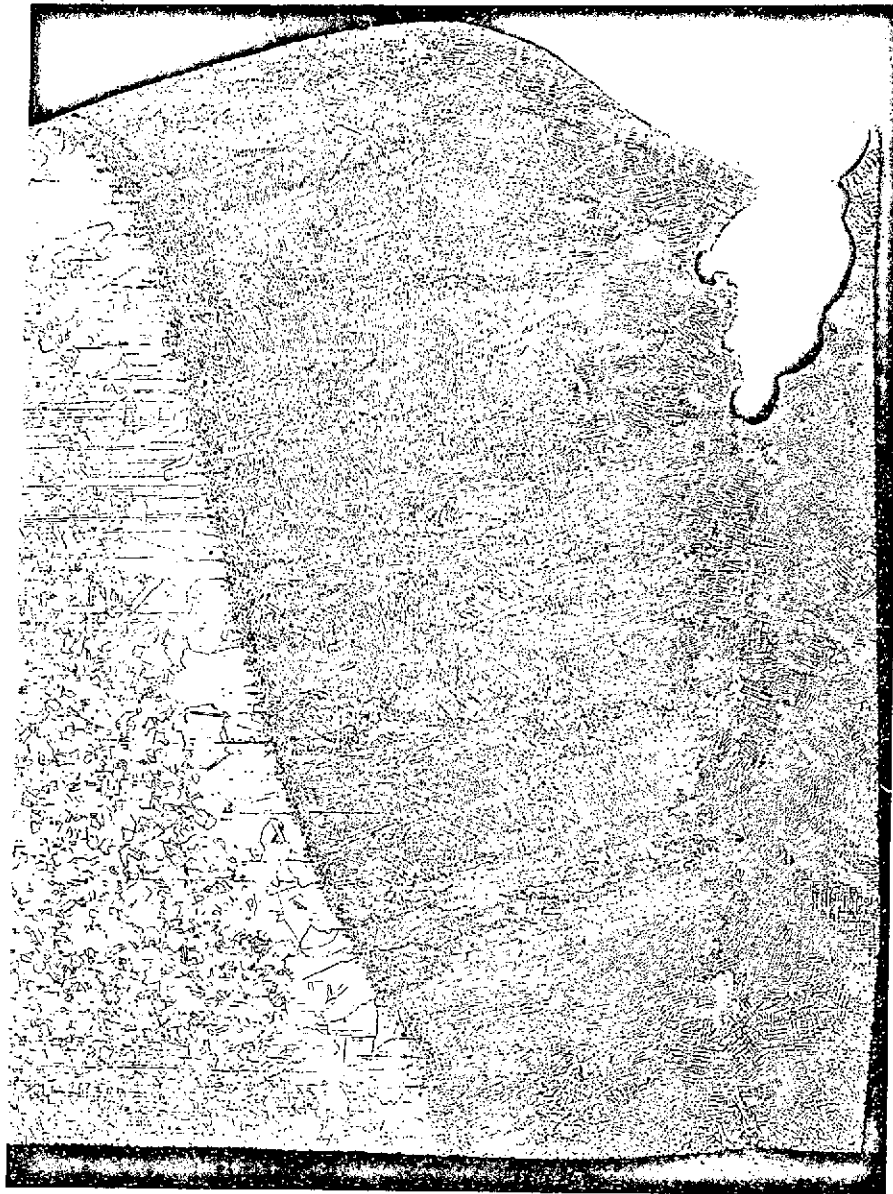
a. Chord Section

FIGURE A-50. SECTIONS THROUGH DWELL REGION, S/N 104

b. Top Edge Fusion Line

c. Typical Weld Microstructure

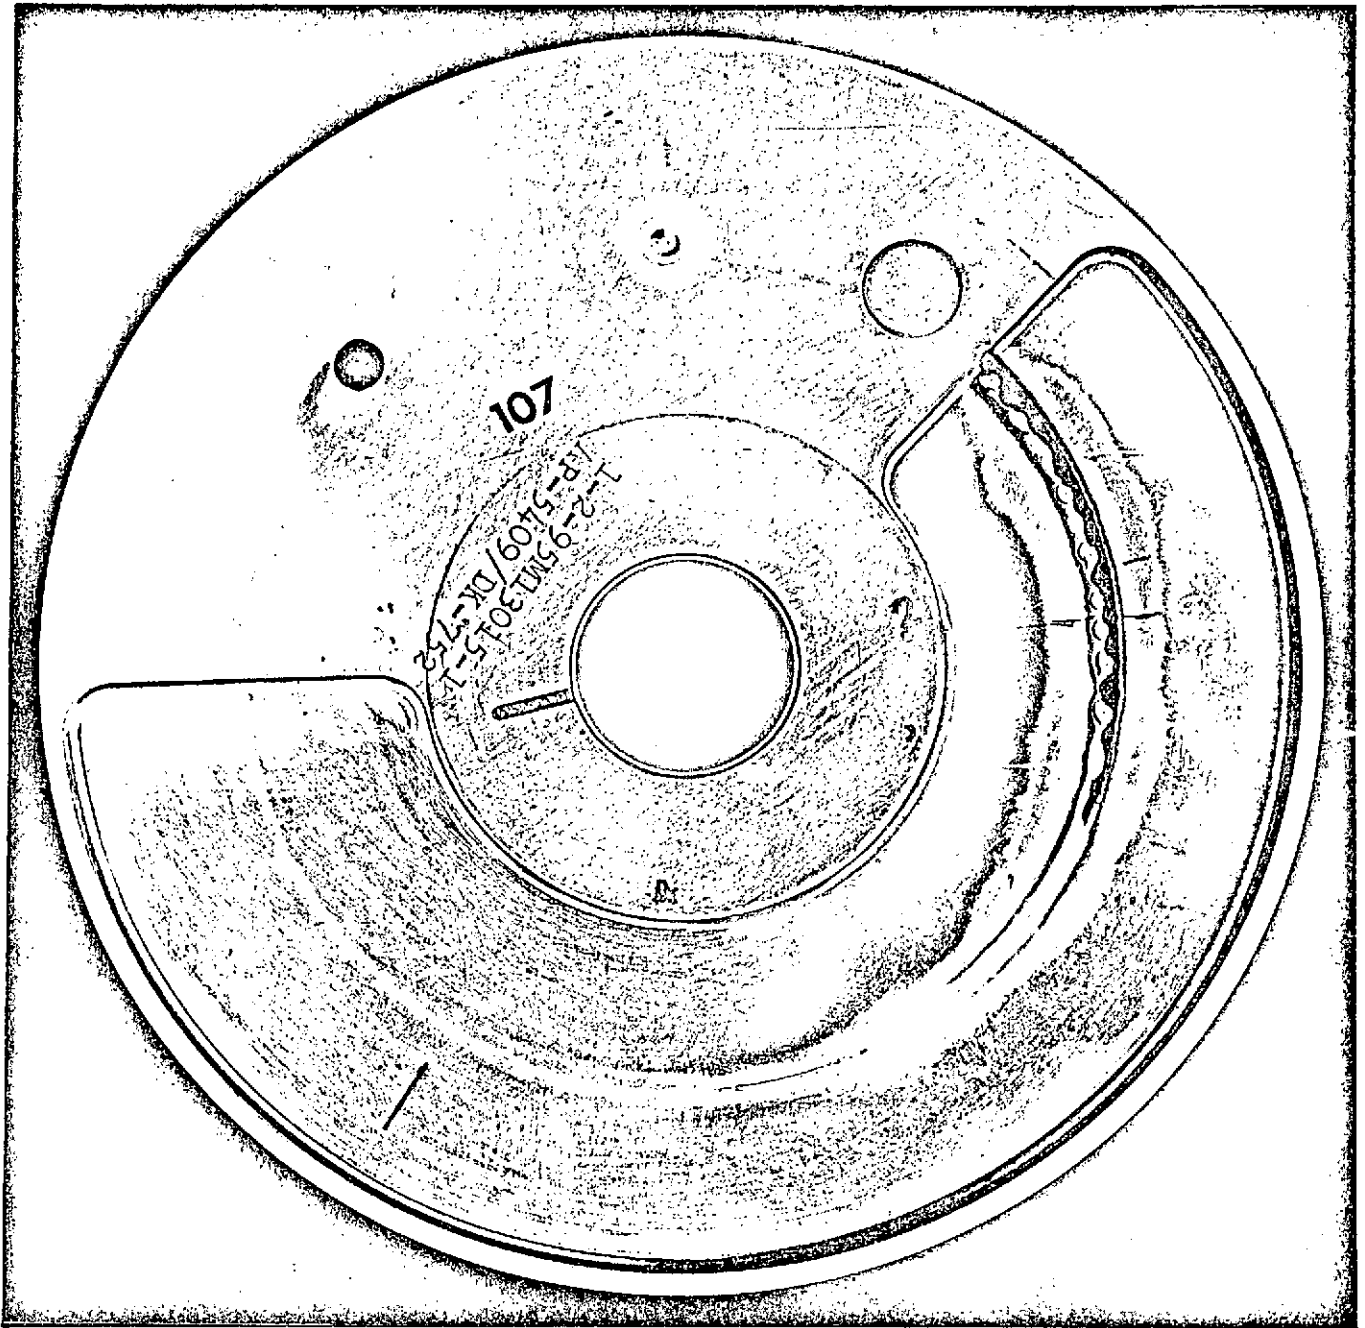
FIGURE A-52. BACK SURFACE

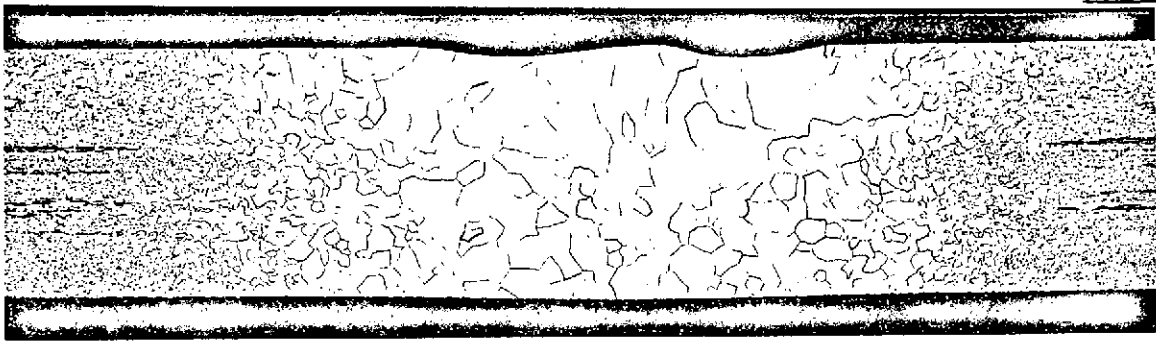
FIGURE A-56. SECTION THROUGH REGION BEFORE CUT S/N 143
