NASA CR-66814

COMPREHENSIVE REPORT
ON
NASA ROCKET MOTOR DEFECTS INVESTIGATION

VOLUME II - TABLES AND FIGURES

COMPREHENSIVE REPORT
ON
NASA ROCKET MOTOR DEFECTS INVESTIGATION
FROM AUGUST 1966 TO JUNE 1968
by R. B. Enie and C. R. Hitt, Jr.

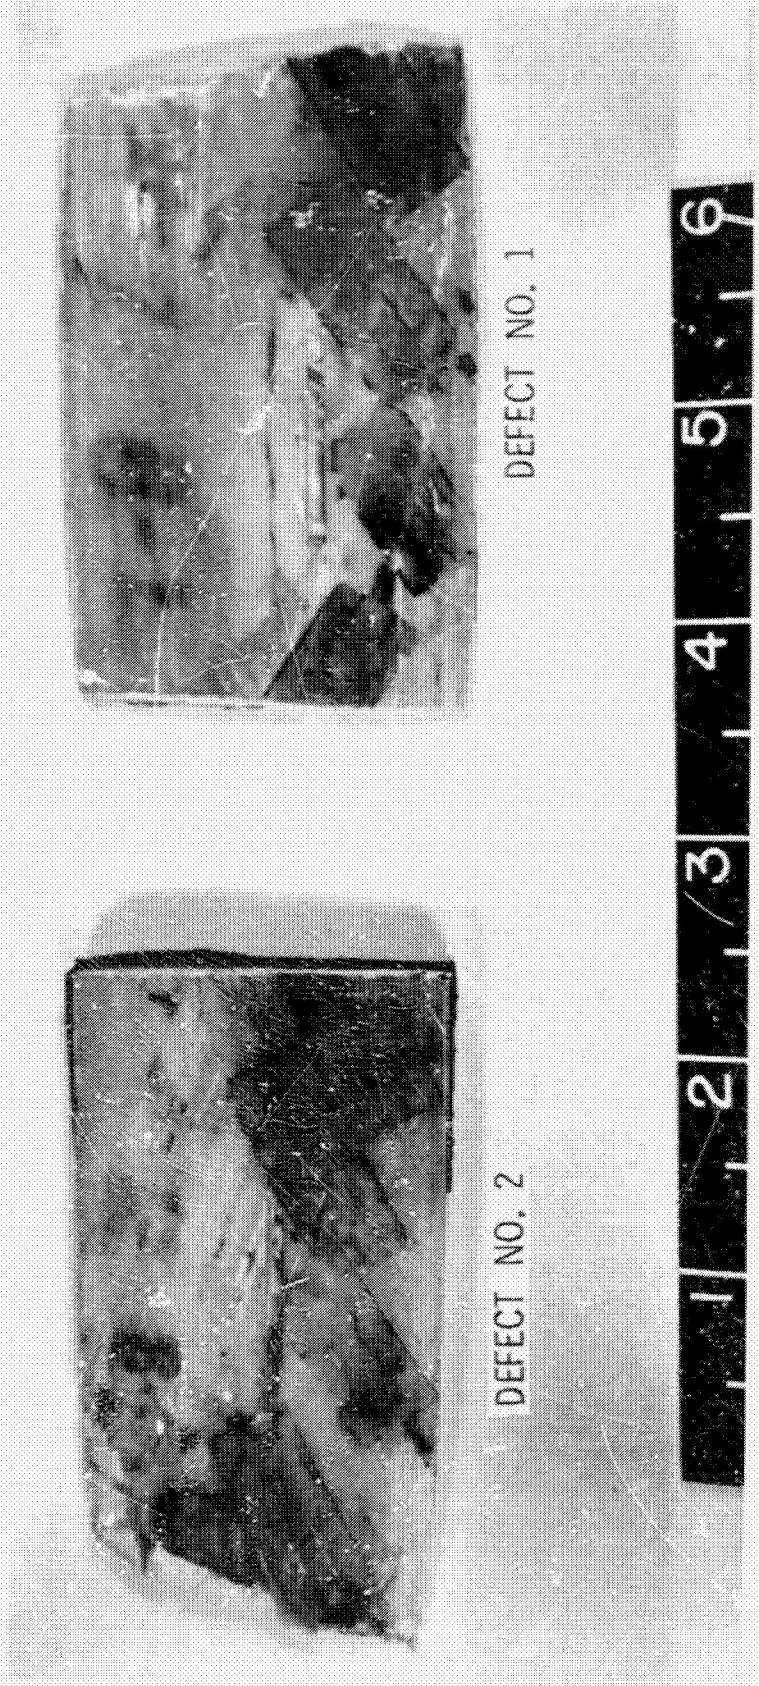
FIGURE 7 - TOP VIEW OF AFT DOME DEFECTS ON NPP-447 (A6)

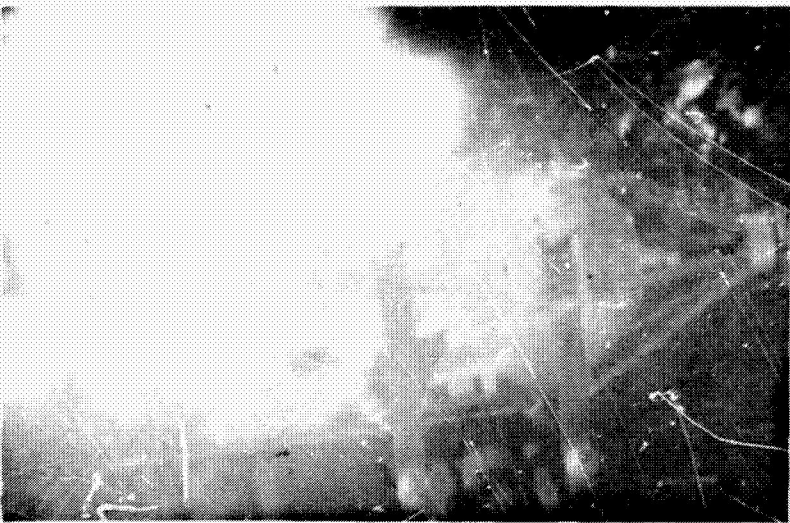
FIGURE 33 - MOTION PICTURES OF S/N 475 (A6) FAILURE

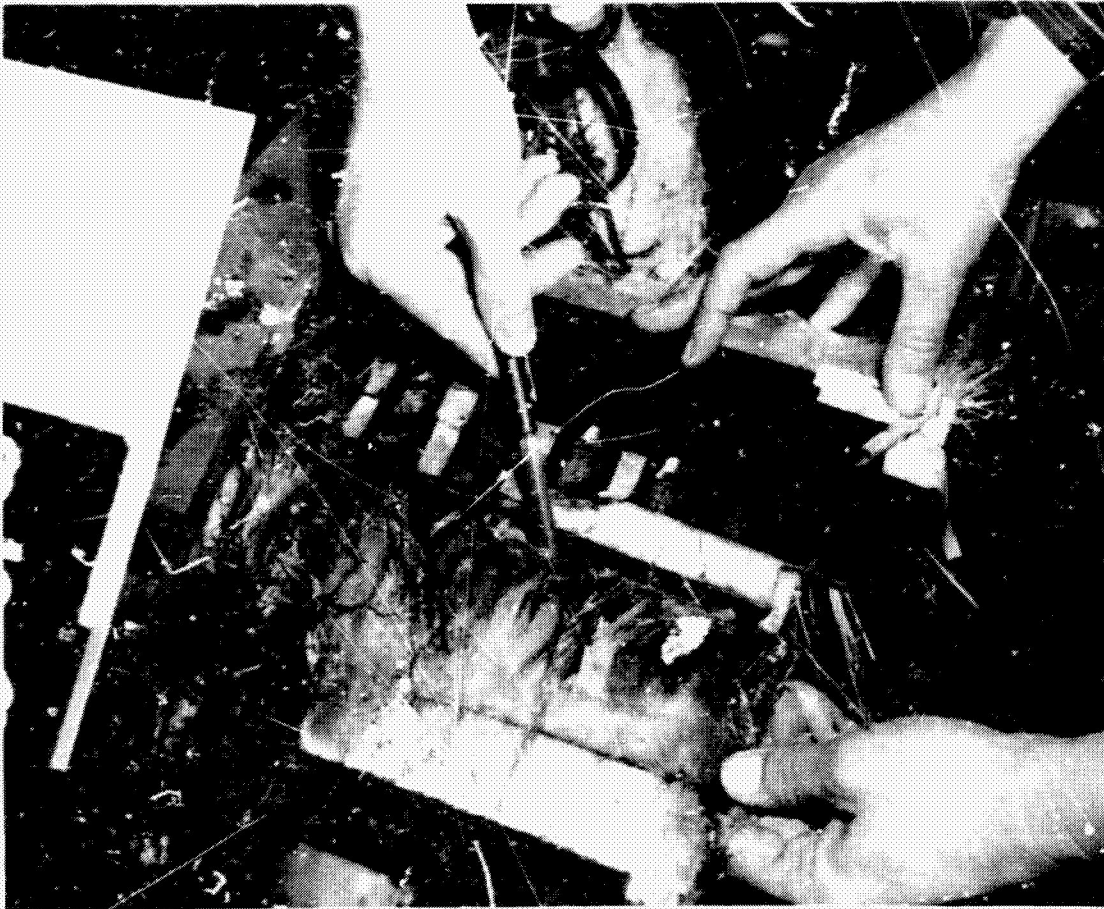
FIGURE 87 - POST-FIRING PICTURE OF FAILURE IN NPP-475 (A6)

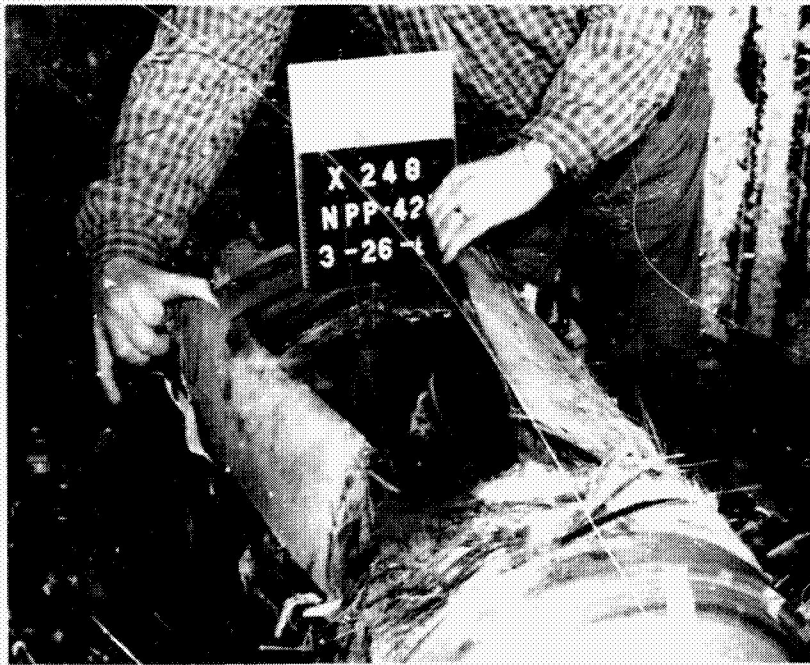
FIGURE 90 - POST-FIRING PICTURE OF S/N-425 (A6)

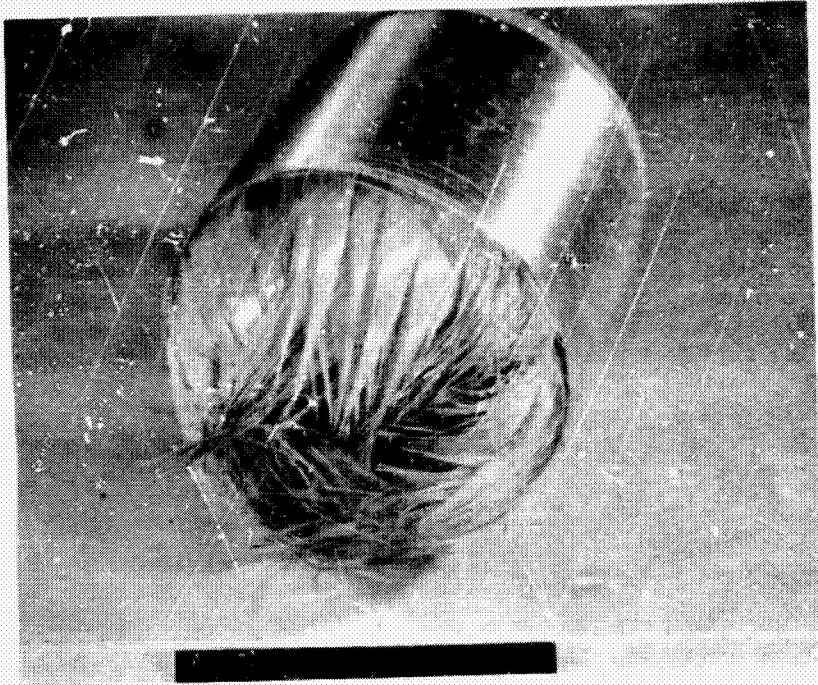
FIGURE 105 - FAILURE OF UNDEFECTED BOTTLE
