NAPTC-AED-1869

NAVAL AIR PROPULSION TEST CENTER
 AERONAUTICAL ENGINE DEPARTMENT
 NAVAL BASE, PHILADELPHIA, PA. 19112
 NAPTC-AED-1869 5 APR 1968

ROTOR BURST PROTECTION PROGRAM
 INITIAL TEST RESULTS

PHASE IV - FINAL REPORT
 PROBLEM ASSIGNMENT NASA DPR R-105

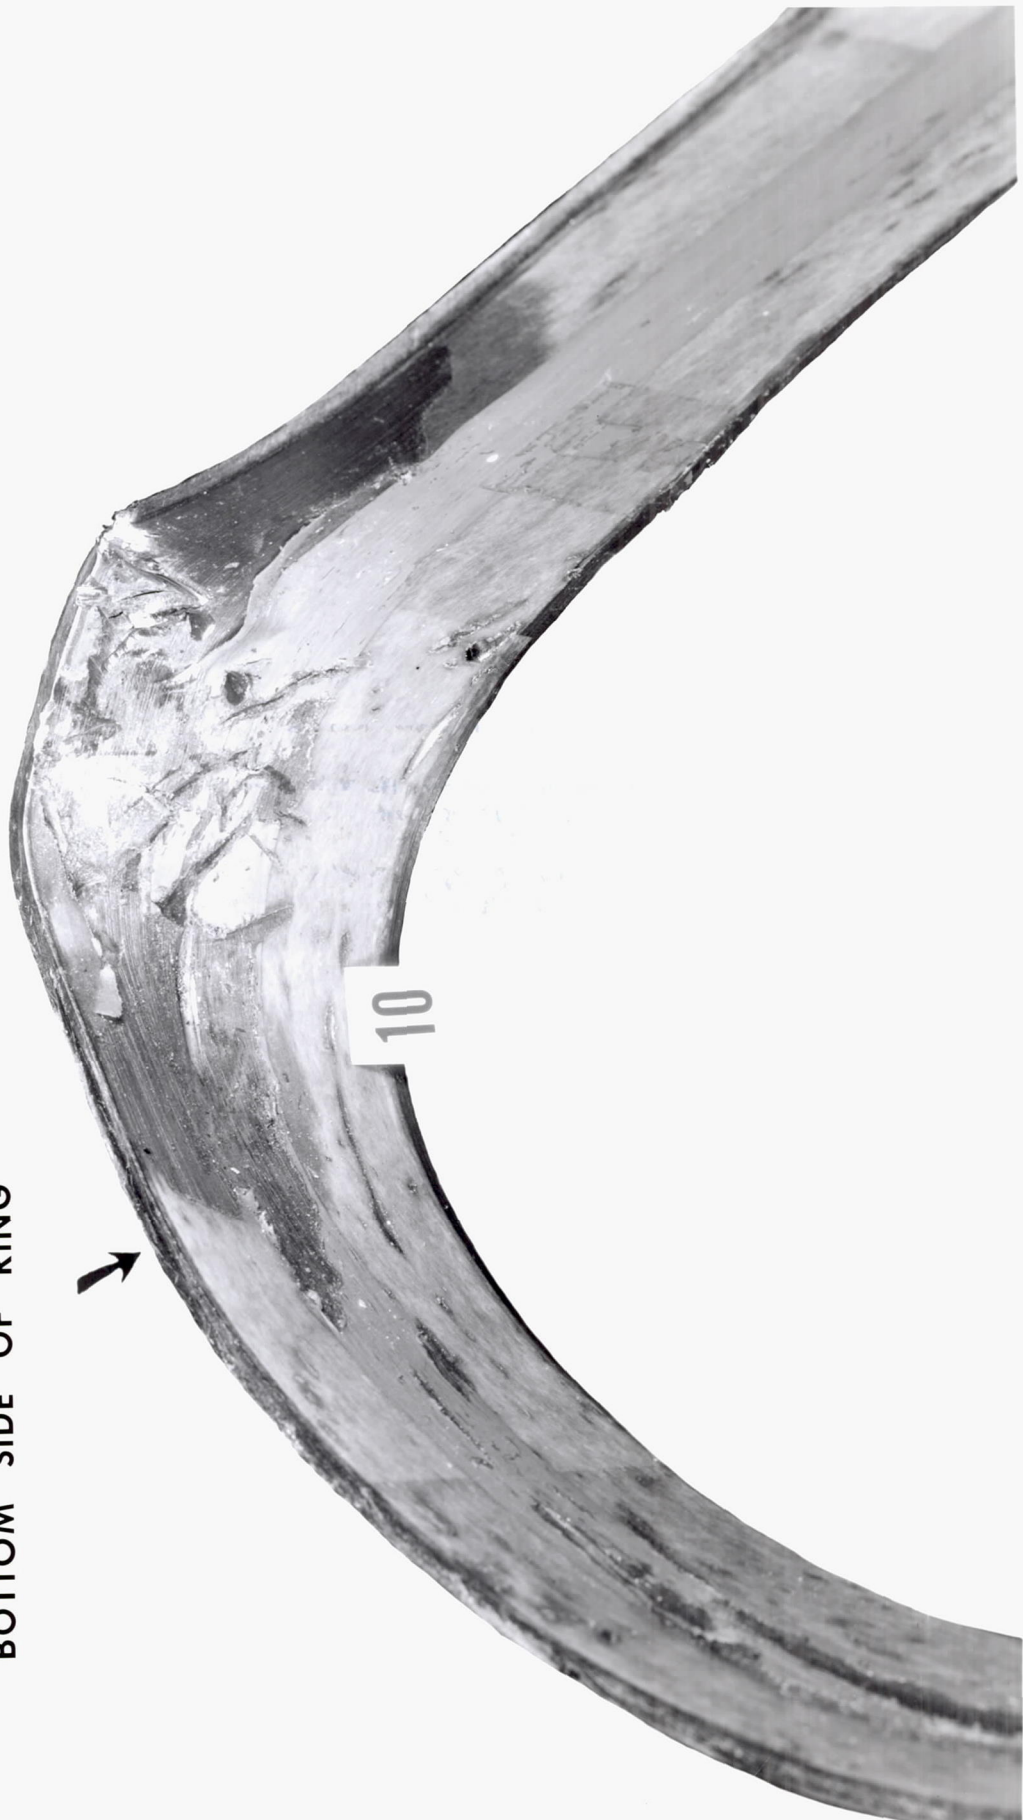
POST-TEST NO. 10
CONTAINMENT RING-IMPACT AREA DETAIL

BOTTOM SIDE OF RING

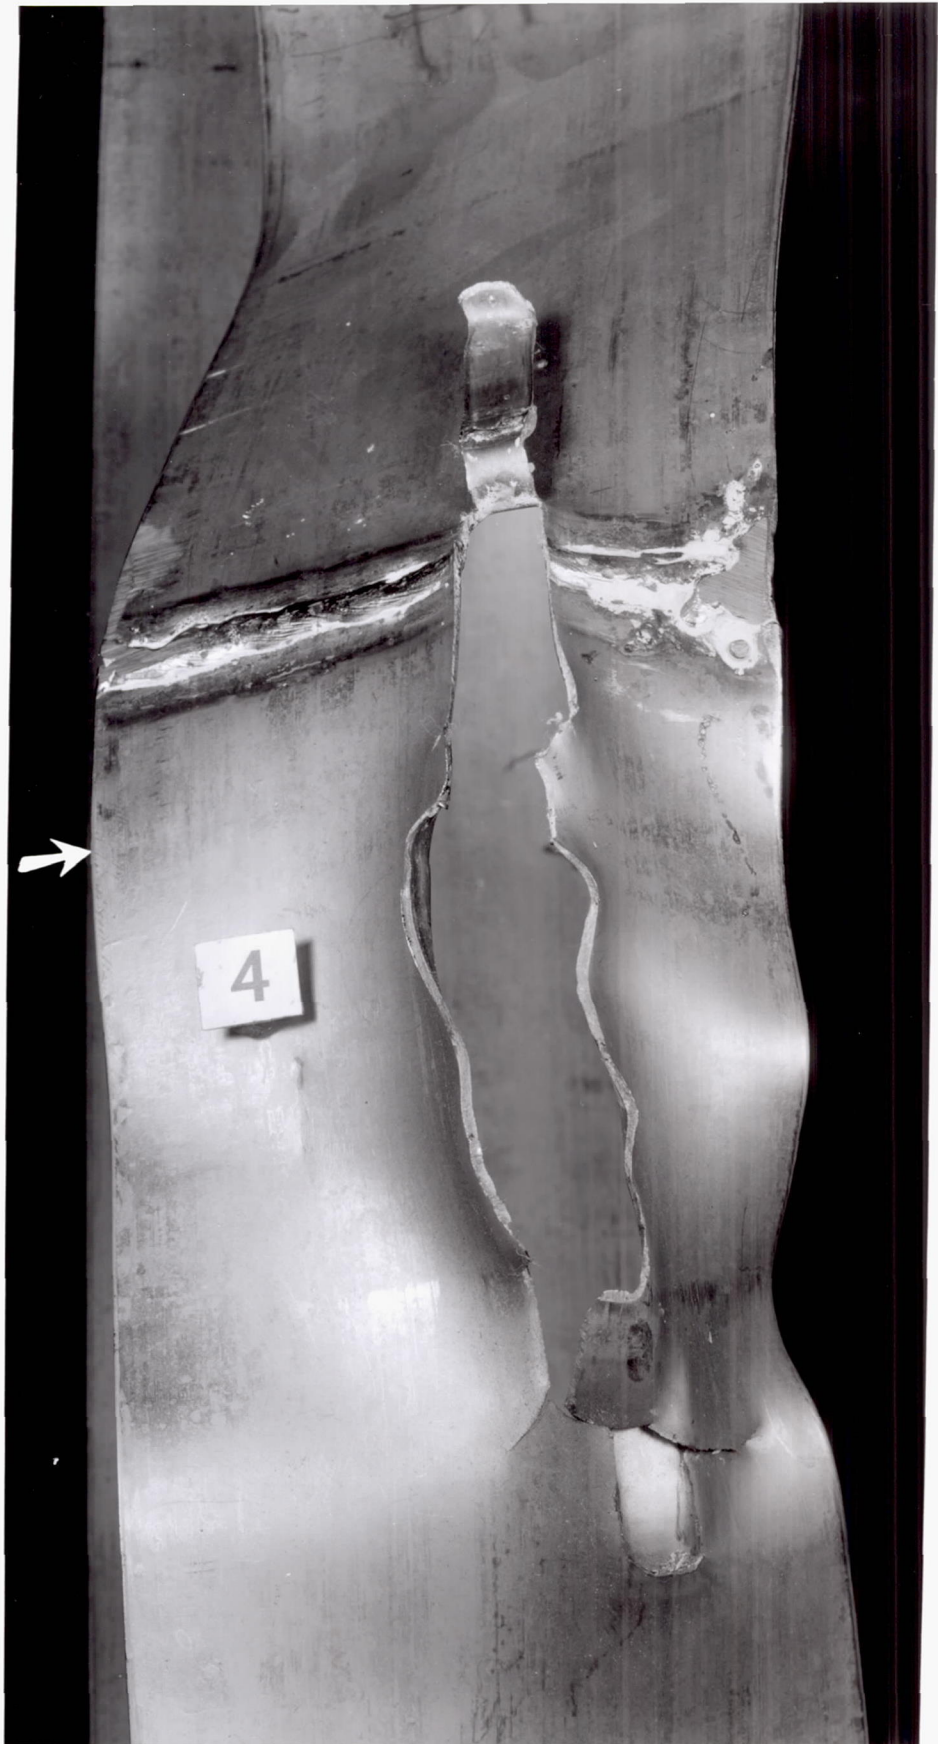
POST-TEST NO. 4
CONTAINMENT RING- FRAGMENT B IMPACTED AREA

Bottom side of ring

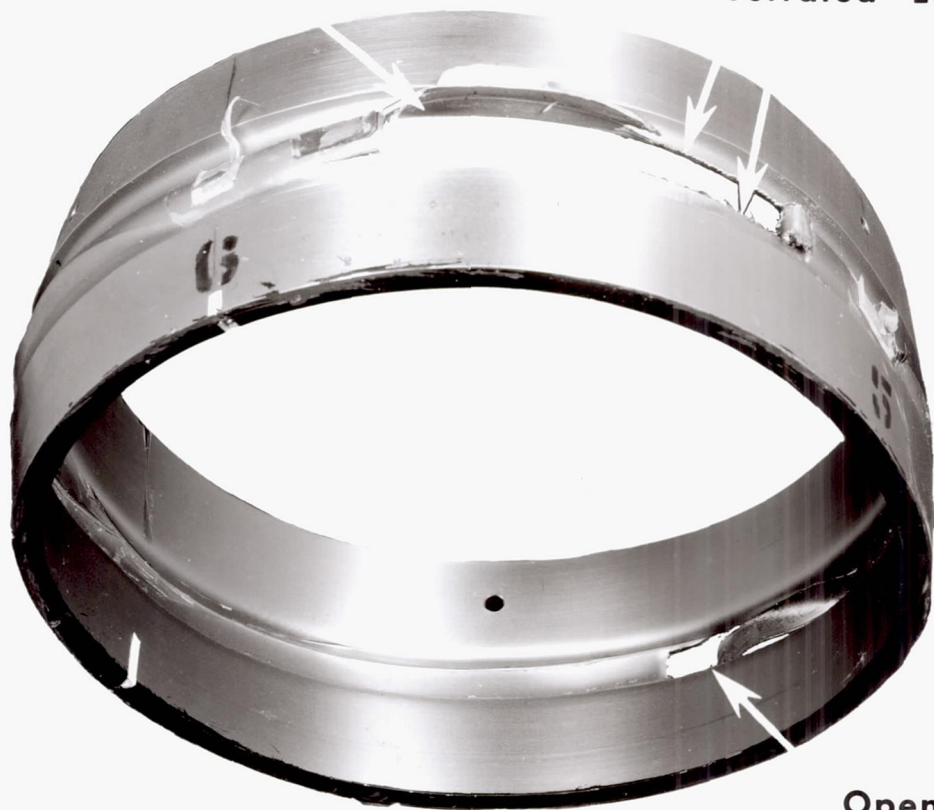
Opening "B"

Serrated Edges

Opening "A"
